Our Ref: 12632

Twywell Barn - Cottages

The purpose of the inspection was to review the structural condition of the Cottages now that the buttressing, recommended in the report of May 2023, has been installed. For reference Cottage 2 is at the north eastern end nearest the collapsed barn and Cottage 1 is more intact at the south-western end.

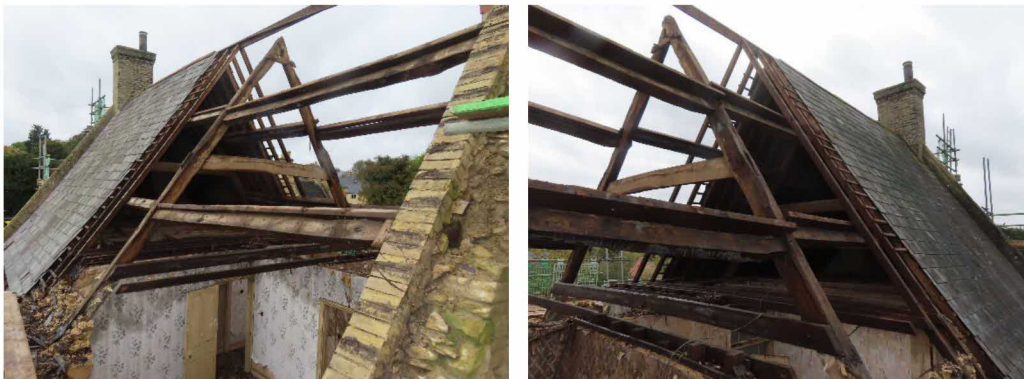
The rafters from Cottage 2 have been removed as the wall-plate had displaced excessively as noted previously. The purlins are still built into the gable which is advantageous to aid restraint.
