Our Ref: 12632

Twywell Barn - Cottages

Frank W. Haywood & Associates
November 2023

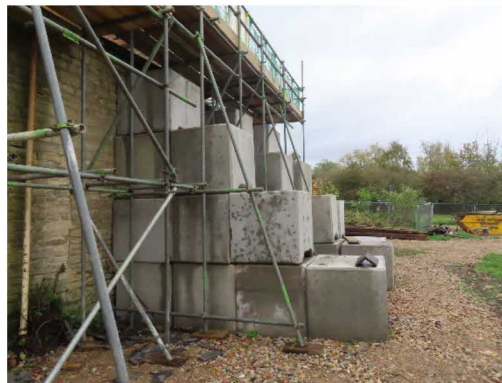
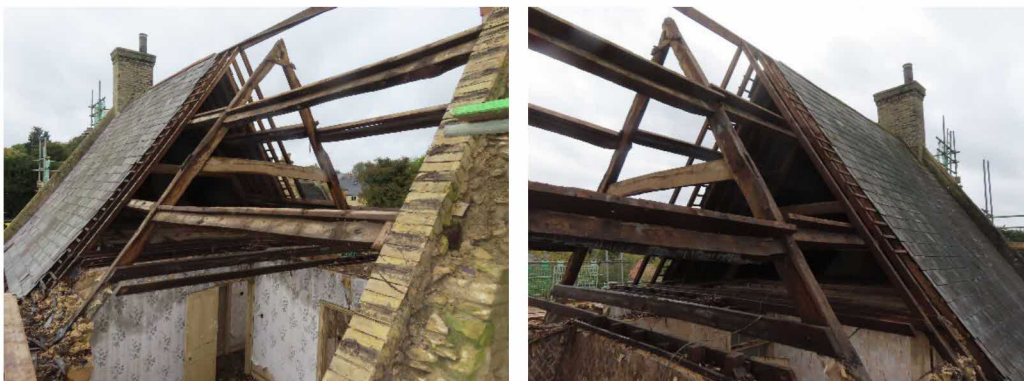
The rafters from Cottage 2 have been removed as the wall-plate had displaced excessively as noted previously. The purlins are still built into the gable which is advantageous to aid restraint.

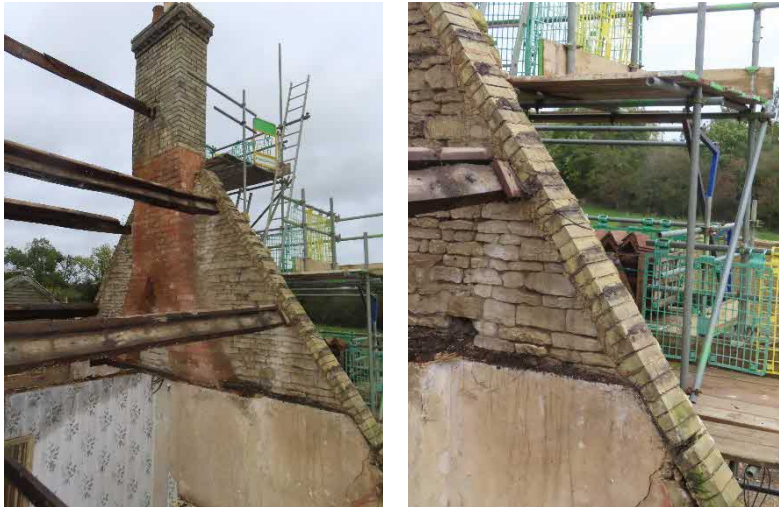
At the junction with Cottage 1, the purlins span between trusses which are located in the middle of each property. The purlins should be propped off the central party wall so that the roofs of Cottage 1 and Cottage 2 are independently supported.

There is a scaffold erected on the northeast gable which it is recommended is upgraded so that it acts as a buttressing scaffold. The chimney is leaning and it is recommended that this is taken down if safe access cannot be provided to restrain it to the scaffold.

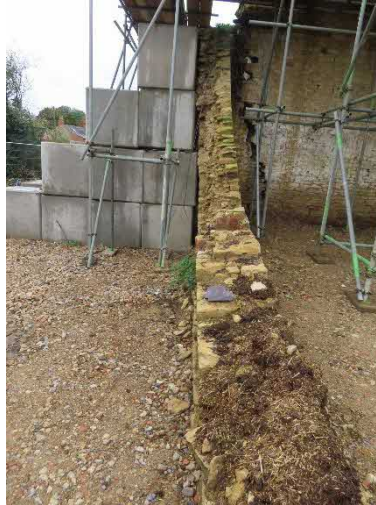
It is evident that the concrete buttress blocks are working as the wall is now leaning hard against them.
