Our Ref: 12632

Twywell Barn - Cottages

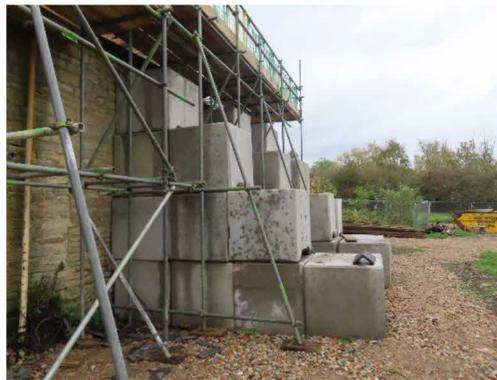
The purpose of the inspection was to review the structural condition of the Cottages now that the buttressing, recommended in the report of May 2023, has been installed. For reference Cottage 2 is at the north eastern end nearest the collapsed barn and Cottage 1 is more intact at the south-western end.

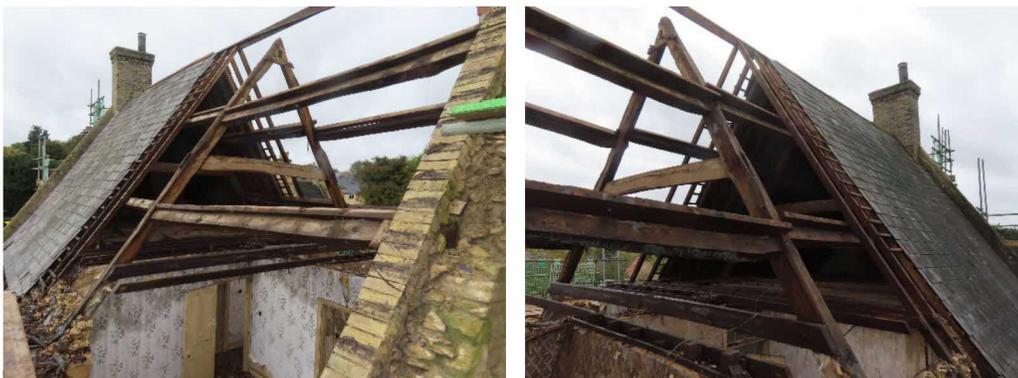
The rafters from Cottage 2 have been removed as the wall-plate had displaced excessively as noted previously. The purlins are still built into the gable which is advantageous to aid restraint.

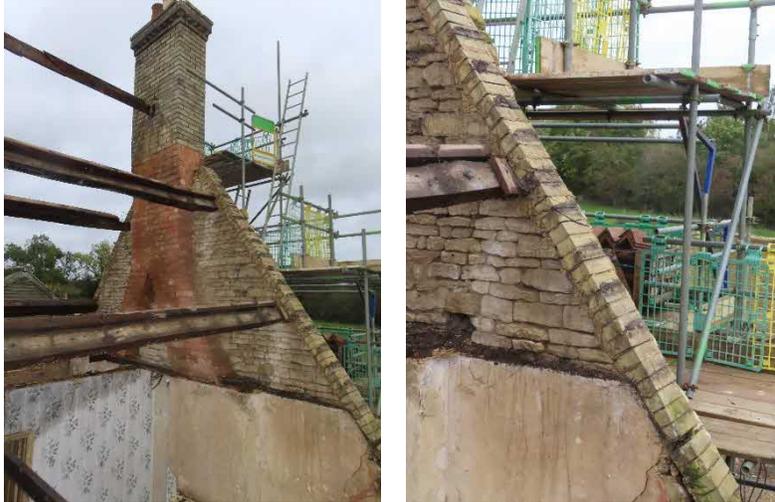
At the junction with Cottage 1, the purlins span between trusses which are located in the middle of each property. The purlins should be propped off the central party wall so that the roofs of Cottage 1 and Cottage 2 are independently supported.

There is a scaffold erected on the northeast gable which it is recommended is upgraded so that it acts as a buttressing scaffold. The chimney is leaning and it is recommended that this is taken down if safe access cannot be provided to restrain it to the scaffold.

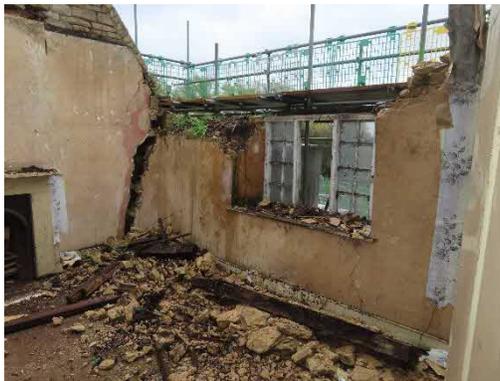
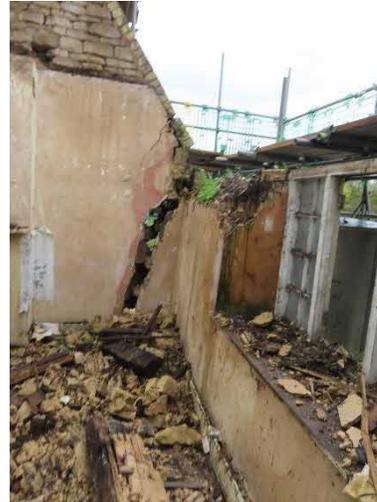
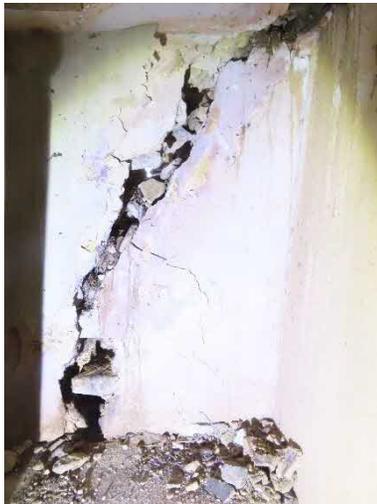
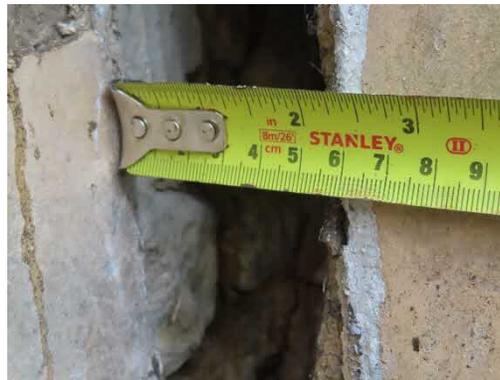
On the opposite side the ivy roots have caused noticeable damage and this will require removing and then repaired.

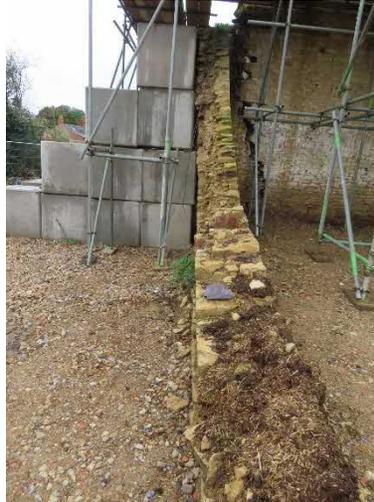
It is evident that the concrete buttress blocks are working as the wall is now leaning hard against them.
