## Mabel House 10a, Dartmouth Road, SE23 3XU

### Proposed Tree Works

### Crawford & Co Site Visit (15/11/23) Notes

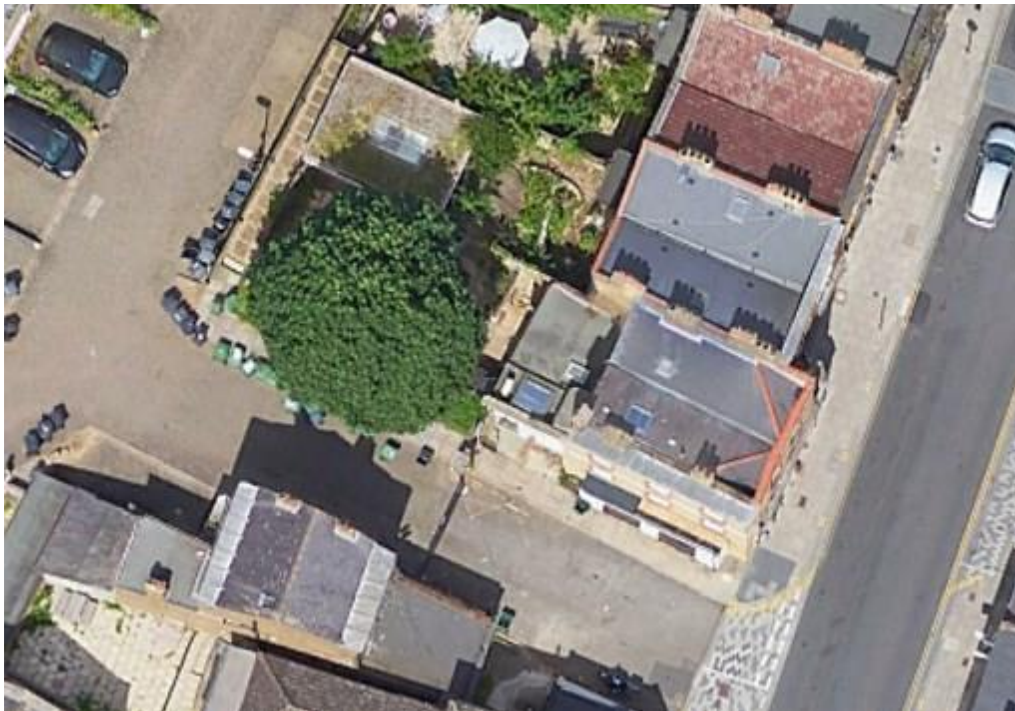
### Arial View of Tree

| Tree No. | Species | Height (m) | Dia (mm) | Work Details | Location |
|---|---|---|---|--|---|
| T1 | Sycamore | 10* | Unknown | Remove to as close to ground level as possible and treat stump to inhibit regrowth | Mabel House 10a, Dartmouth Road, London, SE23 3XU |

The damage evident appears consistent with the central section of the rear extension having experienced subsidence. Given the presence of the sycamore tree in the rear garden, I believe the cause of the movement is the result of root induced clay shrinkage. It's possible that the drains adjacent to the rear extension's rear elevation may have sustained damage as a result of root intrusion.
