**HISTORIC BUILDING RECORDING
OF THE FARMHOUSE AND BOTHY,
SPRING GRANGE,
WOOD END,
ARDELEY,
HERTFORDSHIRE,
SG2 7BB**

PCA REPORT NO: R15208

NOVEMBER 2022

Historic Building Recording

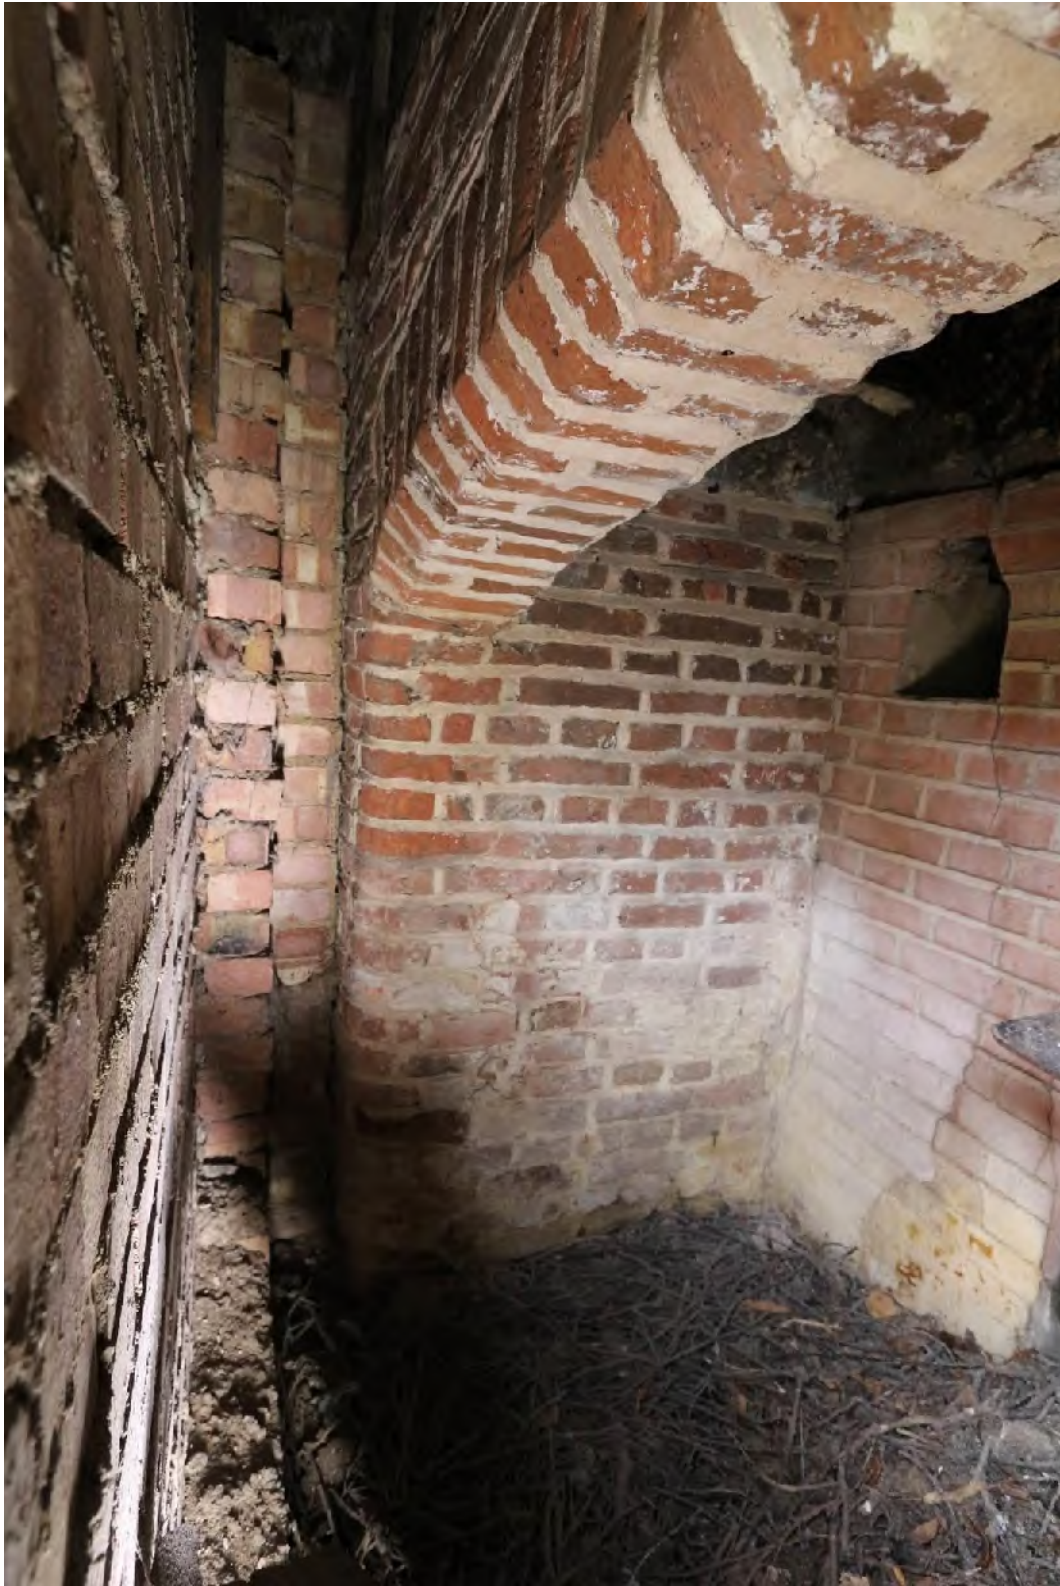
and first floor levels, reveal the eastern facing inglenook fireplaces (i.e., those corresponding to the fireplaces facing into the hall) on both ground and first floor. These 'sealed up' fireplaces share the same characteristics, built with wide Tudor style arches and narrow 17th century brickwork. The fire-back to the ground floor inglenook had been re-built or refaced using modern stretcher courses (**Plate 7**). The brick foundations of the lost eastern wing were still extant below an area of 'crazy paving' abutting the east side of the house (**Figure 11**; **Plate 8**). The bricks used were large, frogged bricks measuring 230x105-110mm x ? which represent a later 19th century underpinning of the east side, built as a foundation or dwarf wall of one and half bricks thick. The south-eastern corner of the brickwork was exposed, thus providing a width of 4.84m or 15ft 9 inches for the lost bay.

Plate 7 Inglenook fireplace behind Fletton blocking wall (left), east elevation

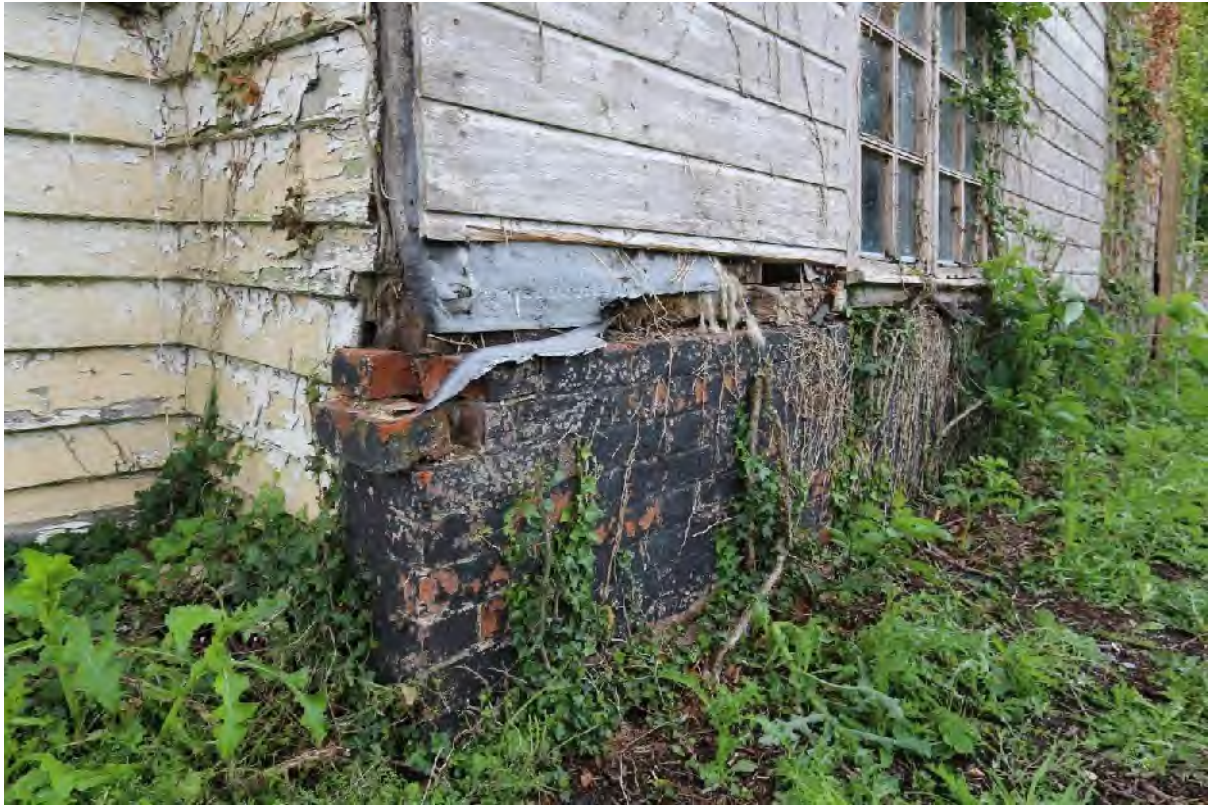
- 6.2.2 A brick-built dwarf wall, of nine (visible) courses, to which lowest course steps out by a quarter brick, extends the full length of the façade (**Plate 9**). It is built using large, frogged nine-inch bricks (230x105x70mm) laid in a sandy lime mortar, and is clearly a later addition built during the 19th or first half of the 20th century. The loss of some lengths of weatherboard reveal that the dwarf wall carries a much-decayed wall plate, comprised of re-used timber. The guttering is plastic and deformed, while the rainwater downpipe to the east side is cast-iron. The roof of the hall has been recovered using cement tiles, laid in regular courses and half round ridges. The chimney stack, situated at the eastern end of the present roof, is a large 17th century brick-built stack, with four in-line, diagonally-set, shafts. They are plainly built, rising from a base or pedestal with three prominent brick strings, and each shaft finished using two courses of oversailing brickwork.

Plate 9 Rebuilt dwarf wall and ship lap boards to south elevation

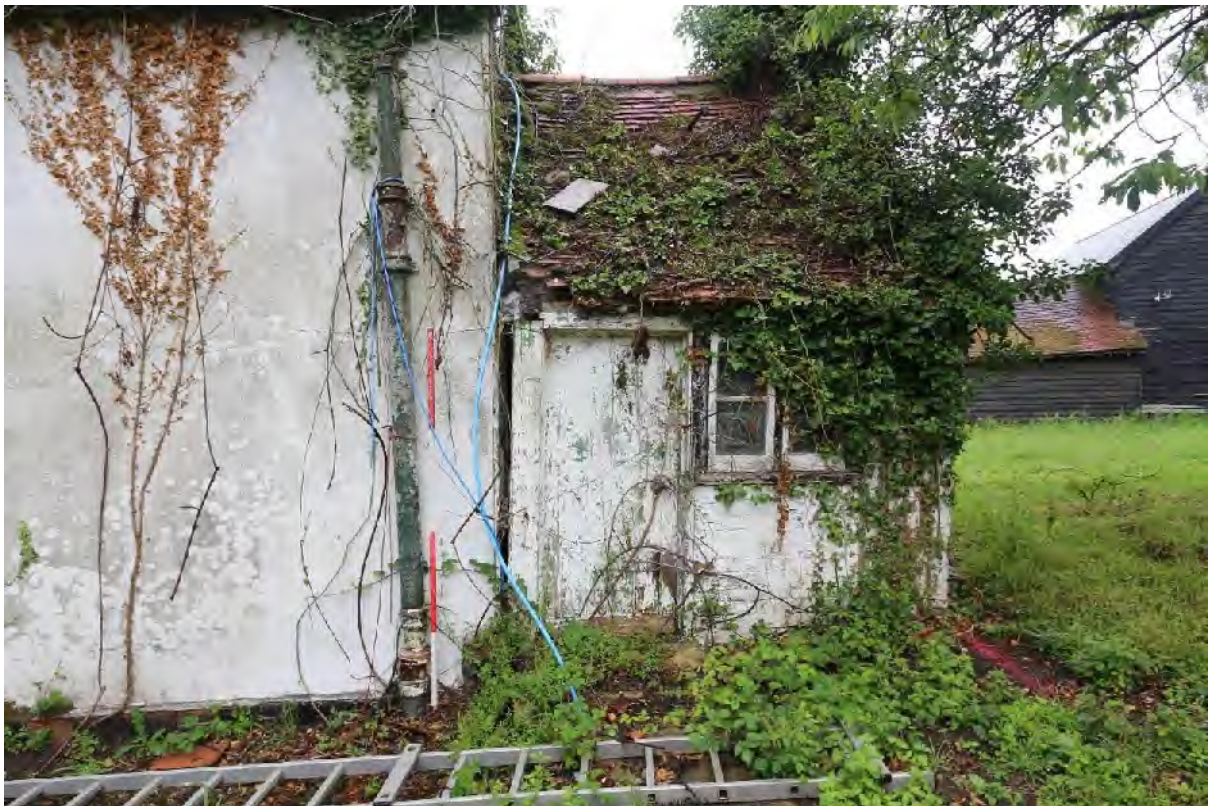
Plate 12 Small in-line extension pulling away from cross-wing

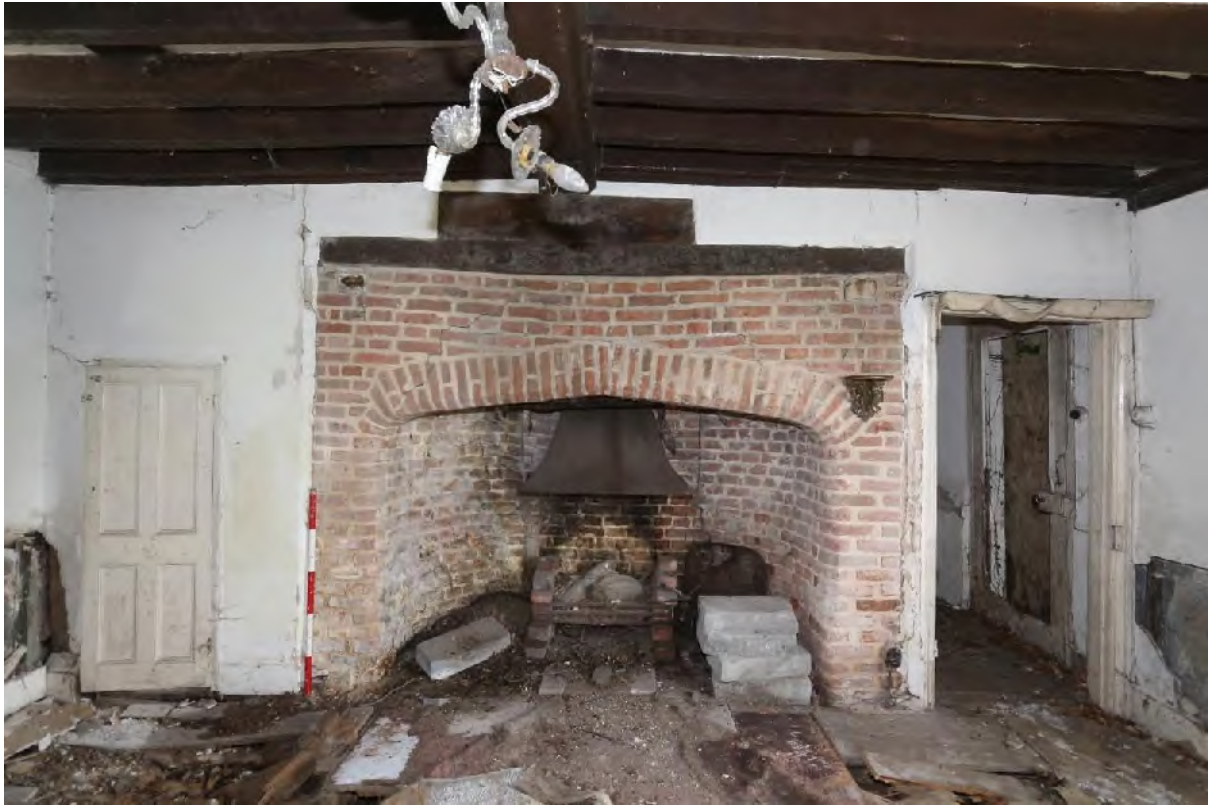
- 6.8.1 The living room floor had been reboarded using 7-inch softwood boards, but had deteriorated badly, collapsing in places, particularly to the east side and in the area of the fireplace (**Plates 17 and 18**). The room was crossed by a central axial beam, which aligned with that in (G1) (**Figures 12 and 15; Plates 17 and 18**) but was set much higher, at 2.35m (7ft 7ins) above the floor level, compared with 1.95m (6ft 4ins) for (G1). The height of the ceiling in (G2) is unusually high for a building of this age, although the hall, which is contemporary with the 17th century brick chimneystack, was clearly built over two floors, and given the level of the fireplaces at first floor, the ceiling height must be correct. The axial beam is of similar scantling at 9x10 inches and has deep soffit chamfers, stopped using an angled runout with a raised step (**Plate 19**). The ceiling/floor joists are laid in deep section (distinctly post-medieval) set at 13-inch centres and measure 6x3 inches scantling. They are regular timbers which are clearly hand or pit sawn and without decoration. Nail hole evidence to the soffits would suggest that they had been enclosed by a plaster ceiling. The eastern end of the axial beam is set into the brick chimneystack and rests directly on a timber pad, which in turn is supported by a 5½ inch scantling timber lintel spanning the full width of

- 6.8.2 The inglenook fireplace is constructed using hard red bricks (measuring 225-230x50x100-105mm) originally laid in lime mortar, but badly repointed using a cement-based alternative (**Plate 17**). Its arched opening is built with a Tudor or four-centred arch which incorporates squint bricks to the arch soffit. The fire back is built with a quarter round at each end and the hearth is stone flagged. Deformation of the arch and cracking within the brickwork suggest some structural movement has occurred.

Plate 17 Inglehook fireplace in (G2), looking east

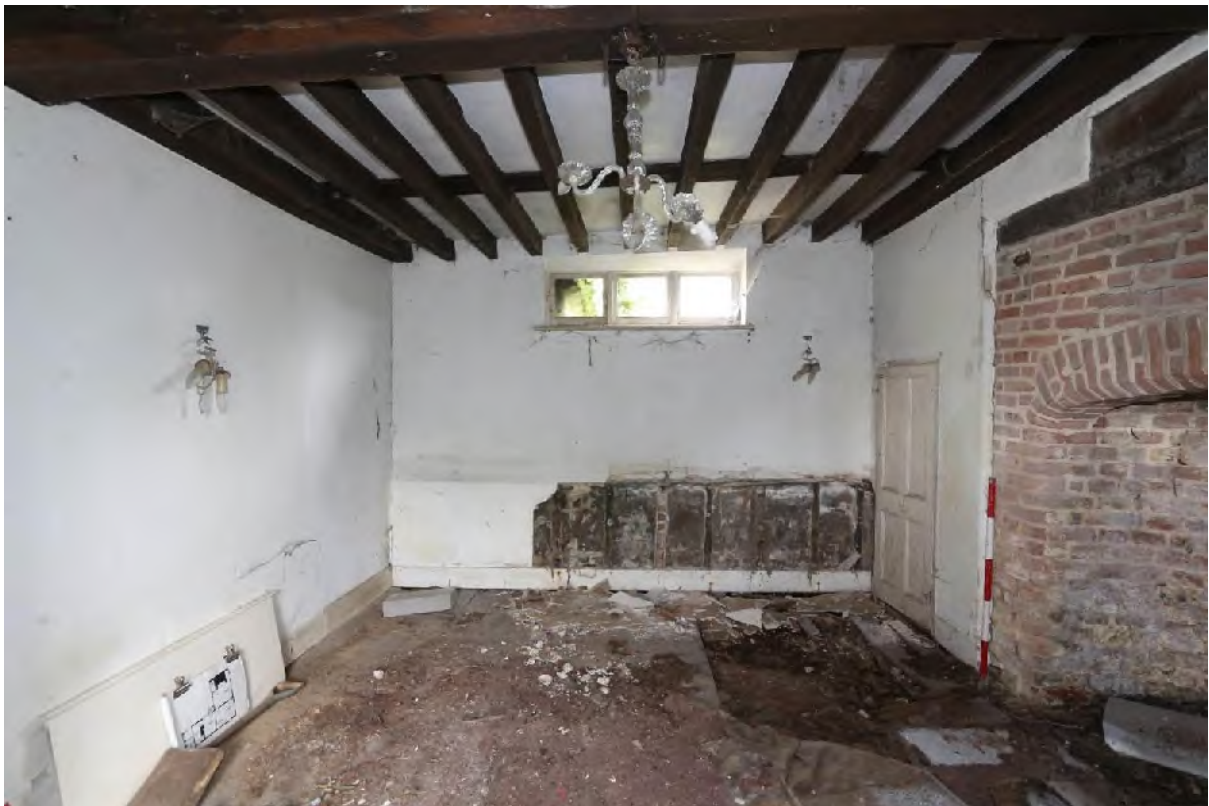
Plate 18 Living Room (G2) looking north

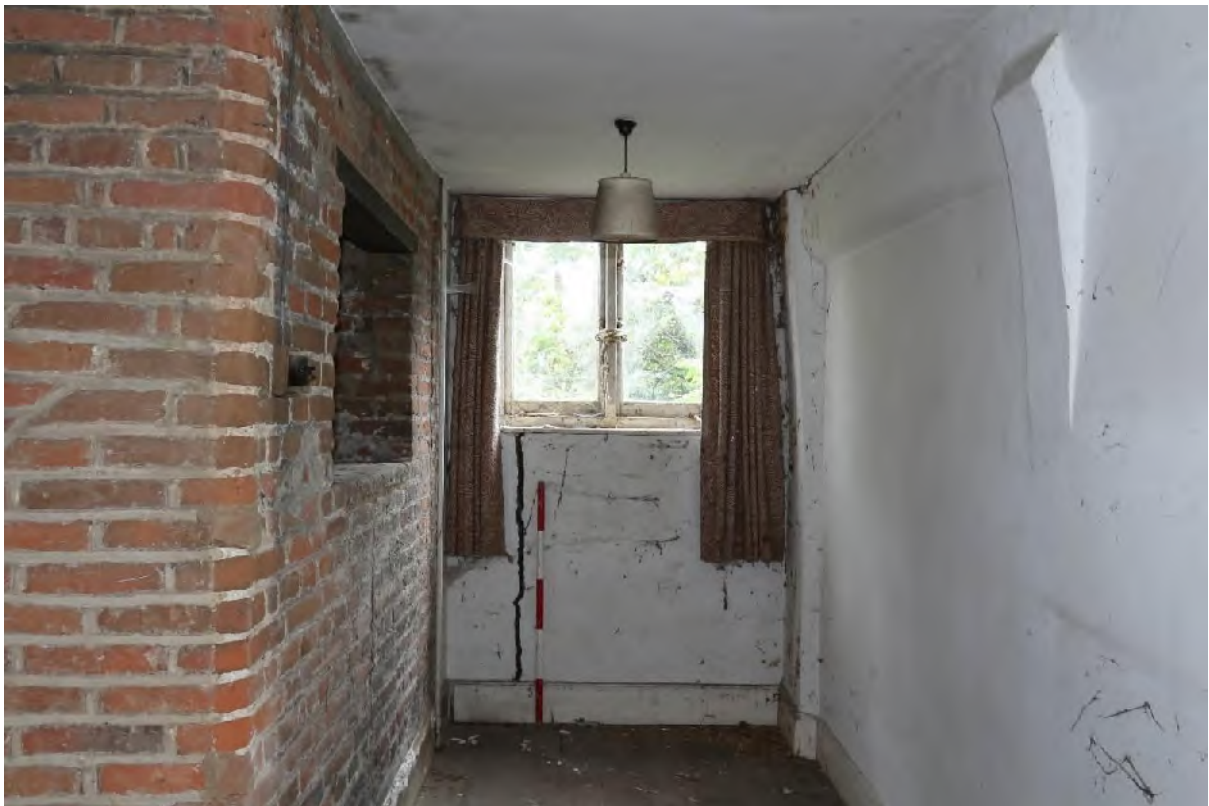
Plate 34 Bedroom (F2), detail of jowled posts (right) and structural crack in blocking wall

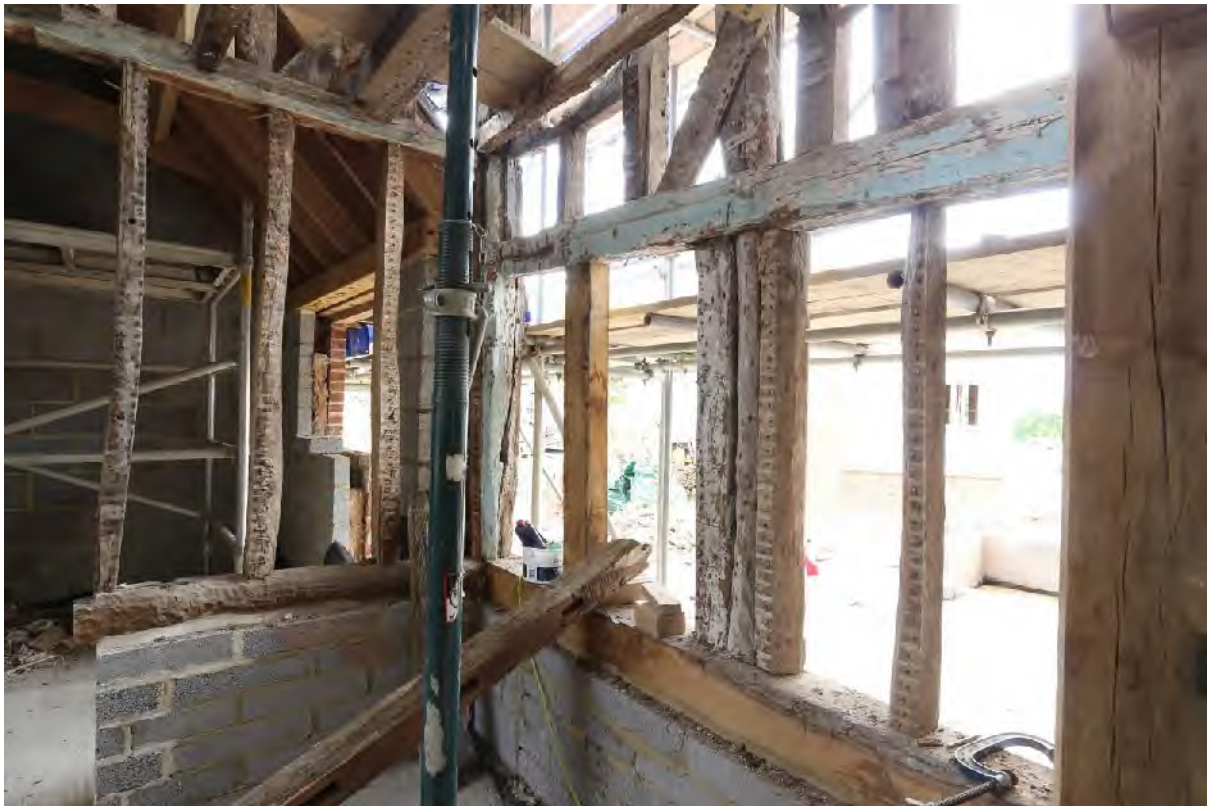
- 6.10.5 The original studwork in the lower register of the east wall (below the mid rail) has been replaced, those present either waney edged and halved over the outer face of the mid rail and nailed in or re-used studs and new (Plate 66). The sill plate is recent and sits, like the northern wall to (G4) on a rebuilt blockwork wall. The upper register is visible and includes a large internal tension brace between storey post G3/G4 and the mid rail.

Plate 66 Eastern wall in (G4)

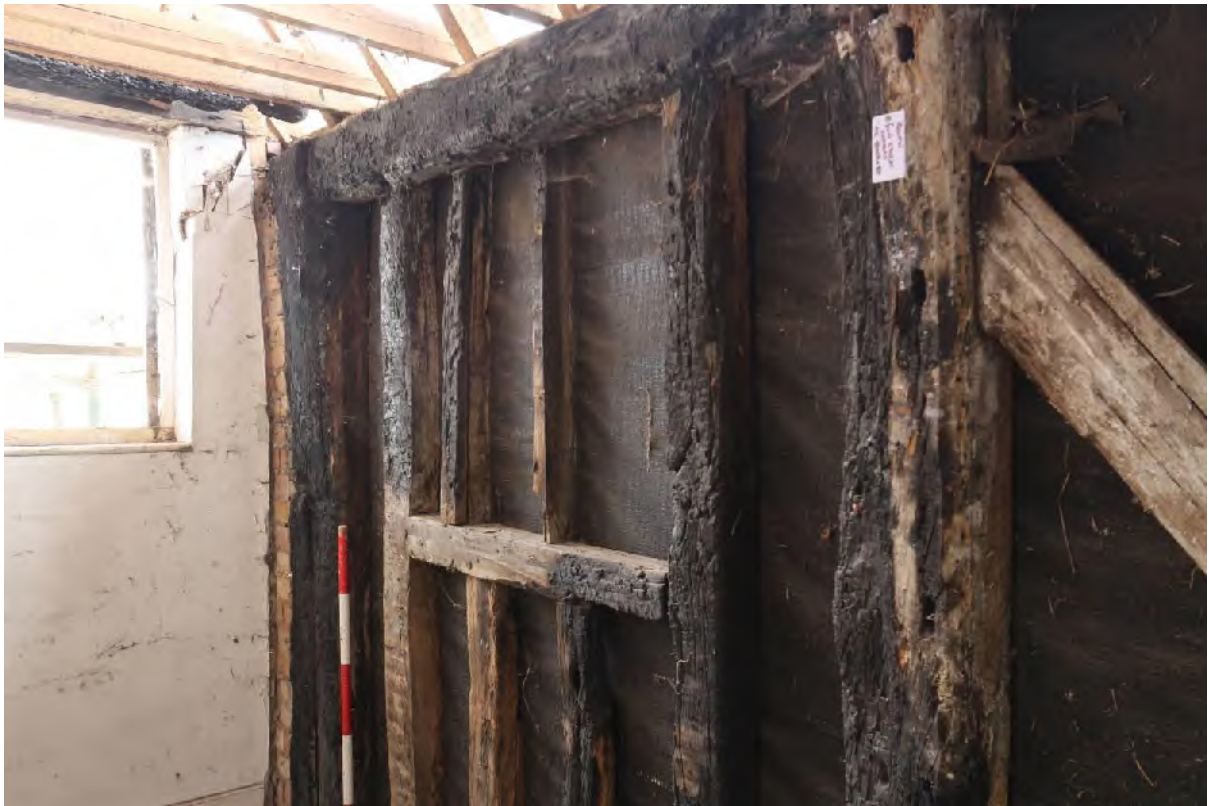
Plate 78 Southern wall to (F2), showing former window and burning
