Manor Farm Swindon Village Gloucestershire

**Historic Building Recording and
Archaeological Monitoring and Recording**

Archaeology Warwickshire
Report No. 2438
Date: March 2024

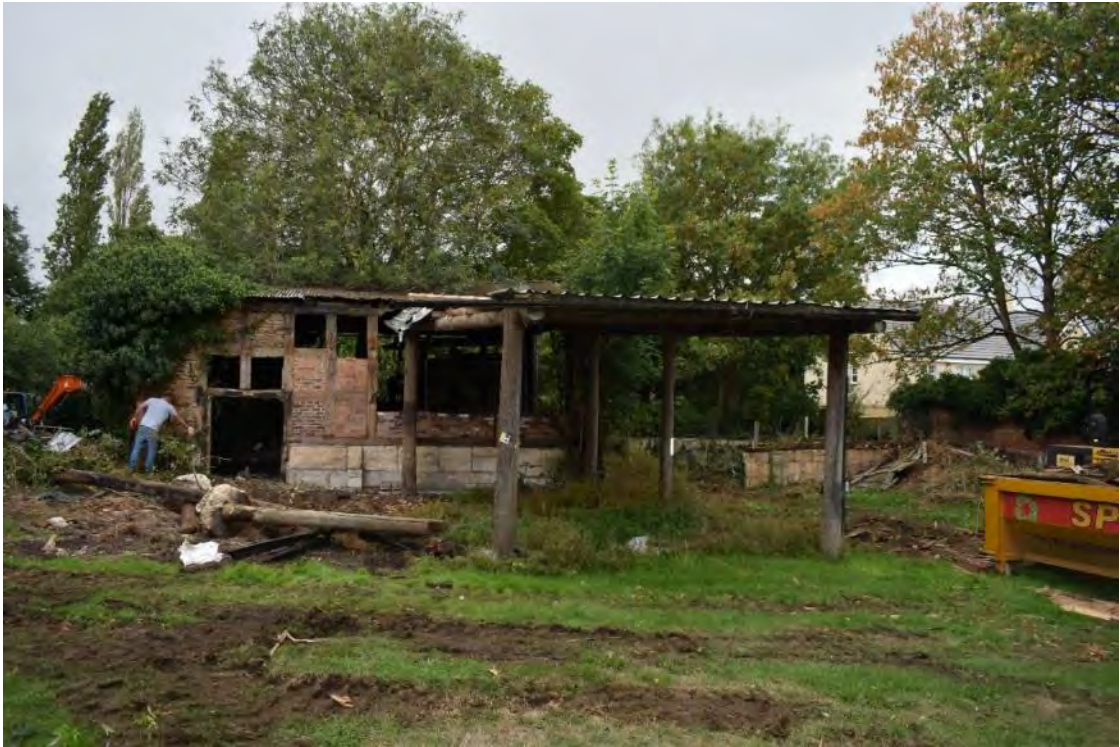
- 5.1 The barn (structure K/J) and its environs were photographically recorded on September 8th 2022 using a Nikon D3500 camera with images captured as RAW images and jpegs. A scaled ground plan of the building was also made (Fig 6). No elevations had been provided of the building which was heavily obscured by vegetation and in danger of collapse. Weather conditions were variable, starting sunny and developing into heavy rain by late morning, clearing later. The four-bay timber-framed building was in poor condition with damaged timbers and areas of broken weatherboarding oversailed by rusted metal sheeting but was generally clear inside. Its height and proportions indicate that it was a barn with the threshing floor likely to be where the current through-way is, in the second bay in from the north-west. A pole barn (I) stood immediately to the building's north at the time of recording (Photo 1).

1 Timber-framed barn, north-east side, with pole barn in front

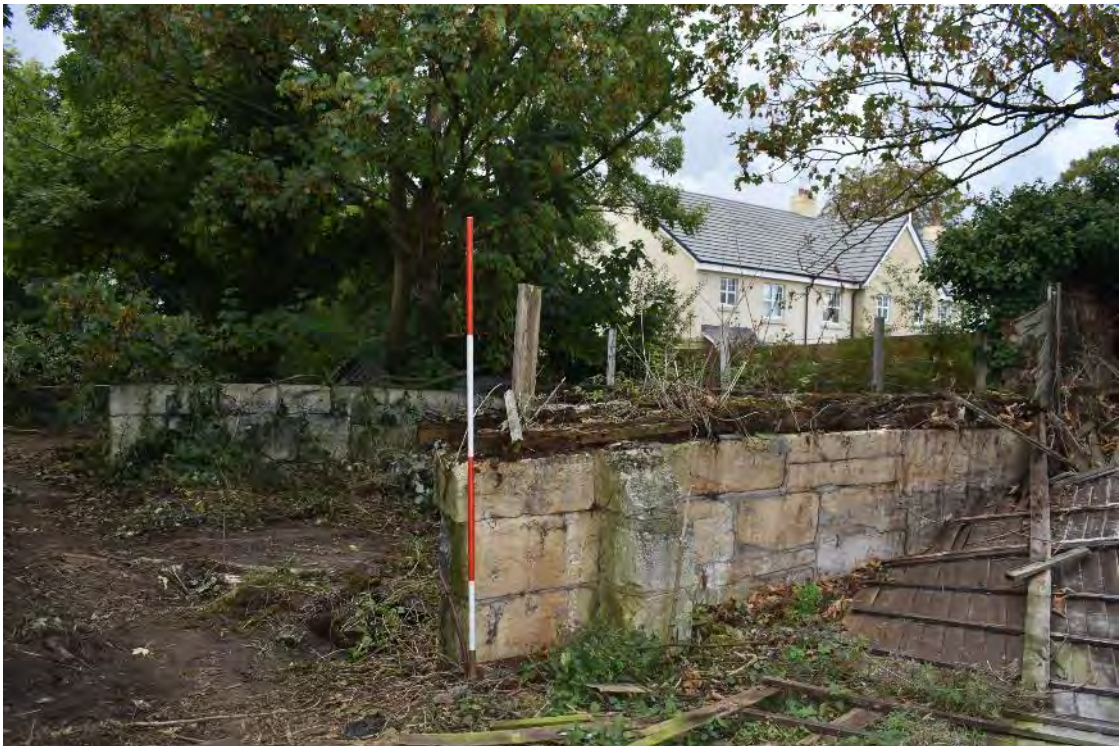
- 5.2 The north-western bay of the building (indicated by the letter K on plans supplied) consists of a well-built stone plinth, on which the sill beam rests, but there is no other superstructure (Photo 2). This part of the building has vegetation within it and to the sides. The south-east two bays of the building are standing to tie-beam level but the roof trusses have gone and the roof has been replaced by corrugated iron. Above the stone plinth the building is timber-framed, with the box-framing on the south-west side infilled with brick nogging of various dates, from what appears to be small 18th-century bricks to larger 20th-century bricks (Photo 3). The doorway on Photo 3 has been created by removing parts of the horizontal and vertical members of the timber framing, and plinth and inserting a timber door surround, bolted onto the sill beam on one side. On the south-west side the timber-framing is covered by weatherboarding, which also has metal sheets fixed to it (Photo 4). It is likely that the building was

2 Stone plinth of western part of building, without superstructure

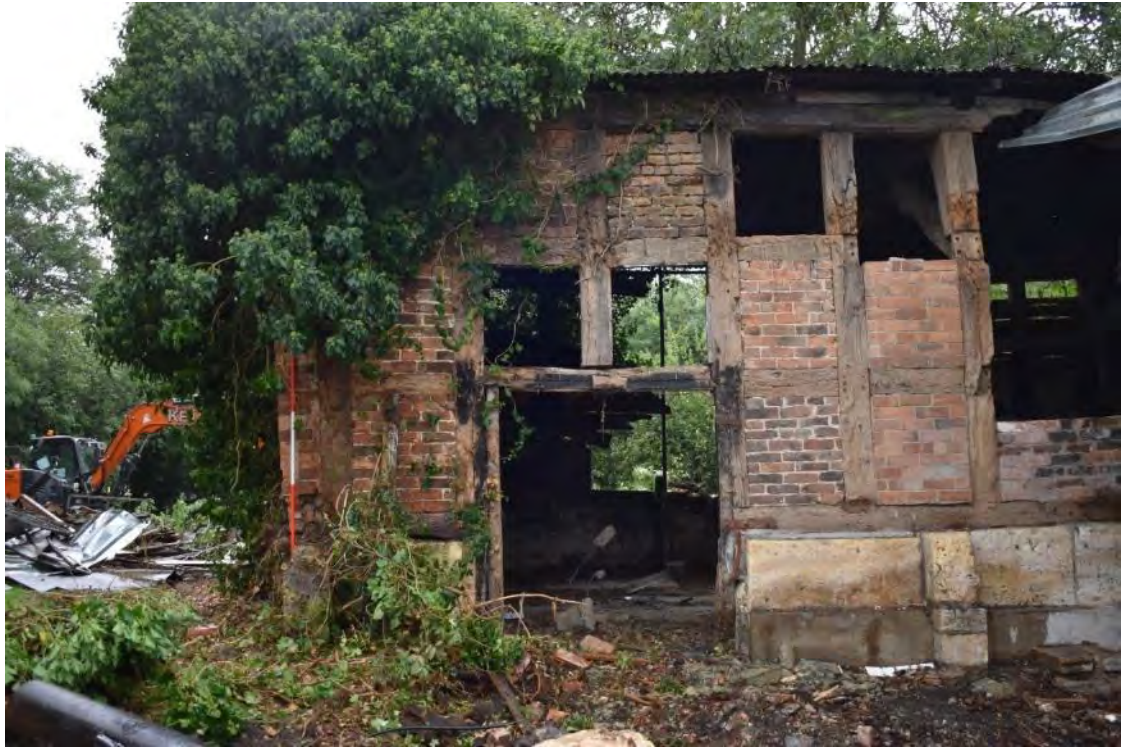
3 Box framing on north-east side of barn

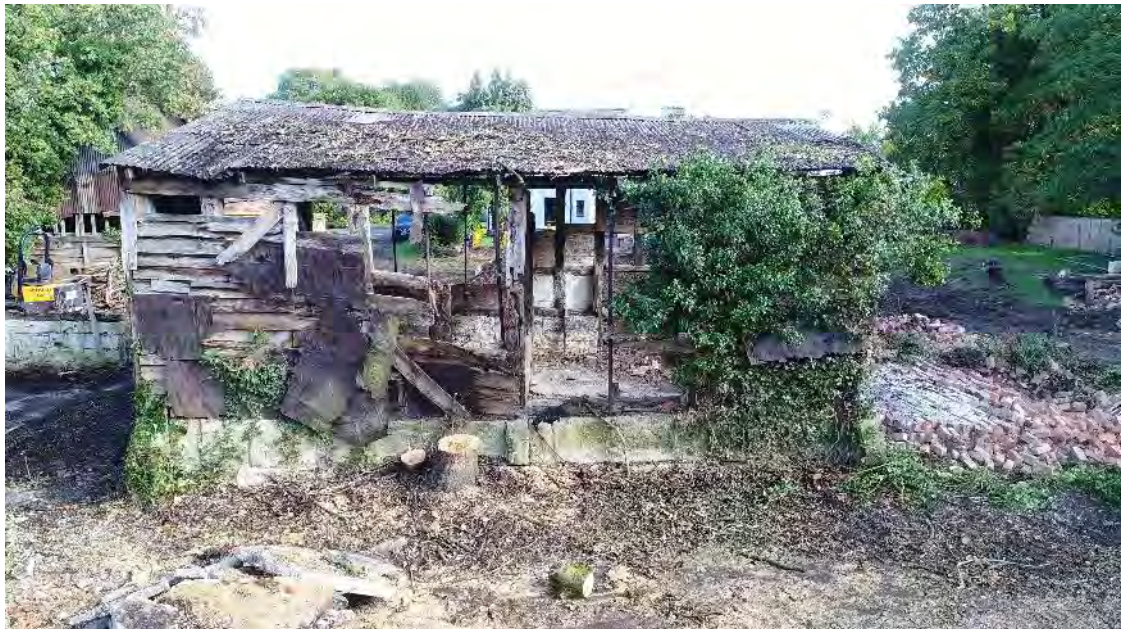
4 Weatherboarded south-west side of barn after removal of trees

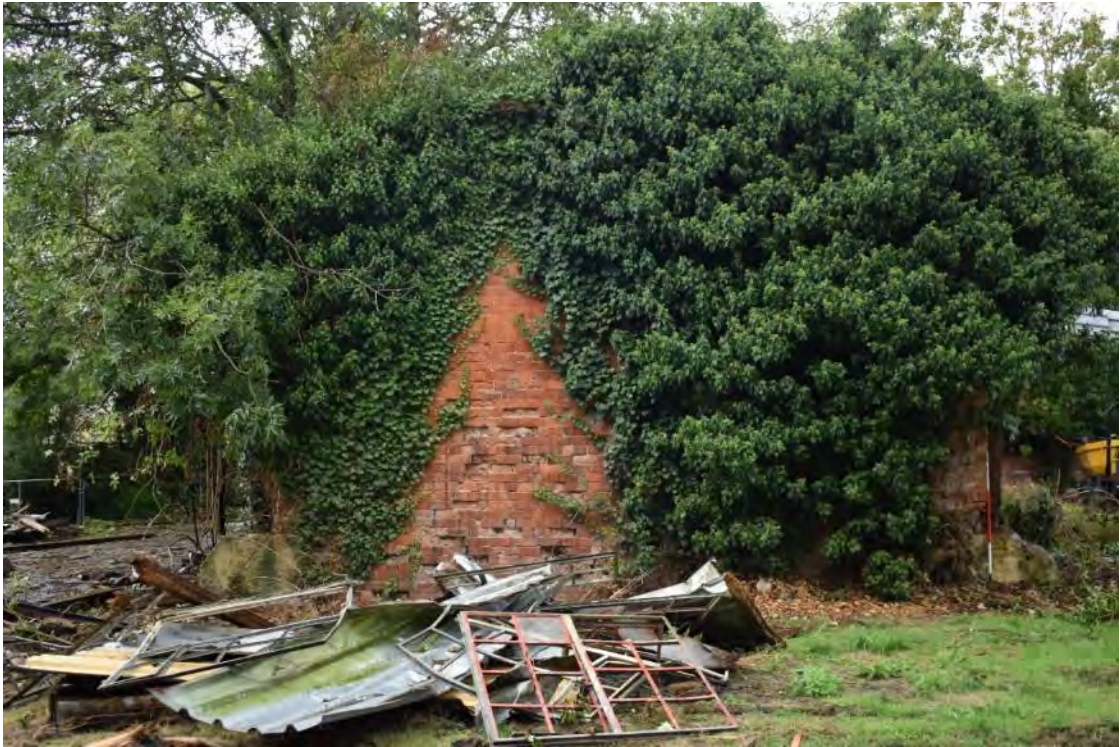
5 Brick gable, overgrown with ivy

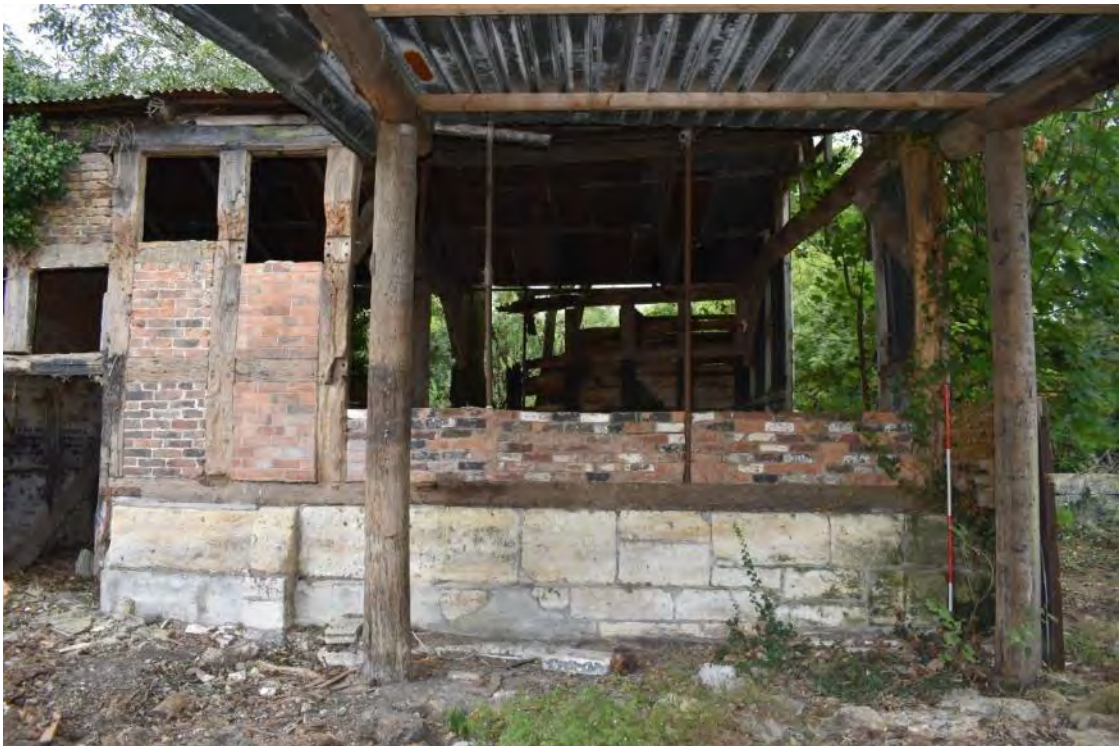
- 5.5 In areas where the timber-framing has rotted or collapsed the wall plate is supported by iron poles. On the north-east side the area between the poles and timber uprights has been partly infilled with seven courses of bricks, of various sizes and dates, many with traces of paint on them (Photo 6). On the south-west side a single iron pole replaces an area of framing where two timber uprights would have been, but no brick infill has been attempted (Photo 7). Photo 8 shows the likely location of the former threshing floor. The north-western end of the standing part of the building has been partly covered with corrugated iron sheeting (Photo 9).

6 Area where timber framing has been replaced by iron poles and brickwork

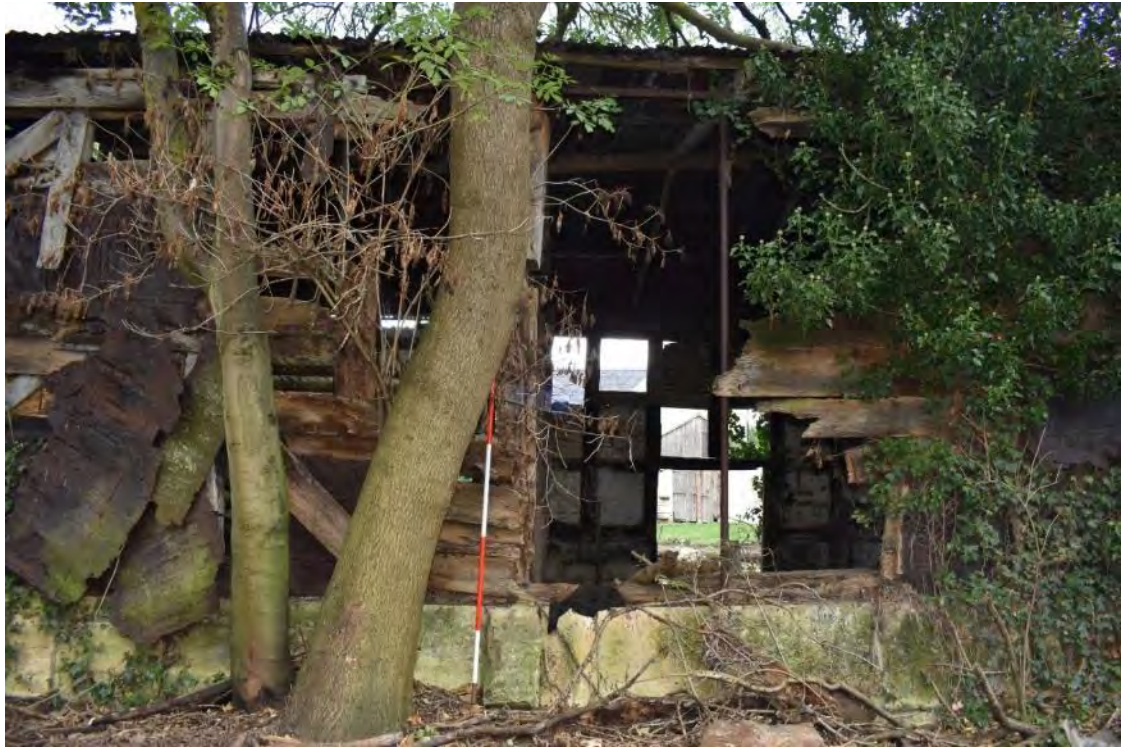
7 South-west side of the building with timber framing replaced by iron pile

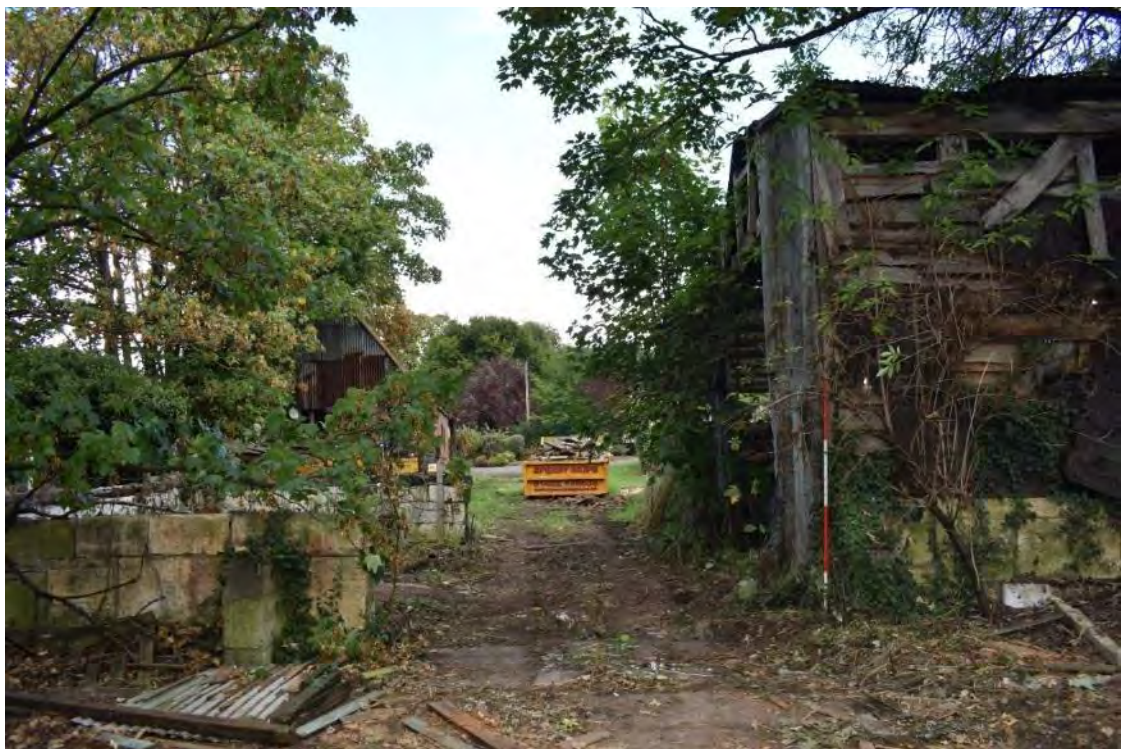
8 Bay of former threshing floor

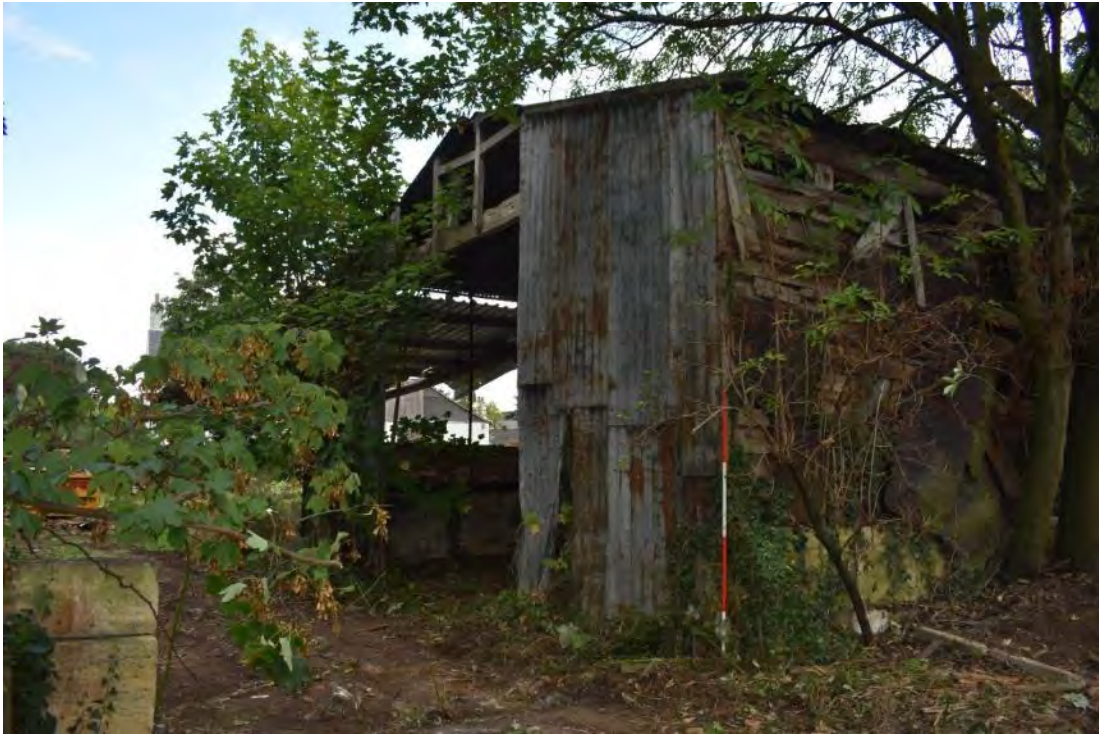
9 Former internal bay division, subsequently covered with corrugated iron sheeting

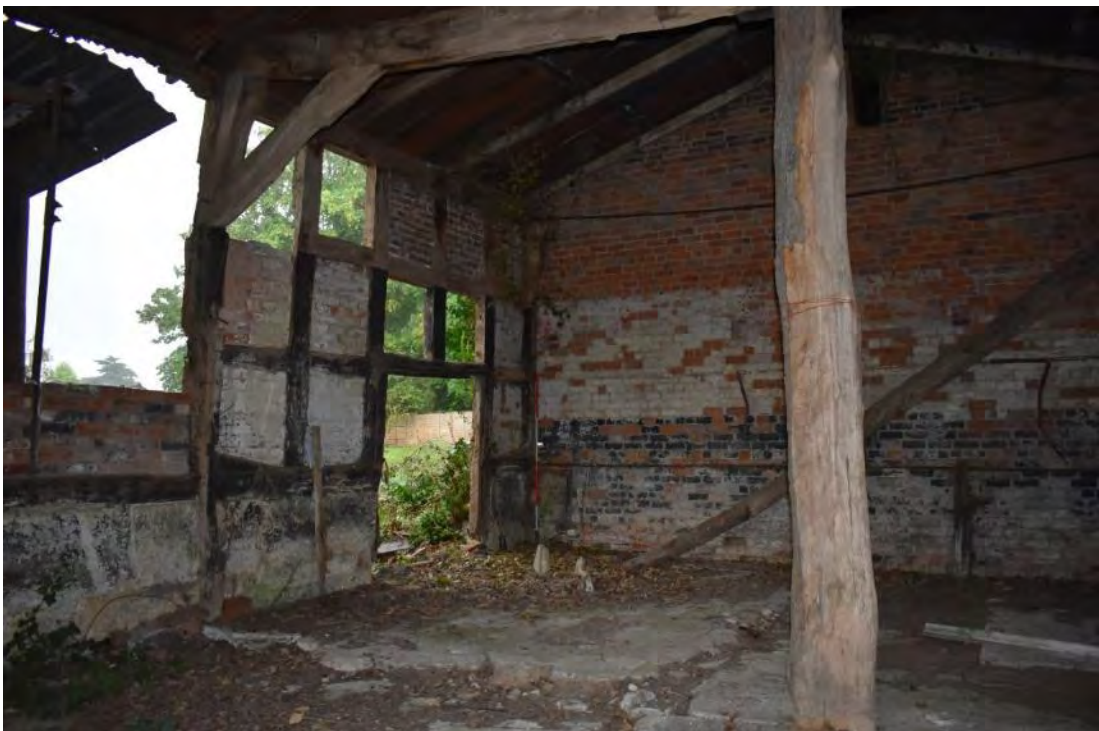
10 Interior of the barn, with concreted floor and partly painted walls and timber framing

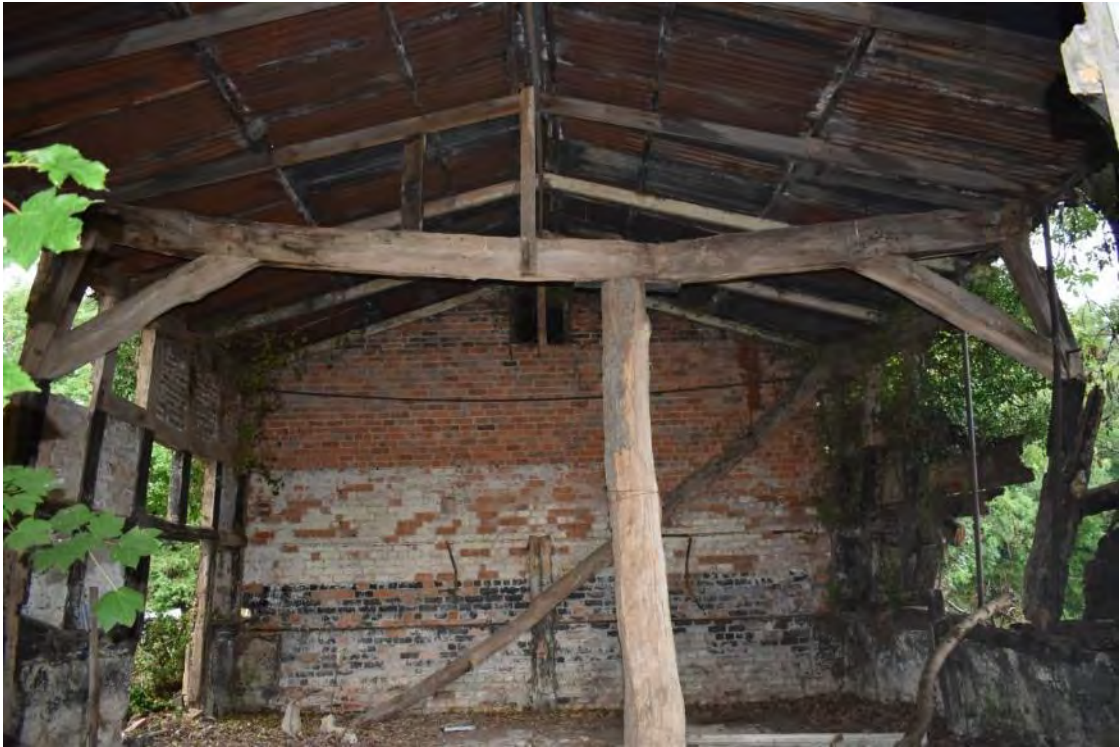
- 5.7 As can be seen in Photo 11 the original roof has been replaced by a low-pitched modern roof and the tie beam is supported with braces to the wall posts; the tie beam is also directly supported by an upright pole as the wall post on the south-west side was collapsing. Pairs of peg holes in the tie beam suggest the roof was originally of queen-post construction. The timber framing in the side walls use face pegged halved joints rather than using mortise and tenons (Photos 12 and 13). In some instances bark was still present on the timbers (Photo 14). The braces were jointed with mortice and tenons (Photo 15).

11 Brick gable wall with mull pitching window near apex

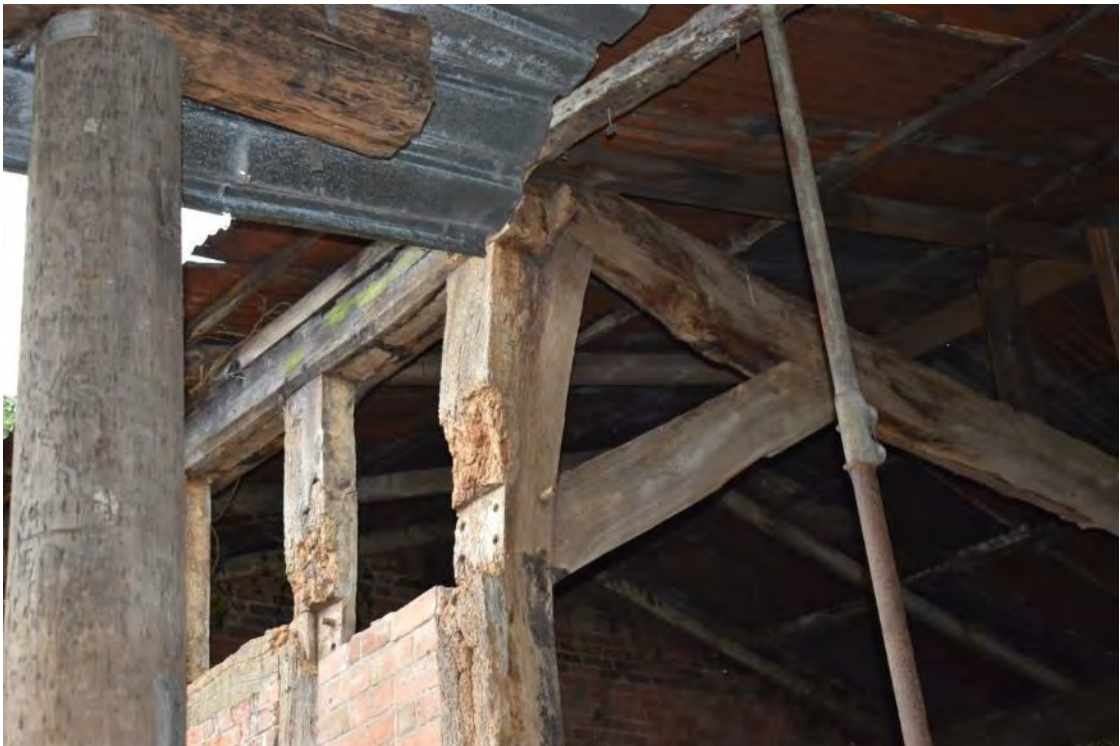
12 Timber framing with detail of halved joint, formerly face pegged

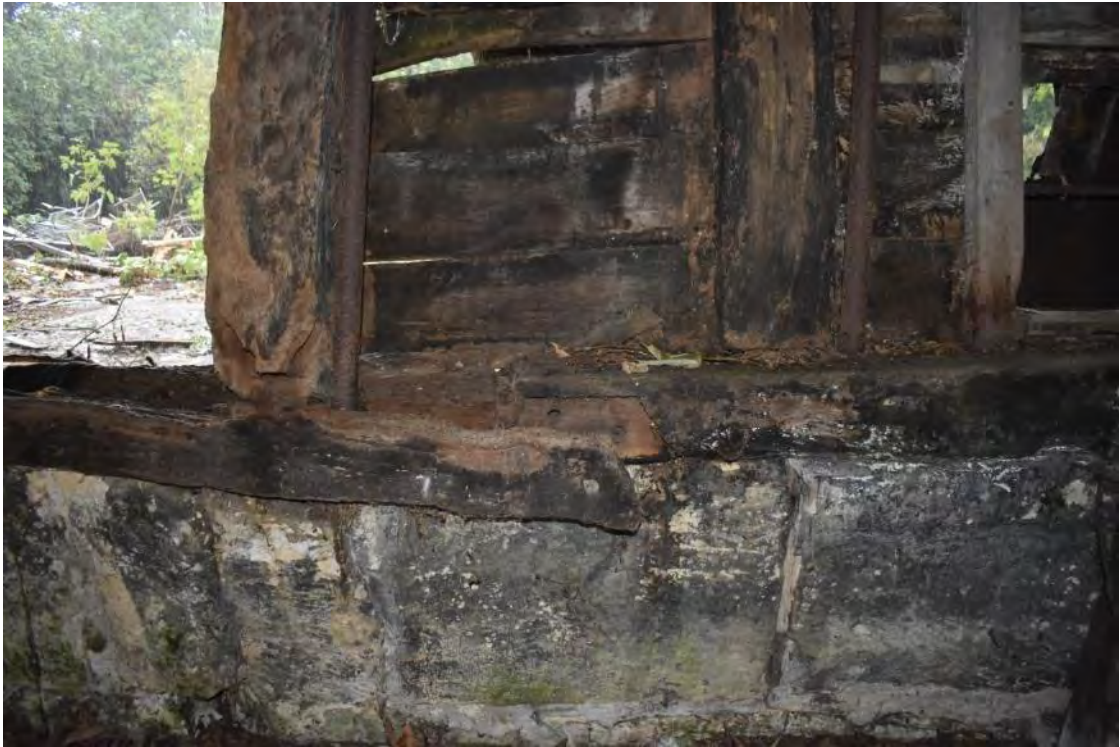
13 Half-jointed sill beam with face pegs

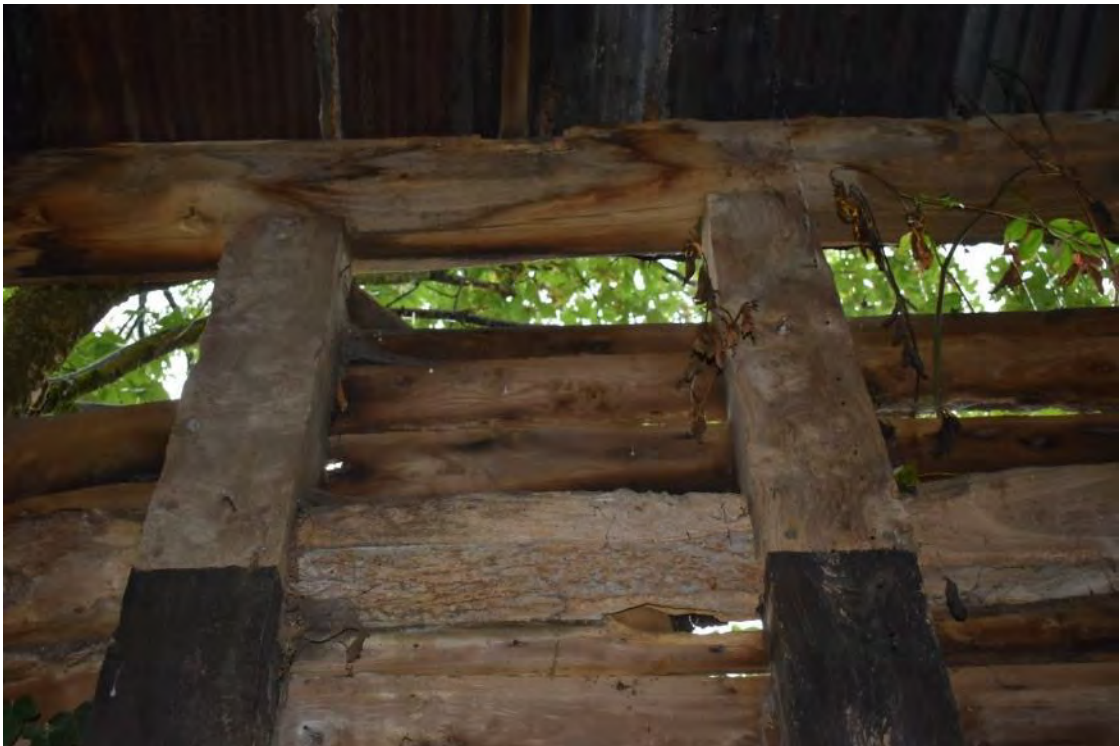
14 Underside of framing with bark below timber

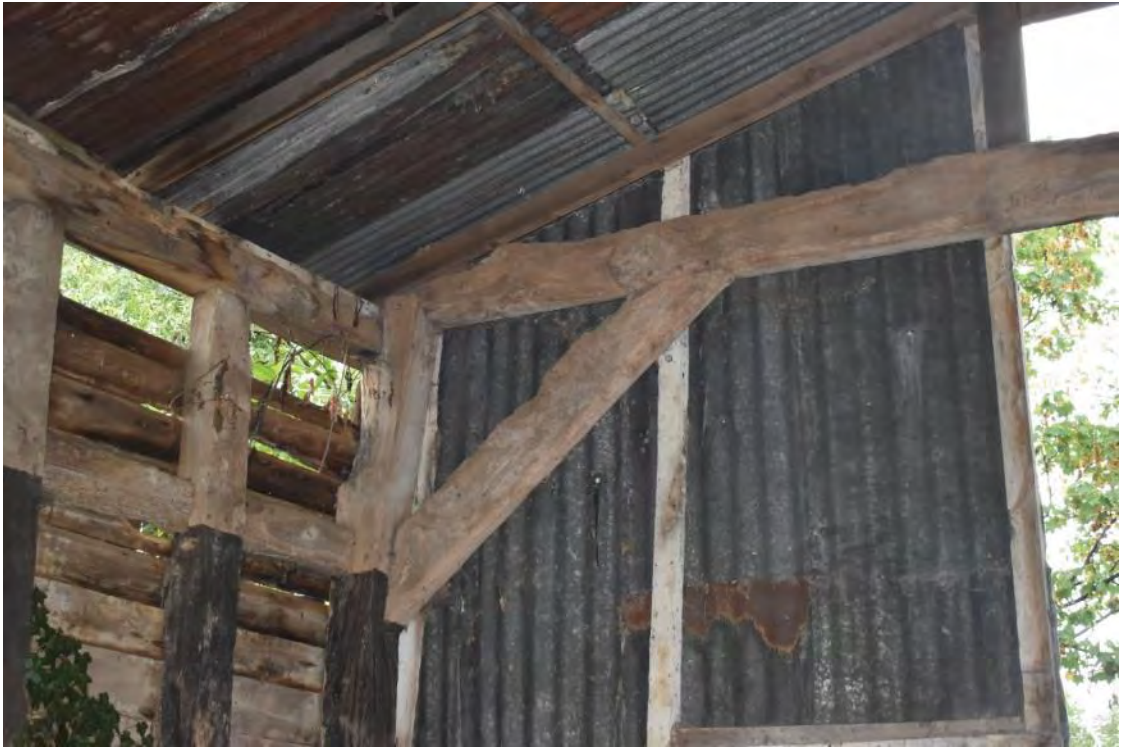
15 Detail of brace with mortise and tenon joints, triple pegged

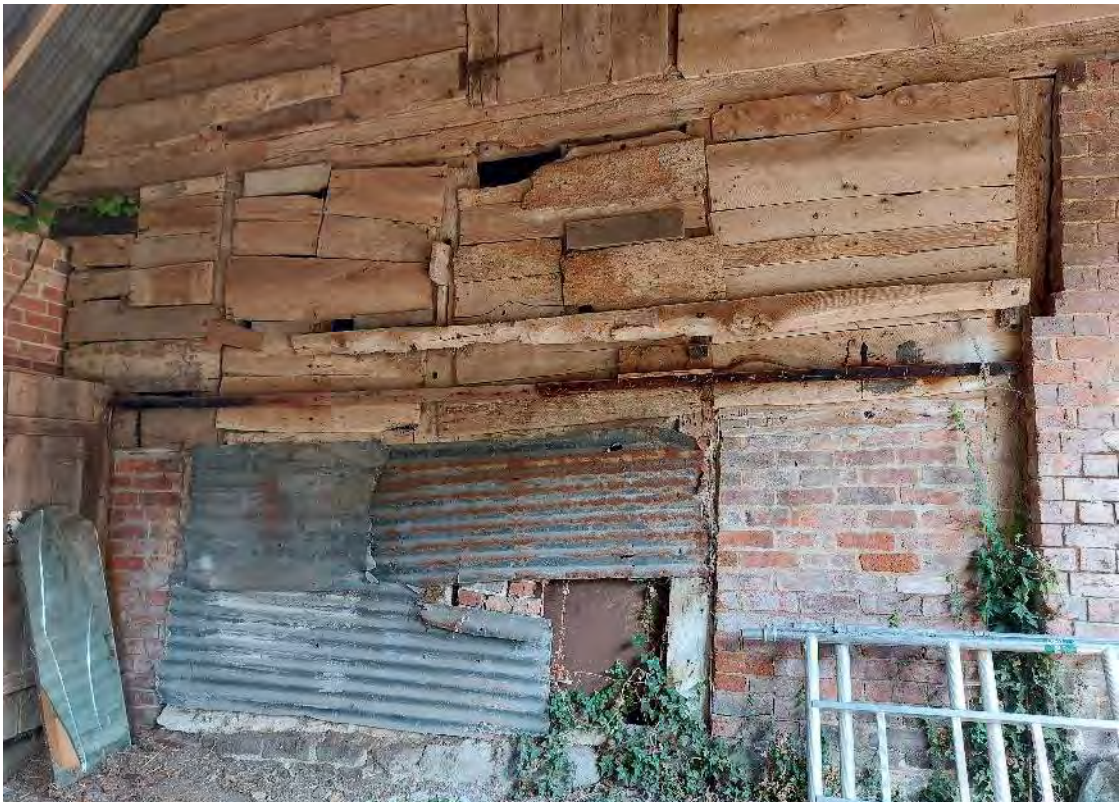
18 Internal wall with rough board and brick infill

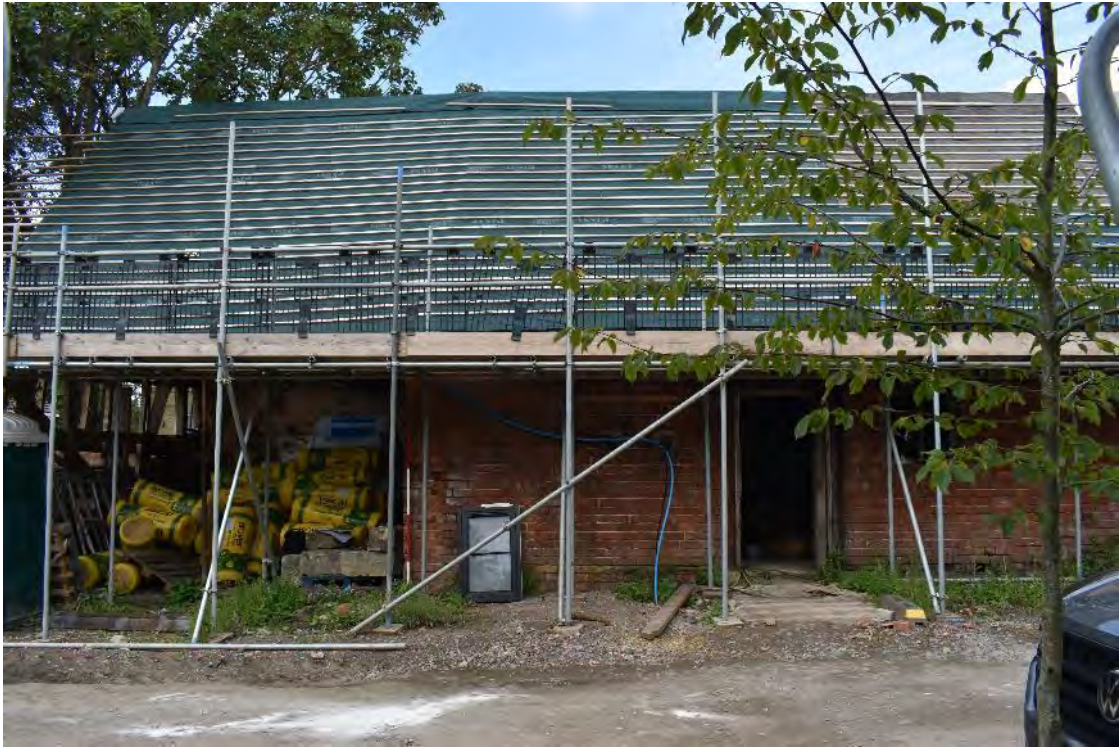
5.10 By August 2023 the building had largely been cleared of vegetation, was scaffolded and the roof had been replaced (Photo 19). The southern elevation, formerly largely covered by corrugated iron sheets, with boarding below and extensive ivy growth, had been cleared to reveal a frame largely made up of non-original machine-cut timbers, partly weatherboarded on the south side, to a height of 1.40m (Photos 20 and 21). Below the weatherboarding part of a stone plinth was exposed (0.47m high) with an old sill beam above it. The stones making up this plinth were smaller and rougher than those that had formed the plinth of the main barn. The south-east corner timber was circular rather than square cut, suggesting this too may have been a replacement.

19 East elevation, August 2023

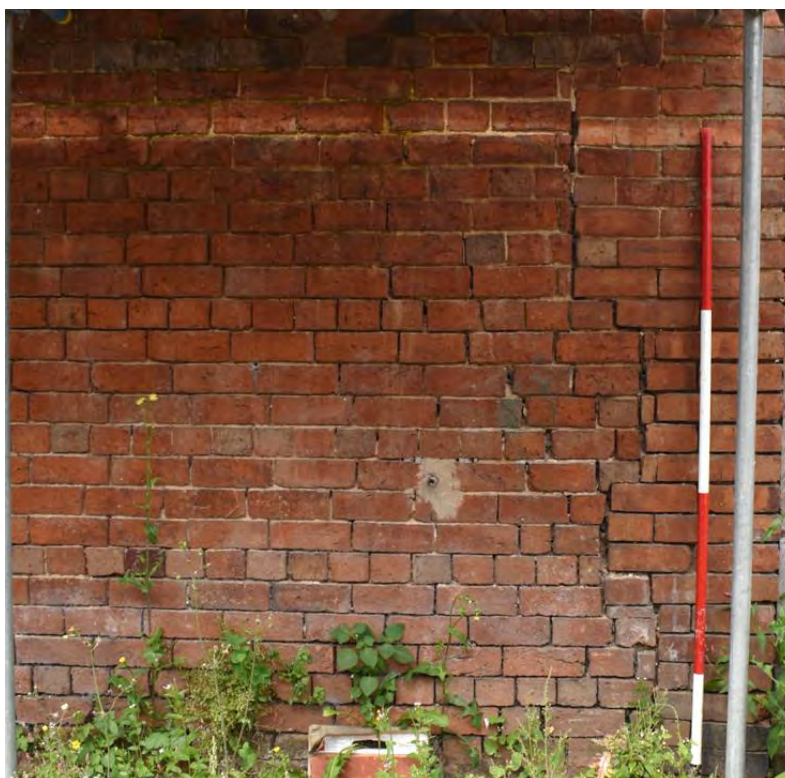
- 5.12 The brickwork changed at the north-east corner of the building (Photo 25). The bricks at the corner, and in the north wall, measure 230mm x 110-115mm x 72-75mm with larger inclusions than the east wall. The bricks have been laid in Flemish Garden Wall Bond, bonded with lime mortar and on the north wall are surmounted by a blue brick rowlock course below the timber-framed gable (Photo 26). It would seem likely that the northern brickwork has replaced a failed timber-framed gable wall. The doorway at the west end of this wall is incongruous, with old decorative strap hinge with an expanded lozenge end and fleur-de-lis design at the butt end affixed to a modern board door (Photos 27 and 28). Such hinges were popular in Gloucestershire in the 17th century (Hall 2005, 50-51). The door appears to have been set in this location relatively recently and has modern cement mortared bricks along the sides and a timber lintel. Above the brickwork the old timber-framing was formerly covered with weatherboarding and the principal rafters covered with plain barge boards (Photo 29).

25 Change of brickwork at north-east corner

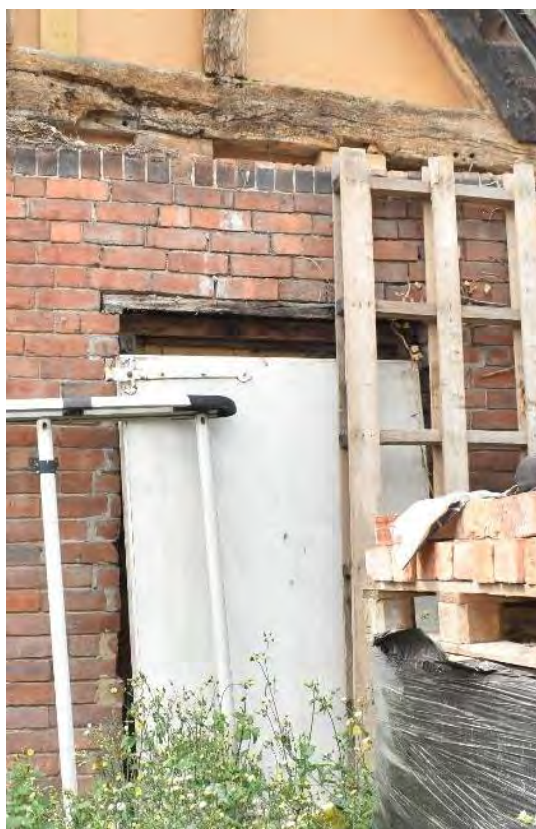
27 Inserted door on north gable wall

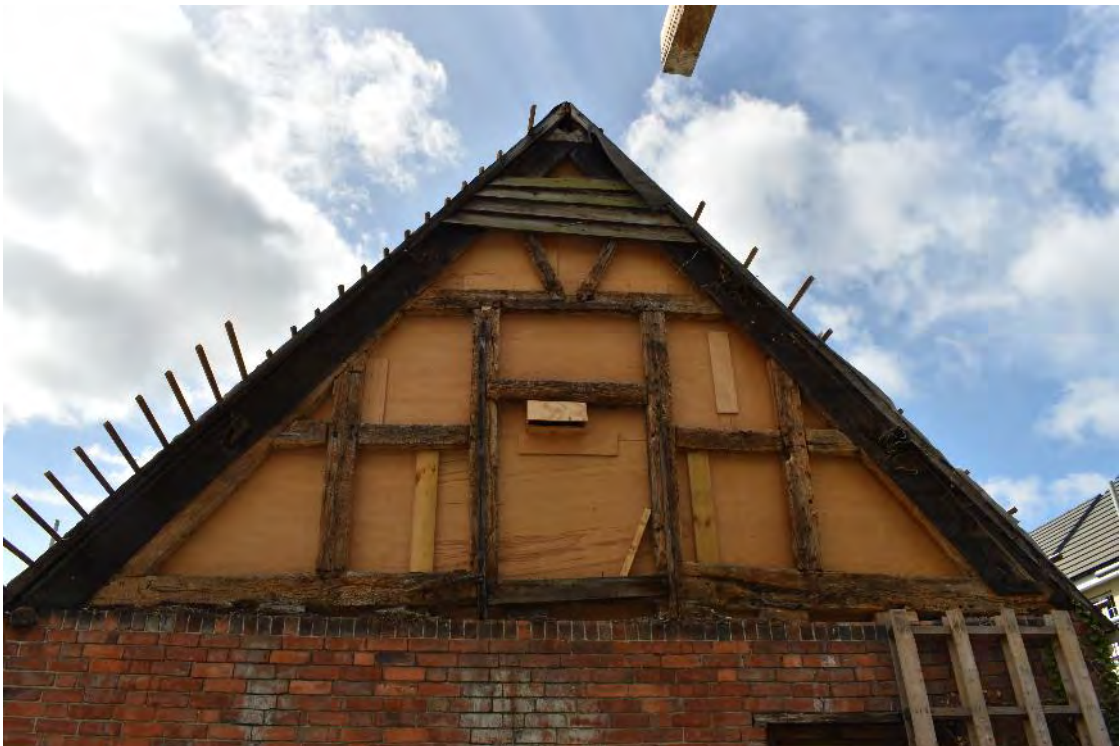
29 Timber framing in upper part of north gable

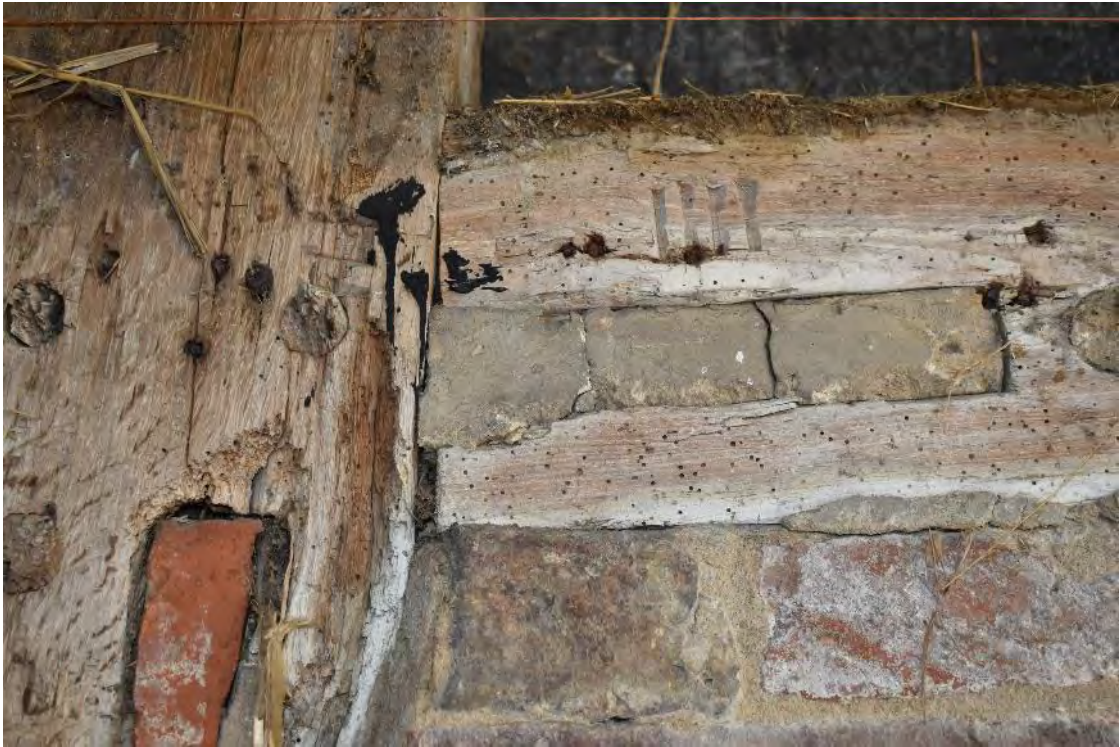
36 Carpentry marks IIII, mortises infilled with brick and mortar

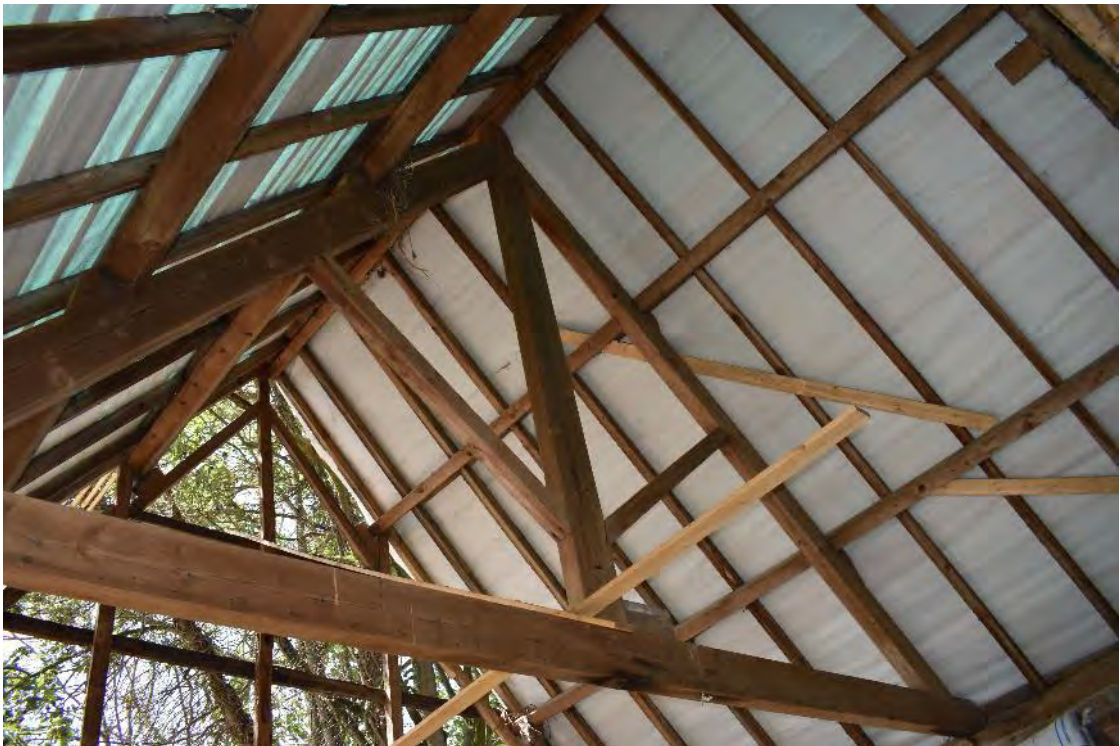
37 Machine-cut, bolted king-post truss with new purlins and rafters

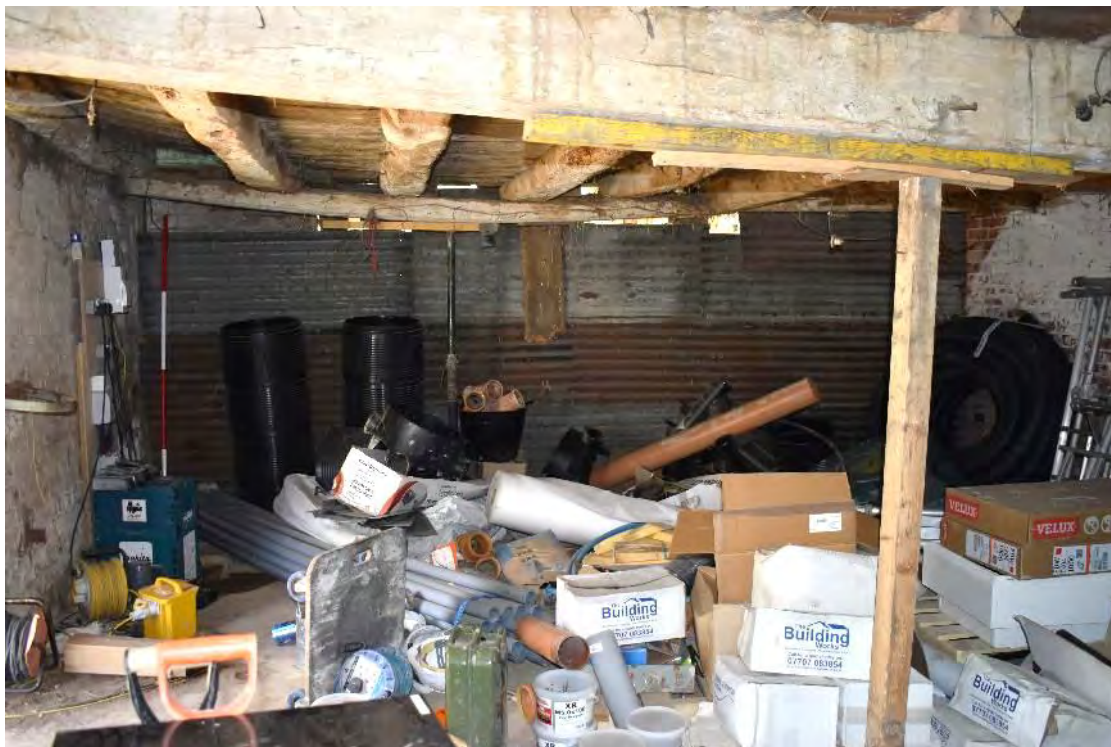
38 Corrugated iron covered wall at south end

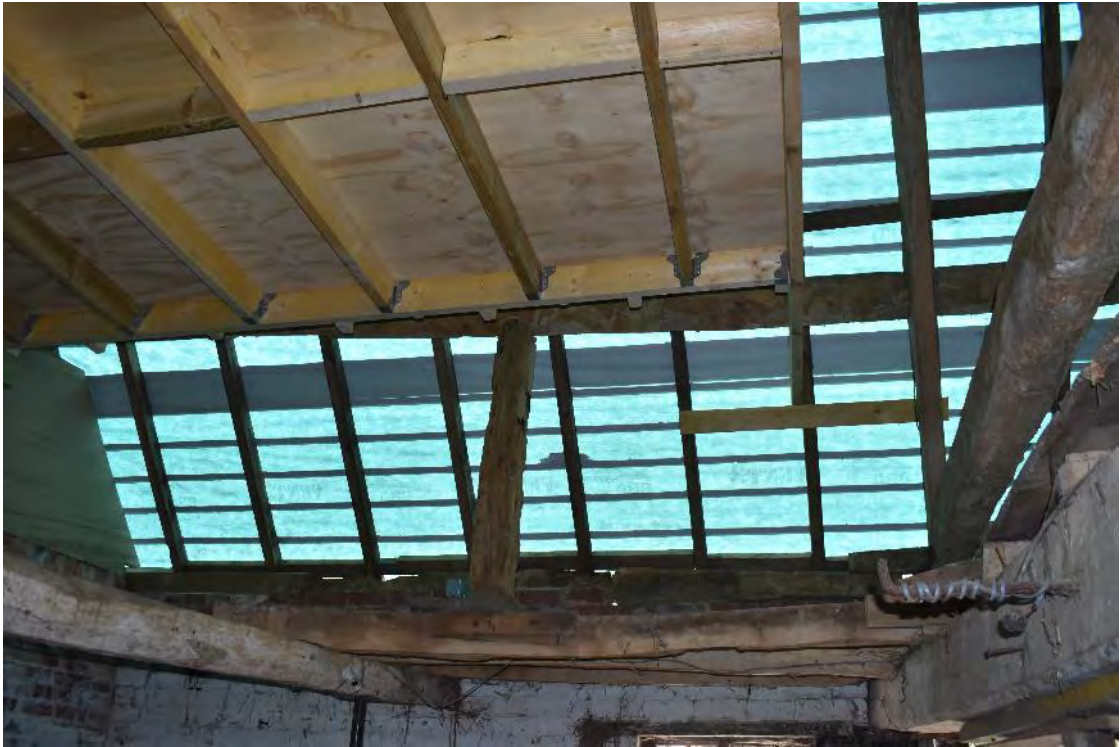
upper part of the northern part of the room (Photo 42). The white painted walls and low ceiling suggest this room may have been used to house cattle, with hay storage above.

42 Modern bat roost above formerly floored area in north part of room, old timbers below

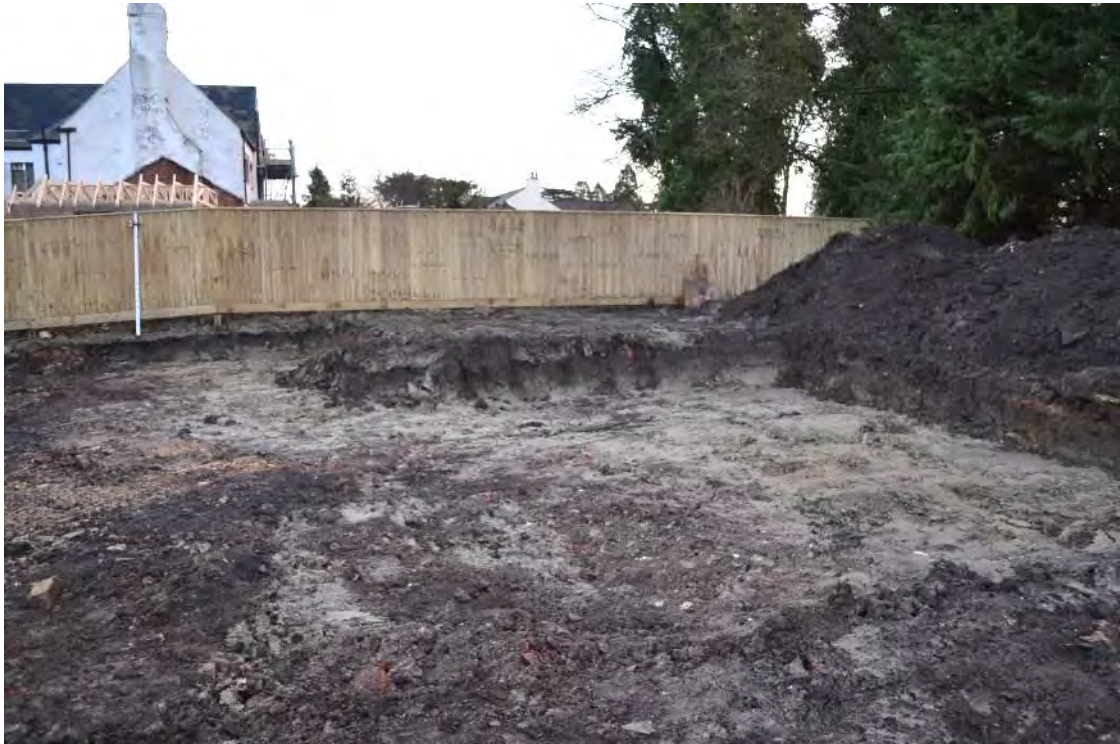
5.17 Ground reduction for the first plot (Plot 4) was carried out to a depth of c. 0.30-0.40m (Photo 47) and this revealed geological natural yellowish-grey clay (2) on the eastern side of the plot. The western part of the plot was further reduced to a depth of 1.30m in order to remove 'contaminated ground' and reach geological natural (Photo 48). On the western side of the site the geological natural was overlain by a thin layer of crushed rubble (9), possibly the remains of a former yard surface. In the northern part of the plot the natural was cut for the foundation trench (8) for a length of limestone wall (5), of which 2m was visible before being machined away. The wall appeared to delineate the eastern side of a pit (4, base not reached) with a sloping south edge, filled with at least 1.50m of dark brown clay loam which contained a large amount of 19th and 20th-century pottery and glass bottles (sampled), brick, metal and wood fragments (6). This 'pit' appeared to be part of the small pond shown on 19th- and 20th-century mapping, with a wall along its south-east side. The crushed rubble layer had been cut by a modern service trench for a water pipe (10) filled with a dark brown clay loam (11). The geological

47 Area stripped for first house plot to south of farmhouse
