Manor Farm Swindon Village Gloucestershire

**Historic Building Recording and
Archaeological Monitoring and Recording**

Archaeology Warwickshire
Report No. 2438
Date: March 2024

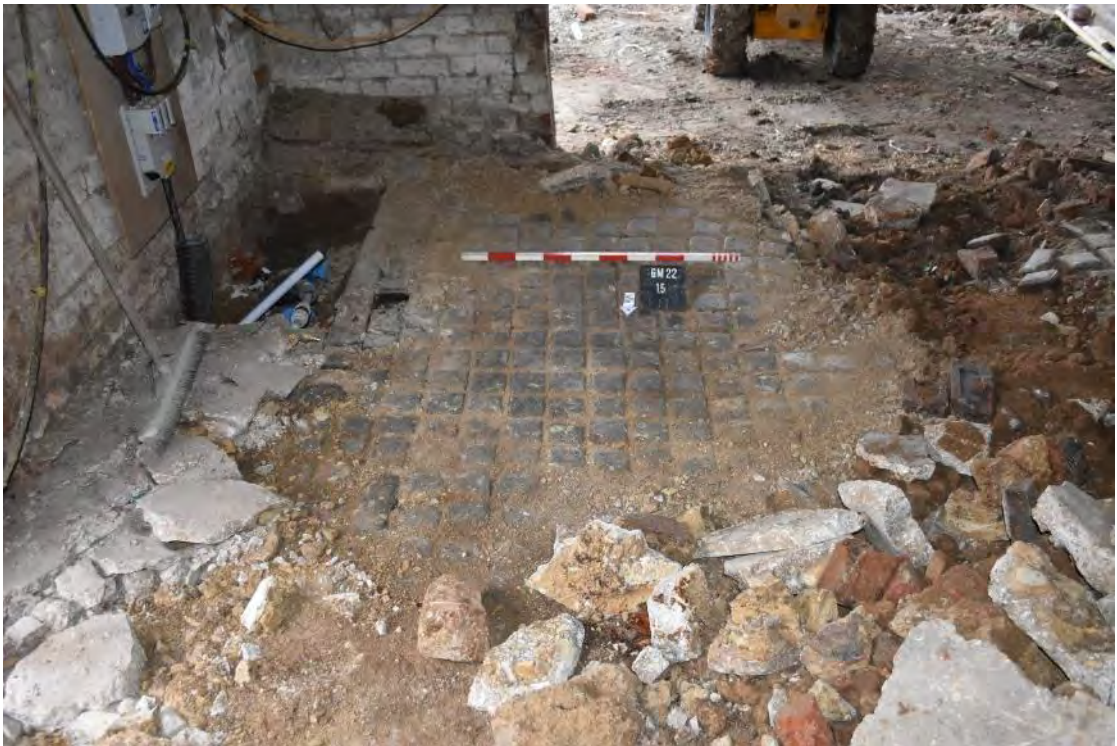
floor but may have been damaged and removed from the northern part. The brick floor and exposed sand were covered with a screed of modern concrete (14), apparently laid in 1972, according to an inscription in the concrete before it set.

51 Brick 'setts' below concrete

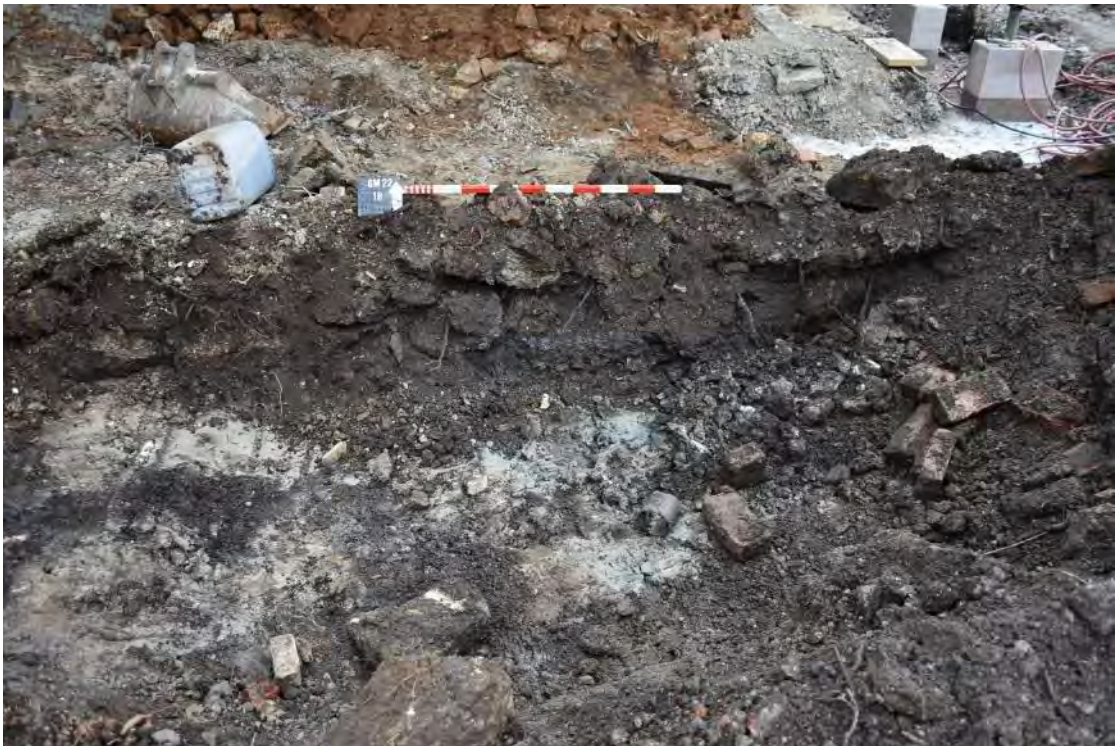
53 Trench excavated through contaminated ground to the south of Building L

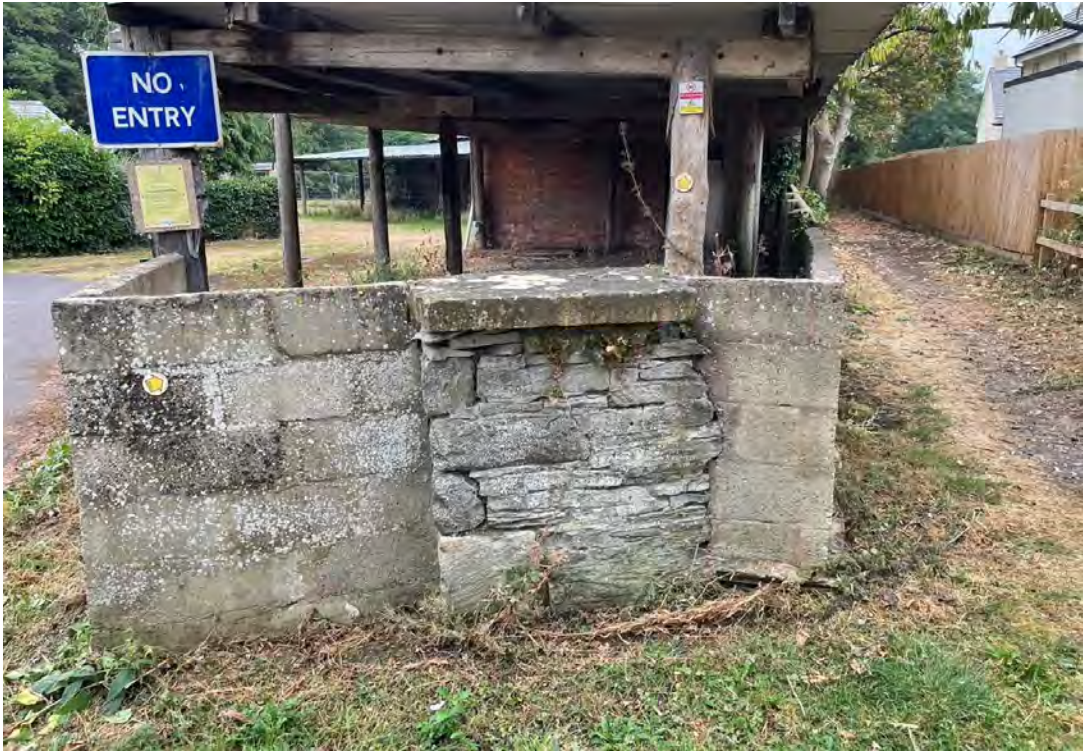
- 5.21 A section of limestone walling to the north of Building L survives, surrounded by the half-height breeze block walling of the former pole barn of Building M (Photos 54 and 55). The wall is low, suggesting it may be the remnant of a former boundary wall and it appears to end with a series of quoins c.1.5m from the north-west corner of the building, potentially the side of a gateway. It is, however, possible that it is a remnant of an earlier building at the entrance to the site, pre-dating the Tithe map of 1841.

54 Section of stone walling of former building or boundary wall at north end of site, surrounded by breeze blocks of Building M, looking south
