Manor Farm Swindon Village Gloucestershire

**Historic Building Recording and
Archaeological Monitoring and Recording**

Archaeology Warwickshire
Report No. 2438
Date: March 2024

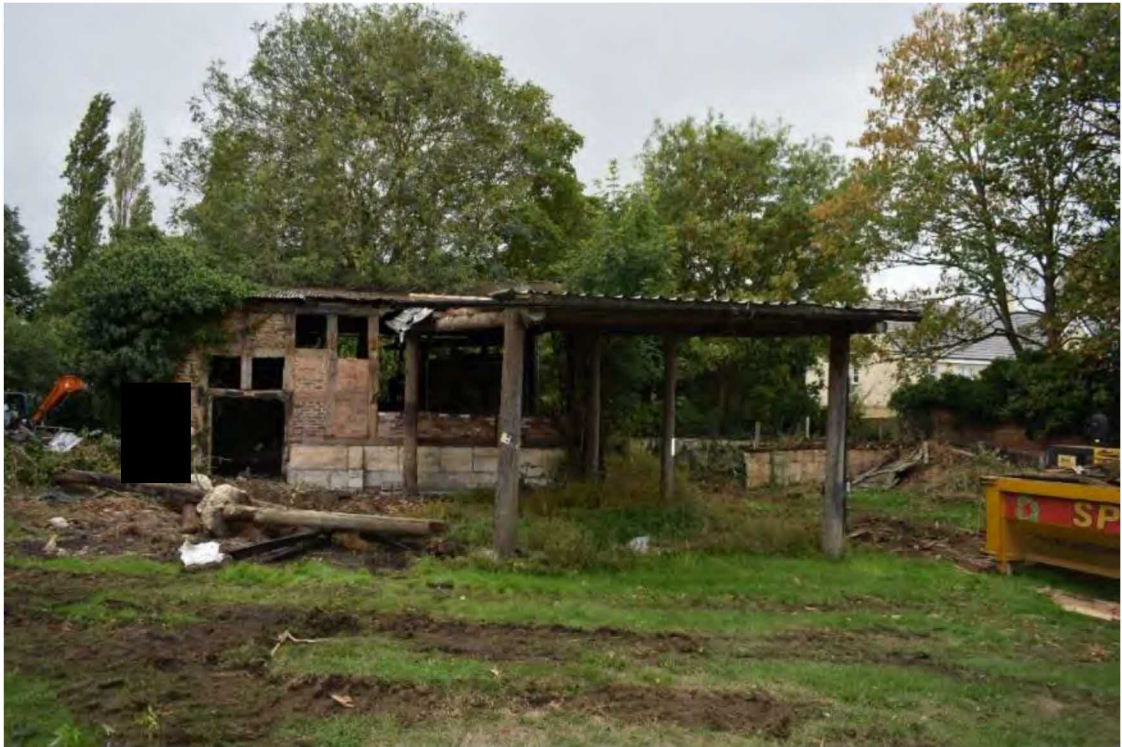
1 Timber-framed barn, north-east side, with pole barn in front

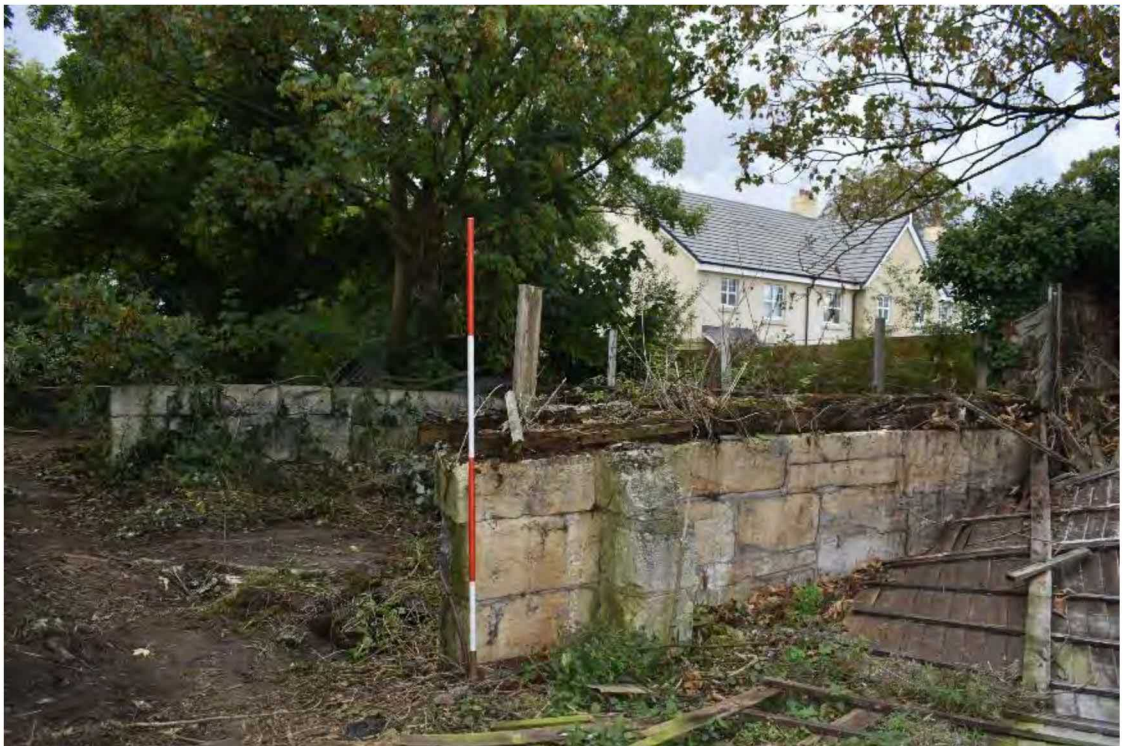
- 5.2 The north-western bay of the building (indicated by the letter K on plans supplied) consists of a well-built stone plinth, on which the sill beam rests, but there is no other superstructure (Photo 2). This part of the building has vegetation within it and to the sides. The south-east two bays of the building are standing to tie-beam level but the roof trusses have gone and the roof has been replaced by corrugated iron. Above the stone plinth the building is timber-framed, with the box-framing on the south-west side infilled with brick nogging of various dates, from what appears to be small 18th-century bricks to larger 20th-century bricks (Photo 3). The doorway on Photo 3 has been created by removing parts of the horizontal and vertical members of the timber framing, and plinth and inserting a timber door surround, bolted onto the sill beam on one side. On the south-west side the timber-framing is covered by weatherboarding, which also has metal sheets fixed to it (Photo 4). It is likely that the building was

2 Stone plinth of western part of building, without superstructure

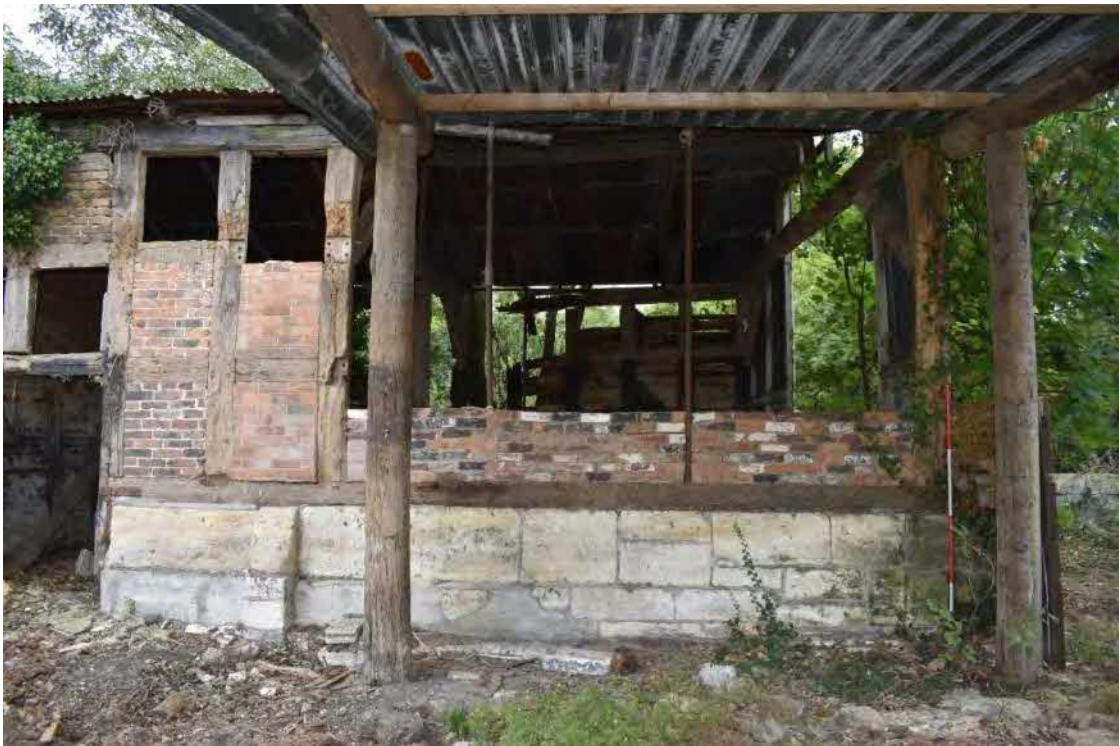
- 5.5 In areas where the timber-framing has rotted or collapsed the wall plate is supported by iron poles. On the north-east side the area between the poles and timber uprights has been partly infilled with seven courses of bricks, of various sizes and dates, many with traces of paint on them (Photo 6). On the south-west side a single iron pole replaces an area of framing where two timber uprights would have been, but no brick infill has been attempted (Photo 7). Photo 8 shows the likely location of the former threshing floor. The north-western end of the standing part of the building has been partly covered with corrugated iron sheeting (Photo 9).

6 Area where timber framing has been replaced by iron poles and brickwork

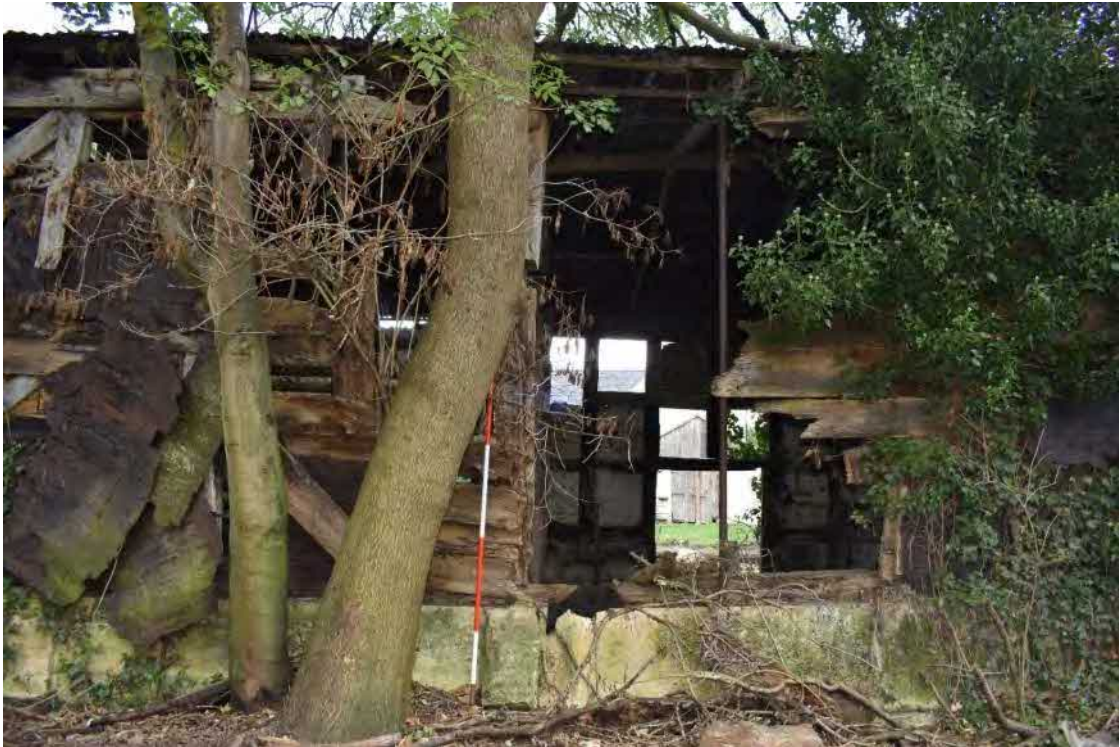
7 South-west side of the building with timber framing replaced by iron pile

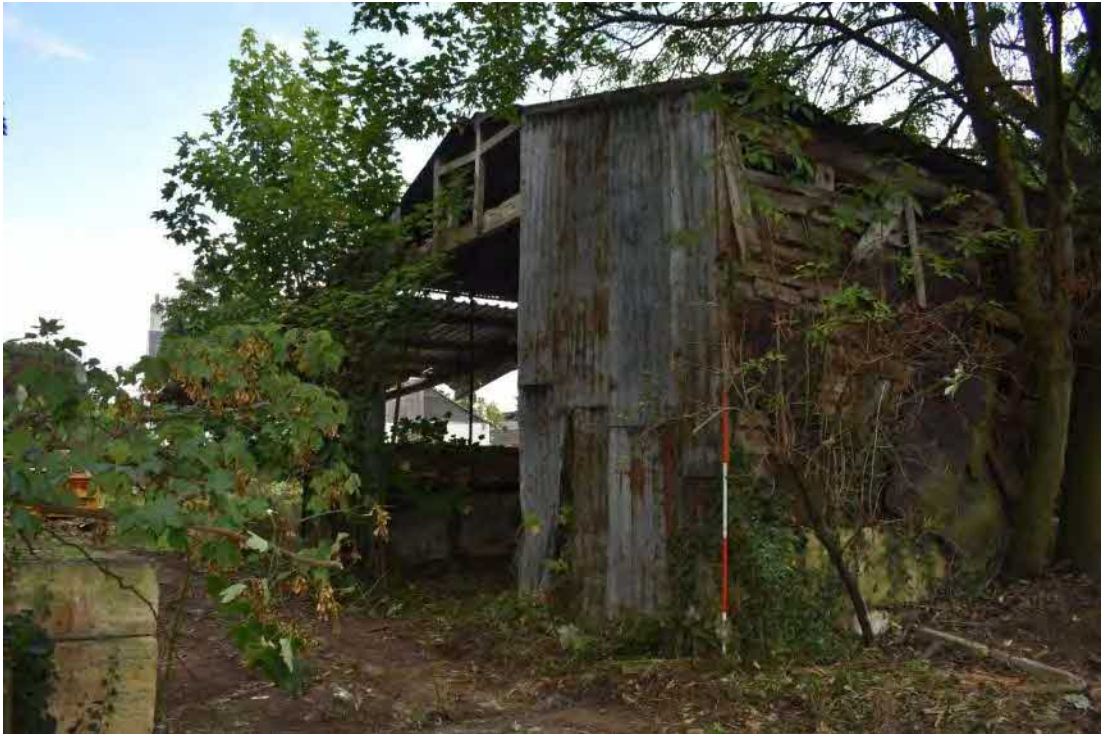
9 Former internal bay division, subsequently covered with corrugated iron sheeting

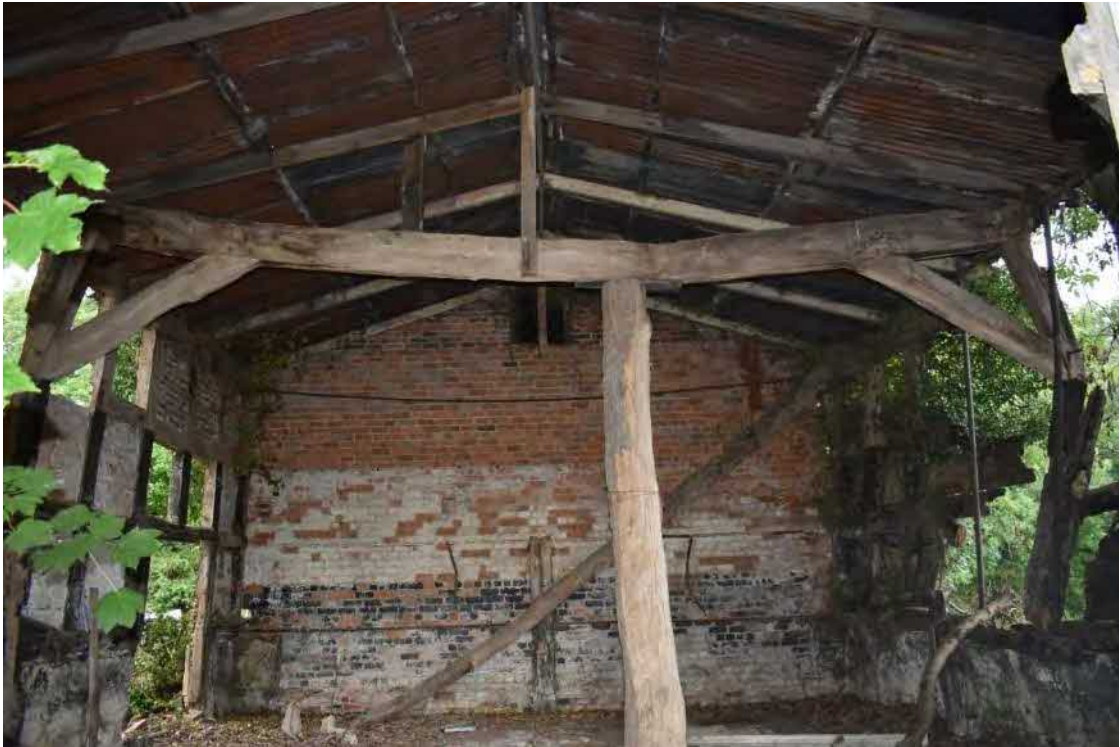
- 5.7 As can be seen in Photo 11 the original roof has been replaced by a low-pitched modern roof and the tie beam is supported with braces to the wall posts; the tie beam is also directly supported by an upright pole as the wall post on the south-west side was collapsing. Pairs of peg holes in the tie beam suggest the roof was originally of queen-post construction. The timber framing in the side walls use face pegged halved joints rather than using mortise and tenons (Photos 12 and 13). In some instances bark was still present on the timbers (Photo 14). The braces were jointed with mortice and tenons (Photo 15).

11 Brick gable wall with mull pitching window near apex

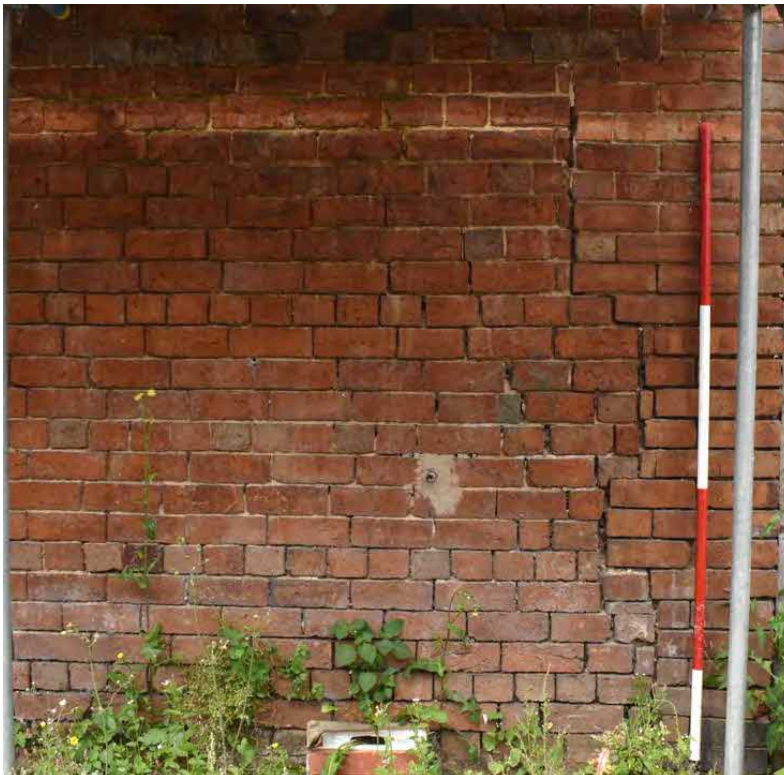
- 5.12 The brickwork changed at the north-east corner of the building (Photo 25). The bricks at the corner, and in the north wall, measure 230mm x 110-115mm x 72-75mm with larger inclusions than the east wall. The bricks have been laid in Flemish Garden Wall Bond, bonded with lime mortar and on the north wall are surmounted by a blue brick rowlock course below the timber-framed gable (Photo 26). It would seem likely that the northern brickwork has replaced a failed timber-framed gable wall. The doorway at the west end of this wall is incongruous, with old decorative strap hinge with an expanded lozenge end and fleur-de-lis design at the butt end affixed to a modern board door (Photos 27 and 28). Such hinges were popular in Gloucestershire in the 17th century (Hall 2005, 50-51). The door appears to have been set in this location relatively recently and has modern cement mortared bricks along the sides and a timber lintel. Above the brickwork the old timber-framing was formerly covered with weatherboarding and the principal rafters covered with plain barge boards (Photo 29).

25 Change of brickwork at north-east corner

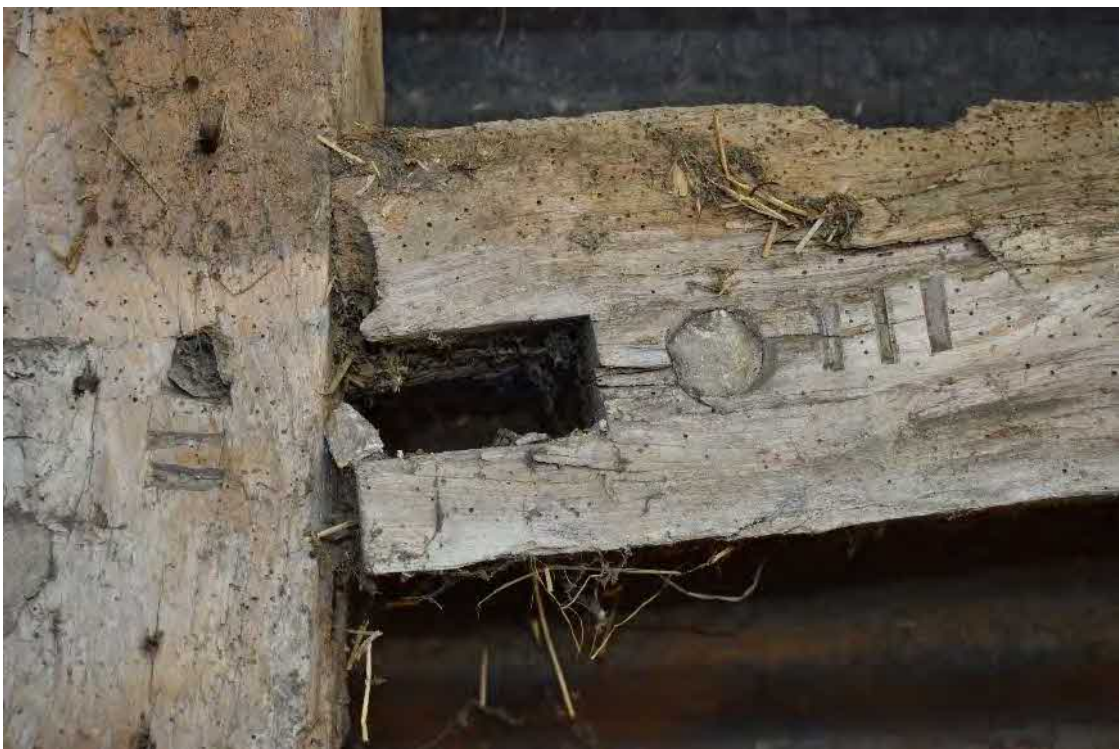
35 Carpentry marks III, infilled peg hole and open mortise

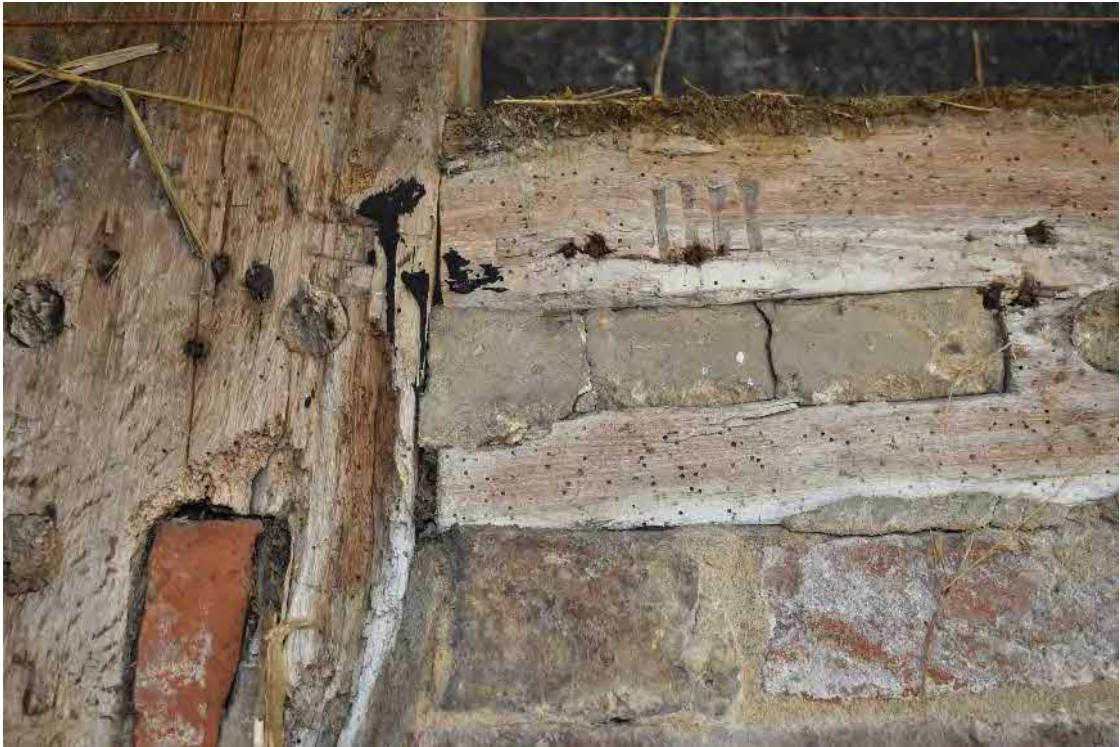
36 Carpentry marks IIII, mortises infilled with brick and mortar

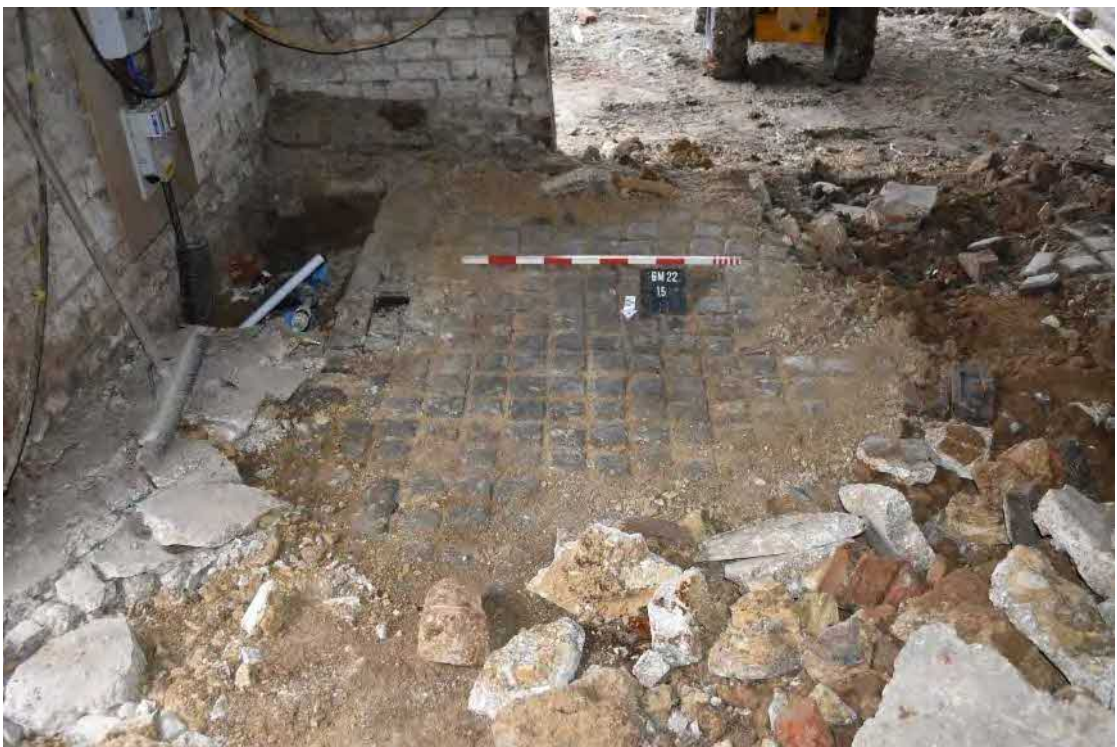
51 Brick 'setts' below concrete

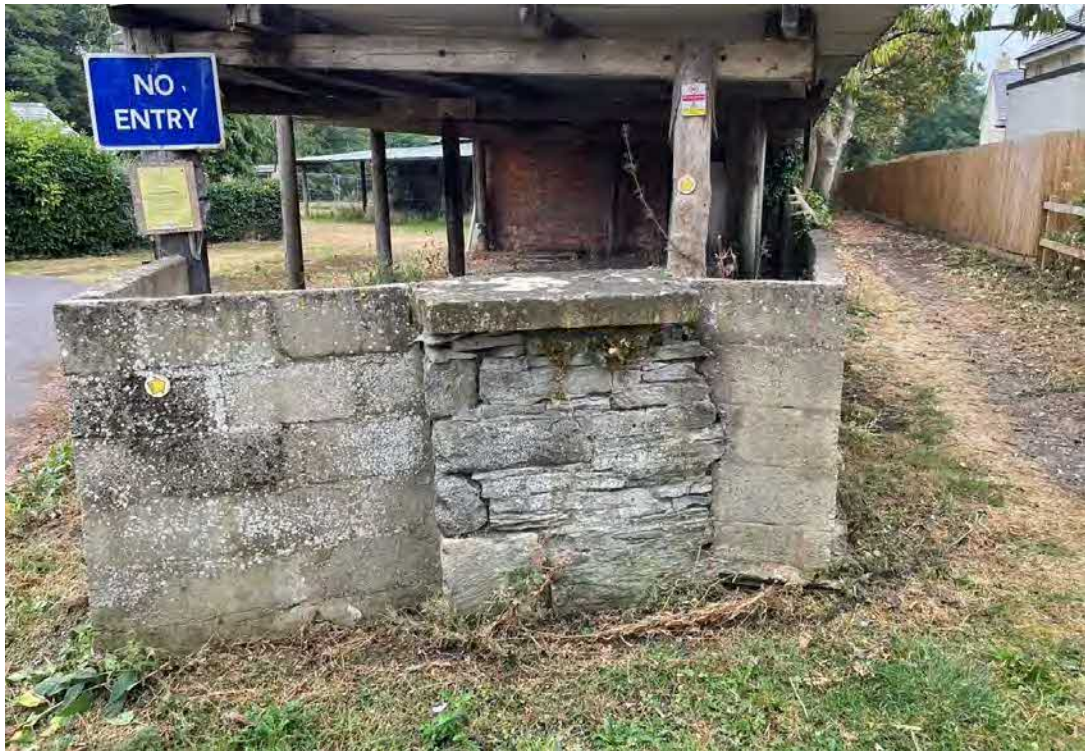
- 5.21 A section of limestone walling to the north of Building L survives, surrounded by the half-height breeze block walling of the former pole barn of Building M (Photos 54 and 55). The wall is low, suggesting it may be the remnant of a former boundary wall and it appears to end with a series of quoins c.1.5m from the north-west corner of the building, potentially the side of a gateway. It is, however, possible that it is a remnant of an earlier building at the entrance to the site, pre-dating the Tithe map of 1841.

54 Section of stone walling of former building or boundary wall at north end of site, surrounded by breeze blocks of Building M, looking south
