Schedule of Ground Floor Windows			
Mark	OA Width	OA Height	Cill	Phase	Demolished	Comments	Description	Base Constraint	Age
EW-1	650	650	-400	Existing	None	No Action	Type B Metal Casement	Level 00 Ground	Replaced in 2001
EW-01	1400	1800	1100	Existing	None	Refurbish, slimline double	Type A Timber Sash	Level 00 Ground	Replaced in 2001
EW-2	1300	650	-400	Existing	None	No Action	Type B Metal Casement	Level 00 Ground	Replaced in 2001
EW-02	1300	1800	1100	Existing	None	Refurbish, leaded lights, Secondary Glazing	Type B Metal Casement	Level 00 Ground	this may be original
EW-03	650	1800	1100	Existing	New Construction	Replace metal slimline double glazing	Type C Metal Casement	Level 00 Ground	Replaced in 2001
EW-04	1300	1800	1100	Existing	New Construction	Replace metal slimline double glazing	Type C Metal Casement	Level 00 Ground	Replaced in 2001
EW-05	1950	1280	1100	Existing	New Construction	Replace metal casement, leaded lights	Type B Metal Casement	Level 00 Ground	part original

Ground Floor Windows South

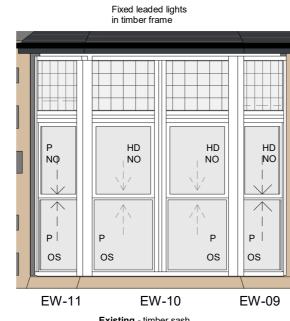
EW-12 Existing - timber sash upper sash non original (NO), lower sash original (OS) in poor condition

Proposed -replace non original and original timber sash in poor condition to replicated original design sash (RS) with Histoglass HD10 thin double glazing with hand drawn outer pane, 10mm sight lines to match frames (HDSDG). Refurbish leaded lights with secondary SL double glazing (Clear float) internally

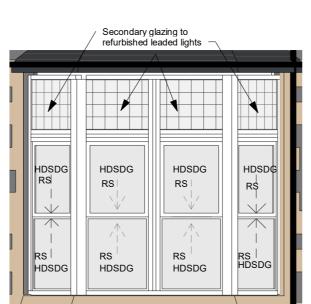
Existing - timber sash upper sash non original (NO), lower sash original (OS) in poor condition

EW-11 EW-10 EW-09 Proposed- replace non original and original timber sash in poor condition to replicated original design (RS) with Histoglass HD10 thin double glazing (HDSDG) with hand drawn outer pane, 10mm sight lines to match frames. Refurbish leaded lights with secondary SL double glazing (Clear float) internally
