Arboricultural Safety Assessment

WC-228.1a

9, Ringstone, Barkisland, Ripponden,
Halifax HX4 0EU

Report type:	Arboricultural Safety Assessment
Report reference:	WC-228.1
Revision:	a
Client:	David Clarke
Site address	9, Ringstone, Barkisland, Ripponden, Halifax HX4 0EU
OS Grid reference:	SE 05473 18290
Report prepared by:	Jack Delaney MICFor MArborA
Date:	18 th December 2023

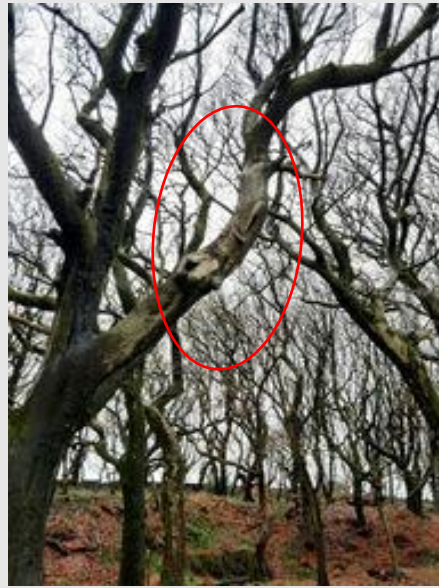
3.5.1. T002 is a mature European beech (*F. sylvatica*), which displays a cavity opening at circa 4 m, at the base of a primary branch extending north-east. There is visible decay to the exposed ripewood, with the cavity appearing to extend upwards in a decay column. European beech (*F. sylvatica*) does not form a true, durable heartwood, and the innermost wood of old species, like T002, consists of dysfunctional sapwood that is readily colonised by decay fungi when exposed by injury or pruning (Lonsdale, 2015). Due to this defect, T002 was deemed to present a RoH of 1/300,000; this level of risk is considered tolerable when the associated risk is imposed on others, provided that the RoH is ALARP.

Plate 2: Decay column at base of primary branch on T002

- 4.1.1.** To reduce the RoH posed by T002, it is recommended that the defective primary branch, which displays a decay cavity at circa 4 m, is reduced by approximately 5 m. Although the reduction of mature trees is usually best avoided, provided that the works are completed in accordance with *BS 3998: 2010: Tree Work – Recommendations*, pruning will only be carried out to the tertiary branches, which is unlikely to be of significant long-term detriment to the tree. The proposed reduction of T002 will reduce the effective ‘windsail’ of the canopy, thereby reducing leverage at the point of the cavity, and so too the probability of failure.

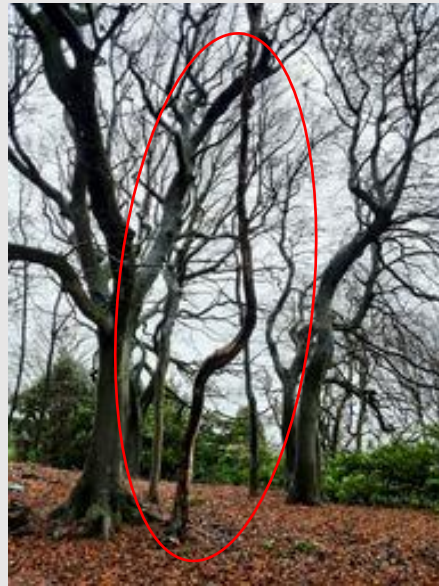
Plate 4: T005

3.5.2. T005 is a moribund tree which was deemed to present a RoH of 1/100,000; this level of risk is considered tolerable when the associated risk is imposed on others, provided that the RoH is ALARP.

- 4.1.2.** To remove the RoH posed by T005, it is recommended that the tree is removed.
- 4.1.3.** Unrelated to risk mitigation and at the discretion of the landowner, it is suggested that further low-priority works to T015, T017 and T018 – which are summarised in **Tab. 4.1**, below - are undertaken in the interests of site management.

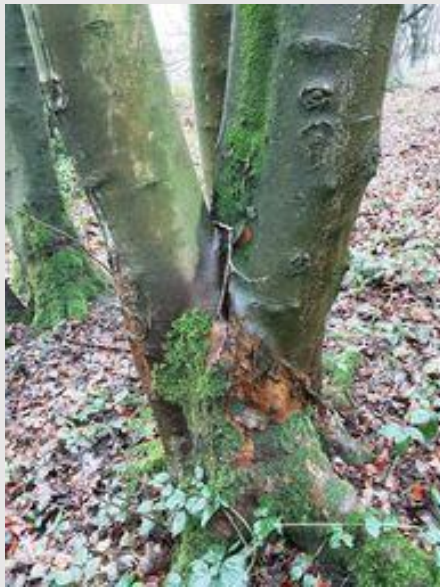
Plate 11: Acute and likely included primary union on T015
