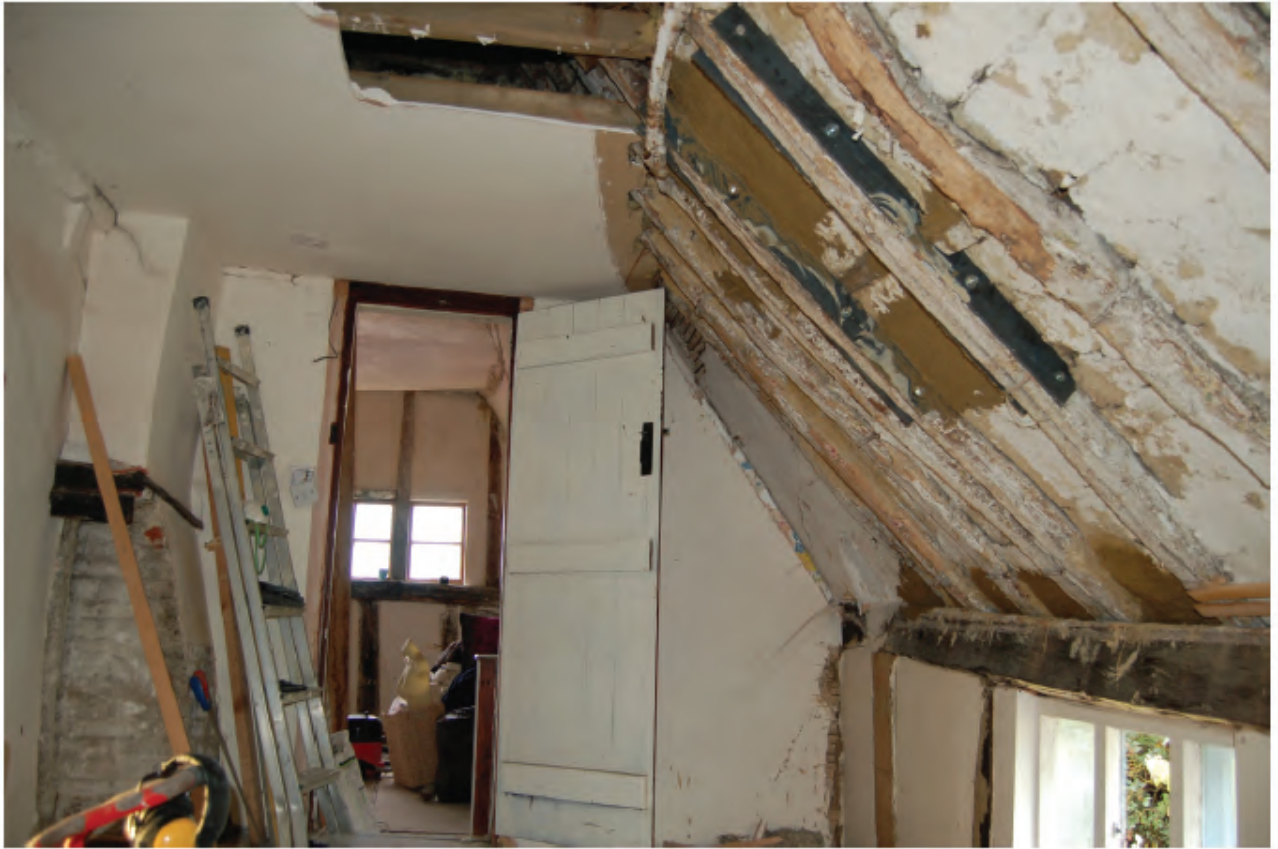
Two of the roof timbers were broken. They were strengthened with 10mm steel plate bolted to either side of the crack. This ceiling was then insulated using Steico wood-wool, 60mm thick thermal conductivity of 0.036 W/mk, lath and plastered. **Pic 22 and 23**

Plc 22 Bedroom 3 with roof rafters repaired using 10mm steel fitch plates

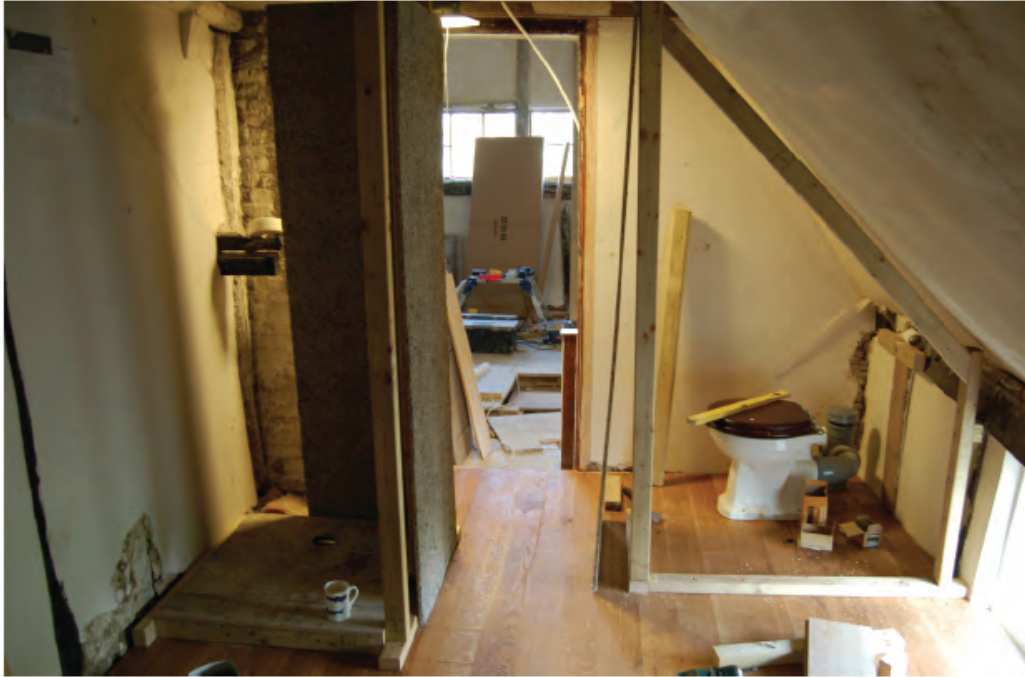
Pic 24

The toilet cubicle was constructed of 4 x 2 framing timber and clad with Savolit board, plastered with lime plaster.

The shower cubicle was framed in 4 x 2, clad with waterproof cement board on the inside which was tiled. Savolit board on the outside and lime plastered. **Pic 24 & 25**

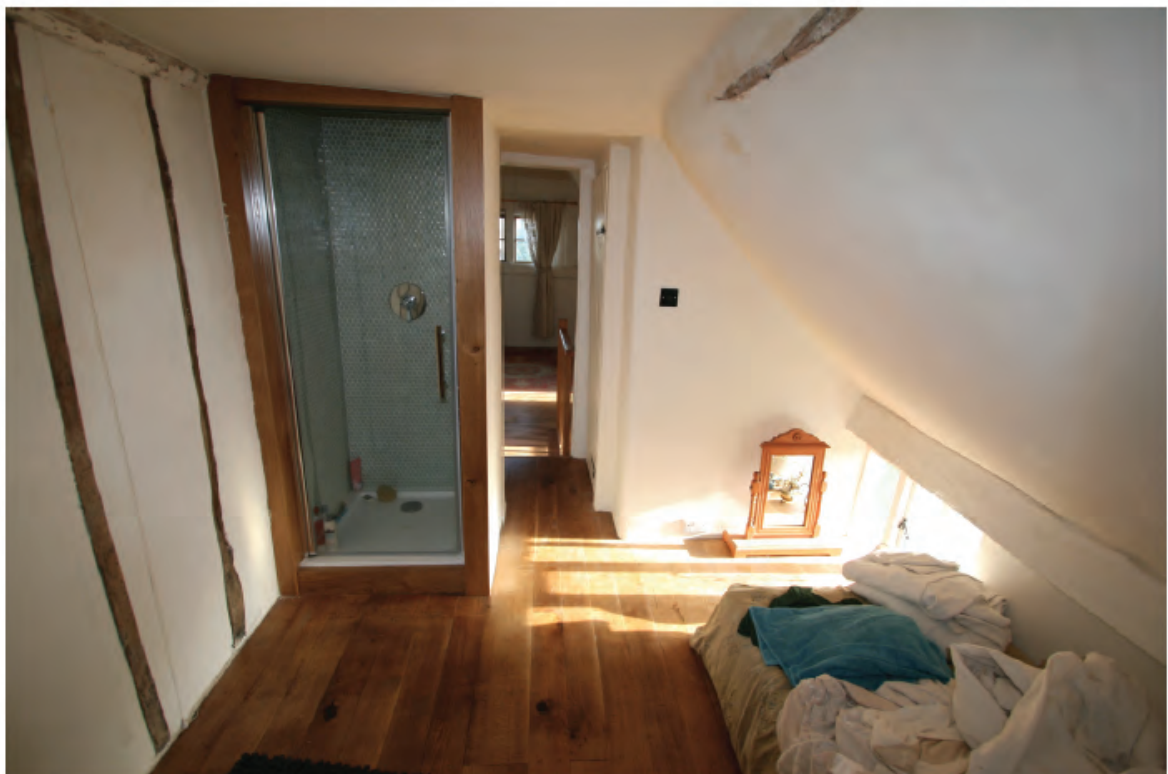
Pic 25 Addition of toilet and shower

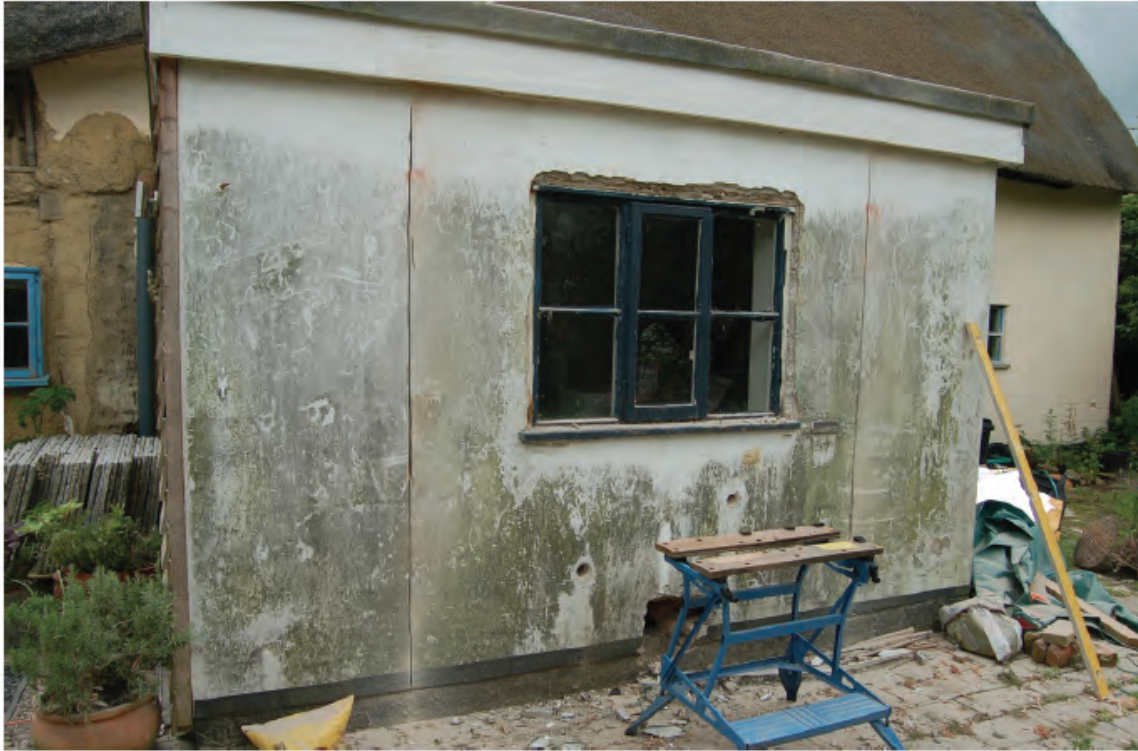
Plc 27

Before

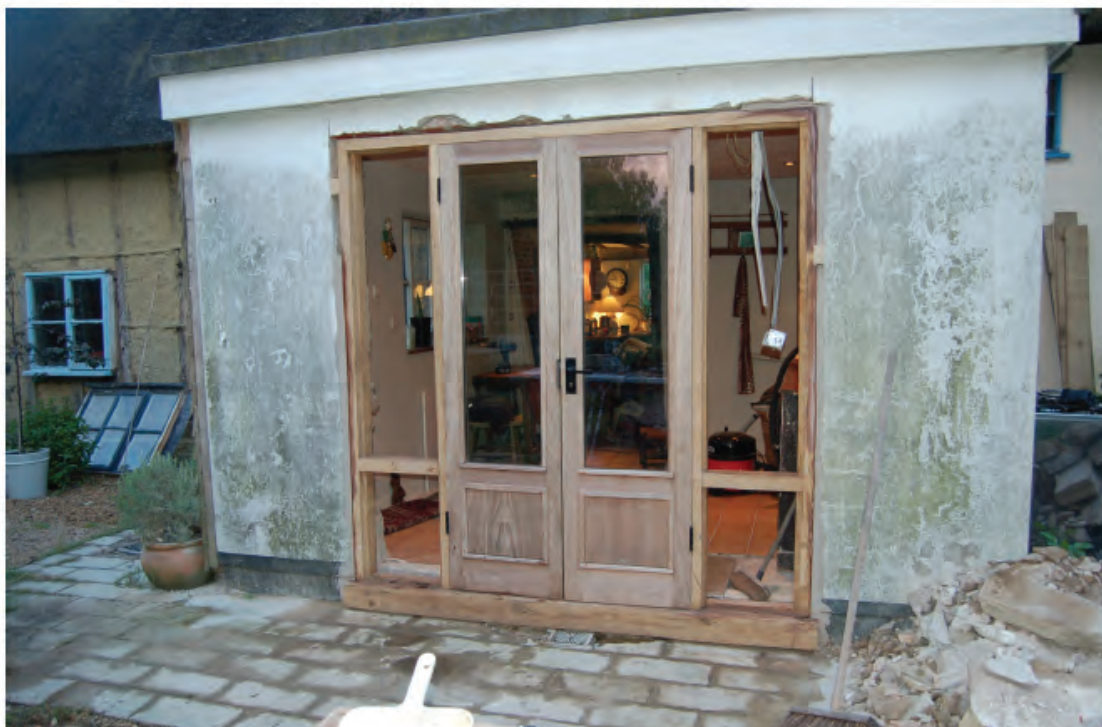
Plc 28

Addition of double doors and side window lights.

After

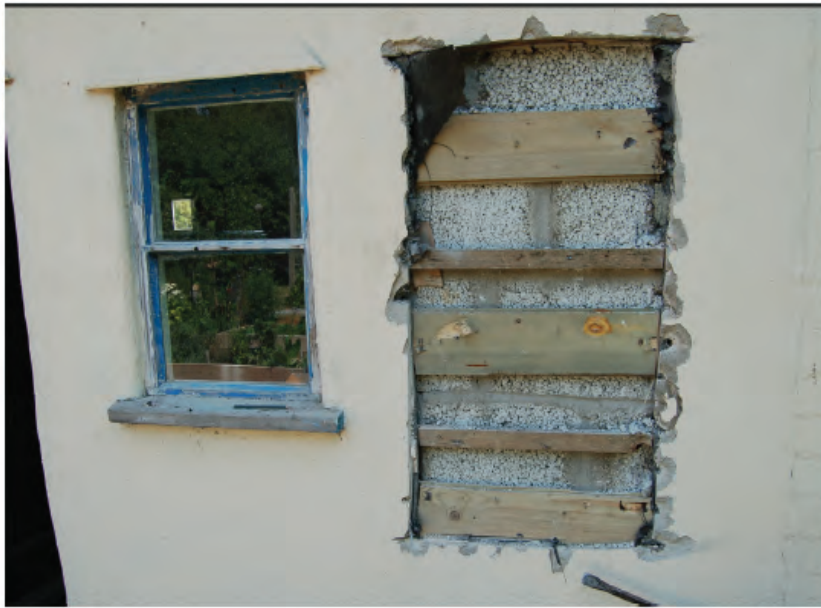
Pic. 29

The opening for **window 2** (see **PGC-Rear elevation proposed**) was cut through the cement render. This revealed blockwork infill. The original wattle and daub had been replaced possibly in the 60's or 70's with blockwork. *Pic. 29 and 30*

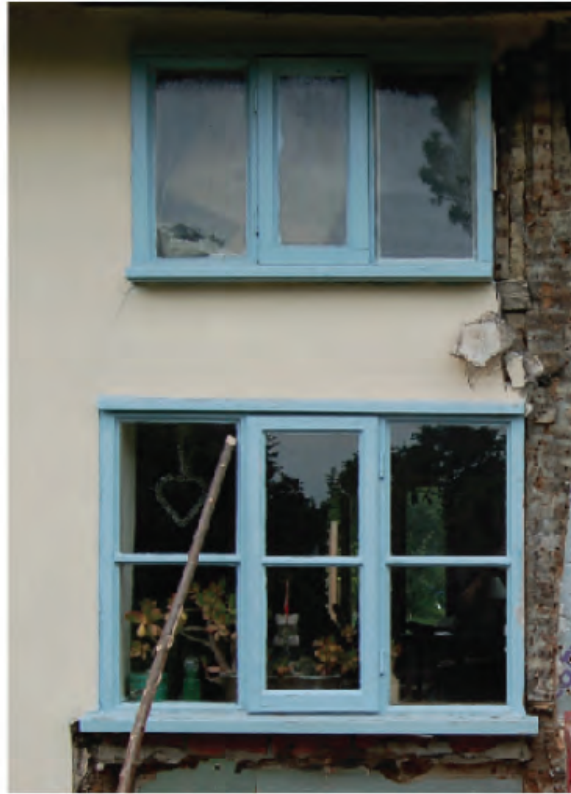
The existing windows when we purchased the cottage in 2011 were all single glazed Boulton & Paul windows form around 1960's/70's.

Poor maintenance had led to decay in many of them. During the restoration of the frame and infill we had an opportunity to research and commission more energy efficient and aesthetically appropriate fenestration.

Pic. 31 Existing windows

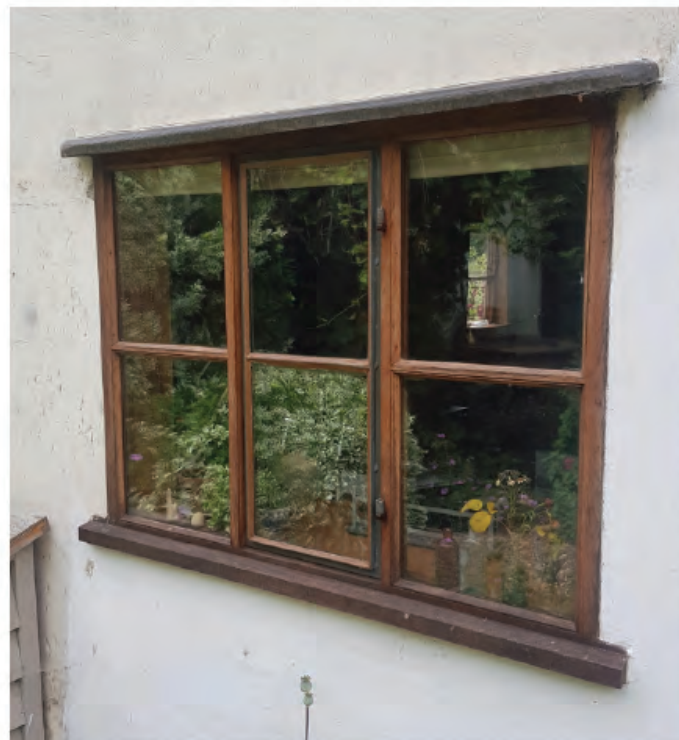
Pic. 32 Replacement windows.
