Removal of external render, fixing plinth, sole plate and reinstating wattle & daub infill.

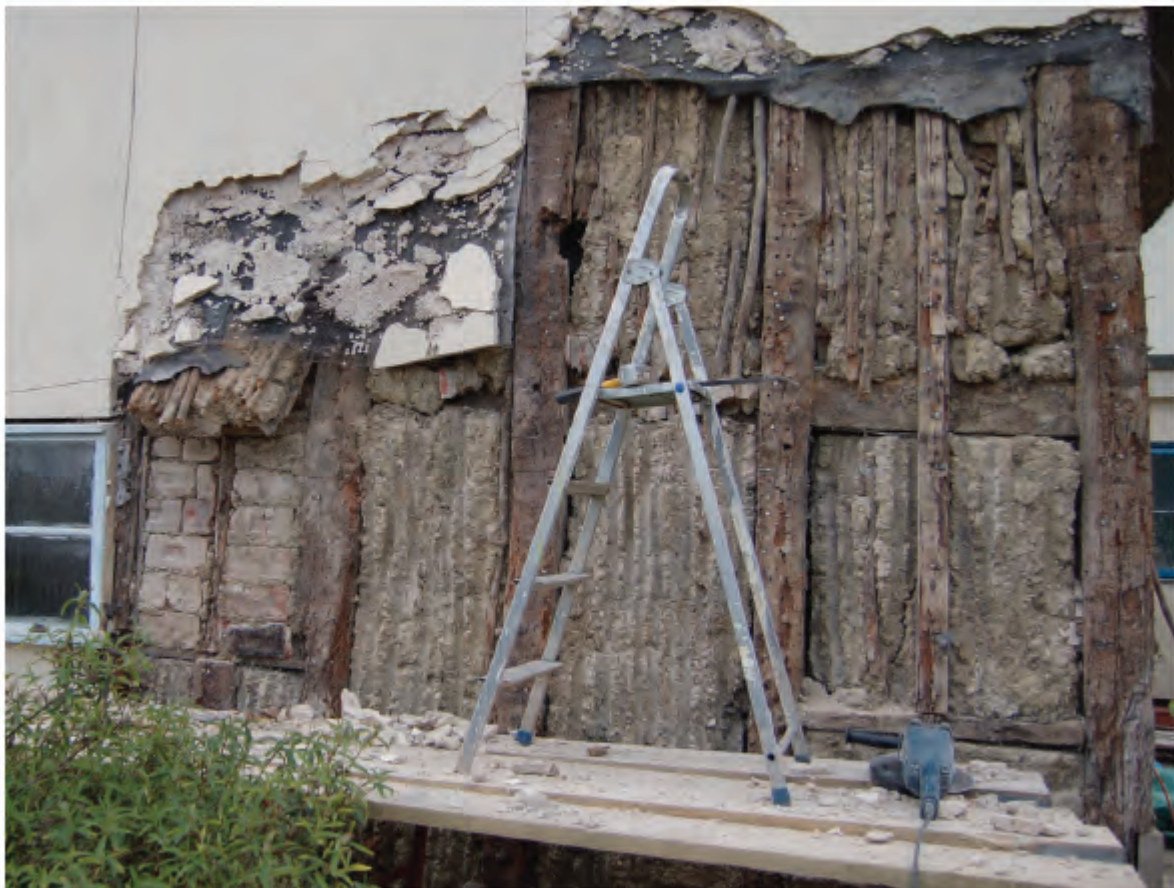
Pic 1

This gave access to the wattle and daub walls. Finding these to be in an extremely poor condition, having suffered from beetle attack and decay over many years, they were removed. We needed to gain access to the frame, that had also decayed and needed repair. **(Pic 1)**

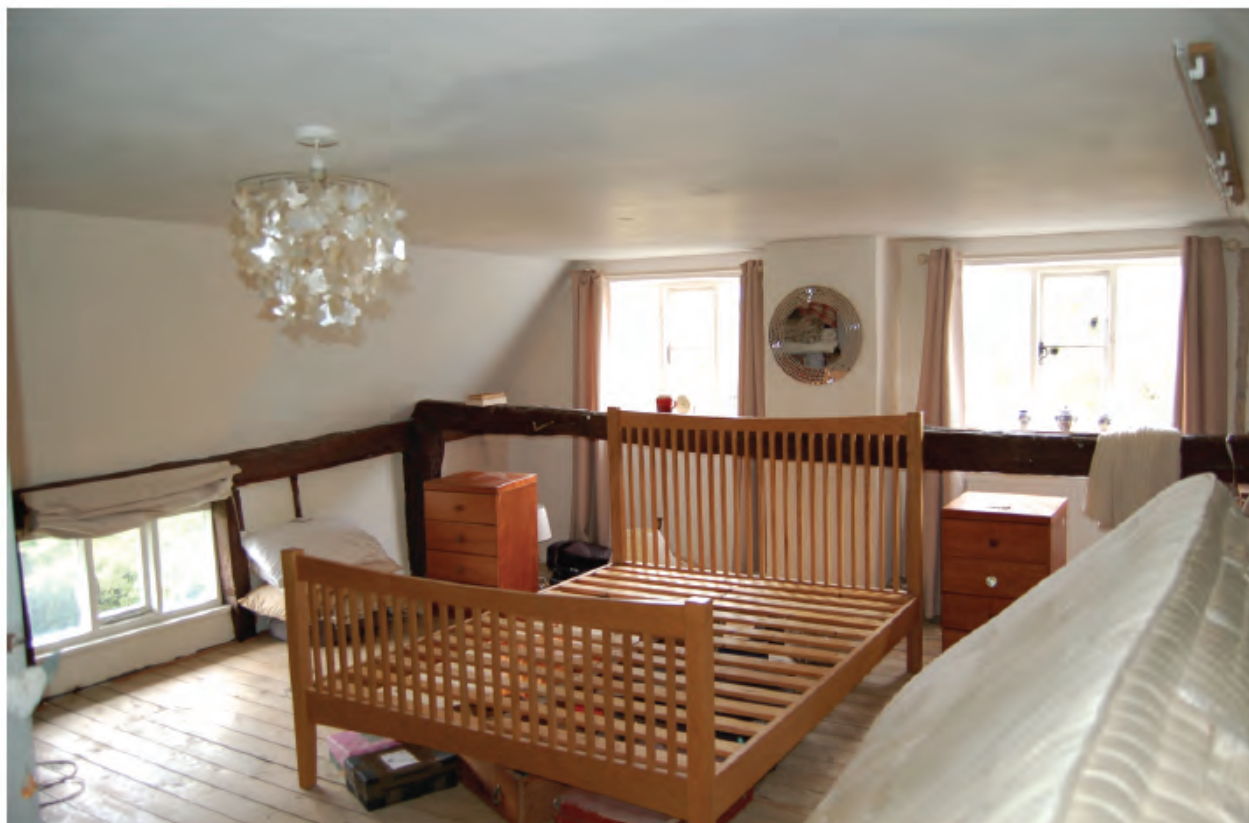
Pic 5

Bedroom 1 with plasterboard ceiling

1960's/70's Plasterboard and studwork additions to this room was removed to give access to the original fabric of the cottage. **Pic 5 & 6** Missing purlins and a roof collar was added see **PGC/ First floor proposed** and **Pic 7** using 6" x 2" green oak.

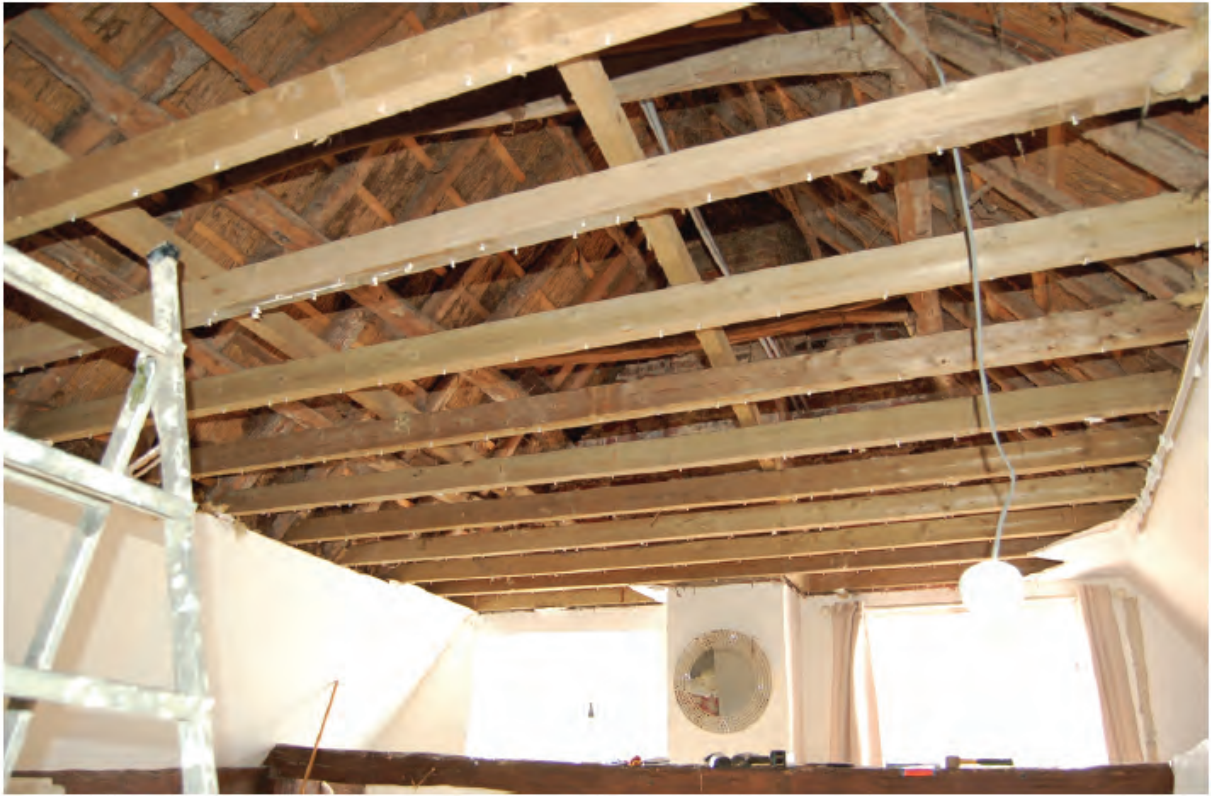
Plc 6

Removal of plasterboard ceiling

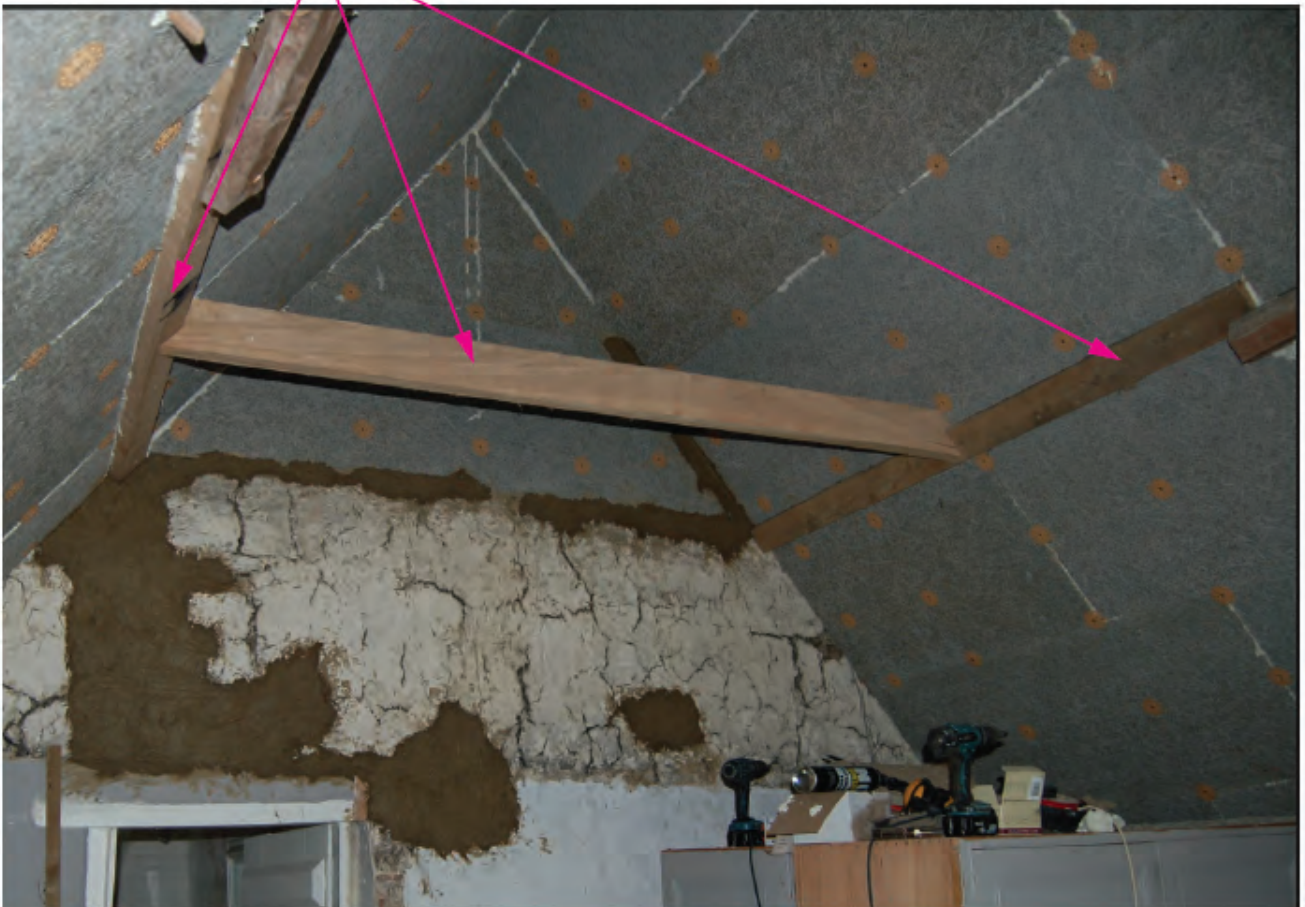
Plc 7

Reinstated purlin and truss

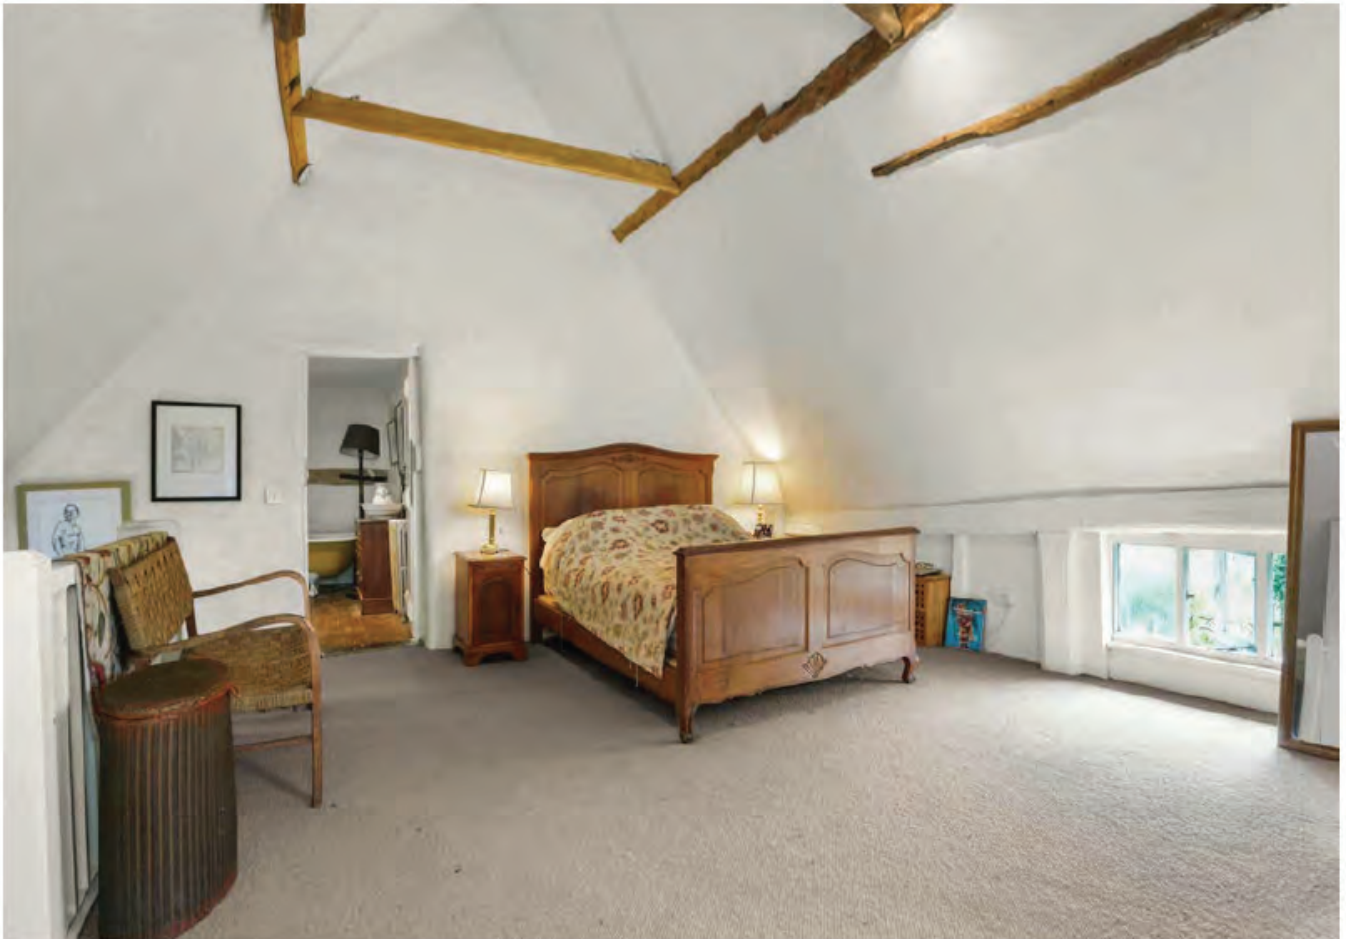
Pic 8 Repaired roof collar and purlins, final lime plaster over savolit board. Sheeps wool insulation.

Where indicated insulation material was added, either Steico wood-wool, 60mm thick thermal conductivity of 0.036 W/mk or Thermafleecce Cosywool 75mm thick, this has a thermal conductivity rating of 0.039 W/mK. Breathable Savolit board was finally fixed and lime plastered. **Pic 8** We used Best of Lime, Limecote plaster.

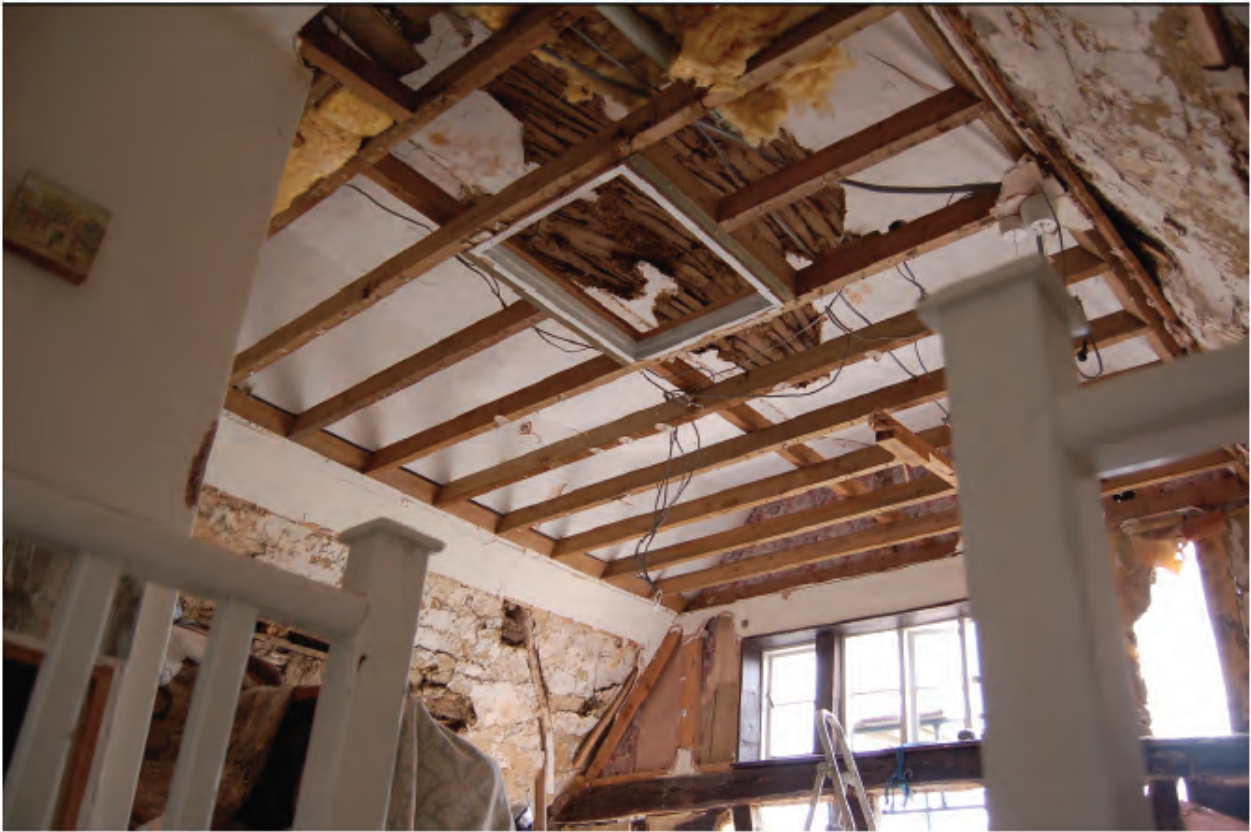
Plc 9 Removal of plasterboard ceiling.

1960's/70's gypsum plasterboard and studwork removed to gain access to original fabric of the building. **Pic 9**
 We removed the studwork and plasterboard constructed shower and toilet cubicle too. **Pic 10 and PGC/First floor proposed.**

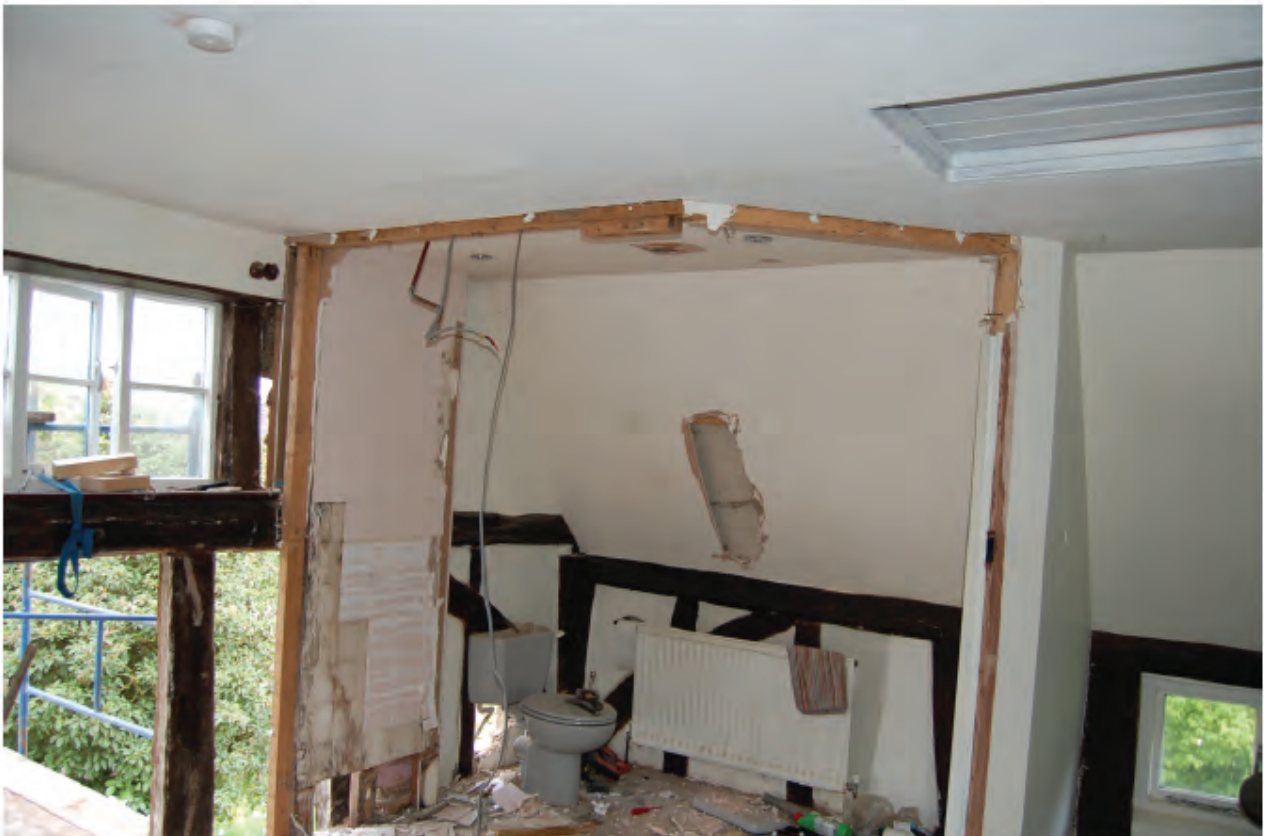
Plc 10 Removal of toilet and shower & plasterboard division in room.

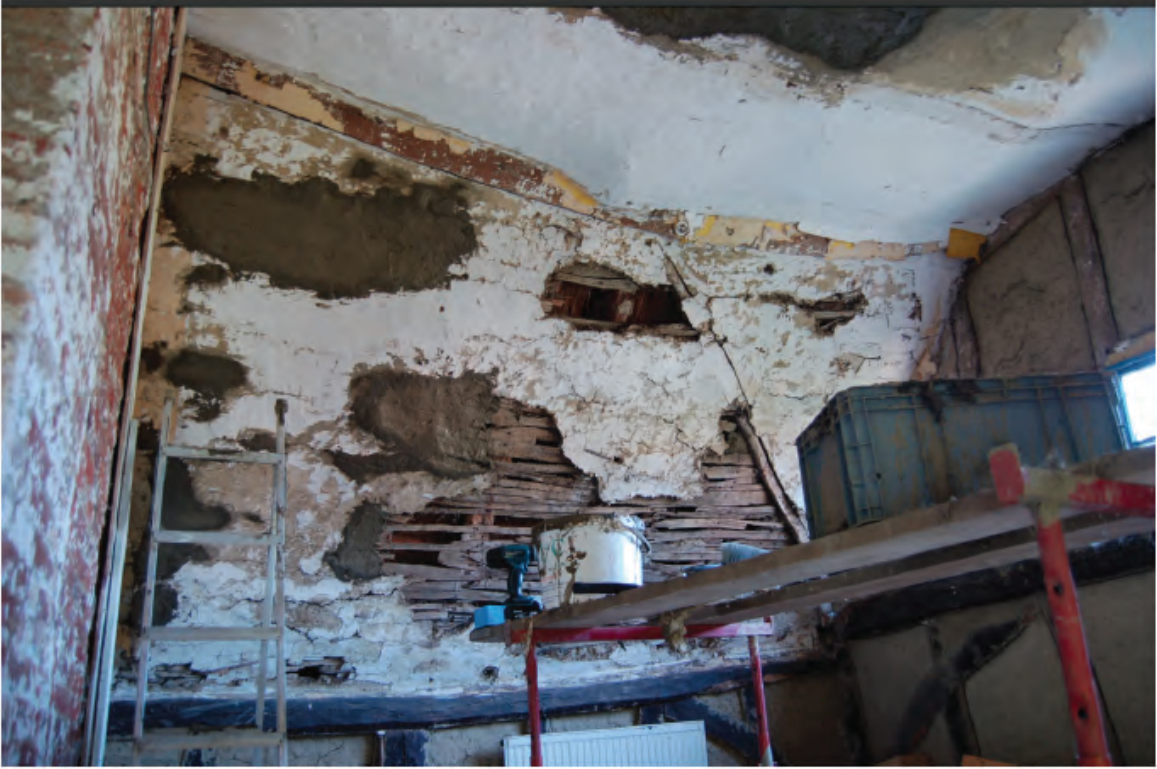
Plc 11

Repair to lath and earth plaster ceiling.

Rear wall was repaired and plastered. **Pic 11**

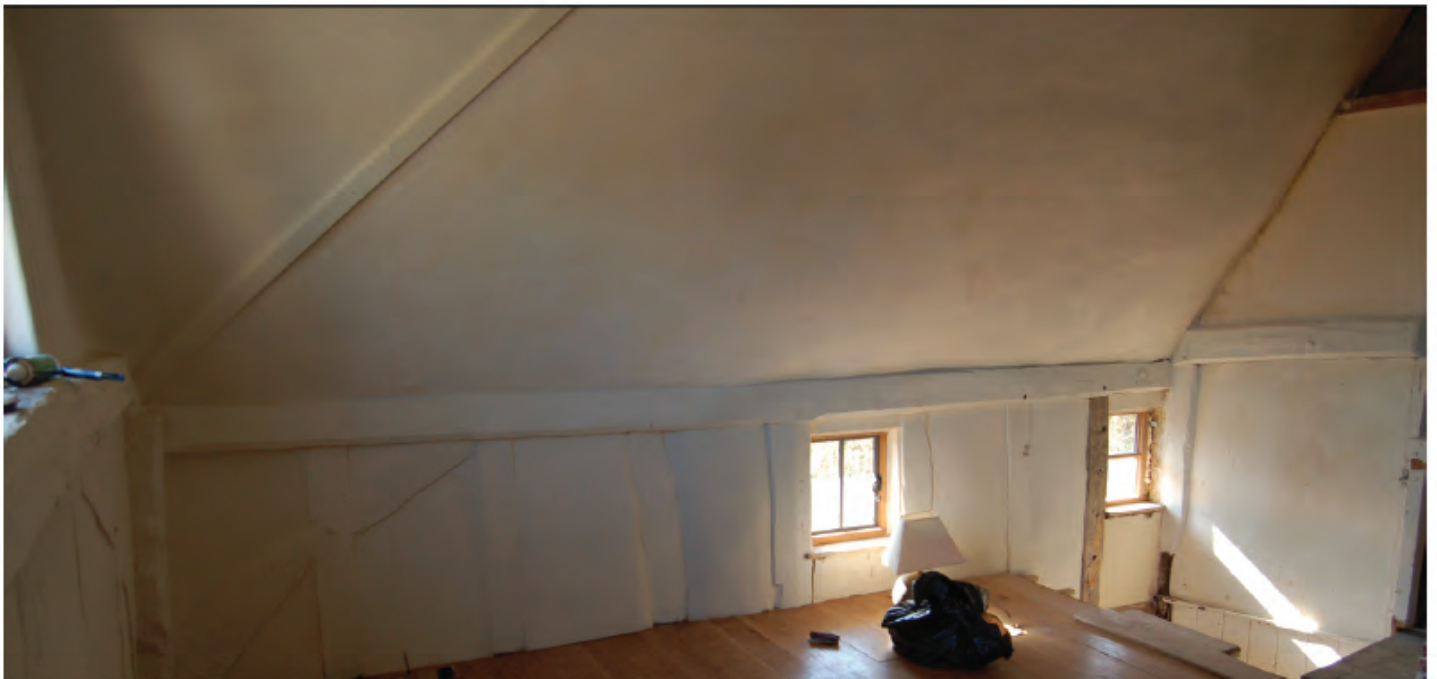
Plc 14

Repaired ceiling, plastered in Limecote.

Decayed front, lath and earth plaster was restored, using sawn oak, earth plaster . Finished off with lime plaster. **Pic 12, 13 & 14.**

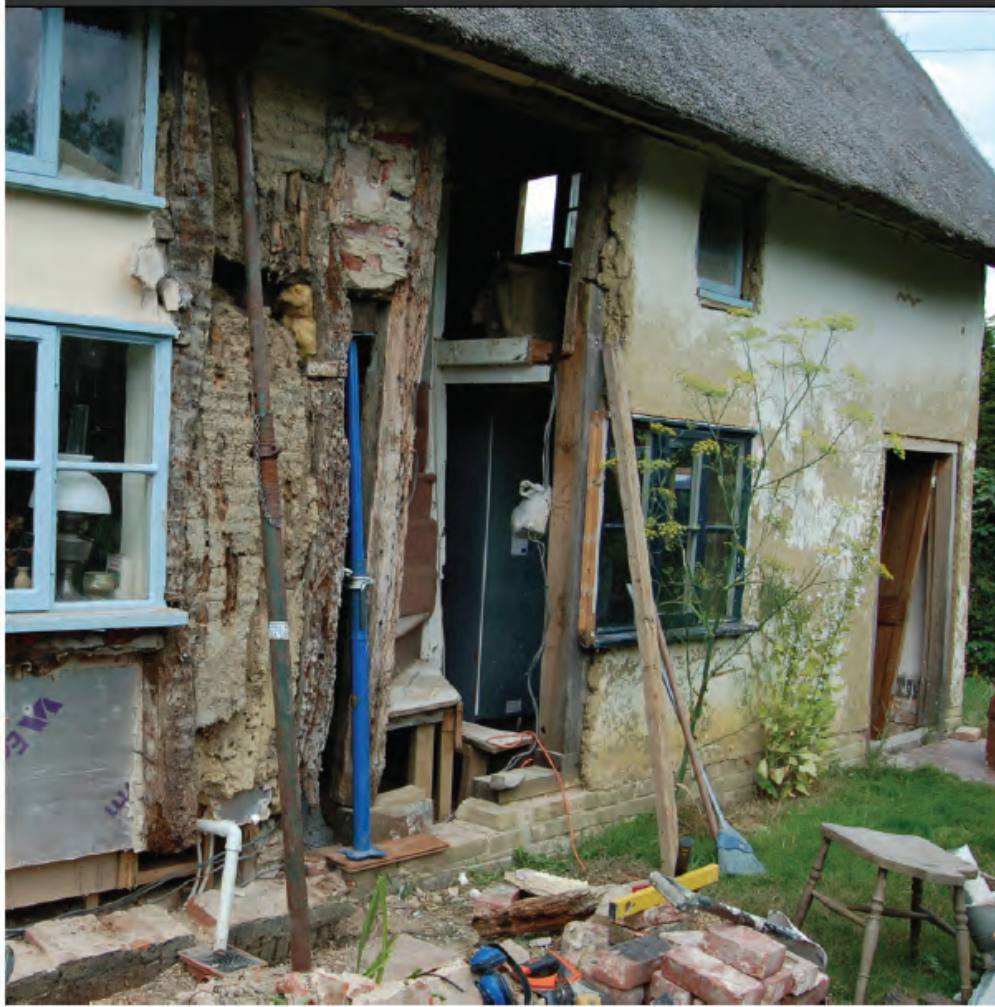
Plc 15

During the restoration of the frame timbers to the front of this section of the wall, a small window opening was left, the idea was to allow more light into the stairwell. **PGC/ Front elevation proposed.**

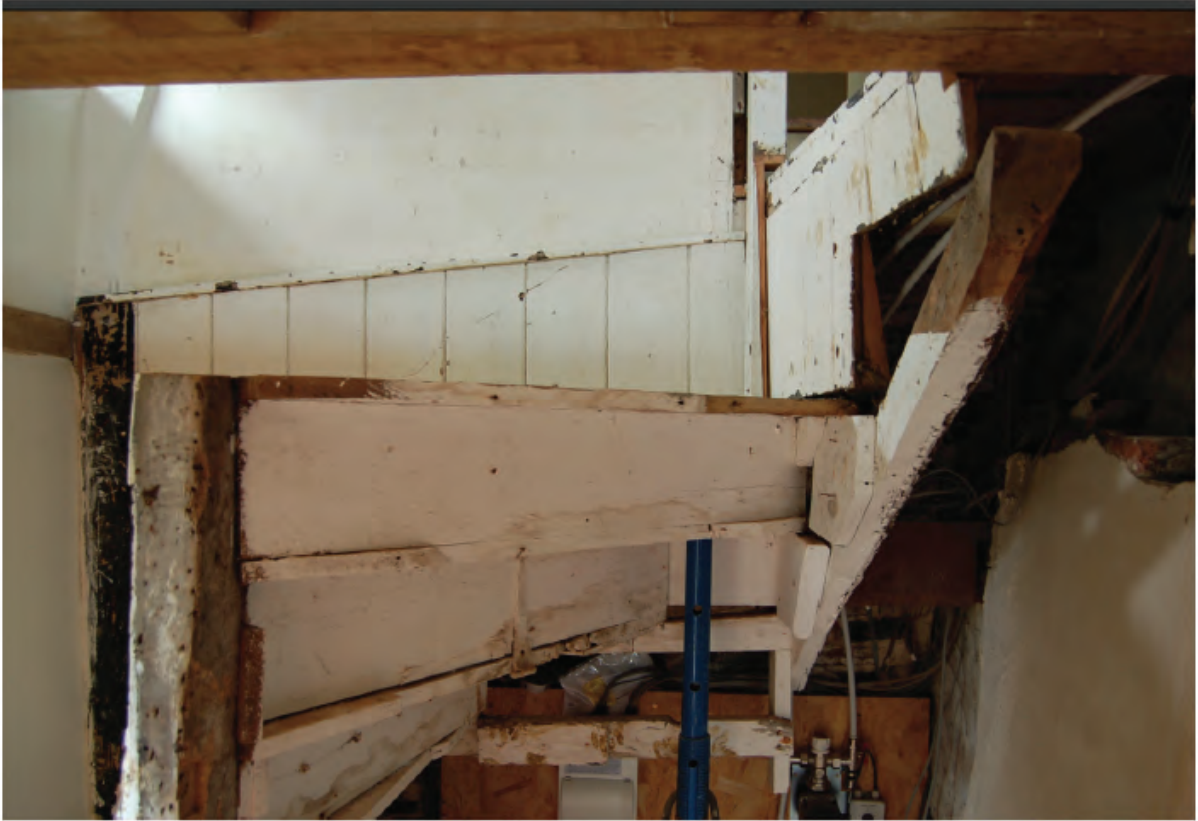
Plc 19

The staircase from the living room to bedroom 2 was found to be suffering from woodworm and some beetle attack. It had lost its structural integrity and was unsafe. For a while it was propped with an acro, but constant heavy use led to failure.

We elected to have a replacement build. This was made by Sam Leah carpenter in situ using oak, replacing the soft wood existing. In terms of design it was like for like. **Pic 19,20,21**
