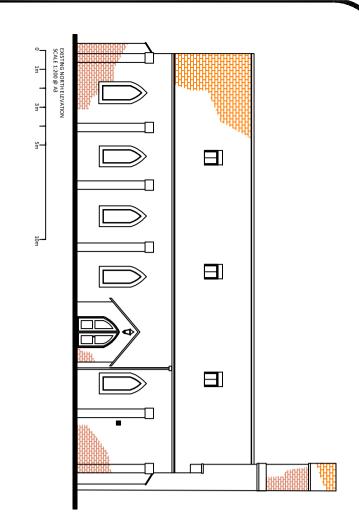
Existing Doors formed from plywood and in poor condition. Doors are not original (ply), so a repair would not be ideal. Replace with solid timber doors and new glazing (double to match existing), painted black. New door handle and locks. New ironmongery.
