St Martin Church, Belper, England	EXISTING SOUTH DOOR
Mar 23	
Ref - 22CHURCHINTERIORS07

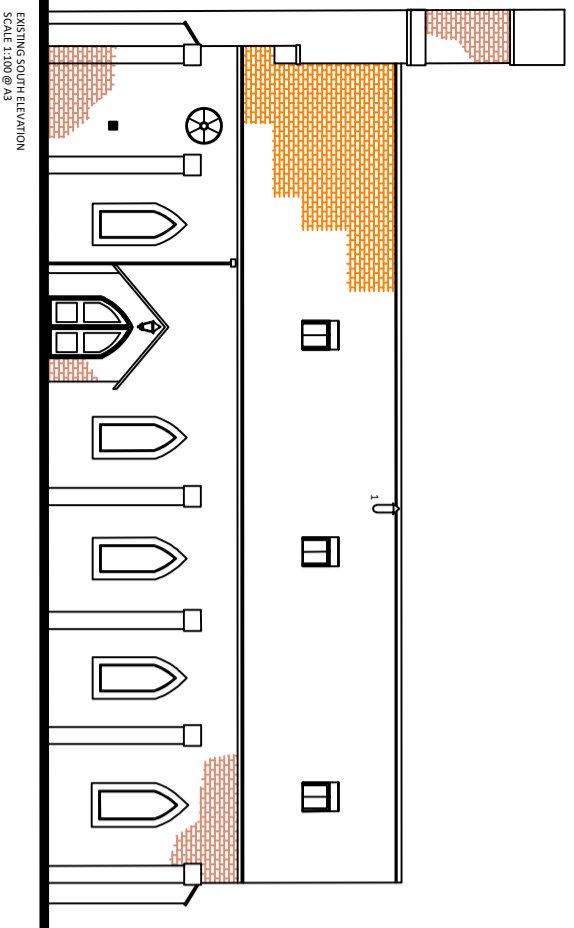
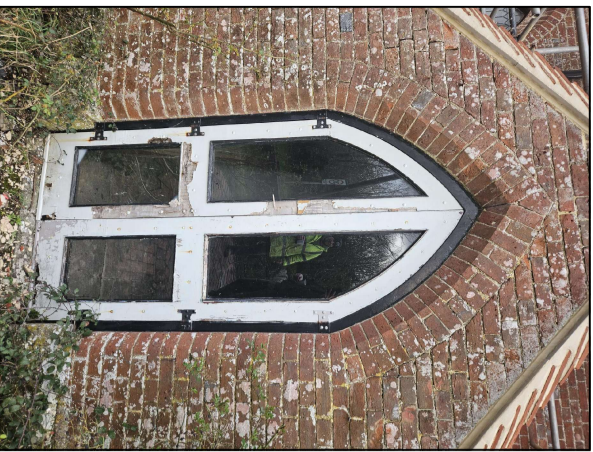
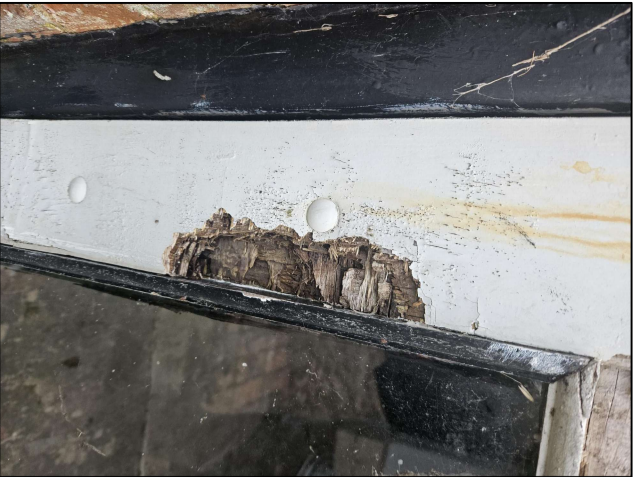
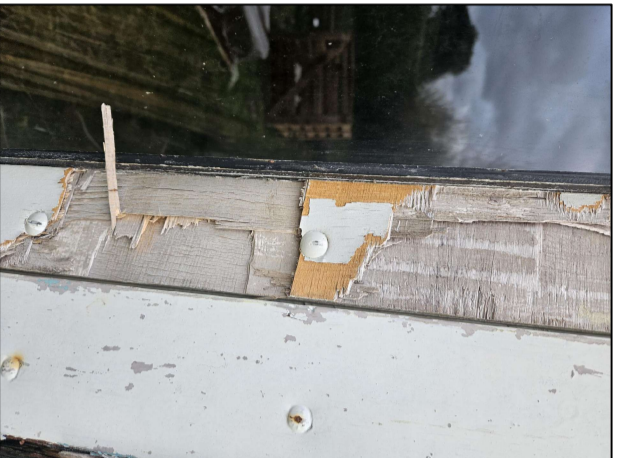
Existing Doors formed from plywood and in poor condition. Doors are not original (ply), so a repair would not be ideal. Door is rotten. Replace with solid timber doors and new glazing (double to match existing), painted black. New door handle and locks. New ironmongery.
