Martin Gustyn and Associates Ltd.

Our Ref: 23984/ MG
22 February 2024

RE: WARWICK LODGE, 42 ST. GEORGE'S DRIVE, LONDON SW1V 4BT – STRUCTURAL INSPECTION OF DAMAGED BOUNDARY WALL TO THE NORTH SIDE OF ST. GEORGE'S DRIVE

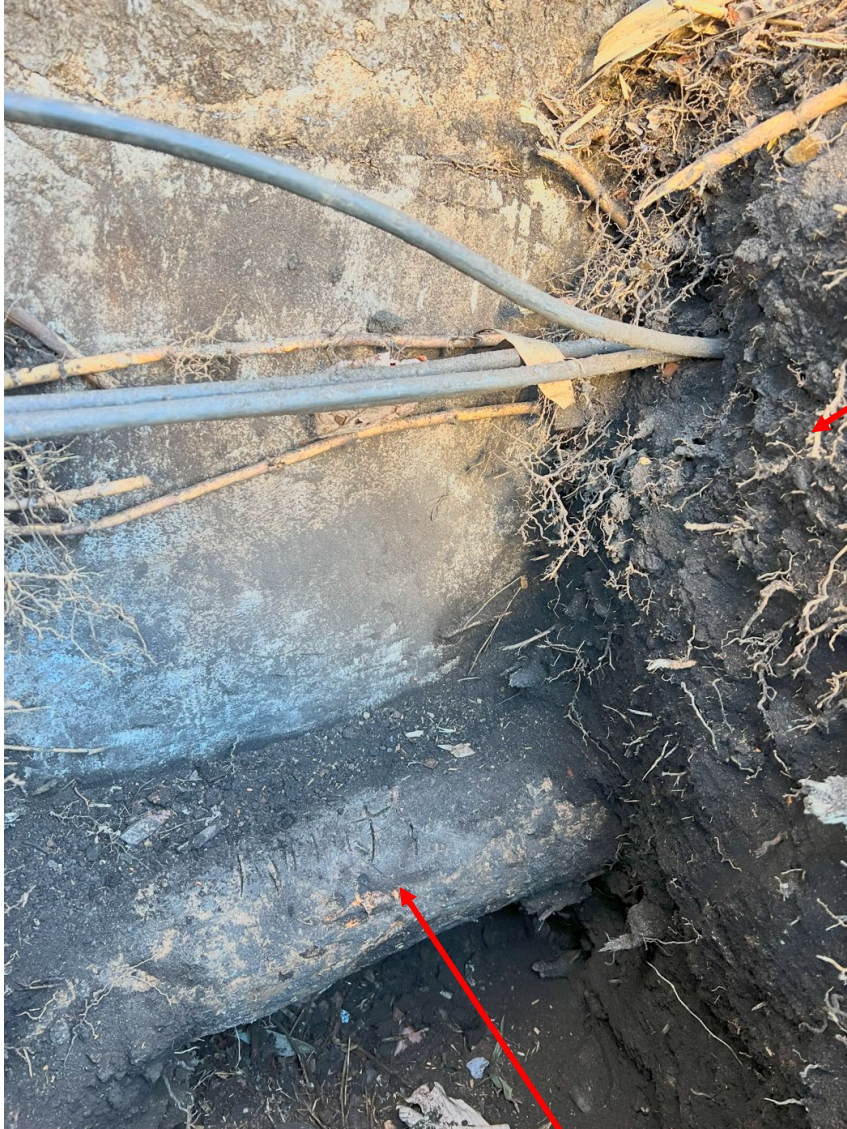
Photograph 1: Trial-pit TP1 – Garden Side

2. A trial-pit excavation (TP1) some revealed some small diameter tree roots and one large 140mm diameter tree root which is pushing against the wall (**photograph 1**).

The close position of the existing Tree of Heaven from the boundary wall and an evidence of one very large diameter tree root touching the wall provide the main evidence that the fundamental reason behind the wall leaning is presence of the tree which is pushing against the wall.

140mm dia tree root

Small diameter roots

1. Fell and grind the Tree of Heaven. All works should be undertaken under a strict supervision of the Tree Specialist. A permission from the Local Westminster Council will need to be sought.

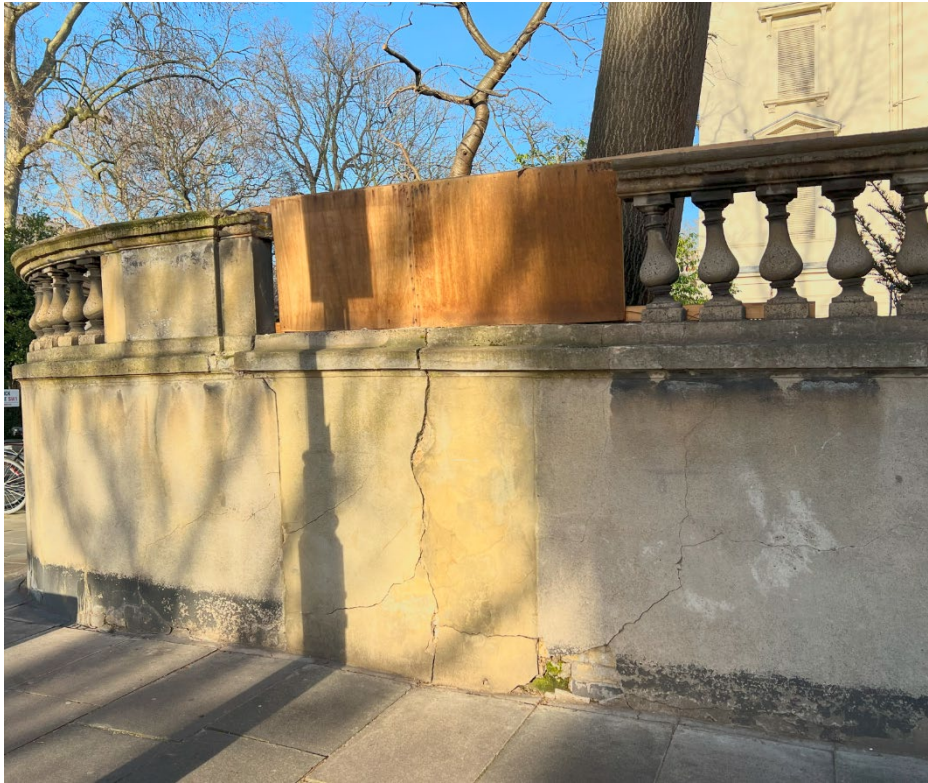
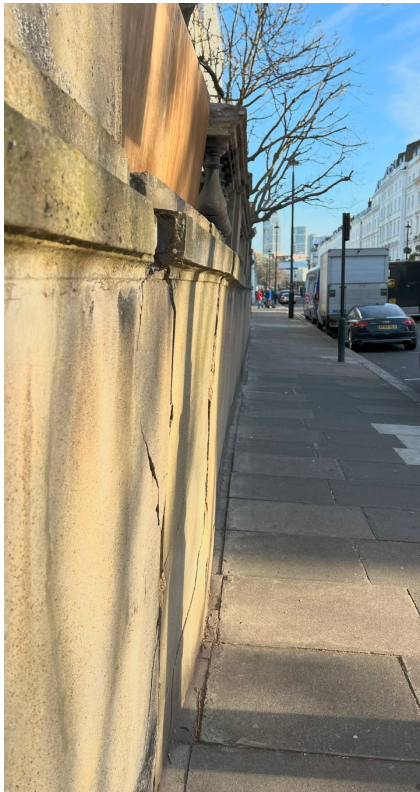
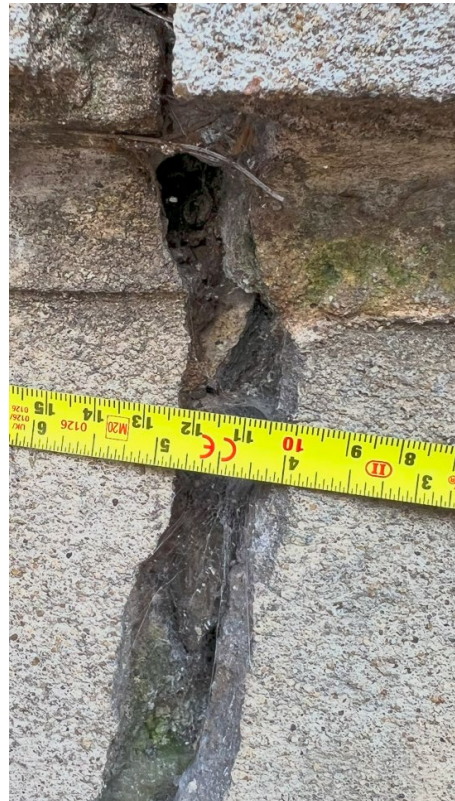
Photographs 3,4,5: Boundary wall view – Street view.

3. There are several cracks ranging between 5mm to 23mm along the boundary wall in a close proximity to the Tree T1. These are structural cracks (**photographs 3,4,5**).

4. The boundary wall is leaning by approximately 3 degrees towards the street. (92mm horizontal distance over a wall height of 1485mm, which exceeds tolerable amount of movement (**photograph 4**).

5. The bottleneck pillars have collapsed on the floor and are temporary stored in the garden .
6. The boundary wall shows signs of historic render repairs (**photograph 3**)

The leaning of the wall in excess of 92mm is considered as structurally unsafe as the resulting centre of gravity of the wall is outside of the centre of gravity of the foundation and the wall might continue to rotate and collapse onto the pavement with no additional warning to pedestrians. A heavy gust of wind might accelerate the process of a wall collapse in the future.

Based on the evidence of this inspection the movement and subsequent cracking is currently causing structural instability. In accordance with *BRE Digest 251: Assessment of damage in low-rise buildings with particular reference to progressive foundation movement* the cracking can be generally classified as category 3 to 4 [cracks 5mm to 25mm]. We attach the relevant section of this BRE Digest for your reference.

2. Rebuild the damaged section of the boundary wall. The boundary wall will need to be designed as a retaining wall capable resisting forces from the raised level of the garden wall. The exact specification of the retaining wall, repairs and new foundation is not within a scope of this report.
3. Filling of the small cracks less than 5mm thick with flexible waterproof filler.
4. Not to increase the garden level with a horizontal distance of 1m away from the boundary wall with the addition of a top soil or other heavy vegetation in the future.

1. A plumb survey should be made to record the current alignment of the entire boundary wall. A further survey can then be made perhaps in 2-3 years time in order to determine the nature of any ongoing movement.
2. A series of 'tell-tales' should be set-up across the boundary wall (from both sides of the boundary wall) in order to ascertain further movement. These should be monitored on a quarterly basis over a period of 2-3 years in order to determine the nature of any ongoing movement.
