GFW02 W02

Project: Whitfield Farmhouse, Hungerford Lane, Shurlock Row, RG10 0NY Drawing: GFW02 W02

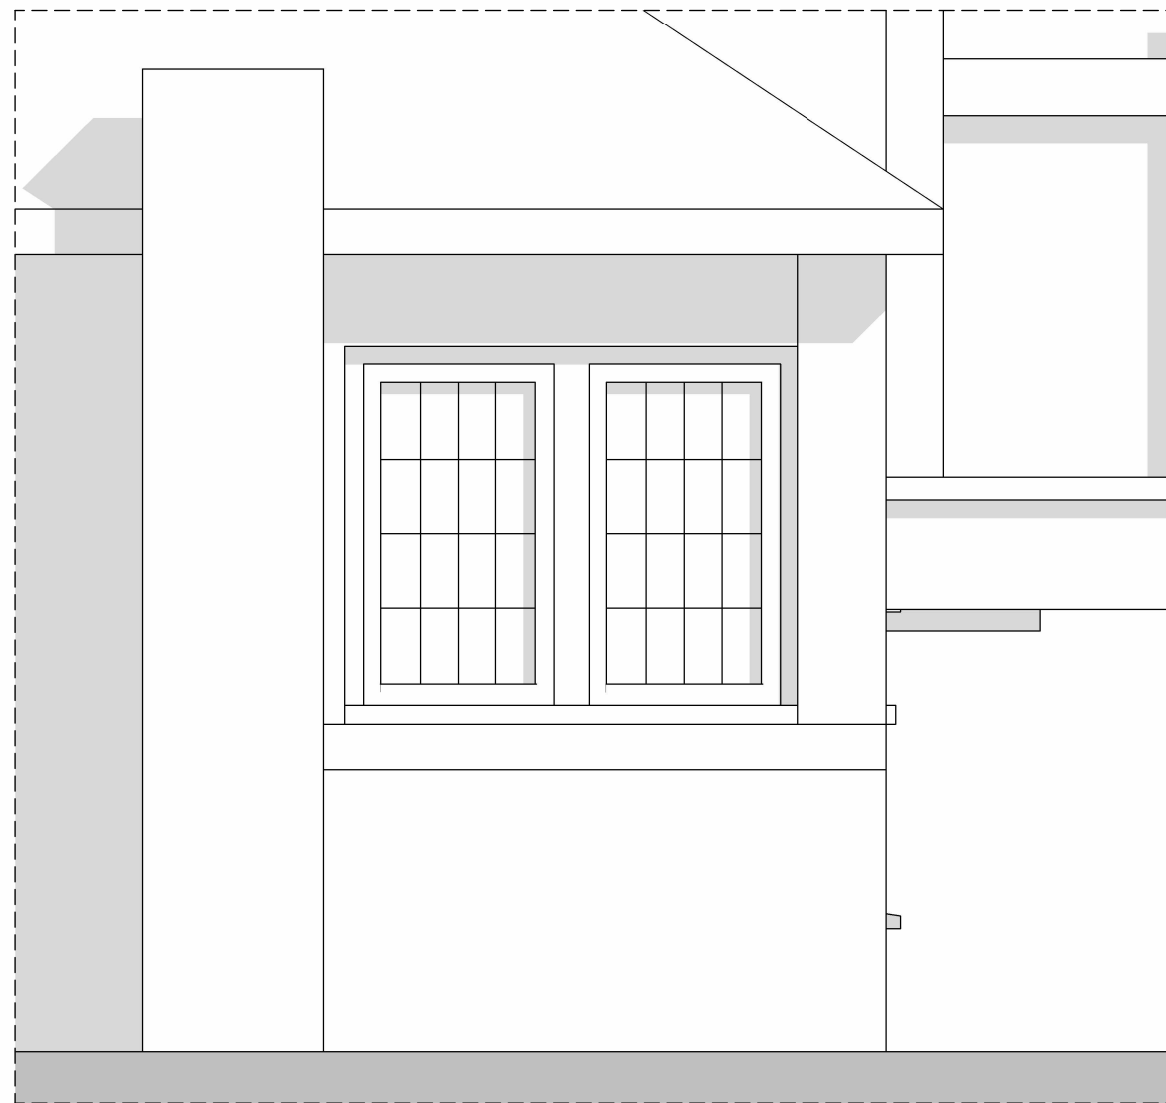
elevation - 1:20

images show the windows have previously had internal glazing bars removed (highlighted with adjacent dashed red linework)

2 light 1 window unit to be replaced with like for like timber unit

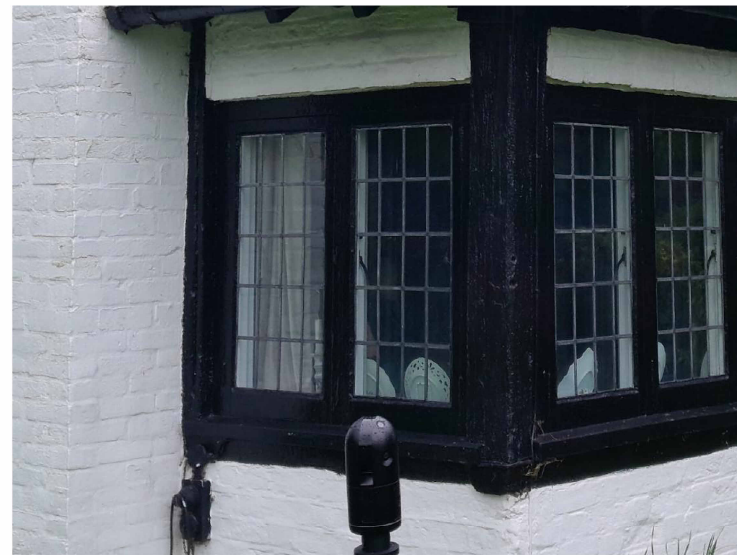
ground floor plan - 1:50

current condition:

estimated early C20 casement window

painted shut, unable to easily open

window has a poor thermal construction, and has therefore been fitted with internal secondary glazing

proposed replacement unit:

replacement unit to contain leadwork to match existing

slimline double glazing to remove the need for any further secondary glazing

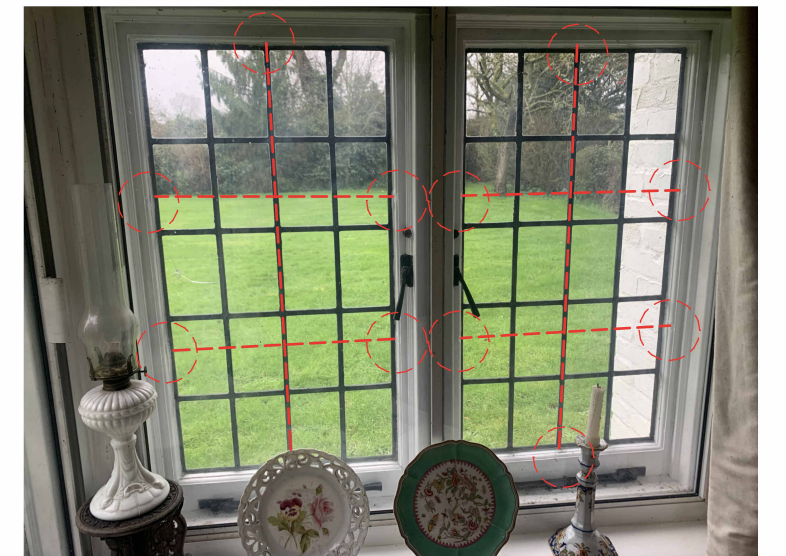
internal view

current secondary glazing
