GFW04 W04

Mar 24 planning Drawn By:

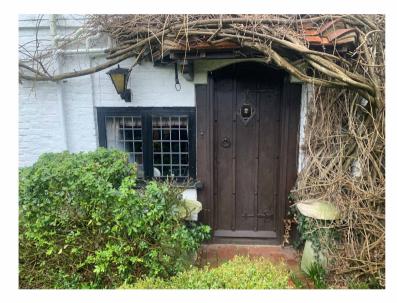
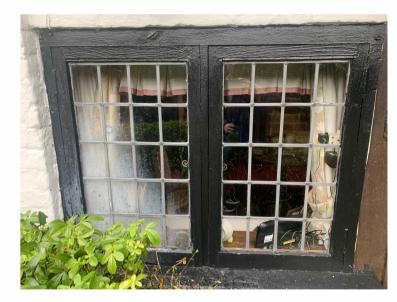
external view

estimated late C20 casement window painted shut, unable to easily open LHS of external cill rotten

3 light 1 window unit to be replaced with like for like timber unit

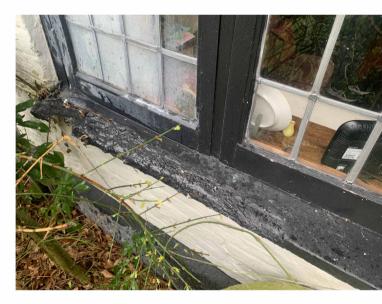
external view - damaged cill

replacement unit to contain leadwork to match existing

slimline double glazing to remove the need for any further secondary glazing
