**GFW01 W01**

Project: Whitfield Farmhouse, Hungerford Lane, Shurlock Row, RG10 0NY Drawing: GFW01 W01		RIBA Chartered Practice
	Collaborating with: Linda Behan	Date: Mar 24	
Job: 997	Drawing: 10-00	Revision:	Drawn By: JB Checked By: EM
Colony Architects Ltd. The Wine Store, Brewery Court, Theale, Reading, RG7 5AJ +44 (0)118 380 0328 hello@colonyarchitects.com colonyarchitects.com

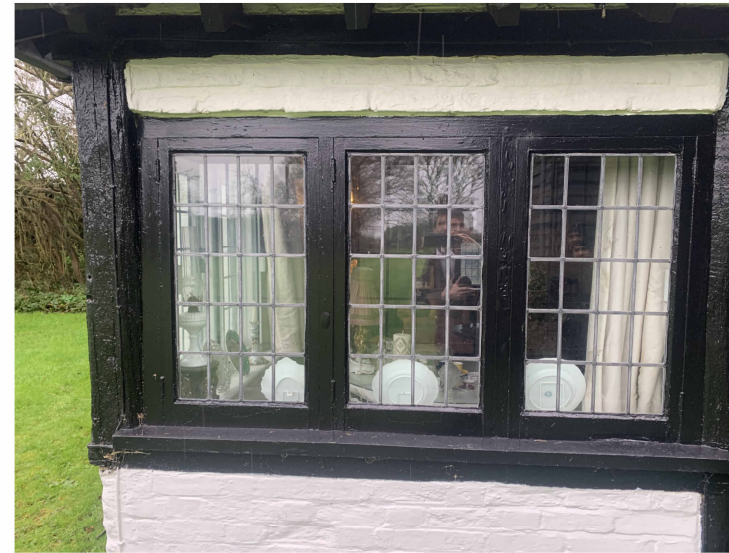
external view

estimated early C20 casement window  
 painted shut, unable to easily open

window has a poor thermal construction, and has therefore been fitted with internal secondary glazing

images show the windows have previously had internal glazing bars removed (highlighted with adjacent dashed red linework)

3 light 1 window unit to be replaced with like for like timber unit

replacement unit to contain leadwork to match existing

slimline double glazing to remove the need for any further secondary glazing
