Stable Building
Sherfield Manor
Structural Inspection Report

Project Number: 02908

28 April 2023

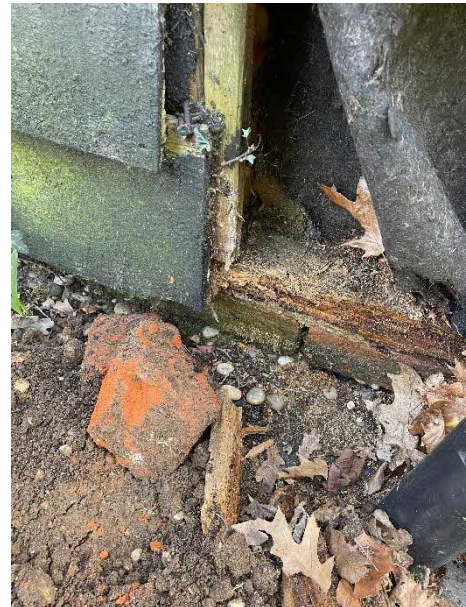
- 2.3 The cladding to the west elevation is in poor condition with a number of weatherboards. A felt membrane is visible behind the boards and is ripped in places. The left-hand pane in the window is broken allowing ingress of water.

Figure 6 - Ripped felt membrane behind loose weatherboarding, decay to timber sole plate

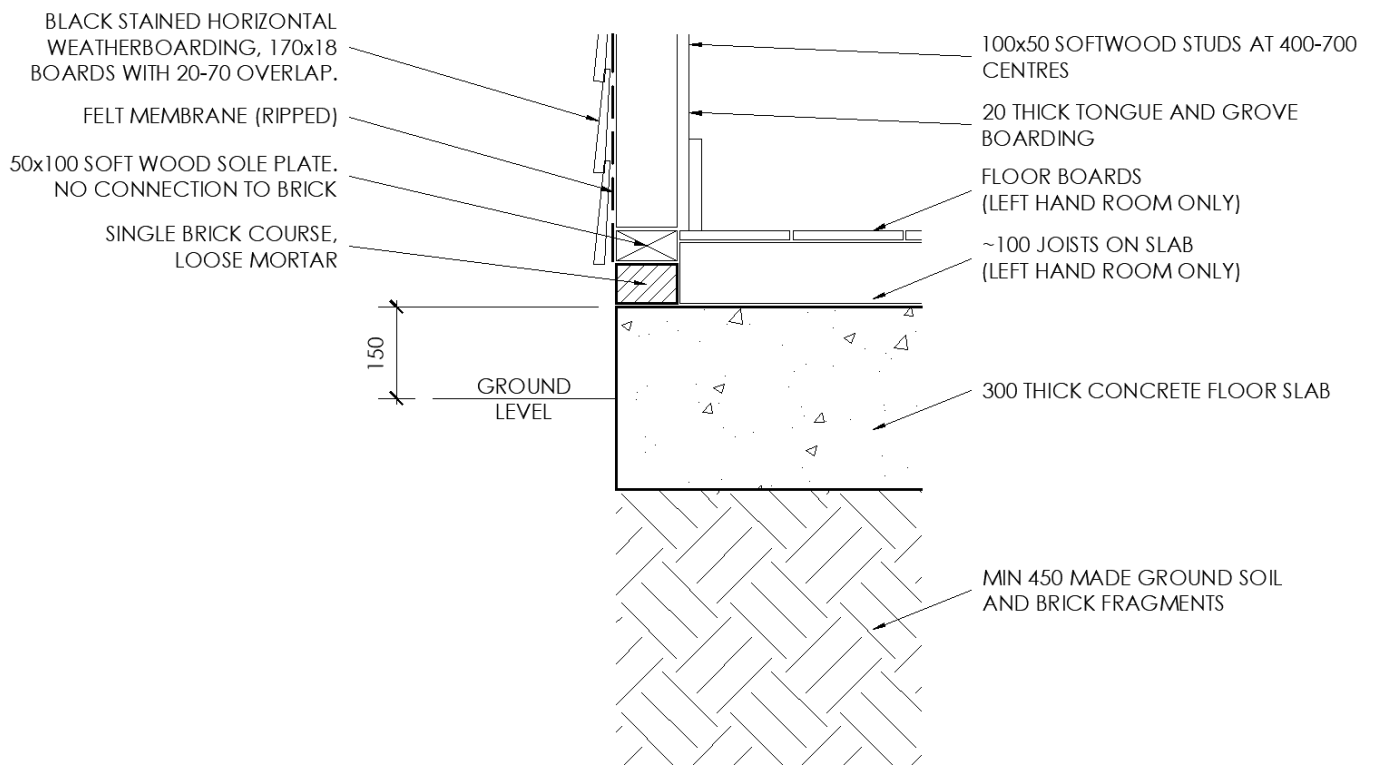
- 2.4 A trial hole was dug at the south end of the west elevation to expose the foundation details. This was found to consist of a 300mm thick concrete floor slab, with 150mm of the slab above ground level. Below the slab is made-ground of sandy soil and brick fragments. Natural ground is at some depth below. The concrete contains large round pebble aggregate, with rough faces to the exposed sides. There is a single brick course laid over the slab and a soft wood timber sole plate above this. There is no damp proof course within the wall build up.

Figure 7 - West gable trial hole information

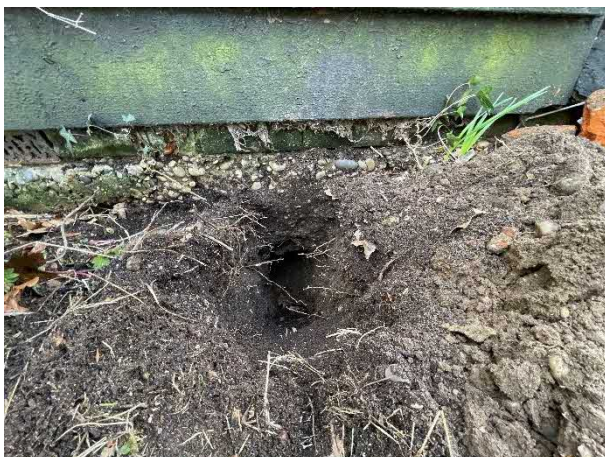
Figure 8 - Trial hole showing concrete floor slab and made ground/soil

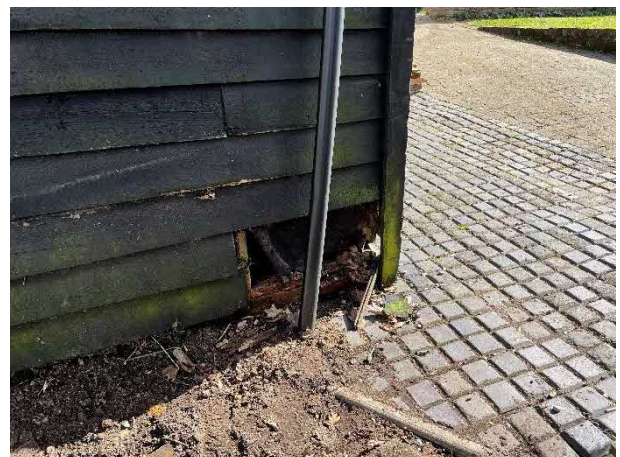
2.5 Also at the south corner, there is an area of cladding missing where a loose rain water pipe discharges straight onto the ground. The timber sole plate is exposed and is in an advanced state of decay (Figure 9).

Figure 9 - South corner of west gable missing weatherboarding and loose rain water down pipe

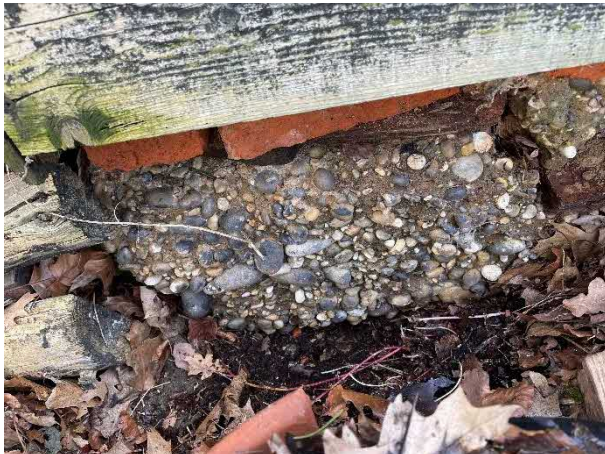
2.6 At the north end of the west elevation, as the external ground level drops away, the full thickness of the floor slab is exposed above ground level. There is a crack 500mm back from the corner and the slab has dropped. Some remedial work has been done at some point in the

past to level the wall here by packing ply wood between the slab and brick course, which is loose with no mortar remaining. The timber is now in an advanced state of decay.

Figure 10 - North end of west gable, crack in slab 500mm from end loose bricks

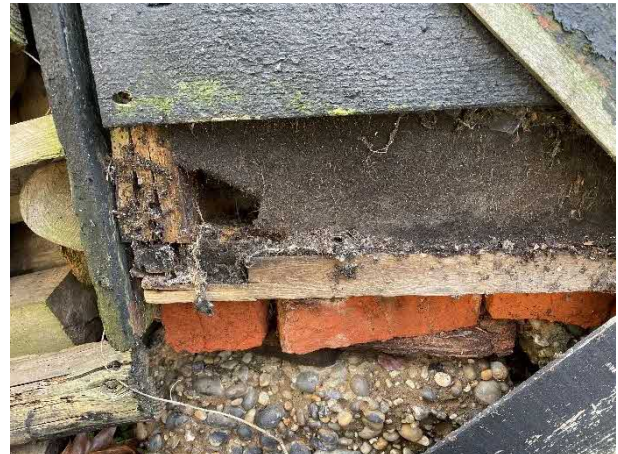
Figure 11 - Felt membrane ripped and sole plate decayed. Loose bricks with ply packing

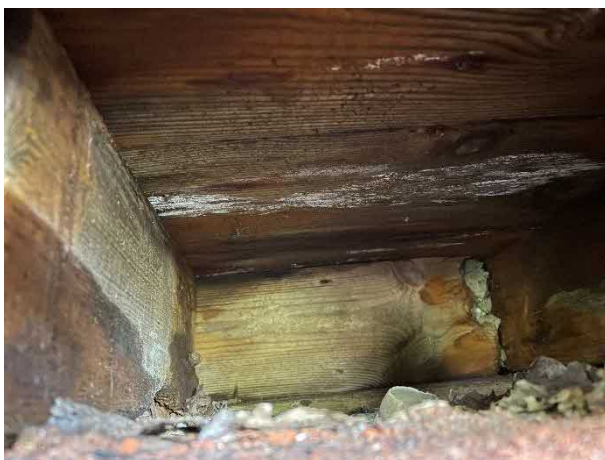
- 2.7 Looking through the dislodged brick course, floor boards can be seen to be supported on timber joists laid directly onto the slab. These are both damp and signs of decay are evident.

Figure 12 – Joists beneath floor boards. Damp and rot visible to boards and joists

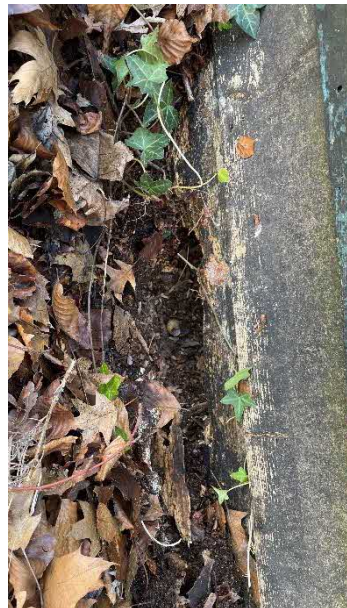
2.14 The natural ground level is higher on this side of the building with the adjacent drive about 800mm above the Stable’s internal floor level. The ground likely originally sloped down between the two but the ground against the building has gradually become infilled with leaf litter raising the ground level over the years such that the weatherboarding is retaining the external ground. From scraping away the soil in front of the cladding this appears to be a depth of around 600mm.

Figure 19 - Rotten boards at low level behind leaf litter and soil

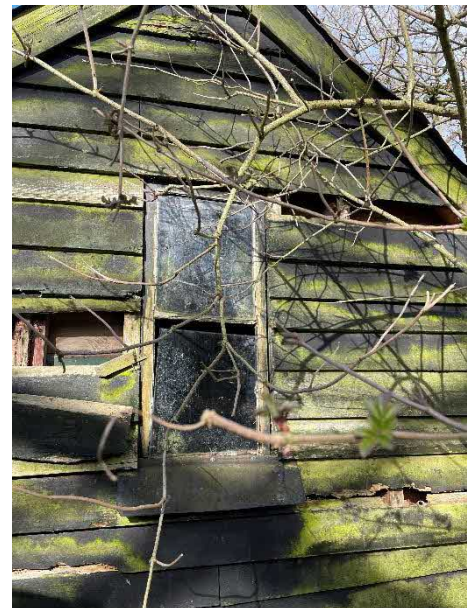
Figure 20 – Loose boards around window, with lower glazing slipped down

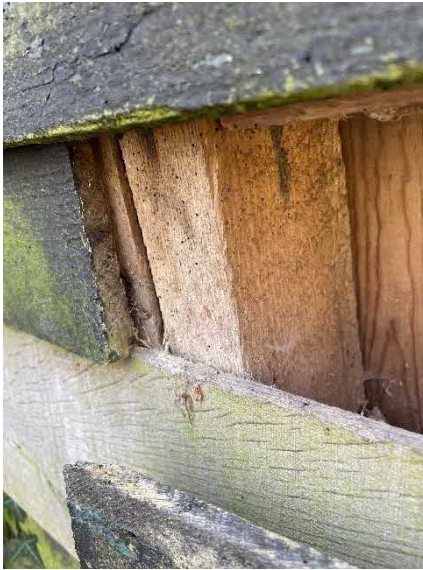
- 2.15 Through the gaps in the weatherboarding the softwood studs could be measured as 100x50 and spaced between 400-720mm apart. One diagonal brace was noted at low level. There is no membrane at this end of the building.
- 2.16 The condition of the studs is poor with evidence of beetle attack to the internal boards, studs and weatherboarding. It is unclear if this is historic or ongoing but as the timber is in a damp environment it is susceptible to ongoing decay.

Figure 21 – Exposed stud with beetle attack in east elevation

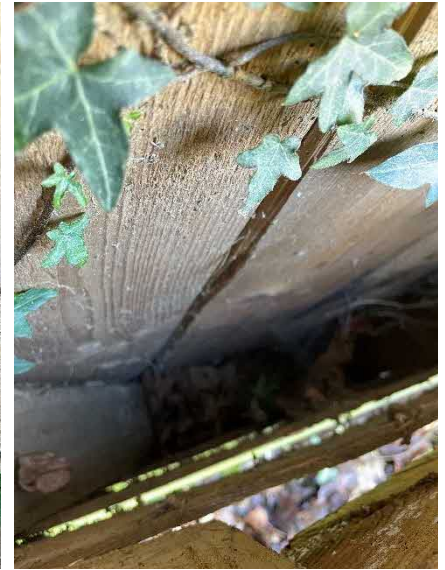
Figure 23 – Ivy growing against internal boards and leaf litter at base of cavity

- 2.17 Ivy can be seen growing against the internal boards and leaves have blown into gaps in the cladding and have filled the base of the cavity.

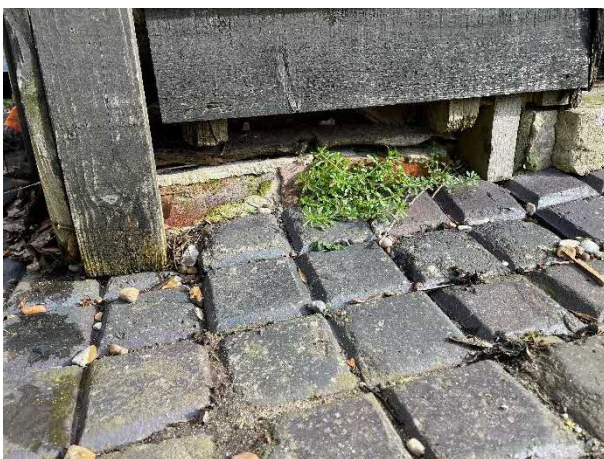
Figure 26 – Decayed sole plate at west end

2.21 At both ends the sole plates have become exposed and are significantly decayed.

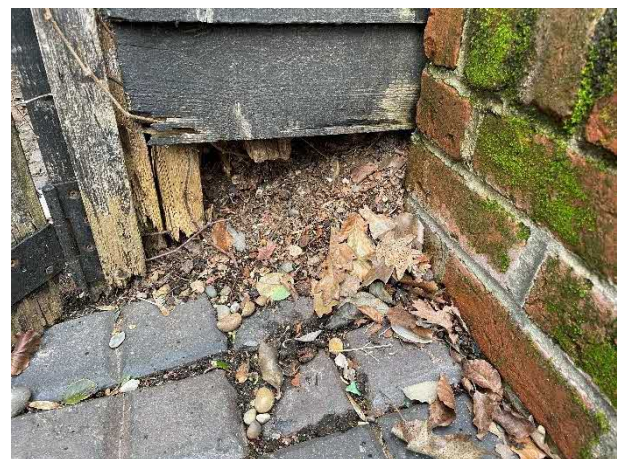
Figure 27 – Missing bottom board and decayed studs to right of east door

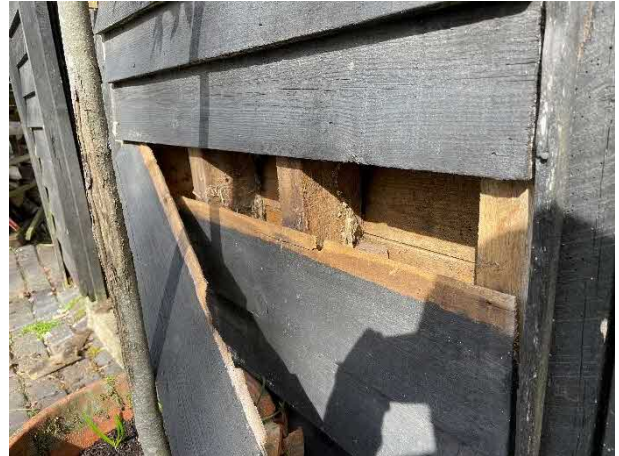
Figure 29 – Loose board between doors, no membrane

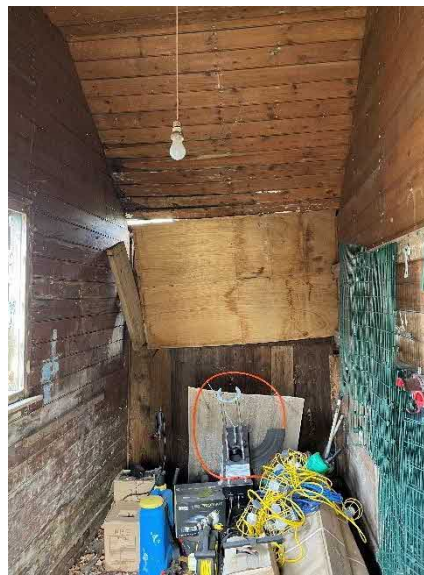
Figure 31 – View to north wall, note temporary ply repair at top of wall

- 2.24 As noted externally, the north west corner is missing a roof sheet and this has led to ingress of water and decay of the timber wall and roof structure. A ply board has been fixed to the remaining structure to offer some protection from the elements.
- 2.25 The top of the wall was found to consist of a single 100x50 soft wood wall plate, with 80x50 rafters over. These appear to be at 380-400mm centres. Looking at the eaves detail it appears that the rafter feet are likely finished with mainly a seat cut with only a minimal (10mm) bird's-mouth. This will provide limited resistance to the rafter feet sliding outwards over the wall plate.

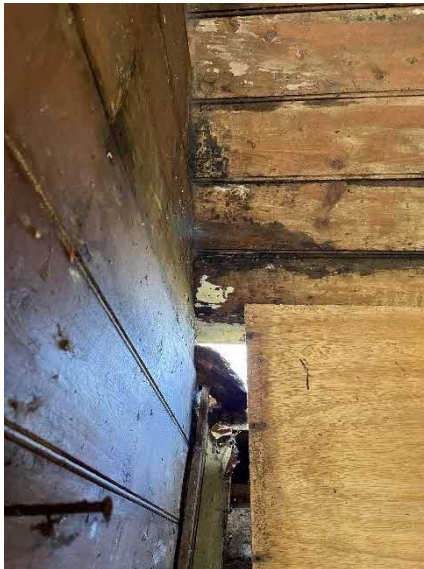
Figure 33 – North west corner, timber decay due to hole in roof

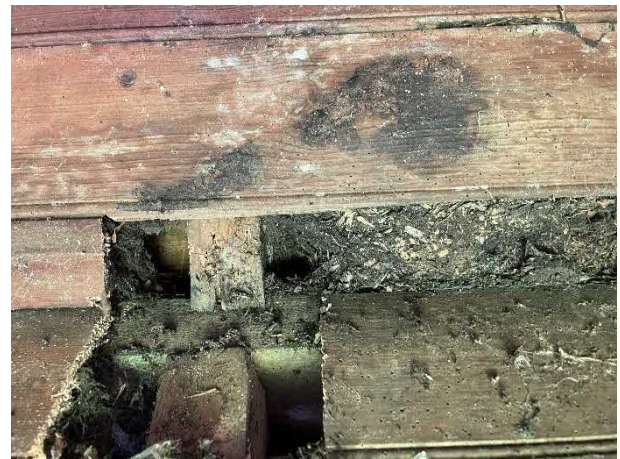
Figure 37 – Roof insulation and upper boards visible, beetle attack to inner boards

2.27 On close inspection the internal panelling boards were noted as being affected by beetle attack.

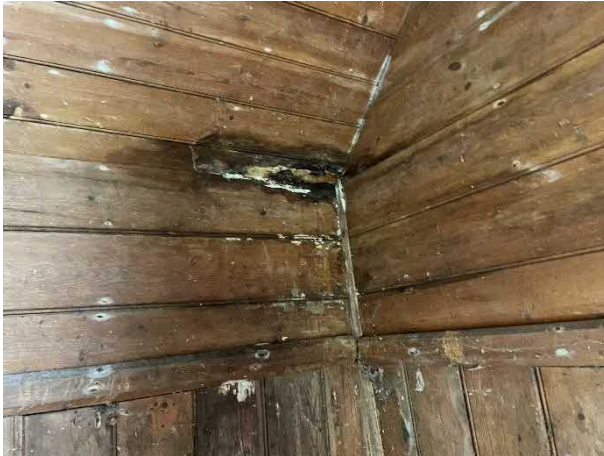
2.31 There are areas of water ingress and signs of timber decay, notably in the north east corner, and also where the flat ceiling meets the skilling about halfway along the room.

Figure 42 – Ingress of water and timber decay north east corner eaves level

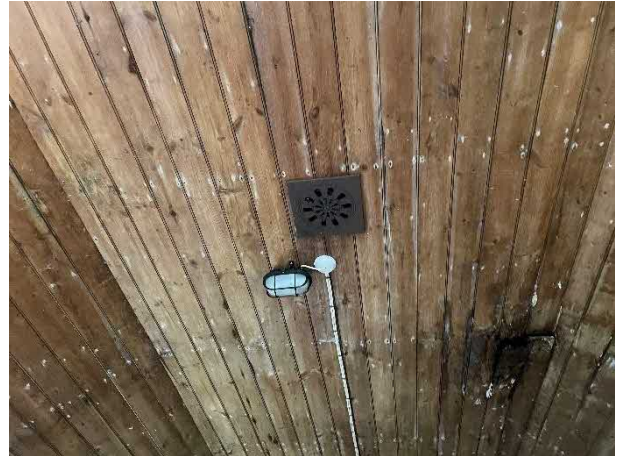
Figure 43 – Ceiling vent, water damage to right hand side

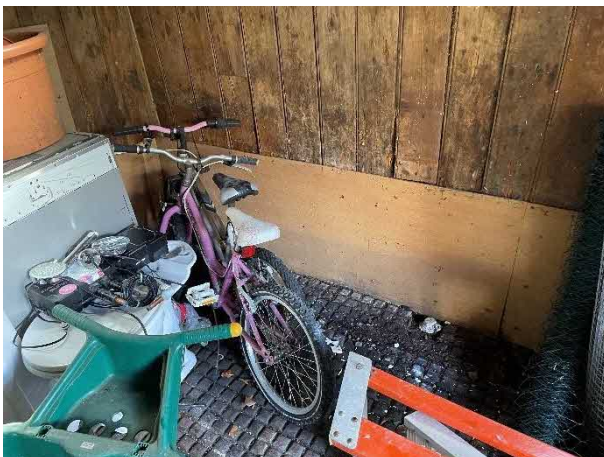
2.32 At low level a plywood board has been added to the east, and part of the north wall. This coincides with the high ground levels externally and it is thought likely that the original cladding behind the ply will be affected by water ingress and decay. There is also slight bowing of the walls in these locations likely due to the wall effectively retaining the ground outside.

Figure 44 – Low level ply boarding to east elevation where ground is high externally

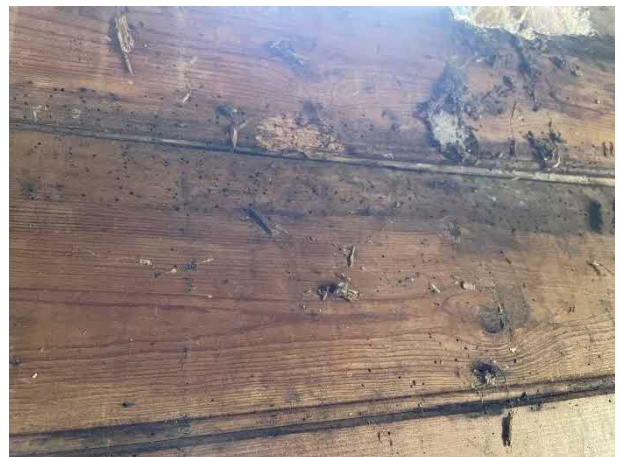
Figure 45 – Beetle attack to timber panelling

- 3.5 There is evidence of beetle attack to the inner panelling, structural studwork and roof member and also to the external cladding. The extent of this highlights the need for wholesale intervention due to the precariousness of the existing structure.
