Structural
Engineering
Consultants

Saturday, 30 September 2023
Ref: 2023_342

Subject: The Lodge, 2 Dyke's End, Collingham, NG23 7LD –Site Inspection

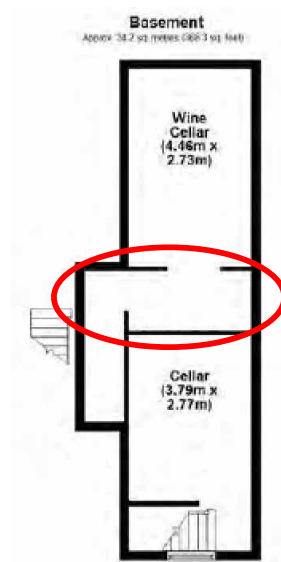
The first defect inspected were the rotten timber elements of the basement ceiling. During the visit it was noted that a number of the timber joists (providing support to the ground floor) seemed soft and spongy, likely indicating timber decay.

Figure 1 - Section of basement ceiling with rotted timbers (red circle)

The inadequate ventilation in the basement is likely to be the cause of the rotted timbers.

Most of the timber joists have damaged sections which if left in their current state could lead to further damage and risk of the floor collapsing.

It was not possible to determine the extent of the timber decay during the visual inspection. However, we believe that the most economical and structurally adequate solution would be replacing the damaged timber elements with new sections with a minimum size of 50x100 C24 at max 400mm ctrs.

Use 2No. 50x100 C24 (max 1.4m long) as trimmers where required.

We recommend that the damaged elements be replaced one at the time ensuring that the surrounding structure are adequately propped.

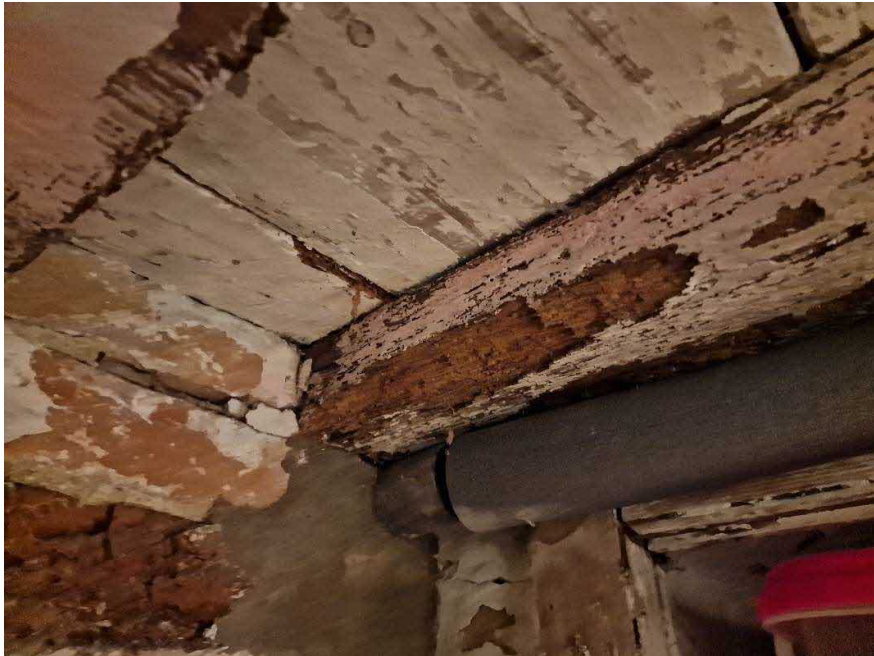
Image 1 – Rotten timber to basement ceiling

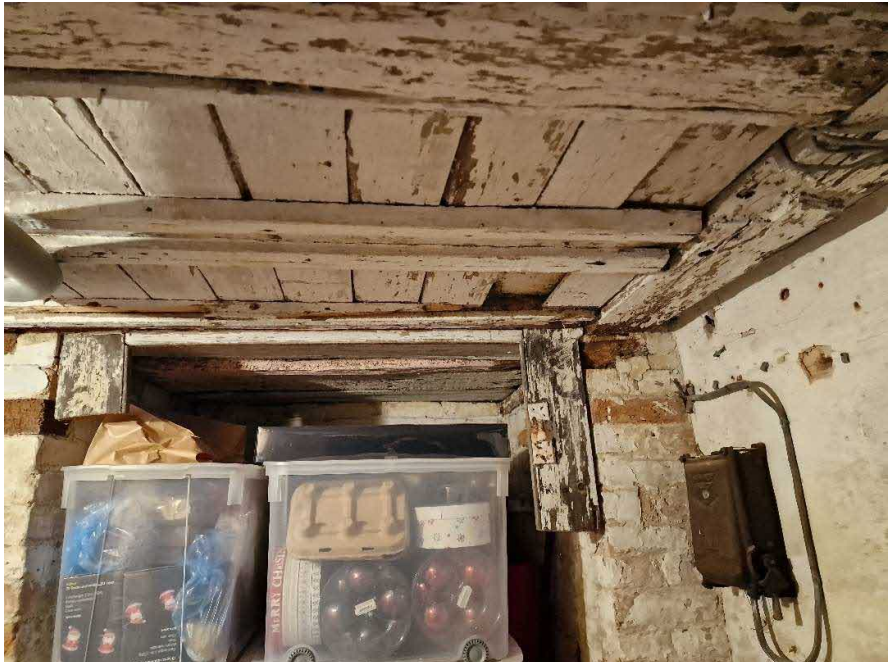
Image 2 – More basement ceiling joists which may require replacement

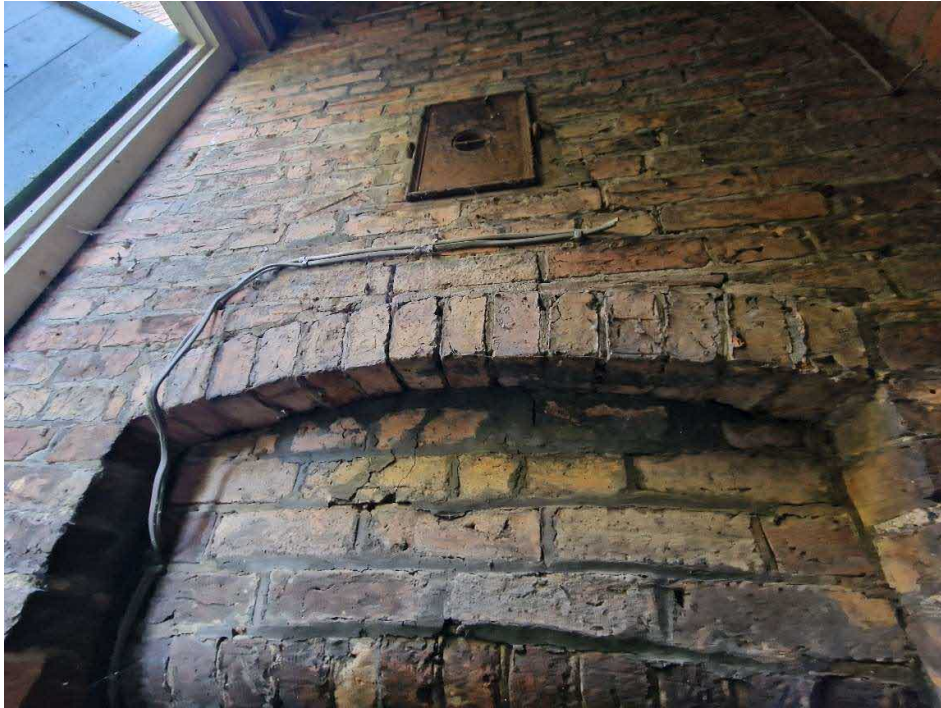
A minor crack/separation (which appears to be historic) was noted to the central section of the brick arch lintel over the opening. An old cast iron pipe seems to go through the chimney flue behind the arch. It is assumed that this pipe used to source heat to the house. It is likely that the cracked brickwork was caused by the expansion action of the hot pipe.

Image 3—Minor crack to brick arch lintel over basement door

The arch and the wall above it did not appear to be unstable, therefore the affected area of brickwork only requires repointing with lime mortar.

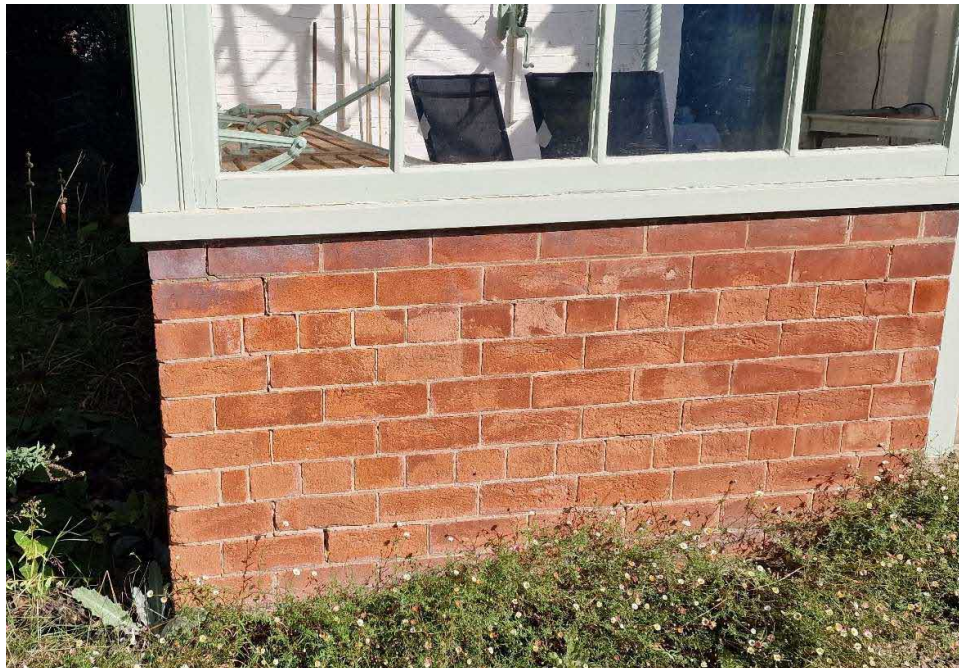
The cracks were not significant and do not seem to be compromising the stability of the walls.

These cracks were likely to have been caused by a combination of shallow foundations and the roots of the nearby tree.

Image 4—Cracking to conservatory wall (left side)

Based on the size of the cracking, at this stage it is recommended that the cracked sections be repointed with lime mortar.

Should the cracks reappear after the repair, further investigation may be required to determine the condition of the foundation.

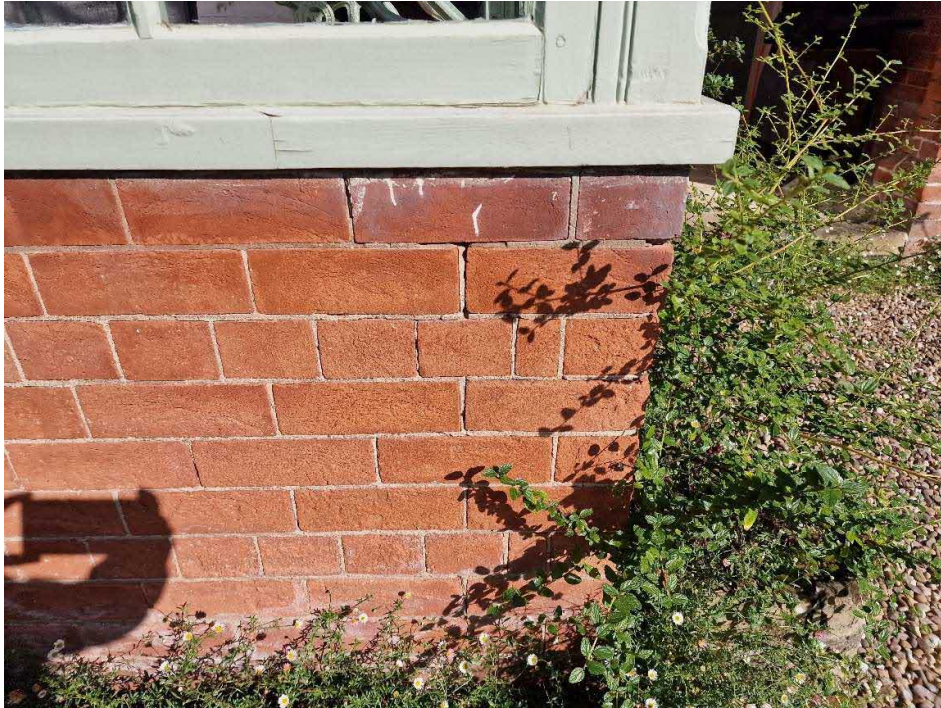
Image 5 – Cracking to conservatory wall (right side)
