Urban Tree Experts

21 February 2024

Ref: SPH/DD-24/20.02

Re: Decay Detection at 40 Horation Avenue, Warfield, Bracknell, RG42 3TX.

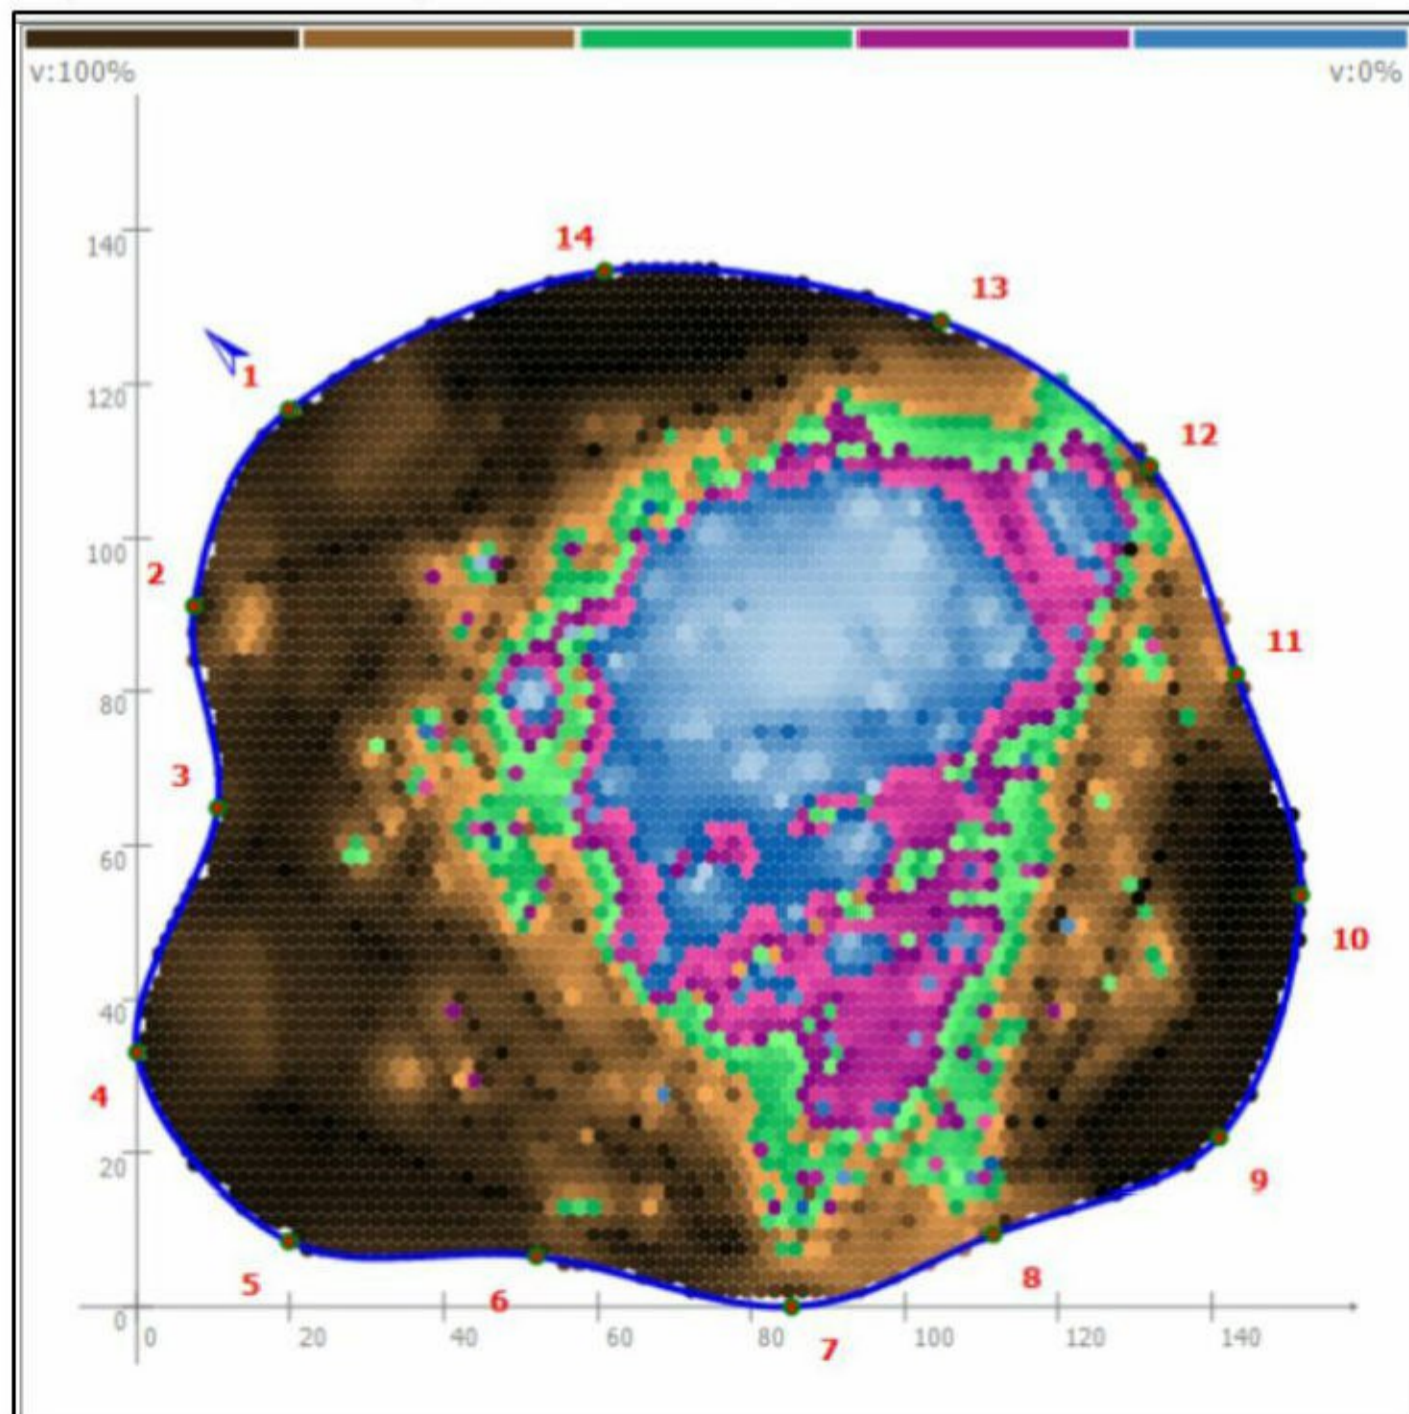
Figure 2: Tomogram undertaken on 20.02.2024

We used 14 sensors to obtain a sonic tomogram, see Figure 2 below.

Both Tomograms show changes in wood density (white, blue and purple pixels) however, it is not possible to do a direct comparison of the results due to differences in the tree geometry and number of sensors used.

What is clear in both Tomograms is the area of decaying wood (white and blue pixels) on the eastern side of the main stem at ground level. The decaying area was also corroborated with the Resi drillings that isolated the decay shown in both Tomograms.

The extent and location of decay (ground level) increases the risk of stem failure at or close to ground level and, as the tree is located in a high-risk location, remedial measures are required to ensure the safety of residents and visitors to the site.

The biomechanical loading on the stem must be reduced to prevent failure. This can only be achieved by remedial pruning (canopy reduction) or felling. In considering the options reducing the canopy will lower the wind loading and reduce the risk of failure but may not prevent it. However, once pruned the canopy will require regular remedial work to maintain the size. Therefore, due to the tree's location and the extent of decay detected we recommended that the tree is felled to ground level and the stump ground out to a depth of approximately 300 millimetres below ground level. All works should be carried out within 3 months from the date of this report.

If the retention of the tree is a priority, a crown reduction of 2 metres to leave a finished height of approximately 16 metres should be undertaken. The crown lateral growth should be reduced to provide a suitable framework for redevelopment and be balanced to meet the natural characteristics of the tree that are in line with good arboricultural practice.

The tree's location, risk of failure, presence of decay in the main stem at ground level and the added stress a reduction may place on the tree will require more frequent inspections and if the tree is retained an annual inspection by a suitably qualified person should be undertaken every 12 months.

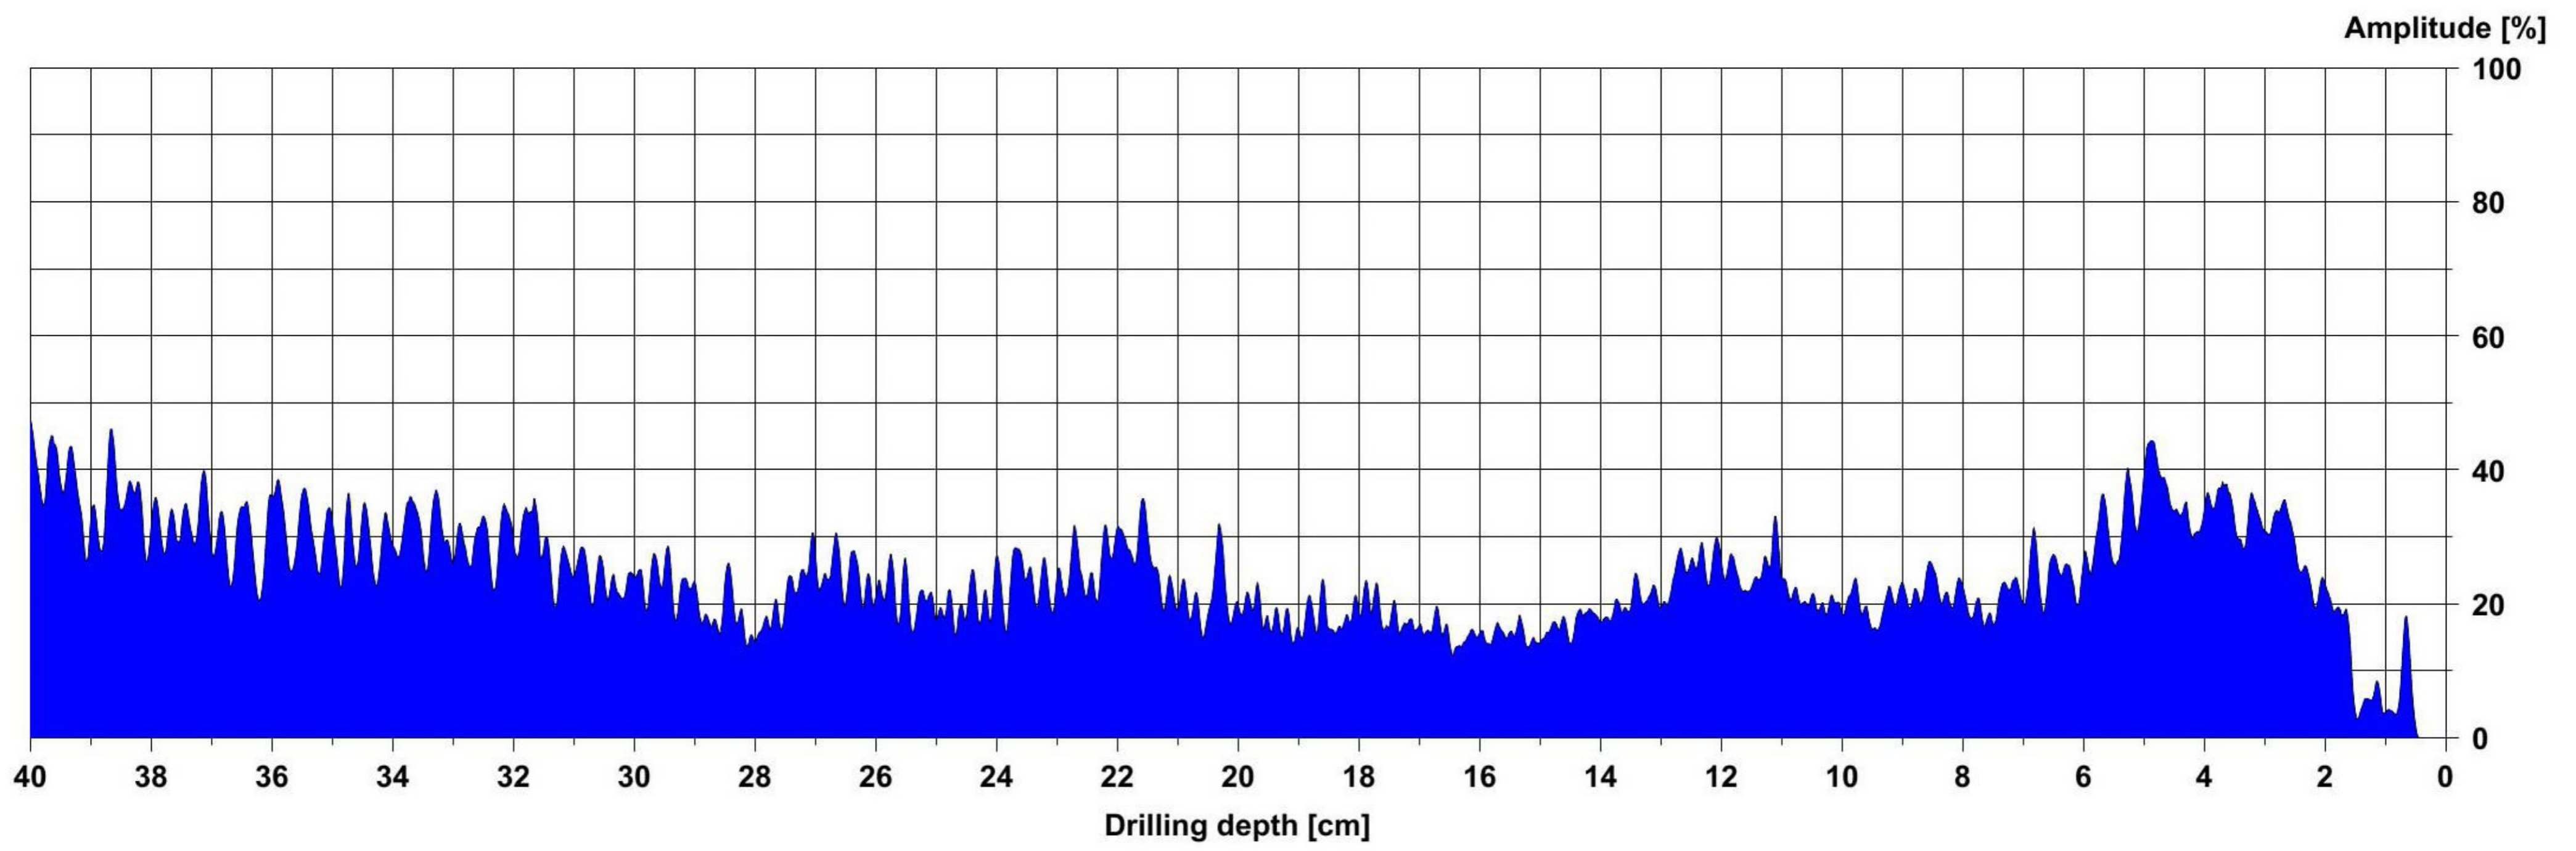
Control test at 1.5m AGL.
No significant decay at the test location
