VISUAL TREE ASSESSMENT AT 40 HORATIO AVENUE WARFIELD

**Prepared for:
Mrs J Biggs
40 Horatio Avenue
Warfield
Bracknell
RG42 3TX**

Ref: SN/VTA-23/22.10

11 December 2023

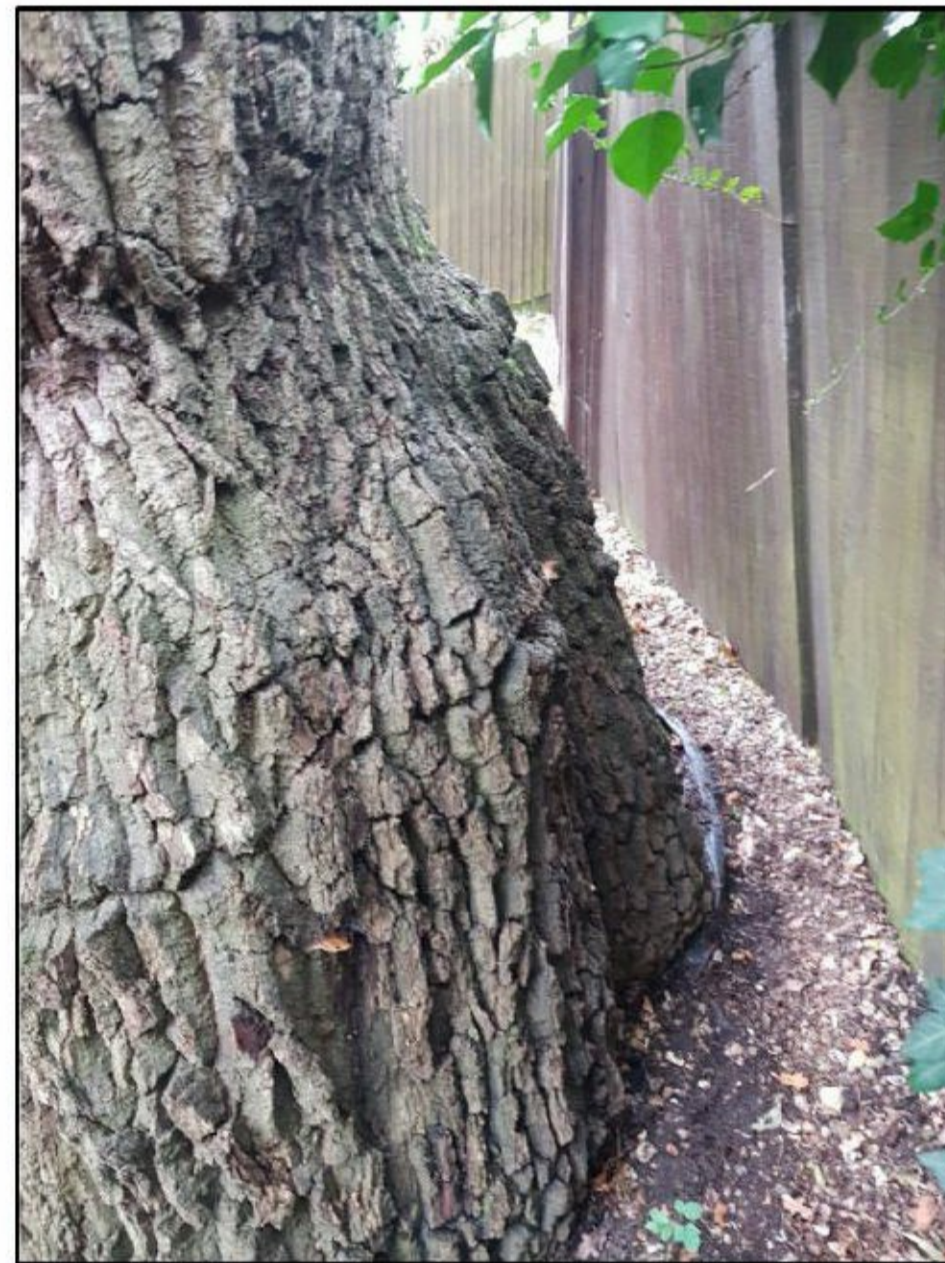
- 3.2.1 There were no visible signs of movement around the base of the tree inspected, no soil heave, mounding or cracking was observed, and the root zone appeared stable at the time of inspection. Soil was scraped back where possible from around the base of the tree to a depth of approximately 50 millimetres, no biotic or abiotic pathogens were detected.
- 3.2.2 The base and stem of the tree was sounded with a nylon mallet to a height of approximately 2 metres above ground level (AGL) and no hollow intonations were returned. Some swelling was observed around the base of the tree to the north and western sides, (see Figure 1 below) and the bark is true to form and firmly attached.

- 4.1.1 The swelling observed around the base of the tree may be as a result of reaction wood growth due to an internal defect. Although when the area was tested with a nylon mallet no hollow intonations were returned this does not rule out the possibility of hollowing within the stem and this swelling must be investigated further.

- 5.1.1 It is recommended that the tree is tested with decay detection equipment to establish the structural stability of the stem. This inspection must be carried out within 3 months from the date of this report.

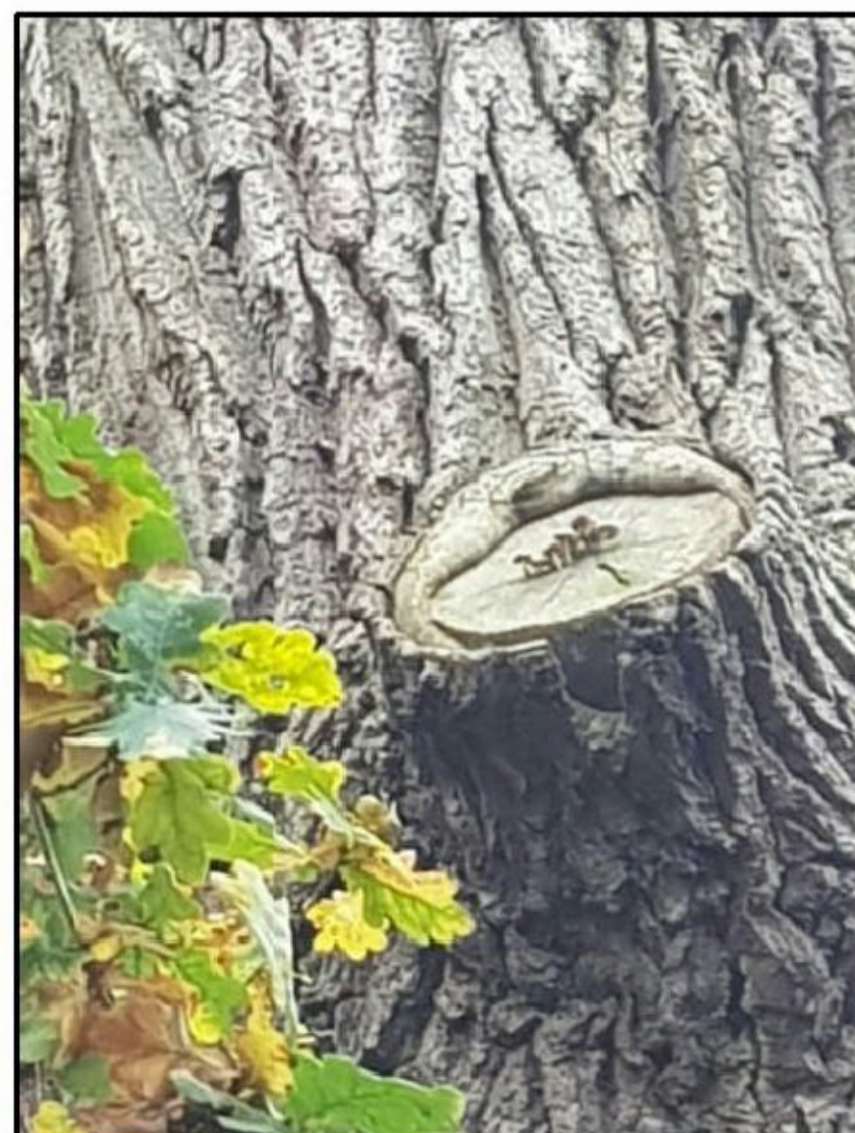
- 3.2.3 The stem leans slightly toward the east with swelling at 4 metres AGL and pruning wounds located up the stem. Fungal fruiting bodies were observed within a pruning wound at approximately 4 metres AGL to the north side, see Figure 2 below.

- 4.1.2 The fungal fruiting bodies observed at approximately 4 meters AGL were not readily identifiable due to their position and early stage of development, but it is believed that they are saprophytic in nature and are feeding from deadwood and not actively decaying live wood.

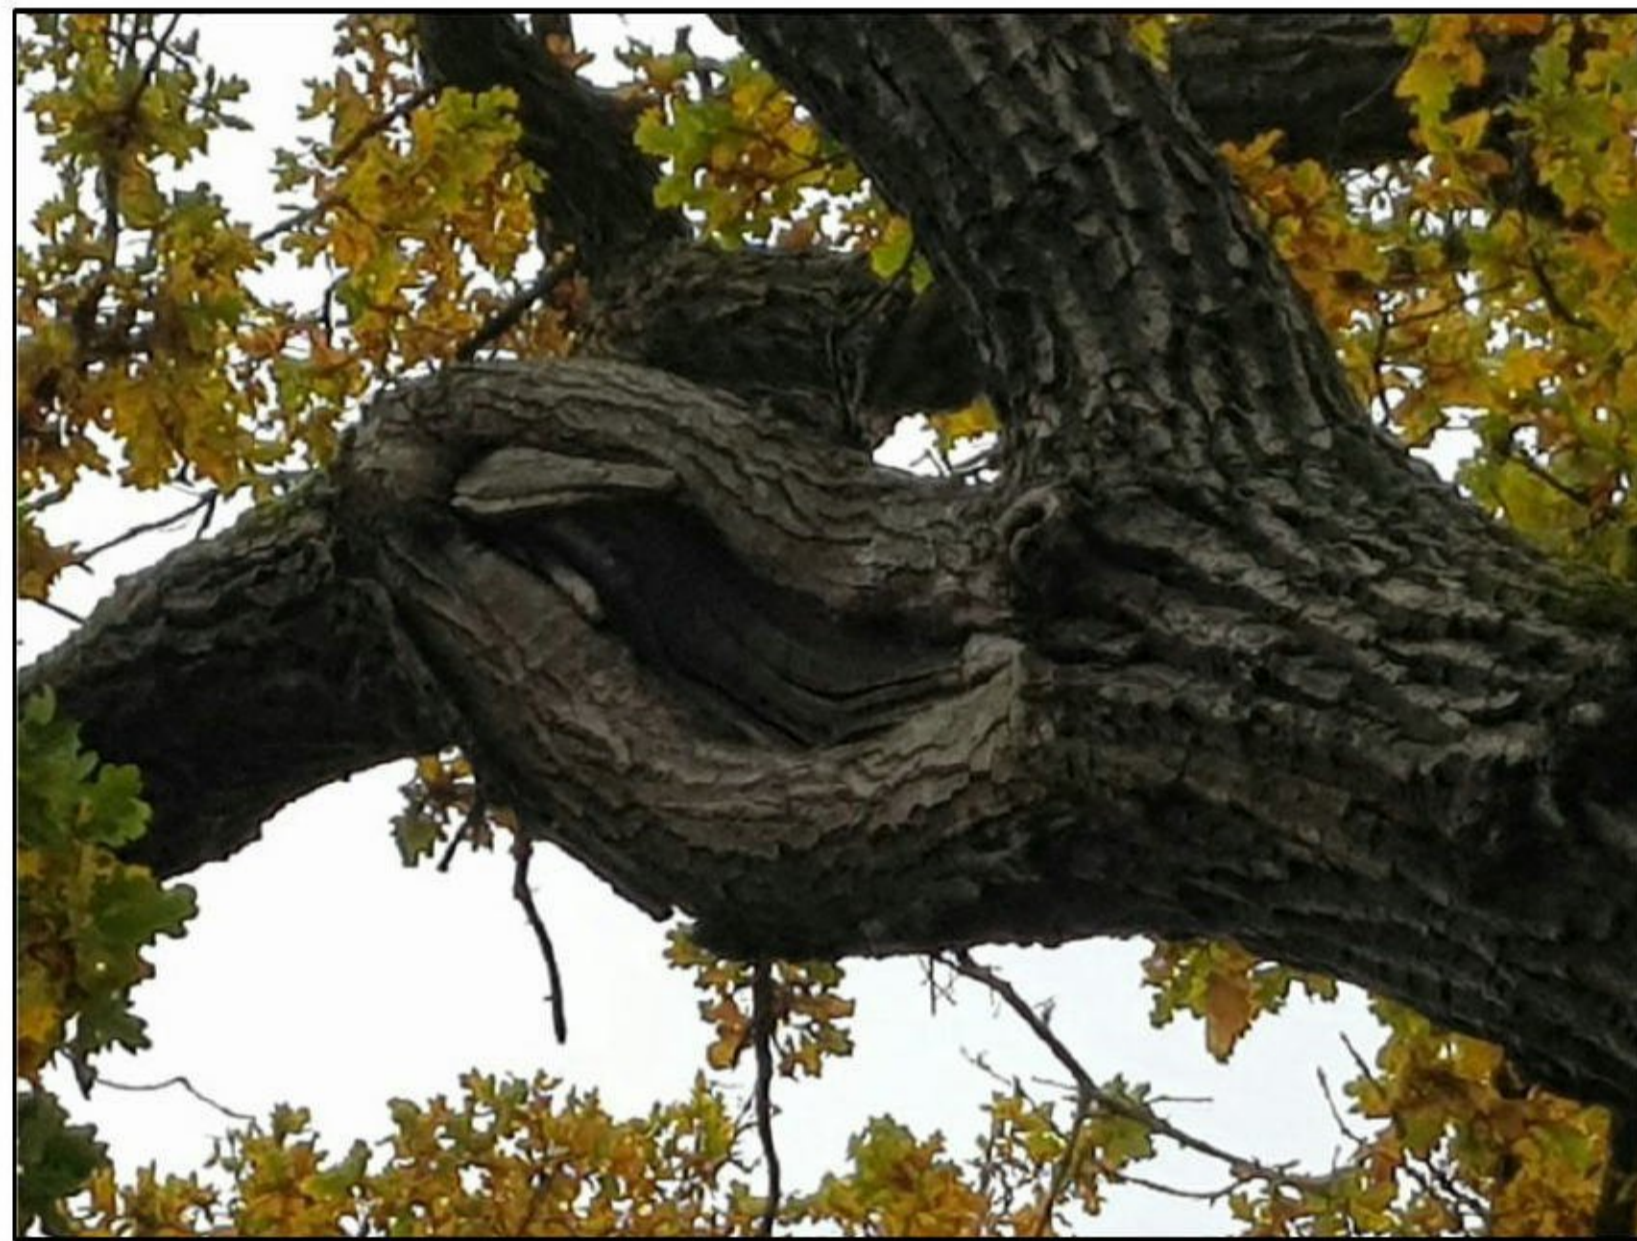
- 3.2.4 The crown of the tree has been heavily reduced leaving a sparse crown with pruning wounds throughout. Damage on the upper side of a large lateral limb extending eastward at approximately 2.5 metres AGL and hollowing of the limb was also observed. Further damage was observed at approximately 11 metres AGL to the east, see Figure 3 below. Deadwood and fine branch dieback was observed within the crown (see front cover) and evidence of branch failures was observed with a branch measuring approximately 1.5 metres in length being pointed out by the tree owner.

- 4.1.3 The crown reduction has left numerous pruning wounds and as a result has reduced the photosynthetic cross section. This appears to have had a detrimental effect on the tree resulting in considerable stress with an increase in deadwood, fine branch dieback and a lack of any significant wound wood production evident. Any further reduction of the tree will only exacerbate the stress and we would advise against this at the moment.
