# Urban Tree Experts

Ref: SPH/DD-24/20.02

**Re: Decay Detection at 40 Horation Avenue, Warfield, Bracknell, RG42 3TX.**

Thank you for your instructions to undertake decay detection upon 1 mature oak tree located to the side of 40 Horatio Avenue. A summary of our findings is included in accordance with your instructions.

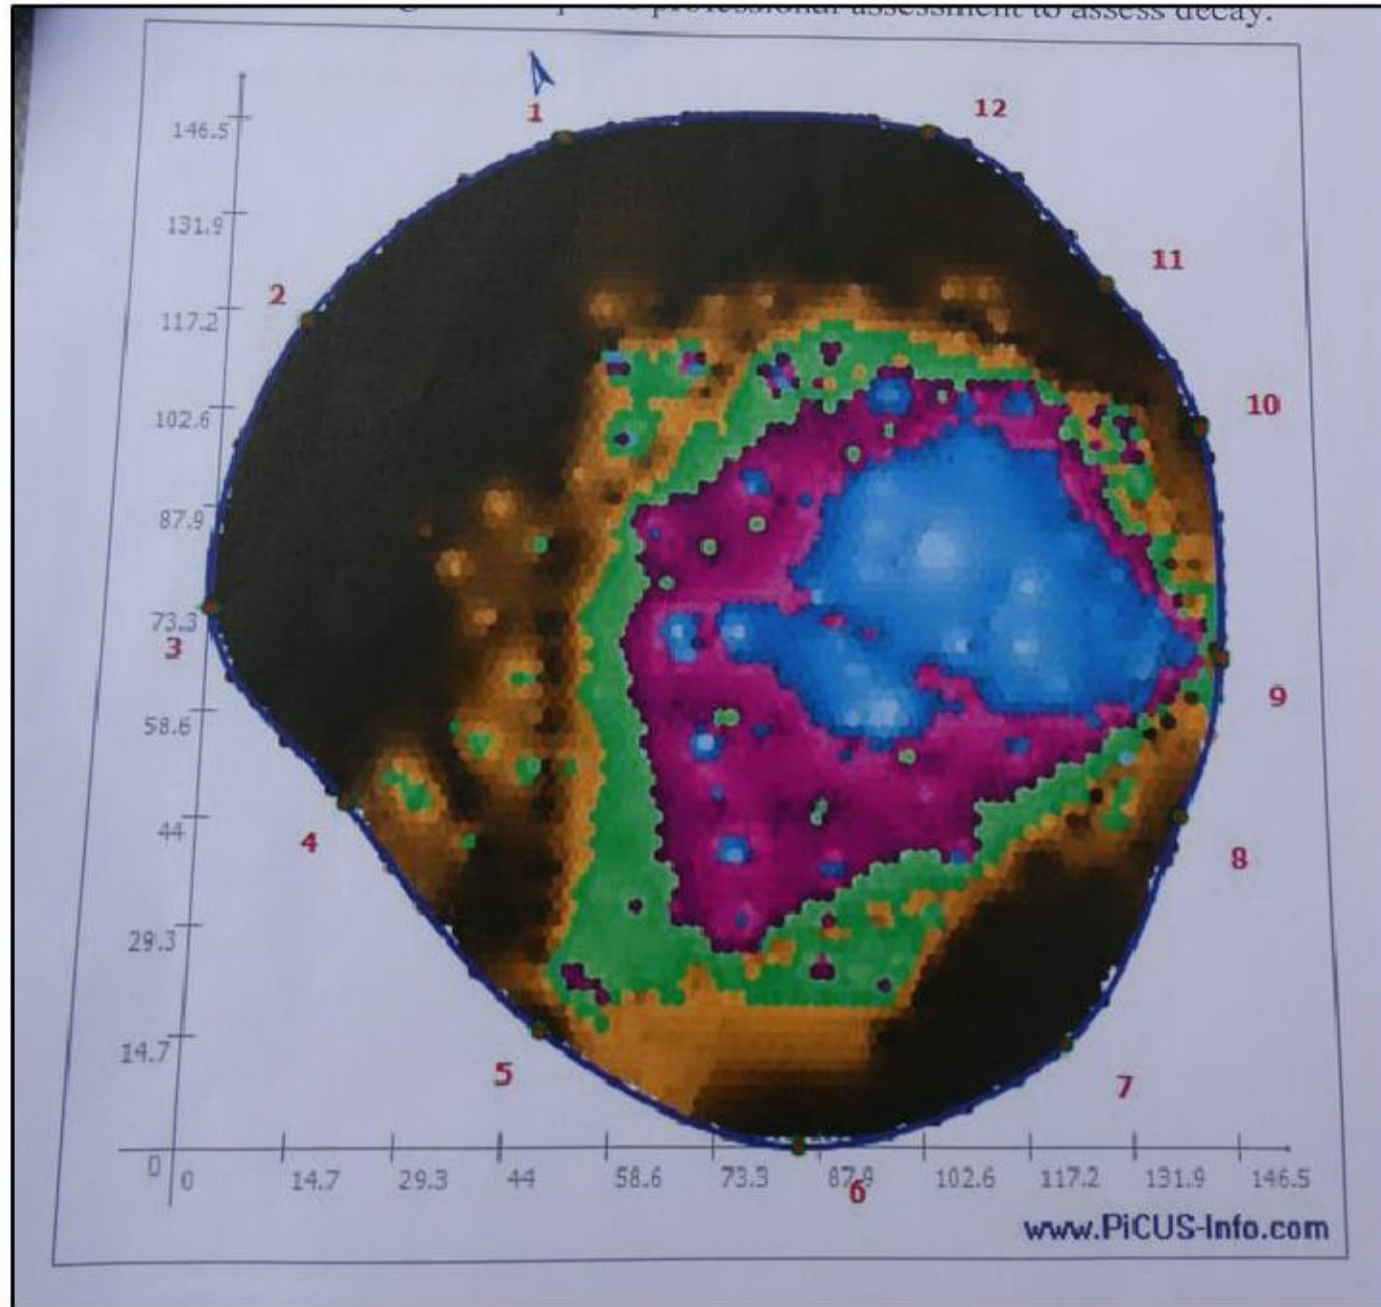
Figure 1: Tomogram undertaken by Atworth Arboriculture Ltd (2107)

The tree was subjected to a Picus Tomograph test on 1 August 2017 by Kim Dear of Atworth Arboriculture Ltd, undertaken on behalf of Fernoak Tree Surgeons. The Tomogram, copy included below at Figure 1, revealed an area of decay and hollowing on the east side of the stem adjacent to sensor number 9. Recommendations made within the Atworth Arboriculture Ltd report were ambiguous and lacked any specific or measured dimensions.

What is clear in both Tomograms is the area of decaying wood (white and blue pixels) on the eastern side of the main stem at ground level. The decaying area was also corroborated with the Resi drillings that isolated the decay shown in both Tomograms.

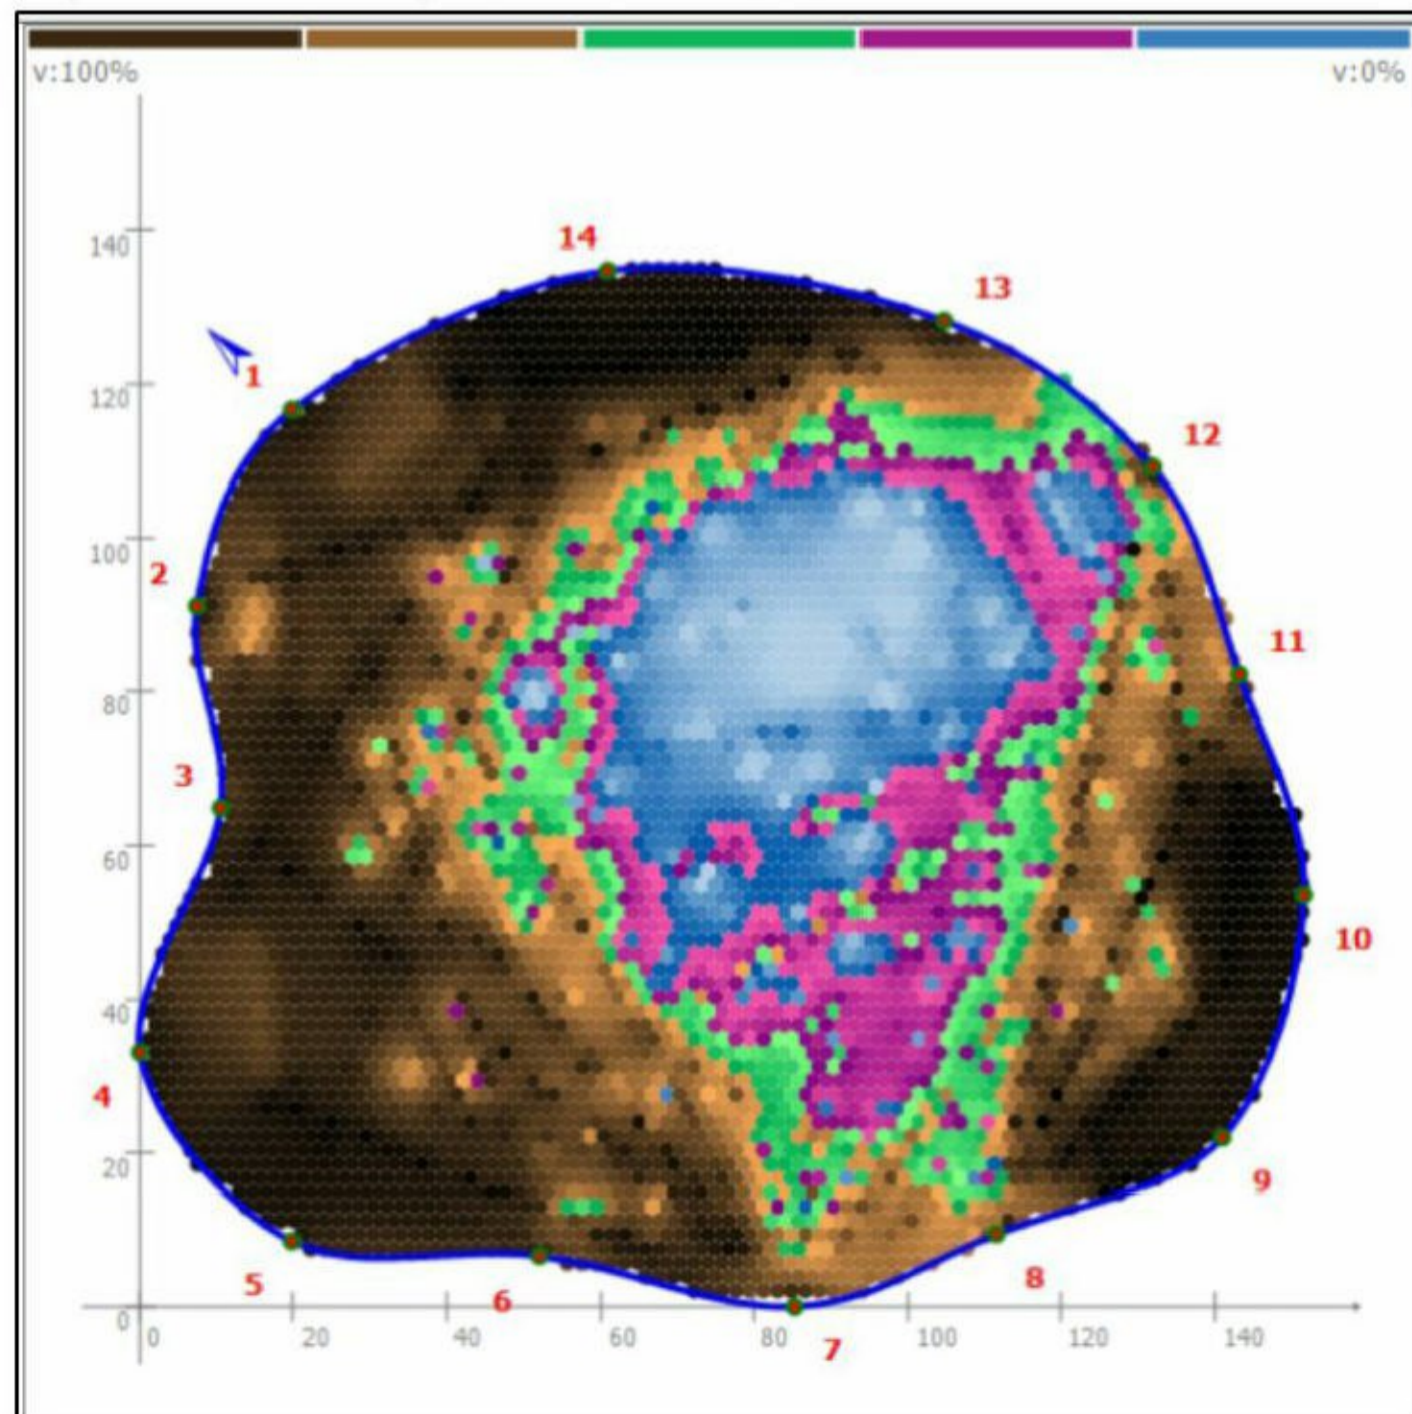
Figure 2: Tomogram undertaken on 20.02.2024

We used 14 sensors to obtain a sonic tomogram, see Figure 2 below.

Both Tomograms show changes in wood density (white, blue and purple pixels) however, it is not possible to do a direct comparison of the results due to differences in the tree geometry and number of sensors used.

The biomechanical loading on the stem must be reduced to prevent failure. This can only be achieved by remedial pruning (canopy reduction) or felling. In considering the options reducing the canopy will lower the wind loading and reduce the risk of failure but may not prevent it. However, once pruned the canopy will require regular remedial work to maintain the size. Therefore, due to the tree's location and the extent of decay detected we recommended that the tree is felled to ground level and the stump ground out to a depth of approximately 300 millimetres below ground level. All works should be carried out within 3 months from the date of this report.

If the retention of the tree is a priority, a crown reduction of 2 metres to leave a finished height of approximately 16 metres should be undertaken. The crown lateral growth should be reduced to provide a suitable framework for redevelopment and be balanced to meet the natural characteristics of the tree that are in line with good arboricultural practice.

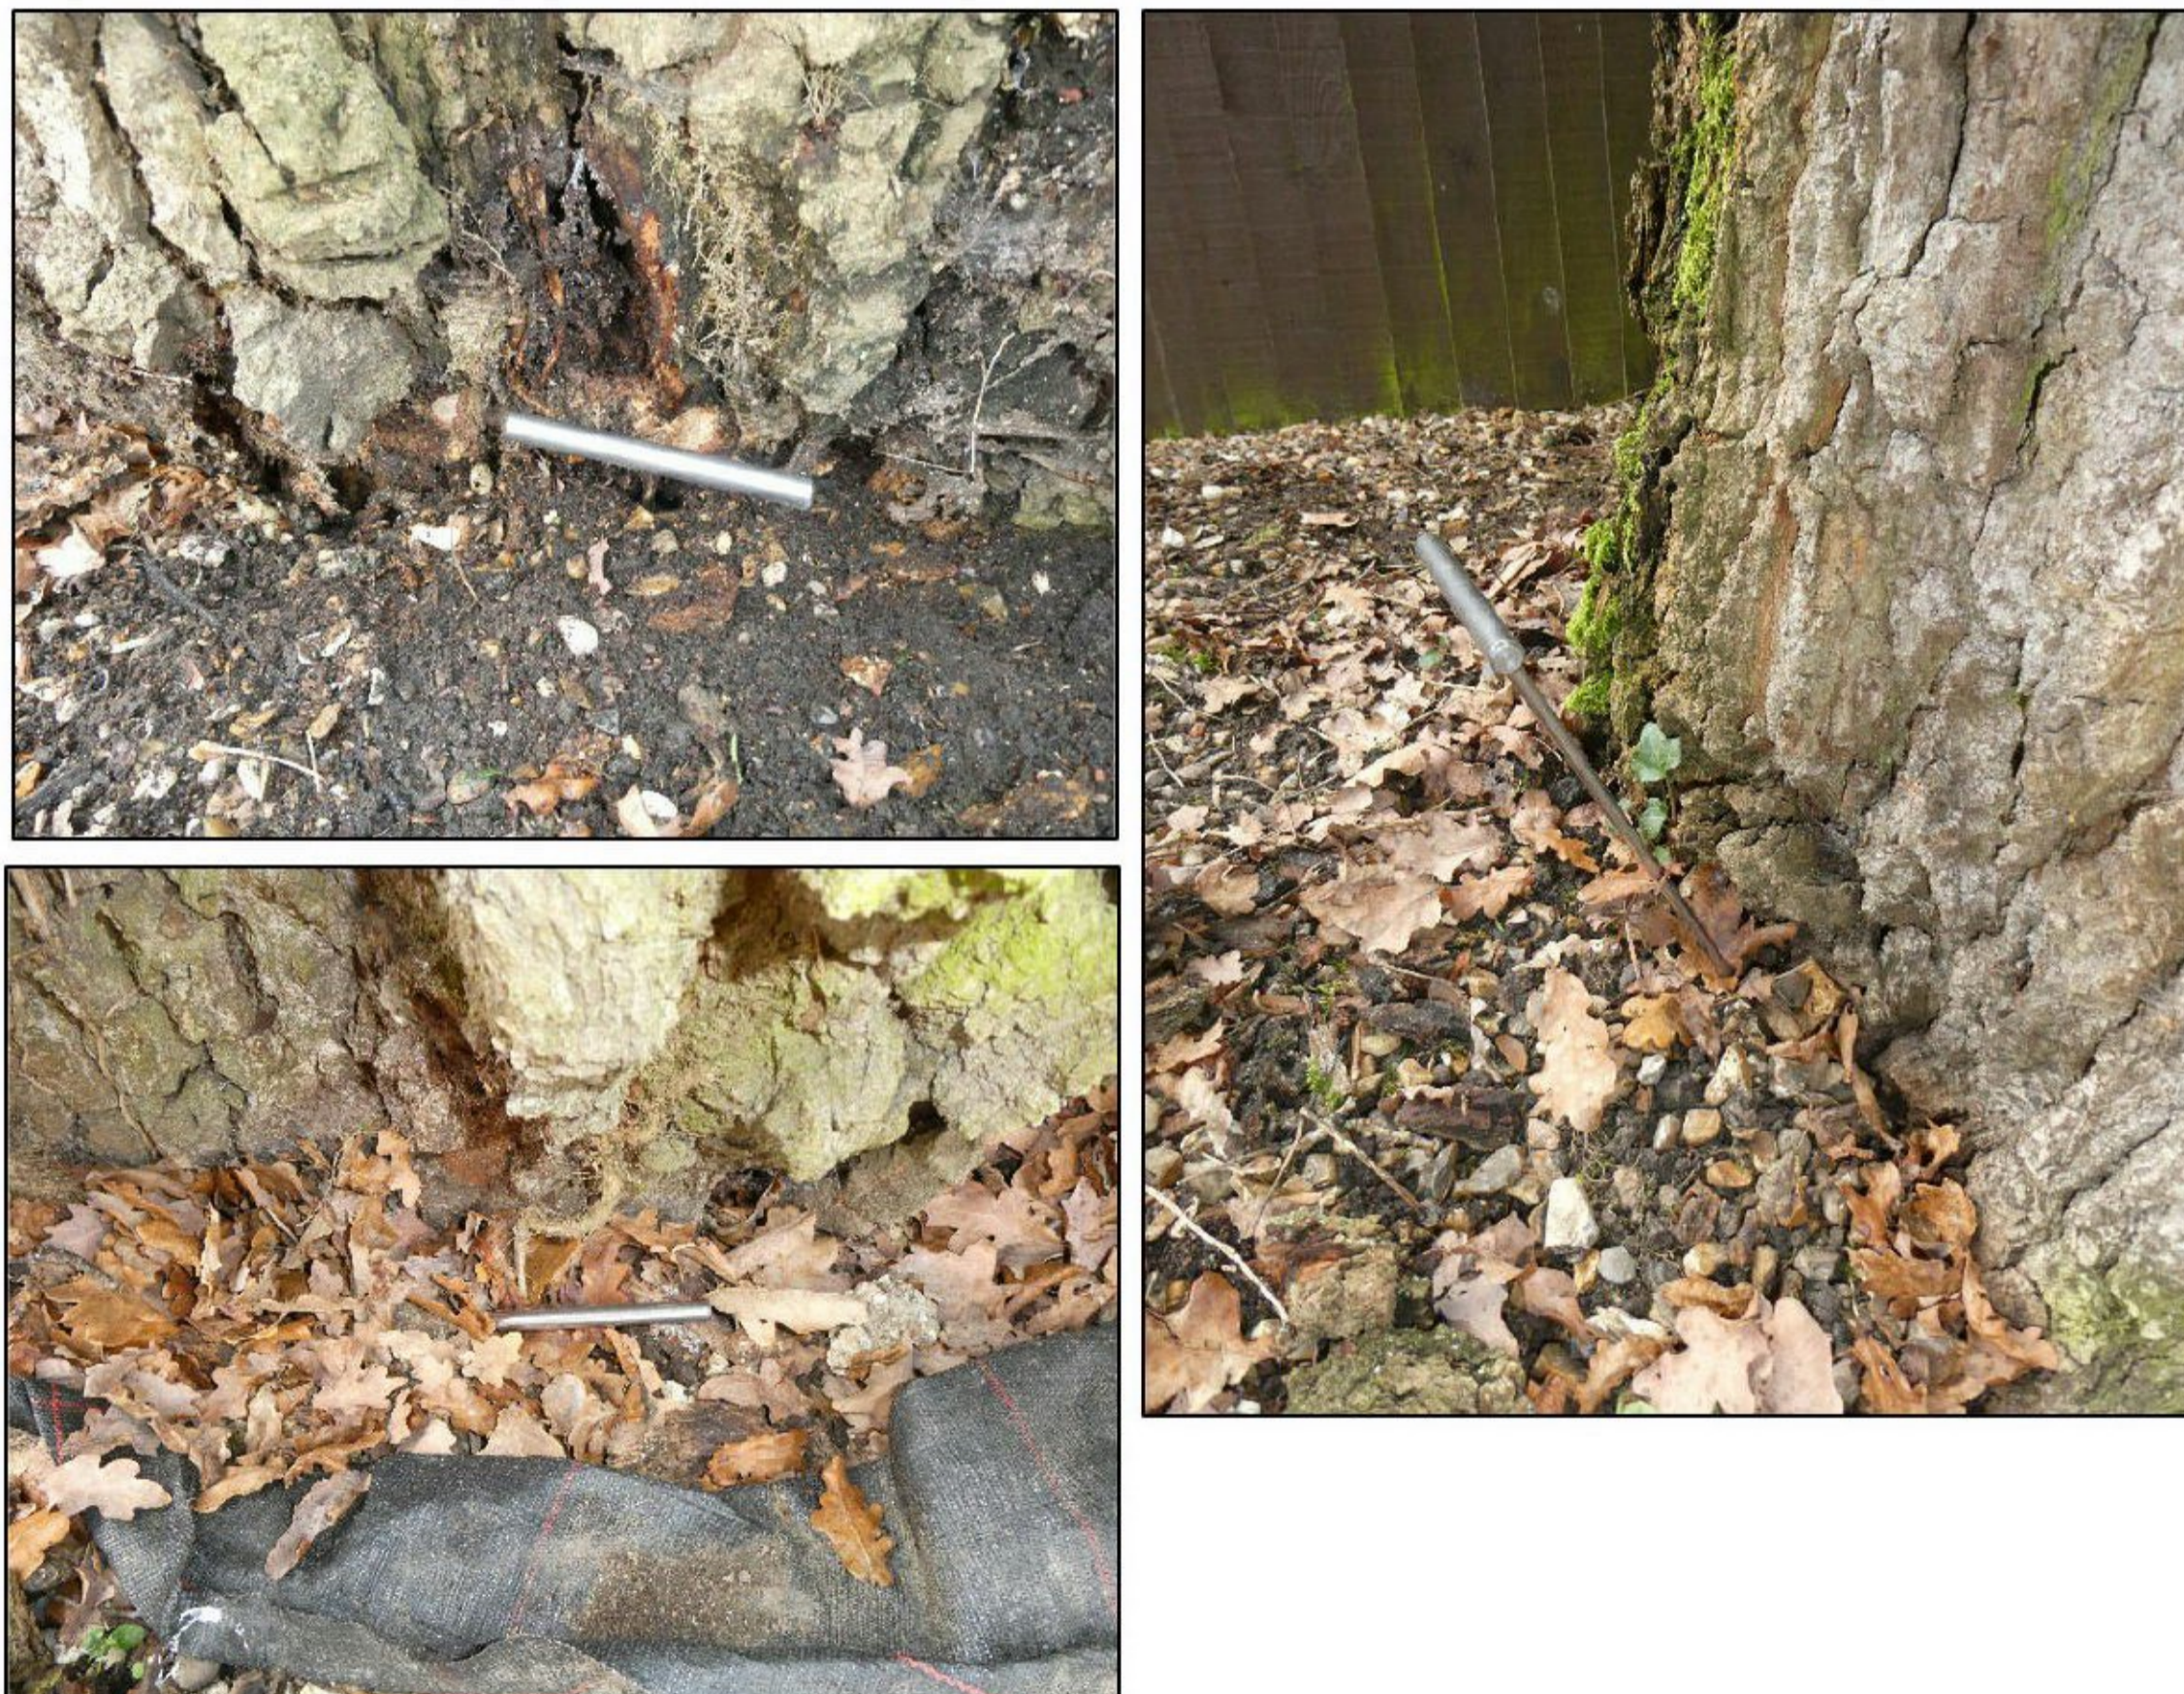
We also examined the root collar as there was a lack of buttressing. This is most likely due to the surrounding ground level having been raised. When we probed the root collar with a 600 millimetre stainless probe we found evidence of decay on the north, northeast and east sides varying between 300 and 600 millimetres in depth, see examples of probe areas at Figure 3 below.

The extent and location of decay (ground level) increases the risk of stem failure at or close to ground level and, as the tree is located in a high-risk location, remedial measures are required to ensure the safety of residents and visitors to the site.

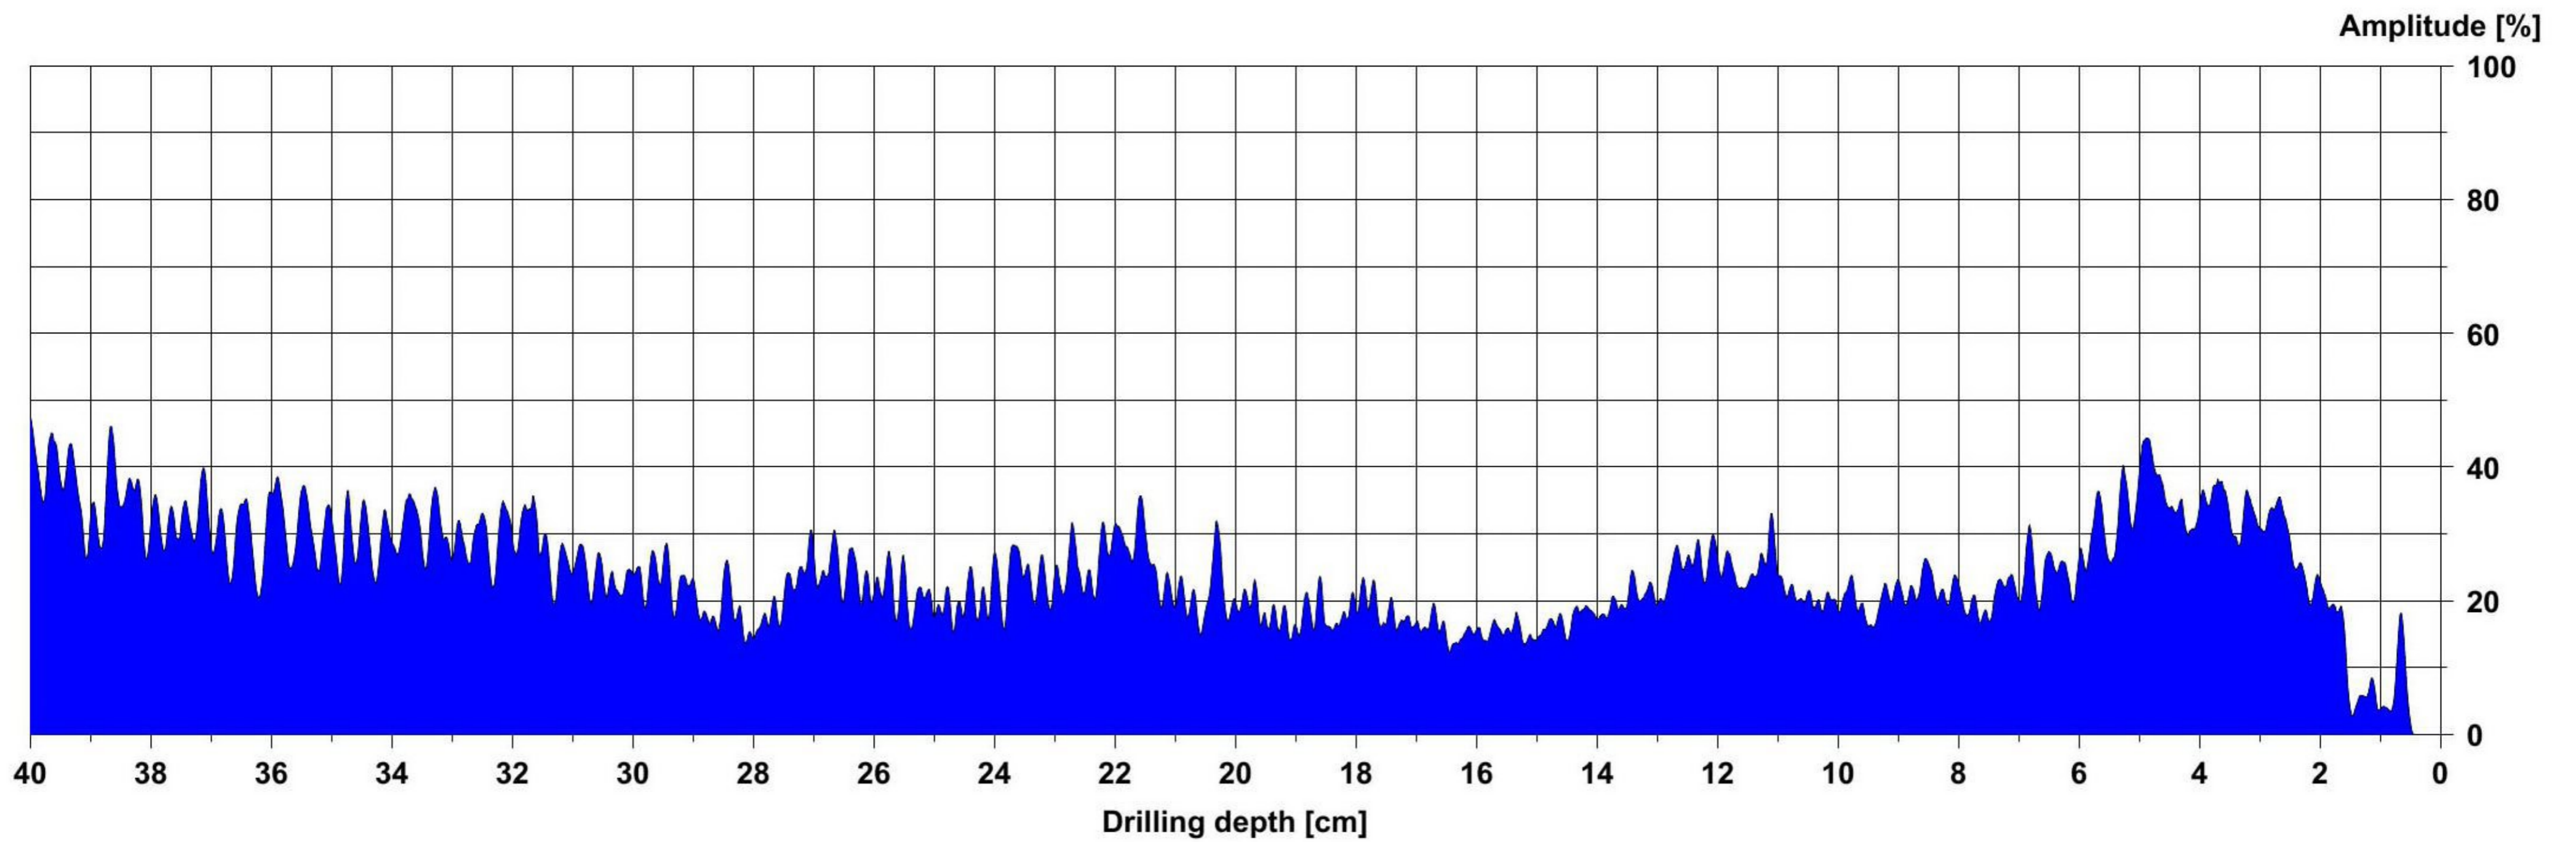
Measurement no.:	5	Speed	: 2500 r/min	Diameter:	128,00 cm
ID number	: HORATIO	Needle state:	---	Level	: 150cm
Drilling depth	: 40,00 cm	Tilt	: 0°	Direction:	North
Date	: 20.02.2024	Offset	: 87 / 285	Species	: Oak
Time	: 12:45:51	Avg. curve	: off / off	Location:	40 Horatio Av
Feed	: 150 cm/min	Name	: Mrs J Biggs

Control test at 1.5m AGL.  
No significant decay at the test location

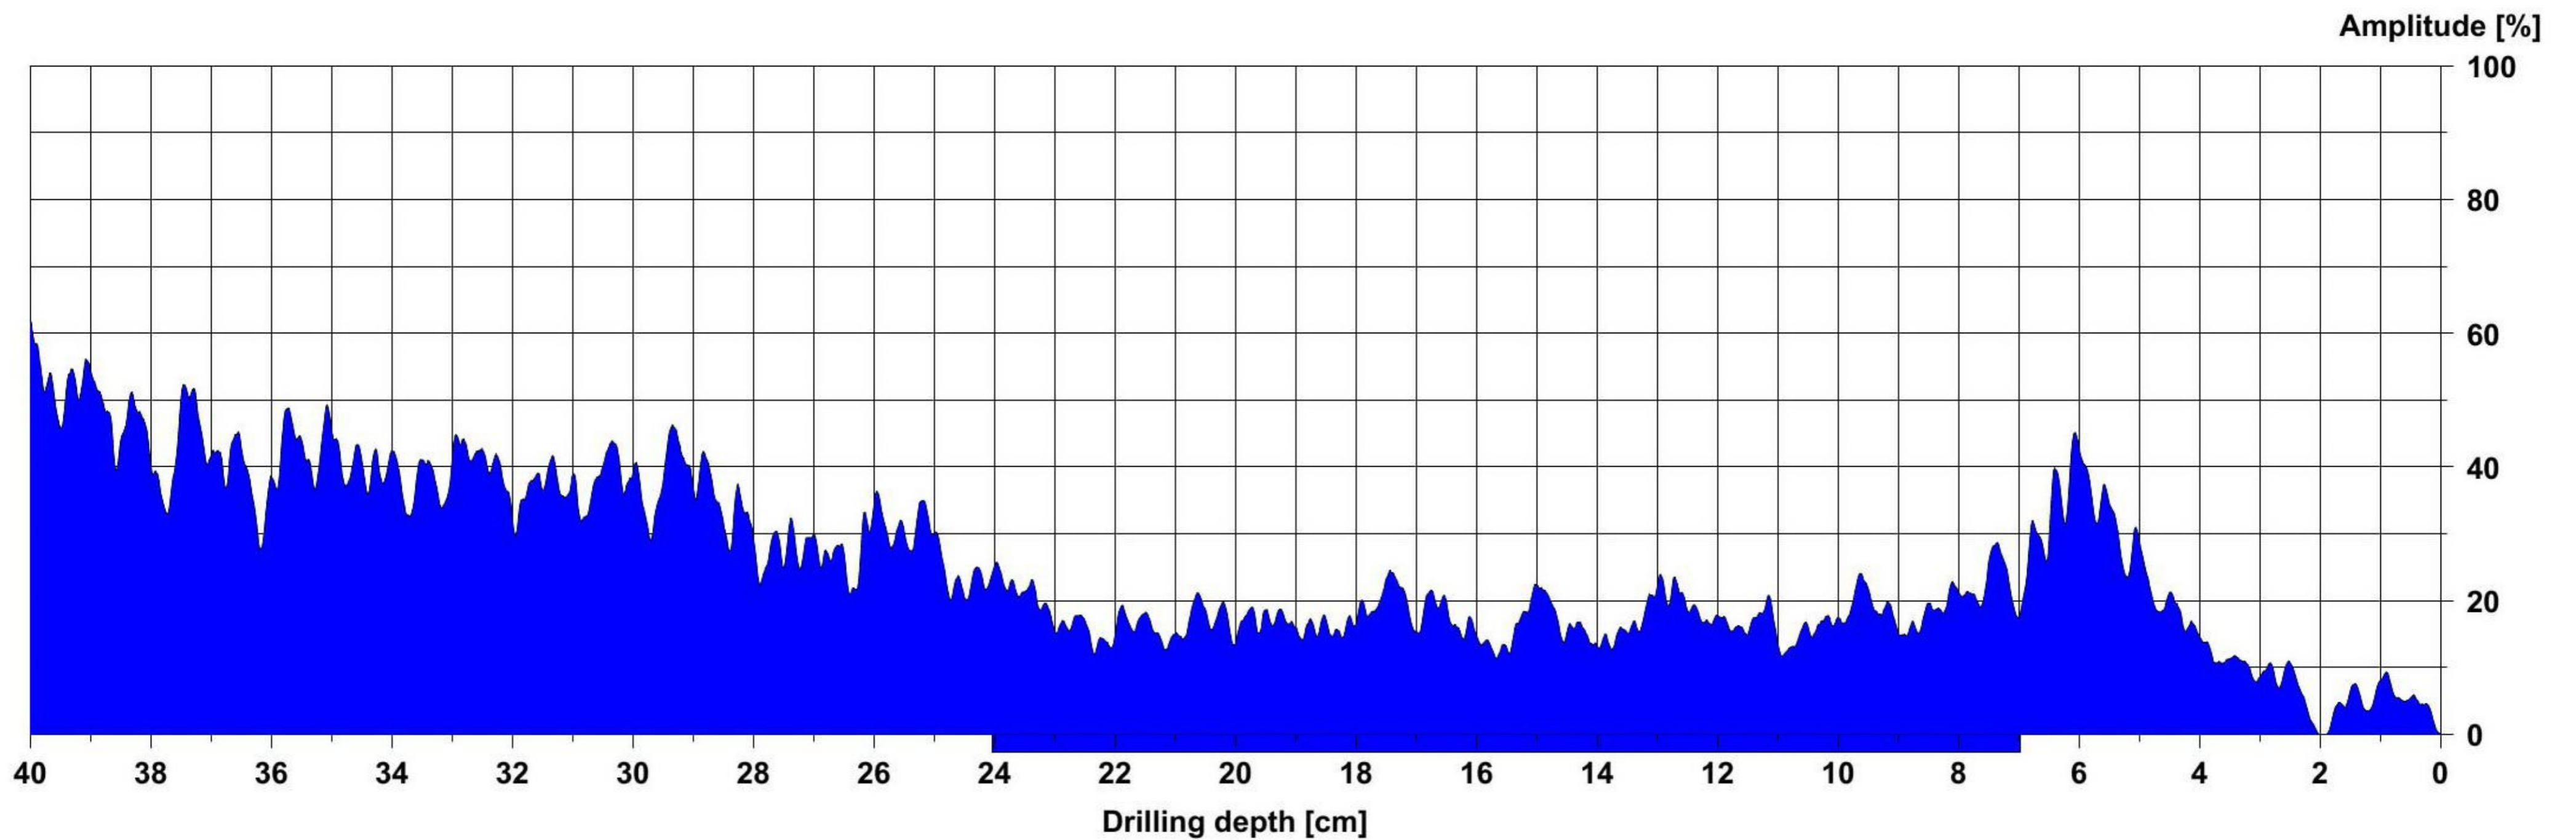
Measurement no.:	3	Speed	: 2500 r/min	Diameter:	128,00 cm
ID number	: HORATIO	Needle state:	---	Level	: 30cm
Drilling depth	: 40,00 cm	Tilt	: -50°	Direction:	Sensor 6 50 degrees
Date	: 20.02.2024	Offset	: 92 / 472	Species	: Oak
Time	: 12:43:35	Avg. curve	: off / off	Location:	40 Horatio Av
Feed	: 150 cm/min	Name	: Mrs J Biggs

■ From 6,98 cm to 24,03 cm : Incipient decay

Test adjacent to Picus sensor 6 but at 50 degrees into the root plate, incipient decay/low wood density from 7 to 24cm

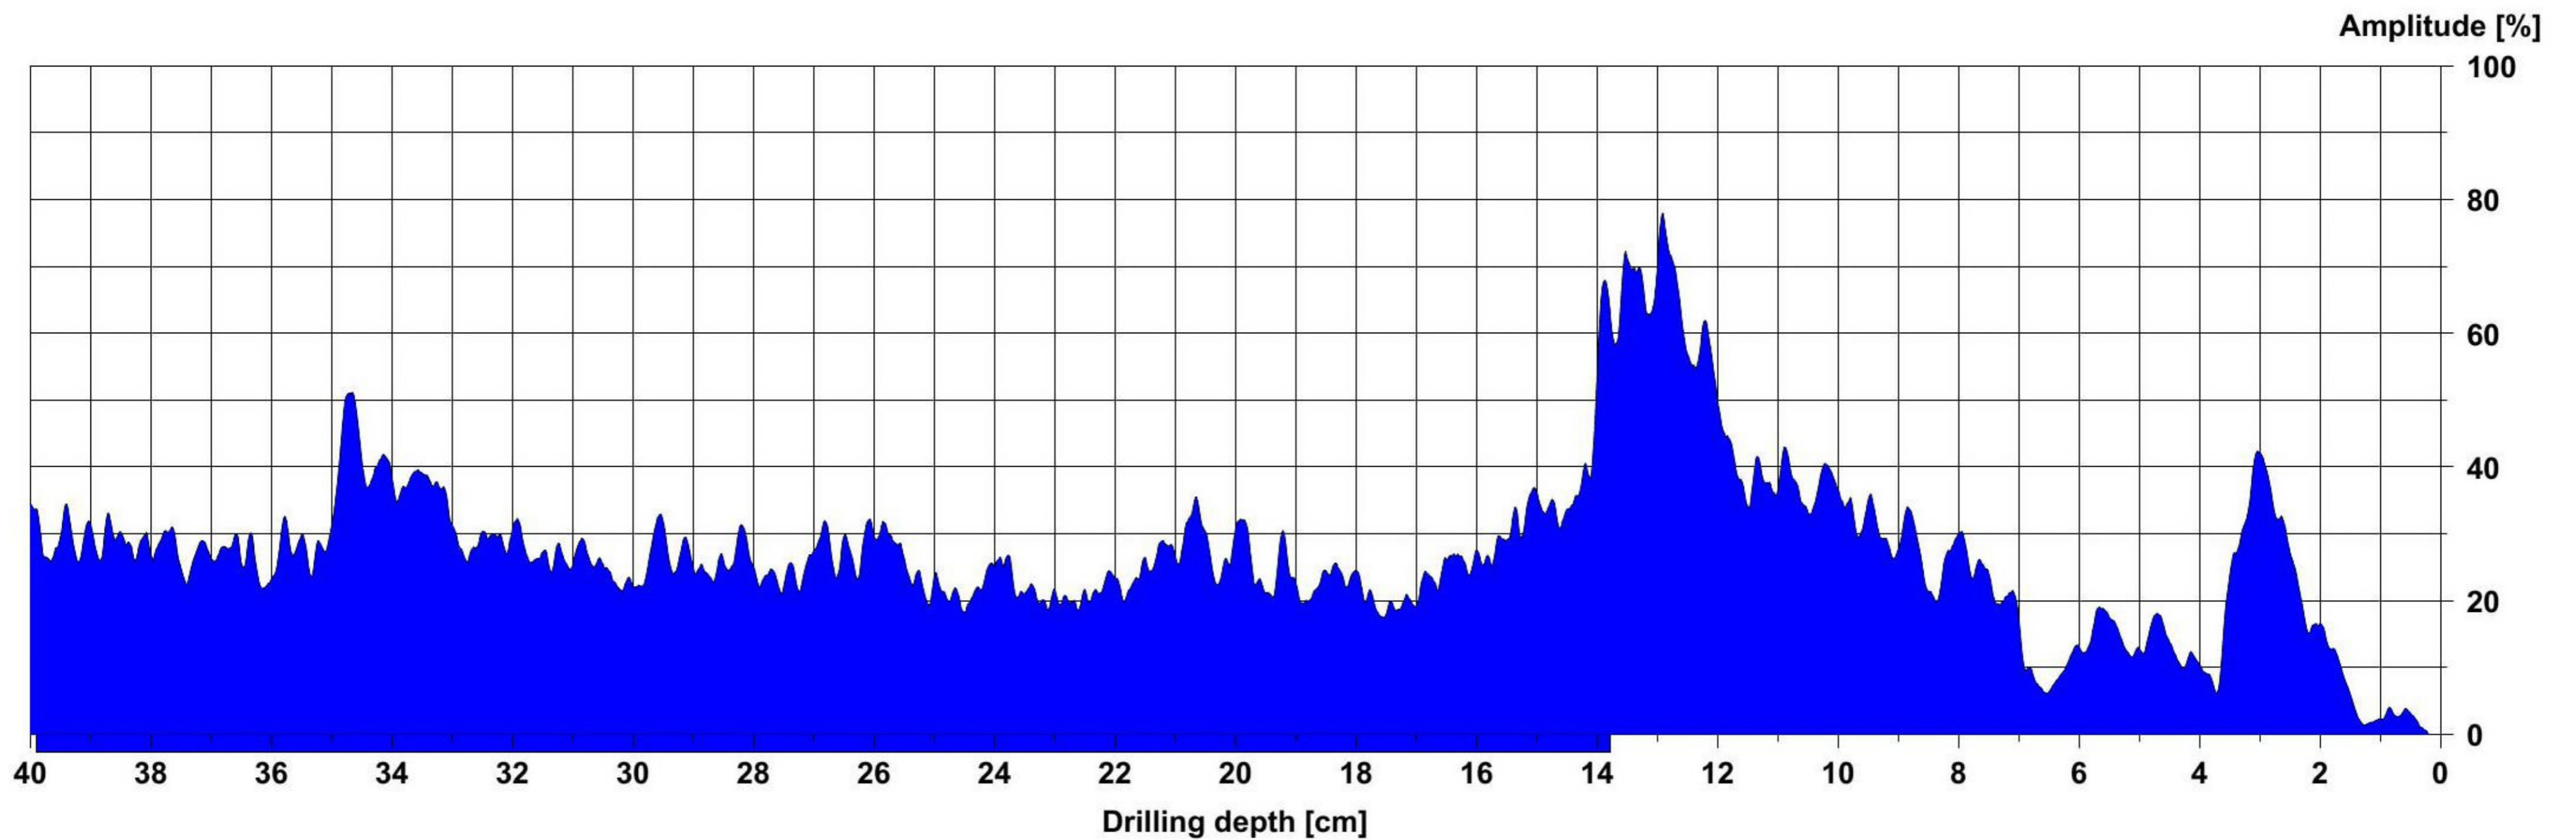
Measurement no.:	4	Speed	: 2500 r/min	Diameter:	128,00 cm
ID number	: HORATIO	Needle state:	---	Level	: 30cm
Drilling depth	: 40,00 cm	Tilt	: -63°	Direction:	Sensor 8
Date	: 20.02.2024	Offset	: 78 / 286	Species	: Oak
Time	: 12:44:49	Avg. curve	: off / off	Location:	40 Horatio Av
Feed	: 150 cm/min	Name	: Mrs J Biggs

■ From 13,79 cm to 39,91 cm : Incipient decay

Test adjacent to Picus sensor 8 at an angle of 63 degrees resulted in low wood density due to decay from 14cm.

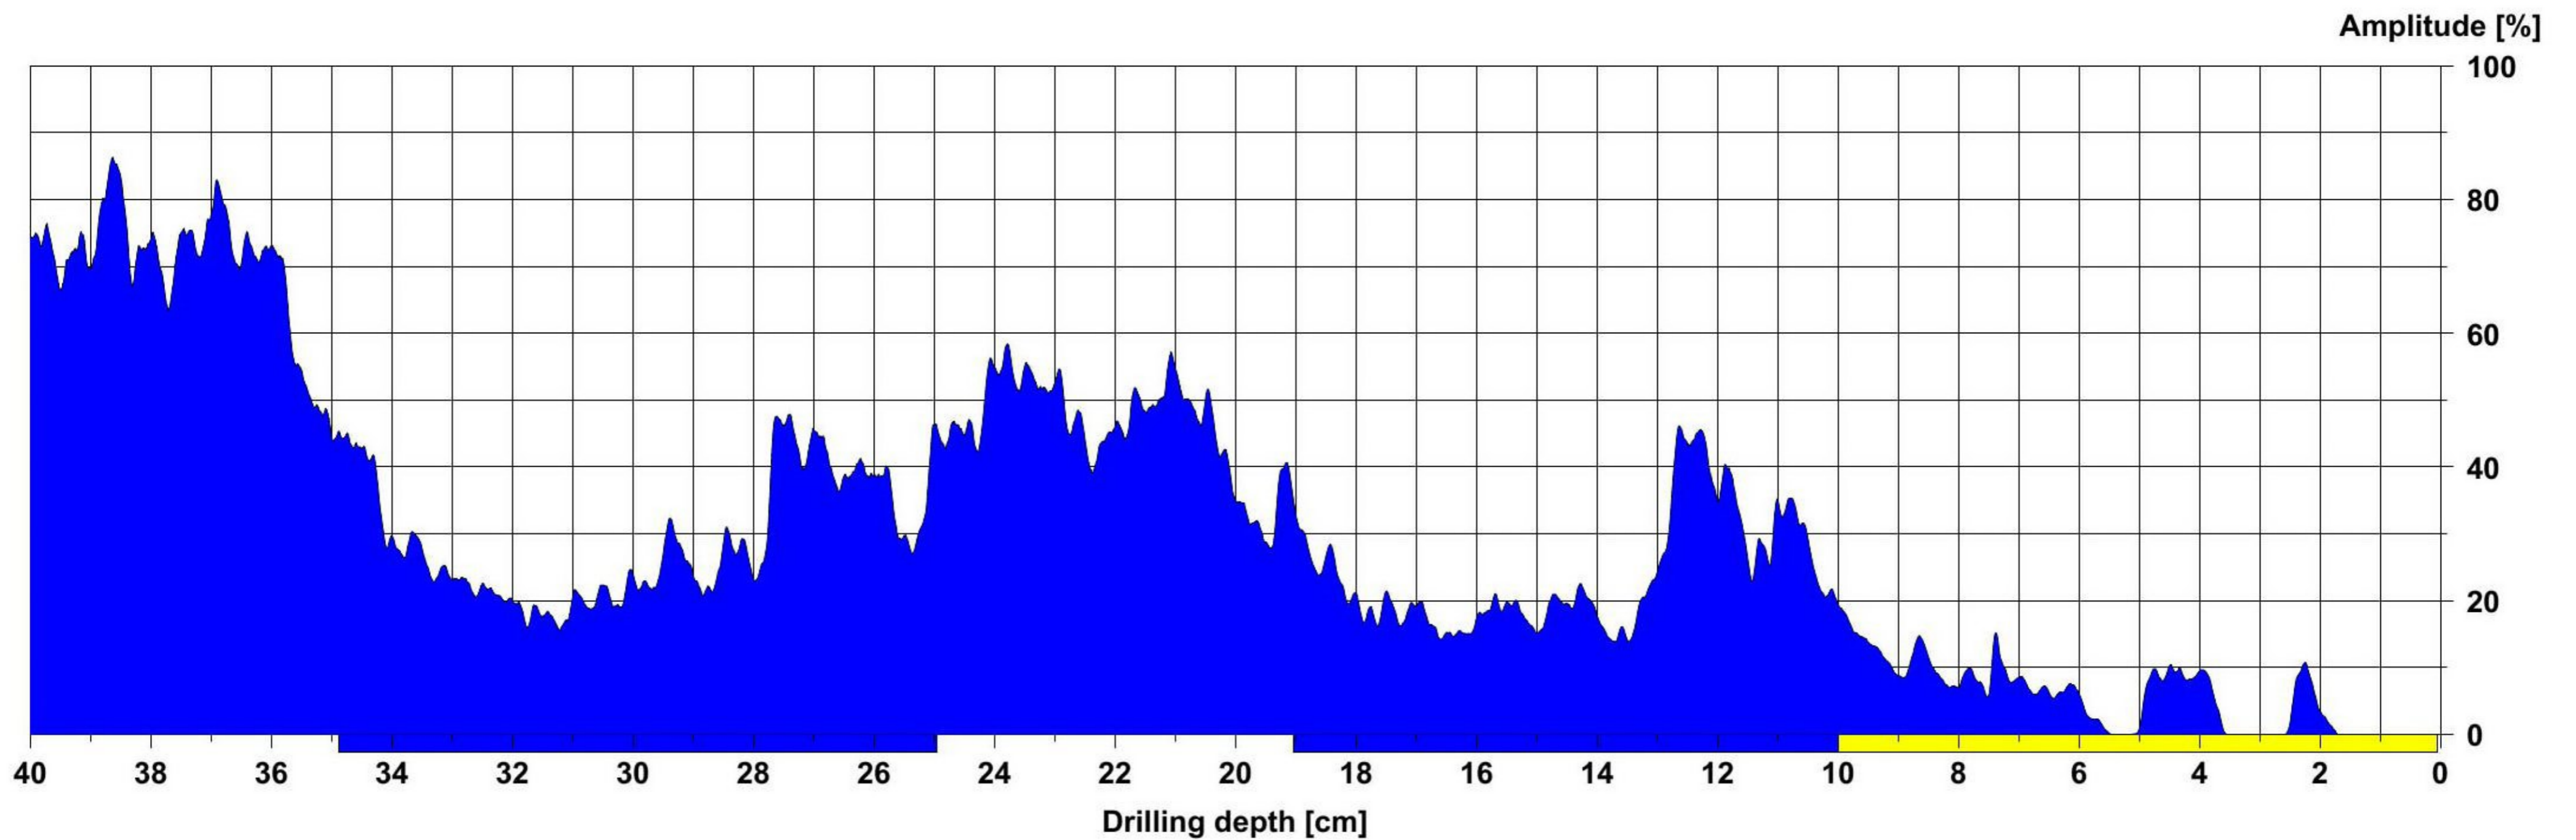
Measurement no.:	2	Speed	: 2500 r/min	Diameter:	128,00 cm
ID number	: HORATIO	Needle state:	---	Level	: 30cm
Drilling depth	: 40,00 cm	Tilt	: -45°	Direction:	45 degrees
Date	: 20.02.2024	Offset	: 90 / 292	Species	: Oak
Time	: 12:42:26	Avg. curve	: off / off	Location:	40 Horatio Av
Feed	: 150 cm/min	Name	: Mrs J Biggs

From 0,06 cm to 9,99 cm	: Decay
From 9,99 cm to 19,03 cm	: Incipient decay
From 24,95 cm to 34,88 cm	: Incipient decay

Test adjacent to Picus sensor 12 undertaken at 45 degrees into root plate 12 confirming very irregular wood density due to decay.

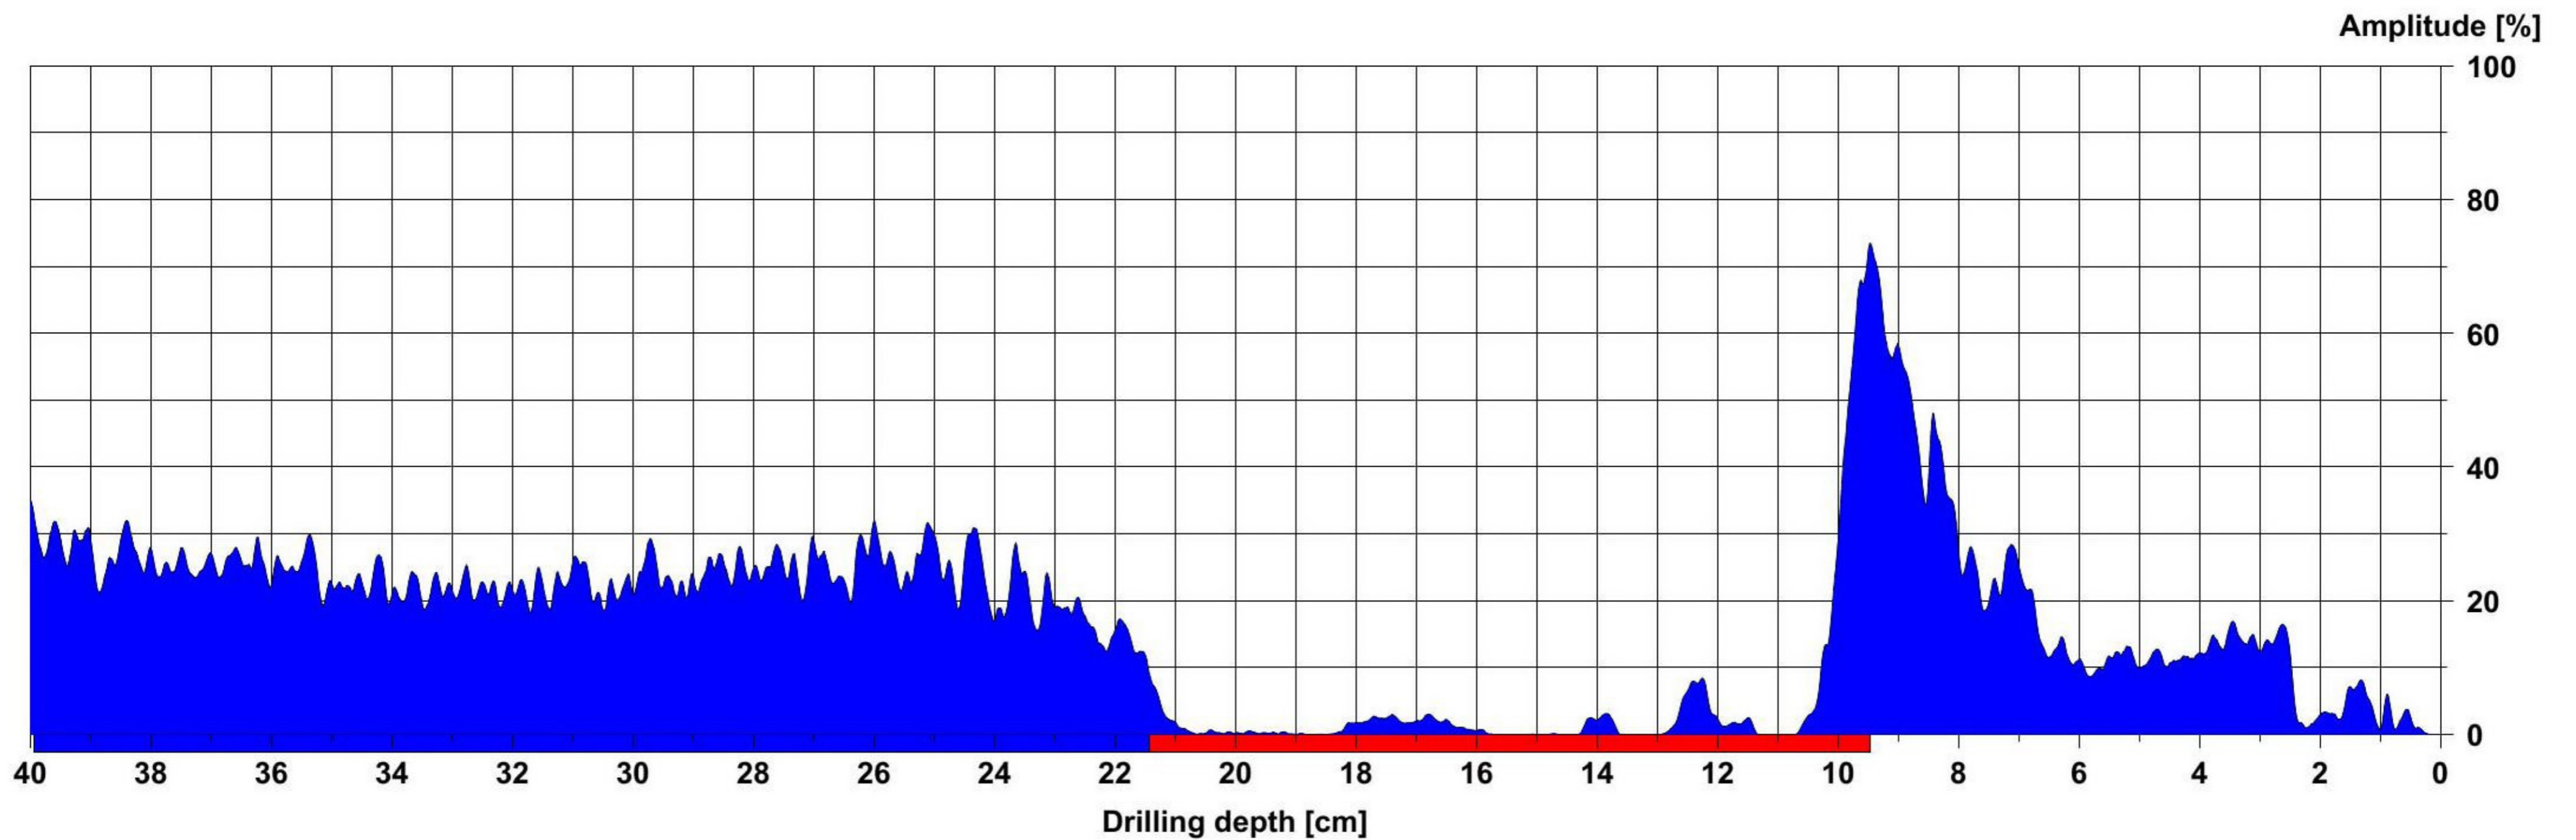
Measurement no.:	1	Speed	: 2500 r/min	Diameter:	128,00 cm
ID number	: 40 HORATIO AV	Needle state:	---	Level	: 30cm
Drilling depth	: 40,00 cm	Tilt	: 0°	Direction:	MP12
Date	: 20.02.2024	Offset	: 97 / 288	Species	: Oak
Time	: 12:41:38	Avg. curve	: off / off	Location:	40 Horatio Av
Feed	: 150 cm/min	Name	: Mrs J Biggs

- From 9,47 cm to 21,49 cm : Cavity
- From 21,43 cm to 39,94 cm : Incipient decay

Test adjacent to Picus sensor 12 confirming cavity from 10cm and low wood density due to decay from 22cm.
