Arboricultural Consultancy for EIG Insurance Group

Insured	Winchester Diocesan Board Of Finance	Address	The Vicarage , 27 Horns Drove, Southampton, Hampshire, SO16 8AH		
Client	Subsidence Management Services	Contact	Richard Bryant	Claim No.	IFS-EIG-SUB-23-0108874
ES Ref	SA-253816	Consultant	Kirk Thompson	Contact No.	
Report Date	18/10/2023 Revised: 11/12/2023

Scope of Report: To survey the property and determine significant vegetation contributing to subsidence damage, make recommendation for remedial action and assess initial mitigation and recovery prospects. The survey does not make an assessment for decay or hazard evaluation. This is a revised report correcting Tree Works Reserve price allocation.

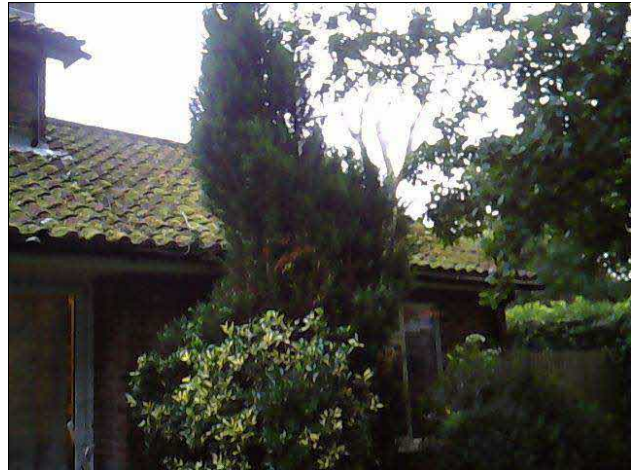
T8 - Cypress

T8 (Cypress) is also considered to retain a contributory influence, albeit in a limited / secondary capacity when compared to the above.

Consequently, we have advocated the complete removal of T8 (Cypress) and T9 (Oak) as it will offer the most certain arboricultural solution likely to restore long-term stability.

Tree No.	Species	Age Cat	Approx. Height (m)	Distance to Building (m) *	Ownership	Action	Requirement
T8	Cypress	1	5	0.7	C - Insured	Remove	Remove close to ground level.
T9	Oak	3	25	11	C - Insured	Remove	Remove close to ground level; do not treat stump due to translocation risk. Where such a risk exists, we advise that any emergent regrowth is removed annually.

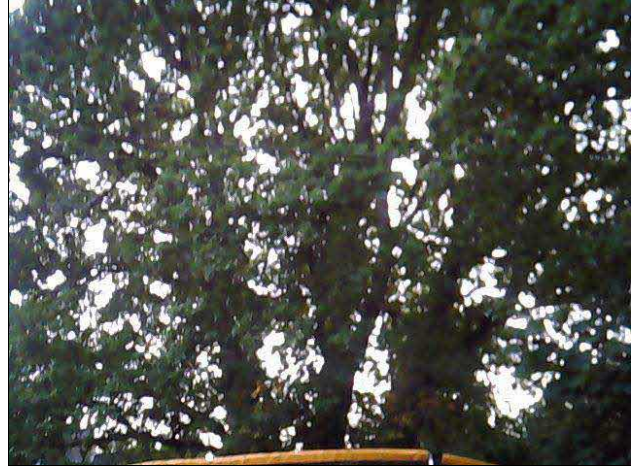
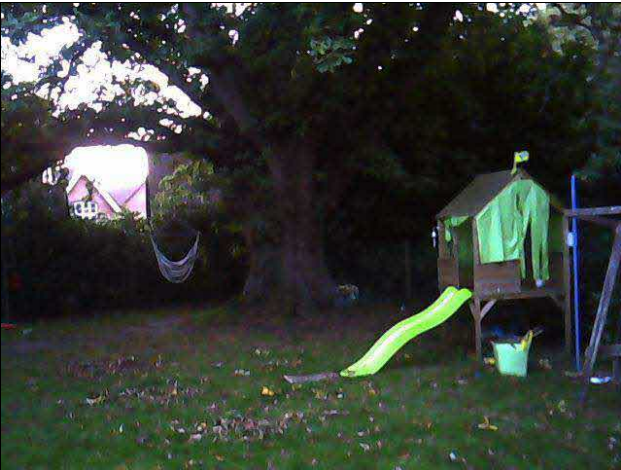
T9 - Oak

With due regards to species profile, size and proximity, T9 (Oak) is considered the dominant feature proximate to the focal area of movement and accordingly, where vegetation is confirmed as being causal, we have identified them as the primary cause of the current subsidence damage.
