**STRUCTURAL REPORT A STONE BARN
ON KINGMORE FARM OLD
GLOUCESTER RD WINTERBOURNE,
BRISTOL, BS36 1RT**

For MR + MRS HOWES

Ref: 11299

June 2023

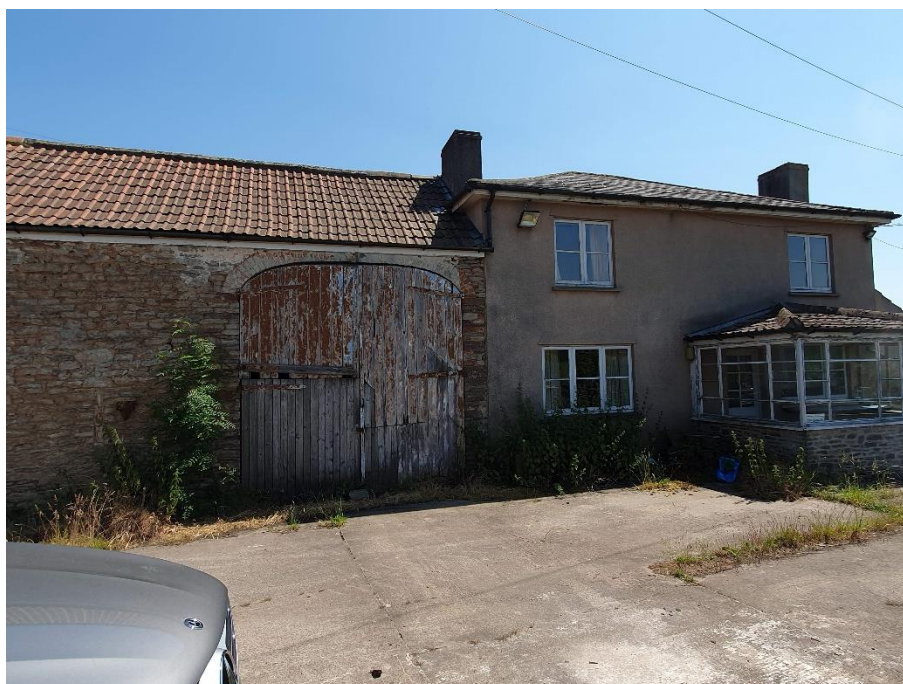
Photo 1857

The barn was inspected by Terry Ventham on Wednesday the 14th June 2023. This is a stone building with a tiled roof and it is attached to the side of the farm house. See photo 1857

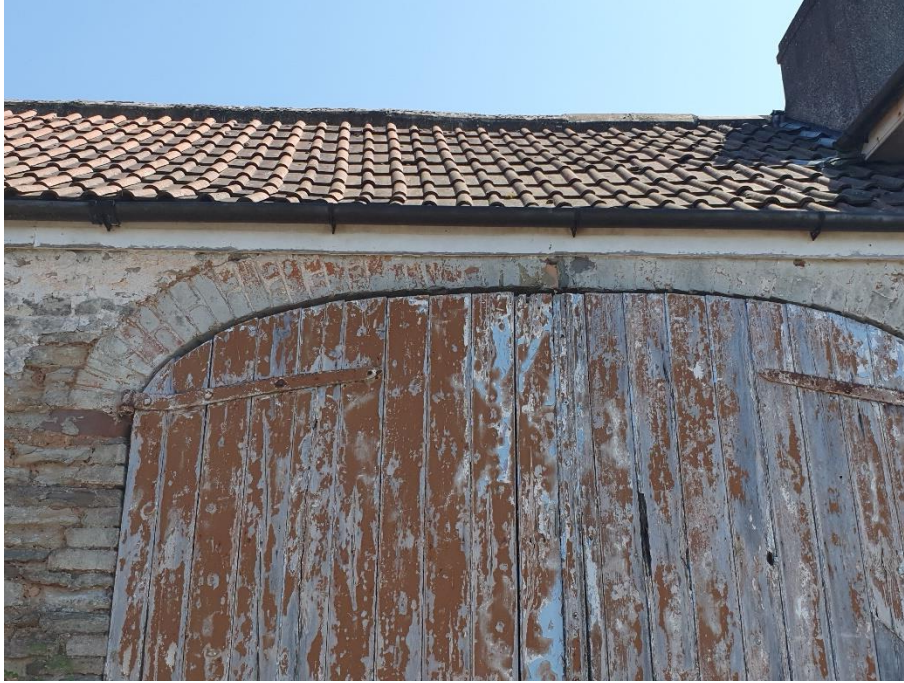
Photo 2152

There are a large pair of wooden doors on the front of the building. There is a brick arch over the top of the pair of doors. Other than the brick arch, the rest of the elevation is in stone. The brick arch is flat across the middle section.

Also, the top of the arch is covered by a fascia board. However, the arch appears to be in good condition. See 2152

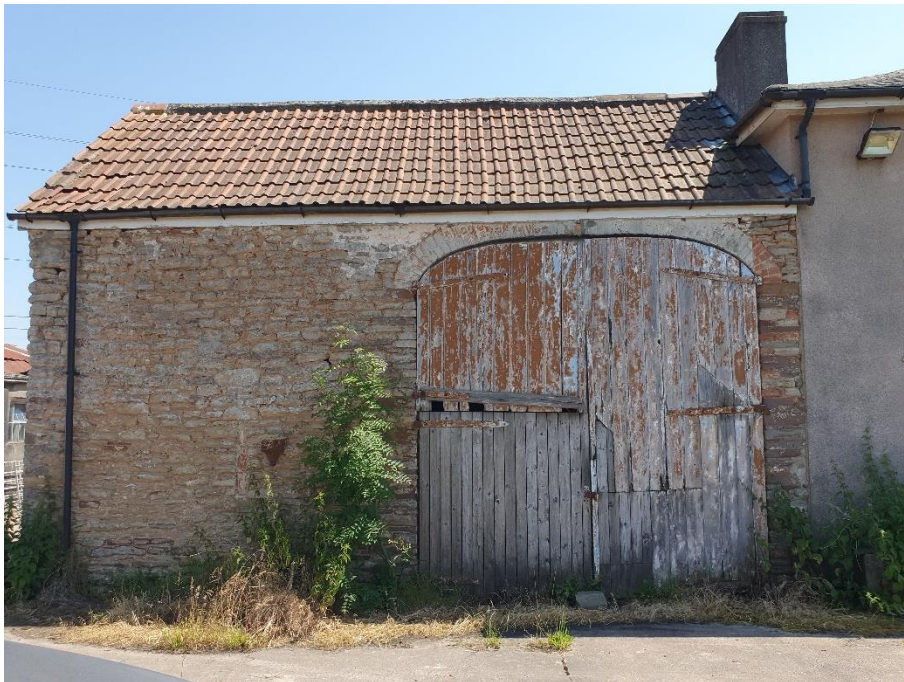
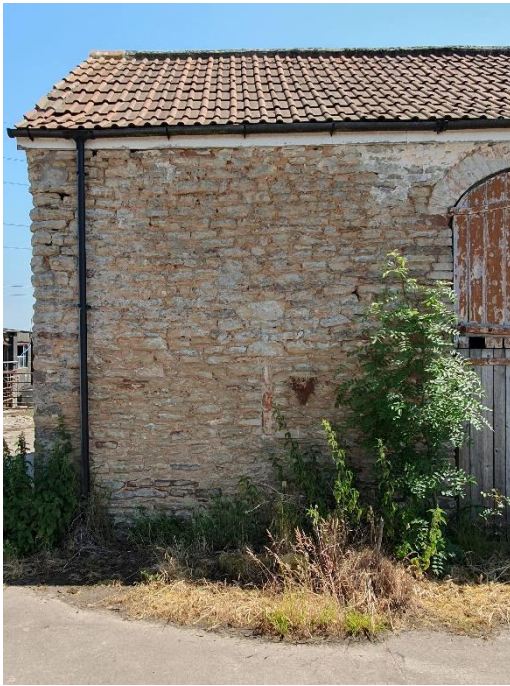
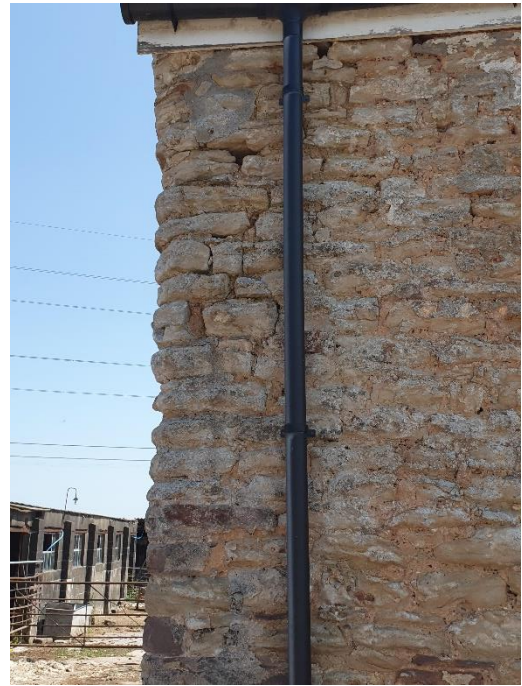
The stonework is approximately coursed, it is in reasonable condition but it would benefit from being re pointed. See 1911, 2111 + 2132

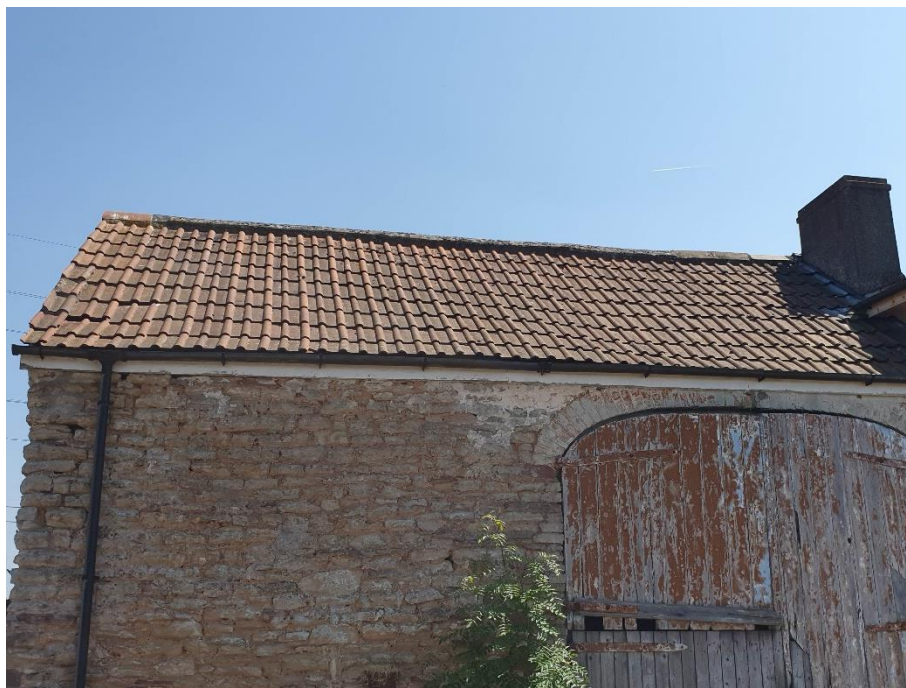
Photo 2031

The roof has some slight undulation but it appears to be in reasonable condition. See photo 2031

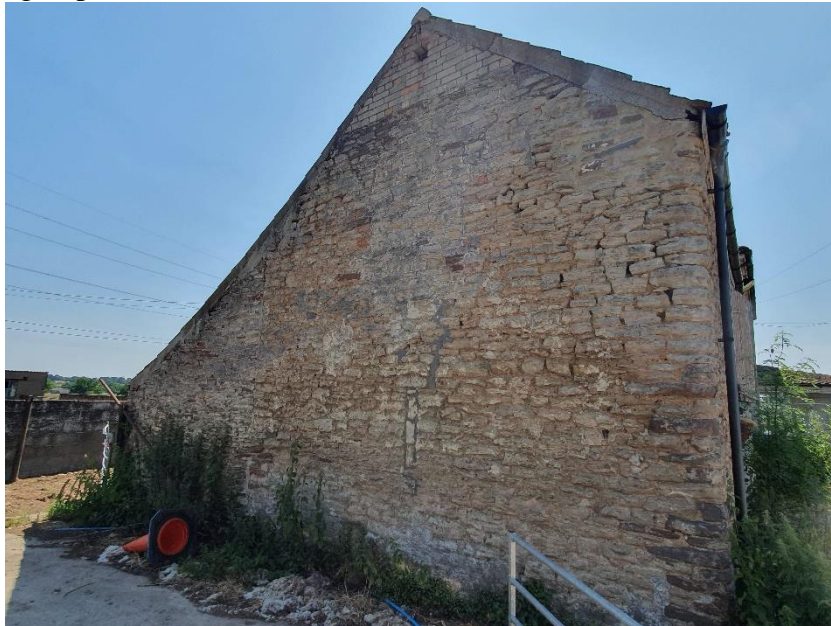
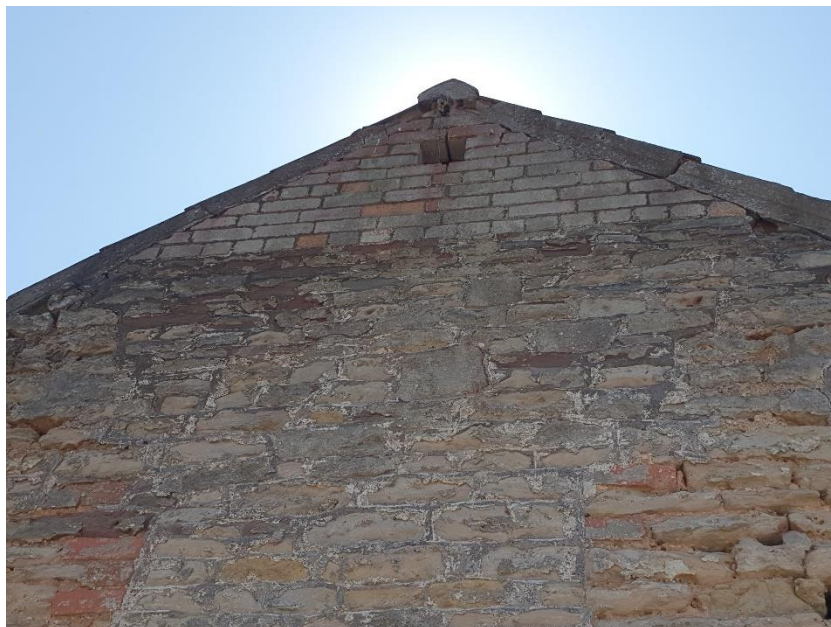
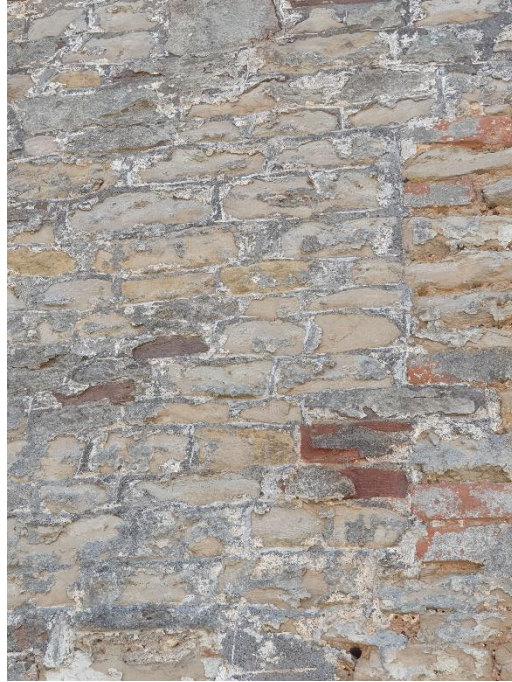
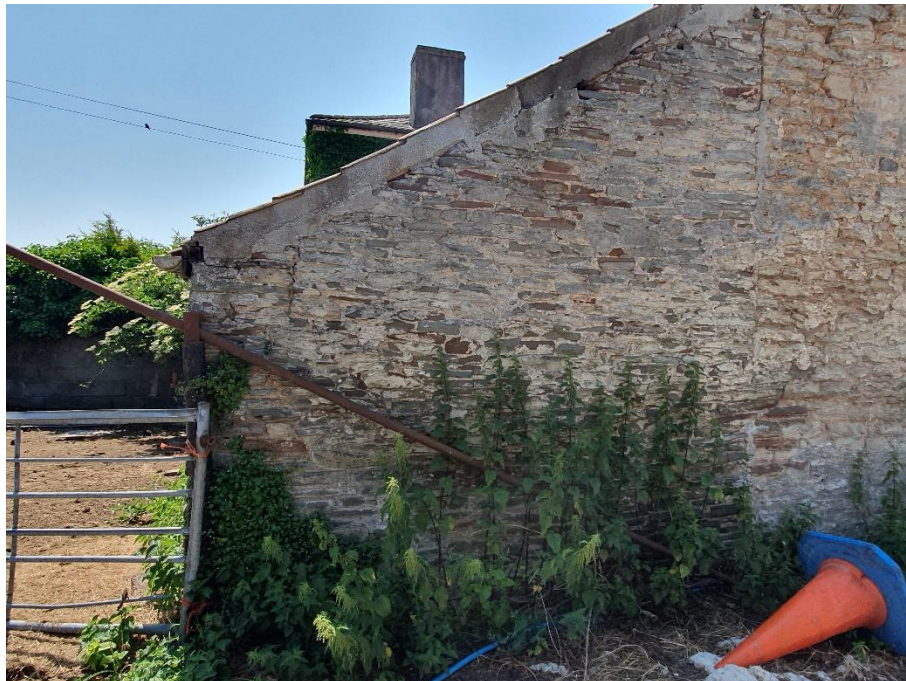
This is a stone elevation except for the top of the gable which is in brick. There is a lean to section on the back of the building and there is a straight joint between the two suggesting that this was a later addition.

There is also an area of stone in the middle of the gable that looks like an infill. There may have been a window or a louver vent panel. The wall is generally in good condition, but it would benefit from being re pointed. See 2307, 2346, 2401 + 2458

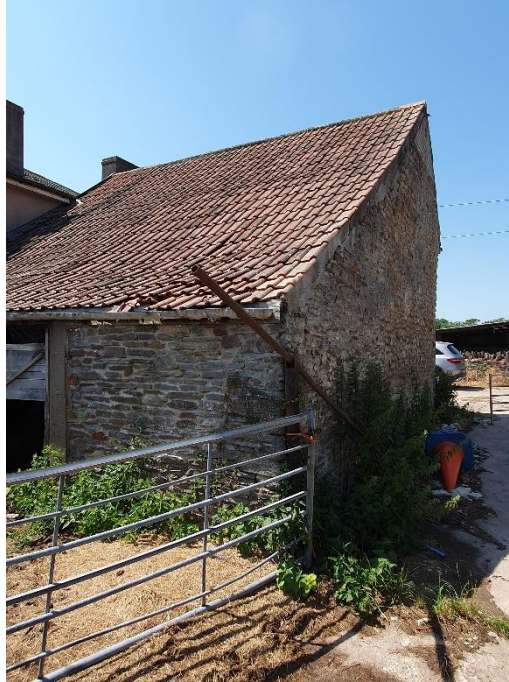
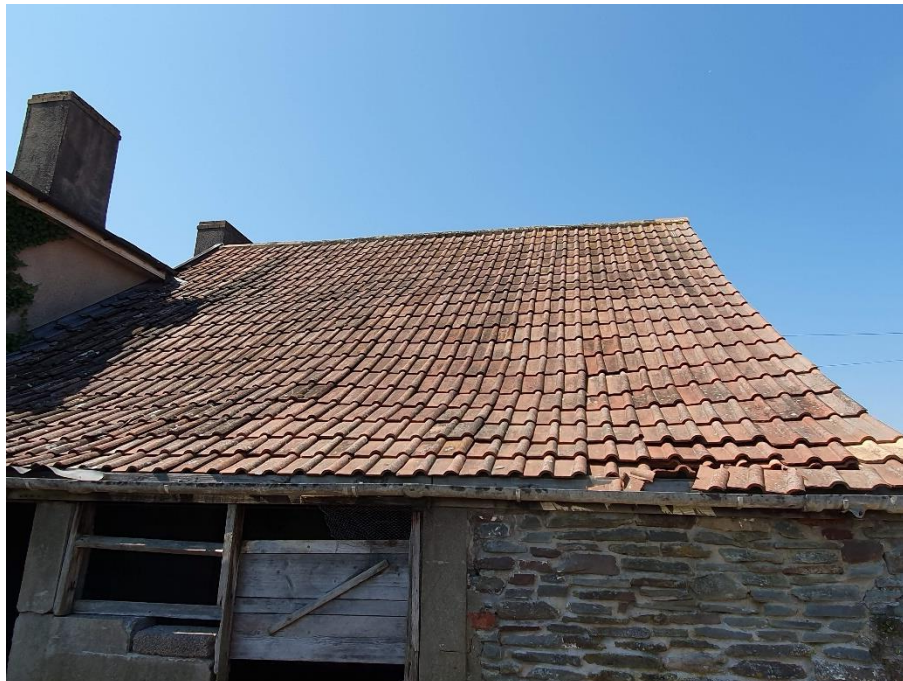
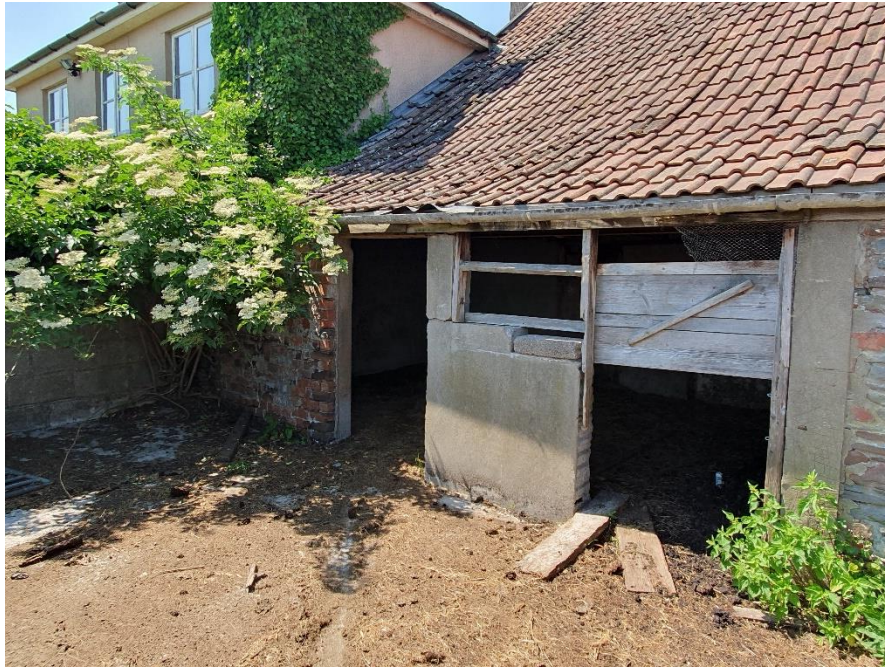
This is also in stone. The tiles roof extends down over the lean to section, the upper part of the roof is in good order but there are some undulations in the surface of the area of roof over the lean to. See photos 2520, 2537 + 2616.

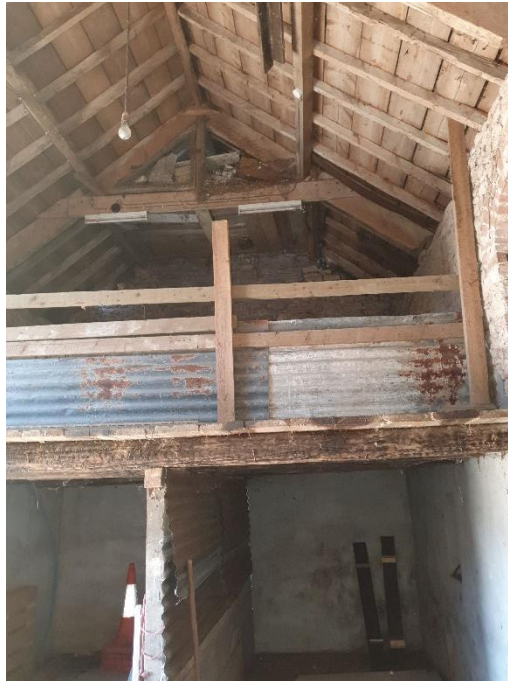
Photo 2246

Inside the main part of the barn there is a timber mezzanine floor over part of the barn. See 2246

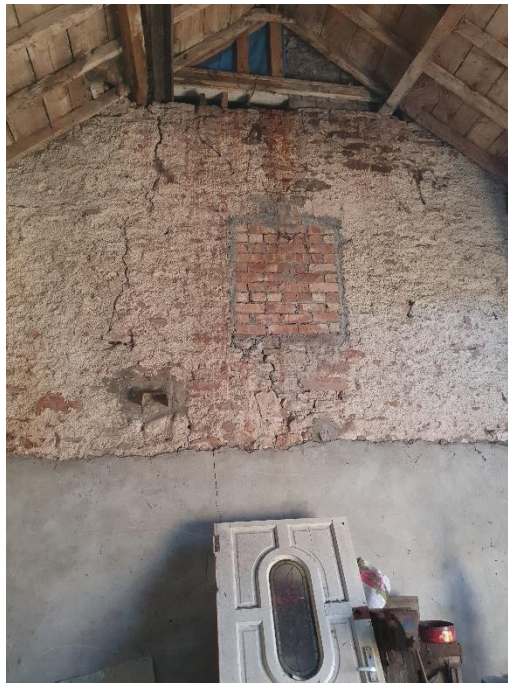
Photo 2301

The gable adjacent to the house is in stone, there is a bricked in opening in the middle. There are some near vertical cracks in the joints to the stonework in this wall. The bottom section has been rendered and this is in good condition. See photo 2301.

The walls to both parts of the building are all in sound condition, there are some minor vertical cracks and joints that should be tied across with “Helibar” or similar reinforcement. However, there are no signs of subsidence or serious distortion. The large brick arches need to be treated carefully but they are sound and they are providing adequate support to the roof. The roof of the main barn is generally sound and well-constructed, the roof of the lean to needs some improvement but a couple of extra main rafters and possibly some extra purlins would make it work and preserve the bulk of the existing structure.

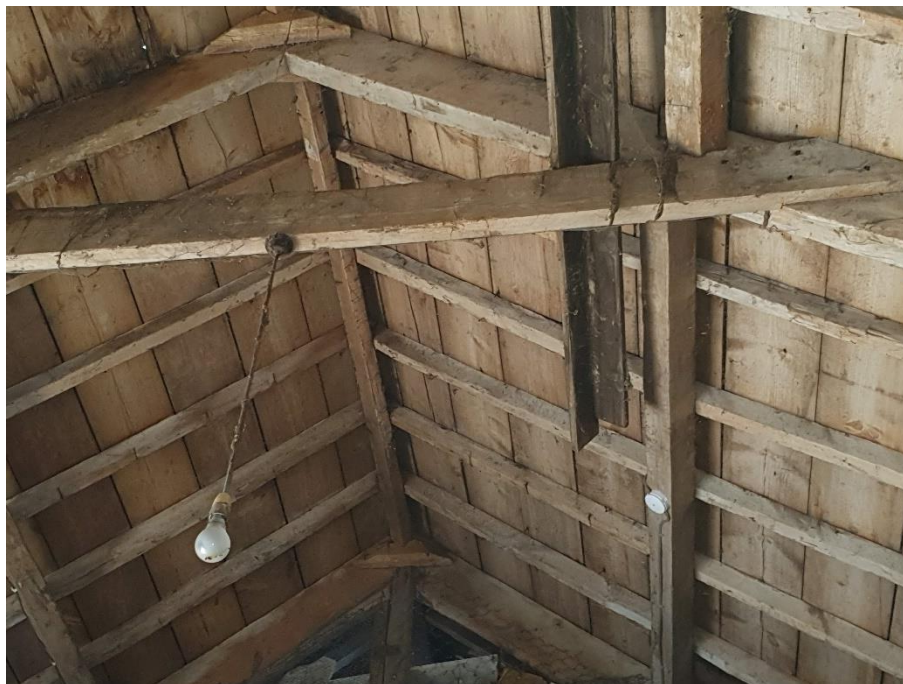
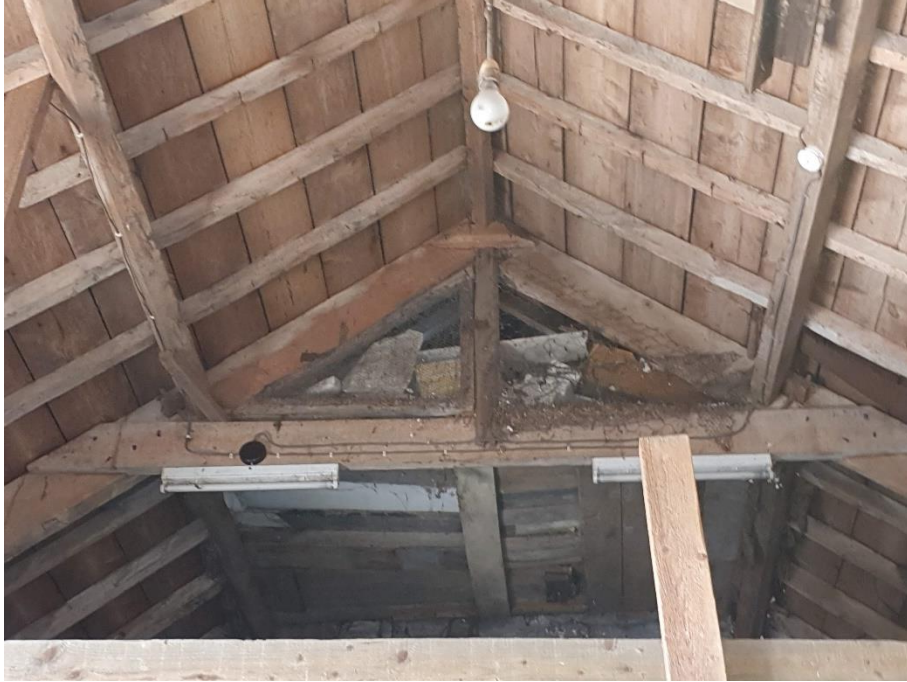
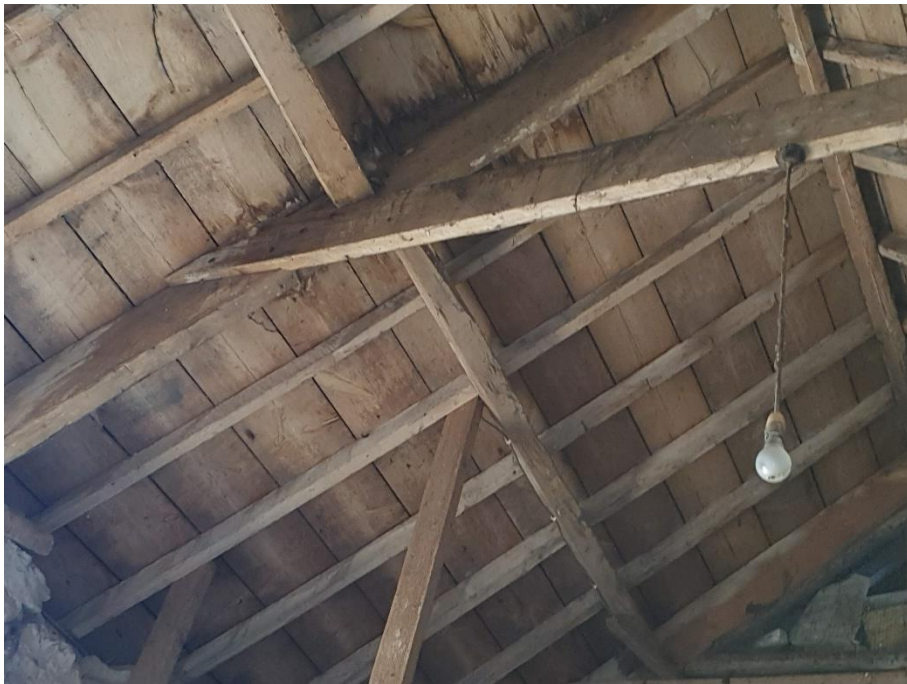
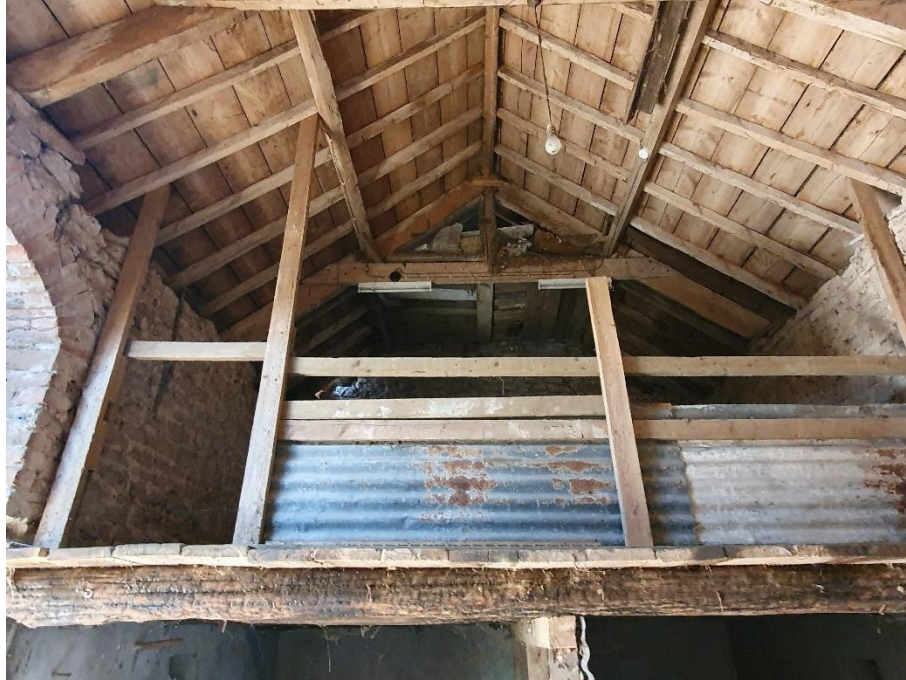
The roof consists of rafters on to a single purlin per slope. The purlins are supported on main trusses and the roof is boarded under the tiles. See photos 2732, 2800, 2747 + 2337.

This is all generally in good condition.

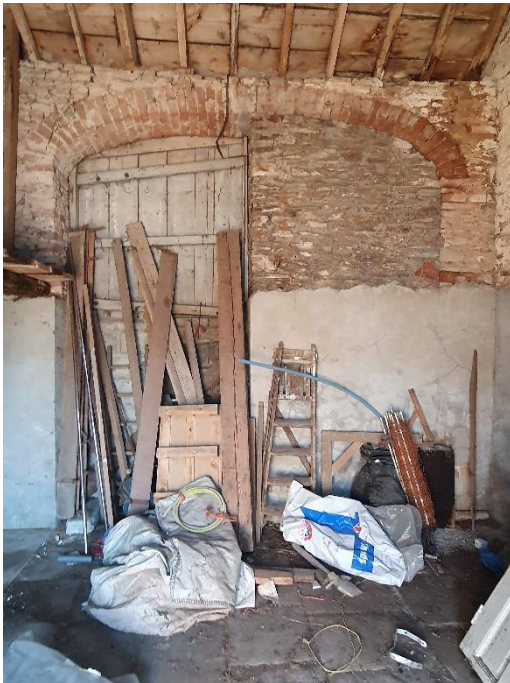
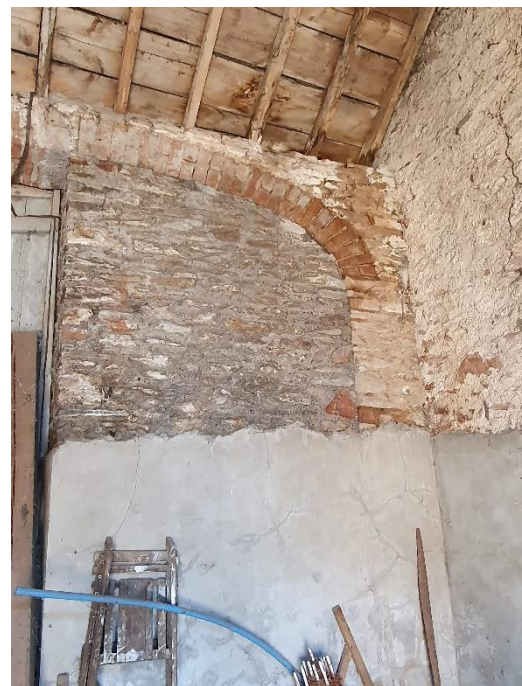
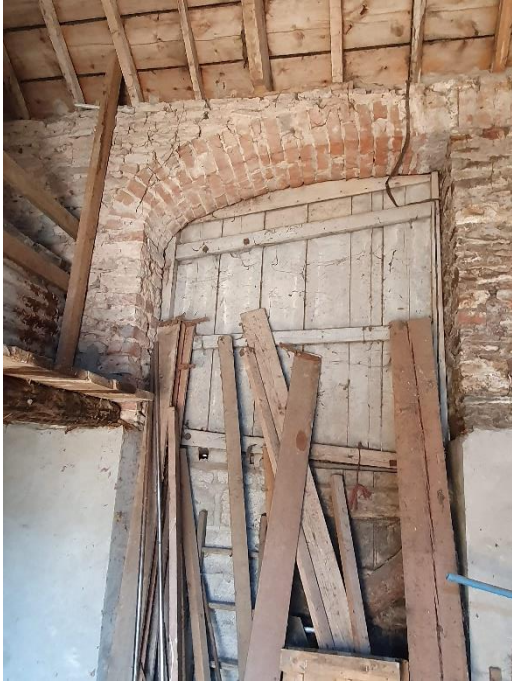
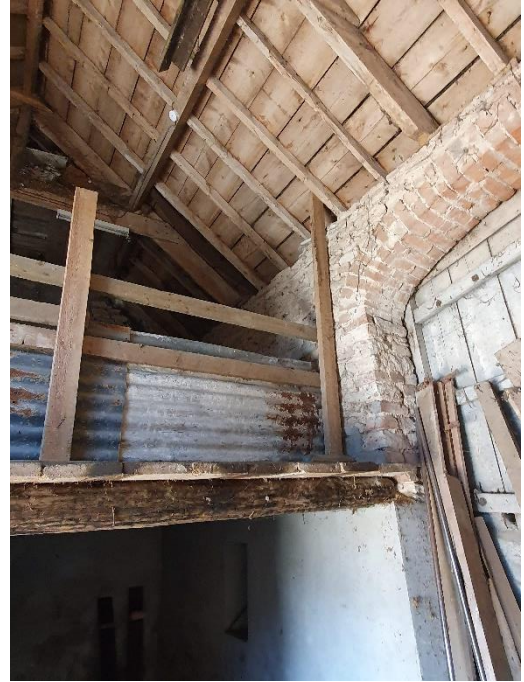
The wall between this room and the lean to section is in stone. There is a large brick arch in this wall also. Half of the arched opening has been infilled with stone but the brick arch can be seen to be substantial. This is directly opposite the arch in the front elevation see photos 2436, 2446, 2452 + 2421

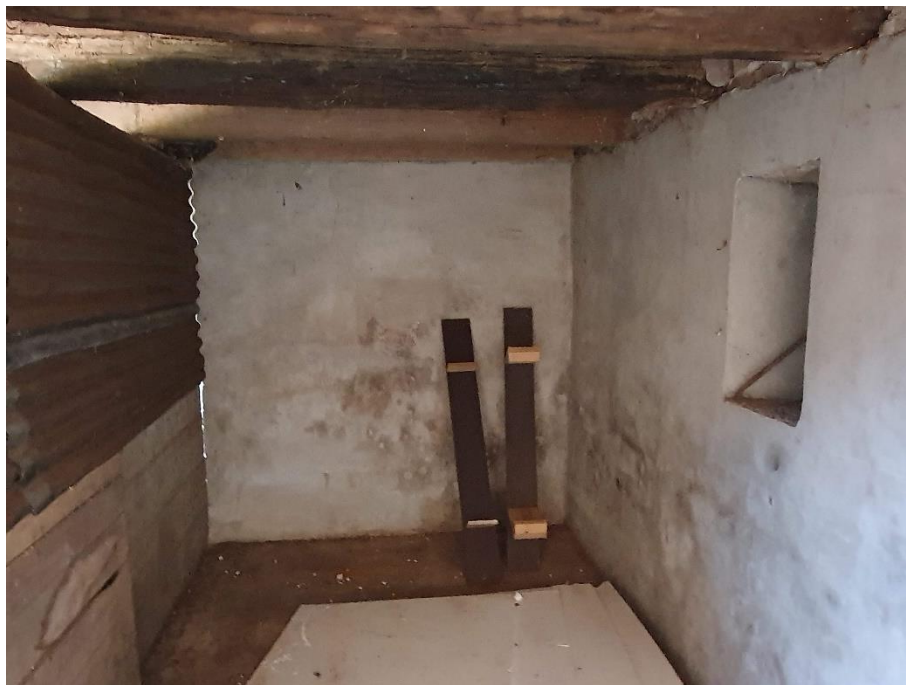
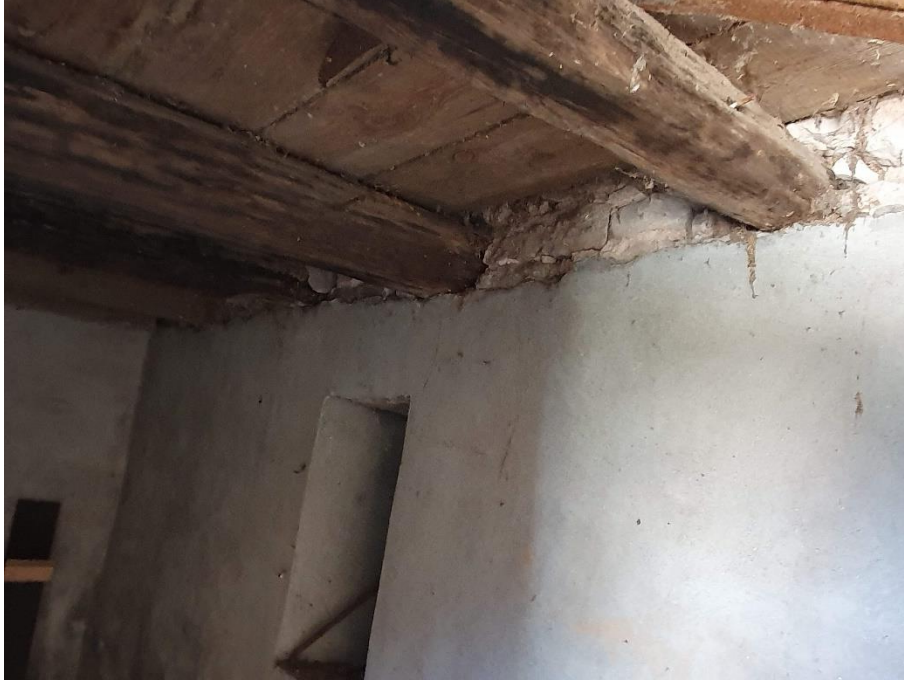
The brick arch in the front wall can be seen in more detail from the inside. This can be seen to be substantial and in good condition. The mezzanine floor is constructed with large timber joists and some thick planks. See photos 2528 + 2543

This is in sound condition.

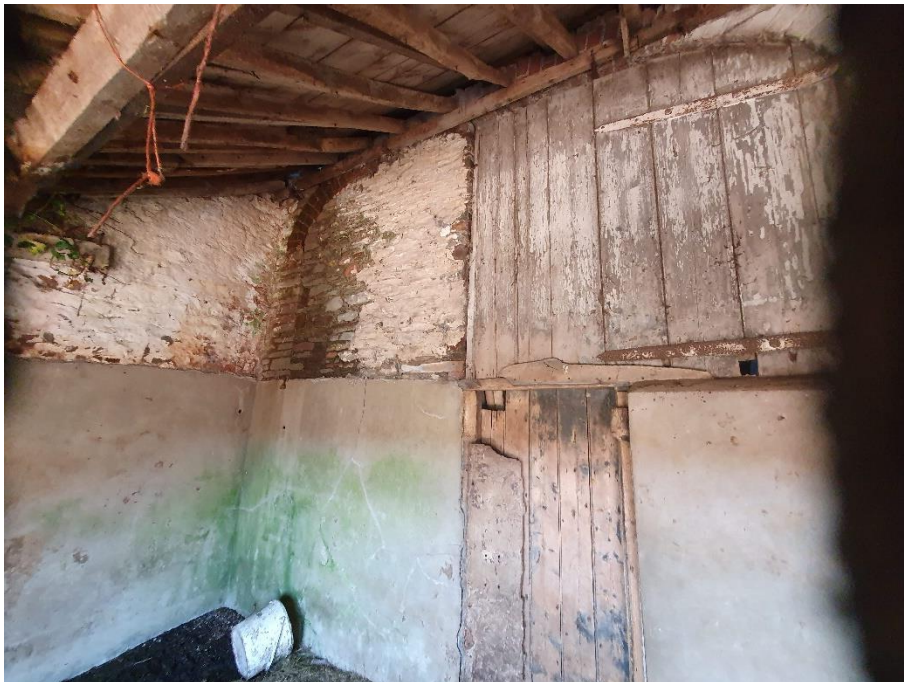
Photo 2710

The brick arch in the internal wall is partially visible in here see photo 2710

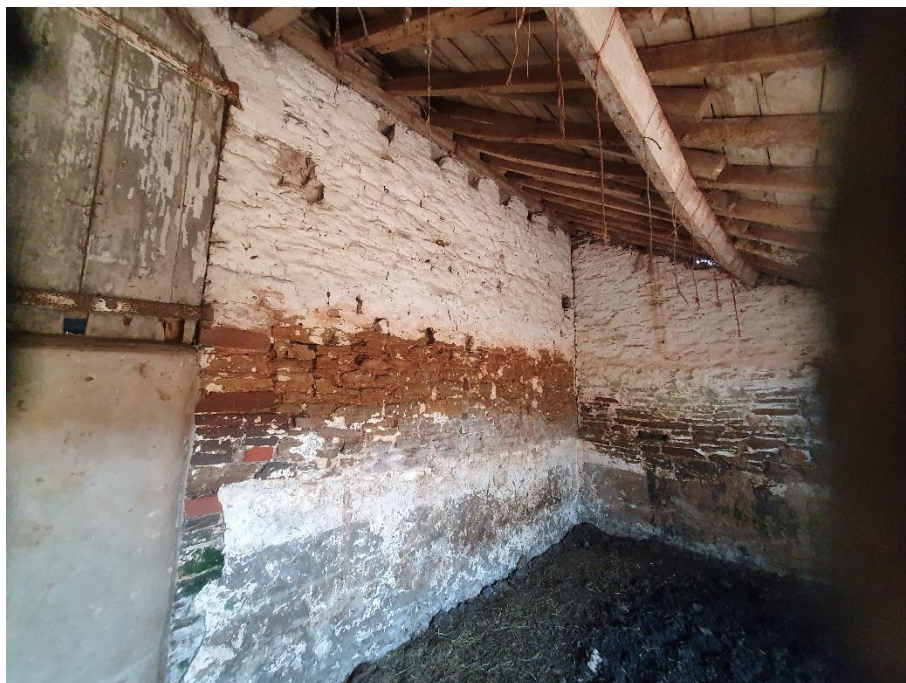
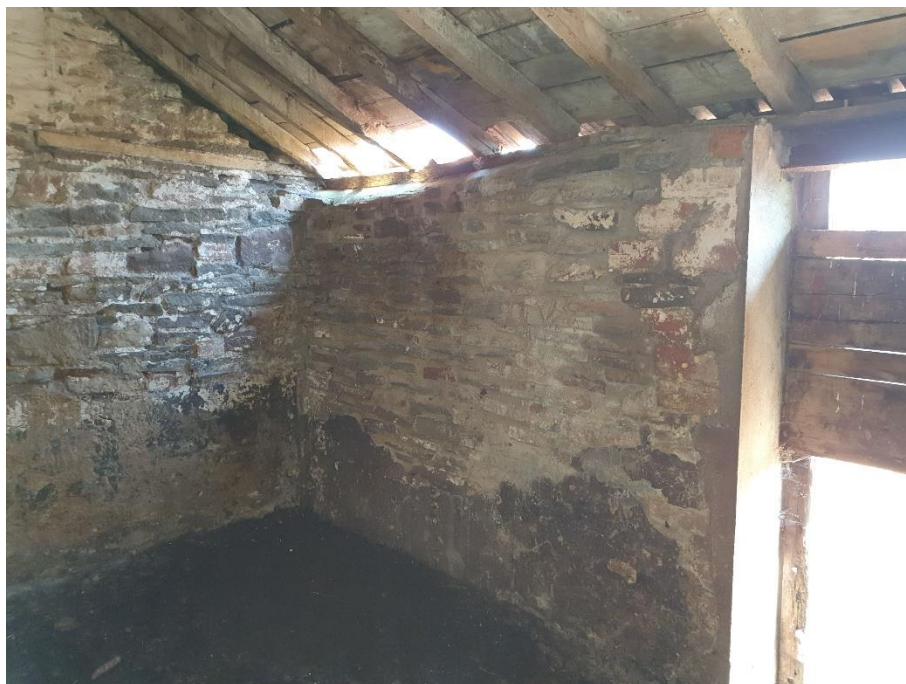
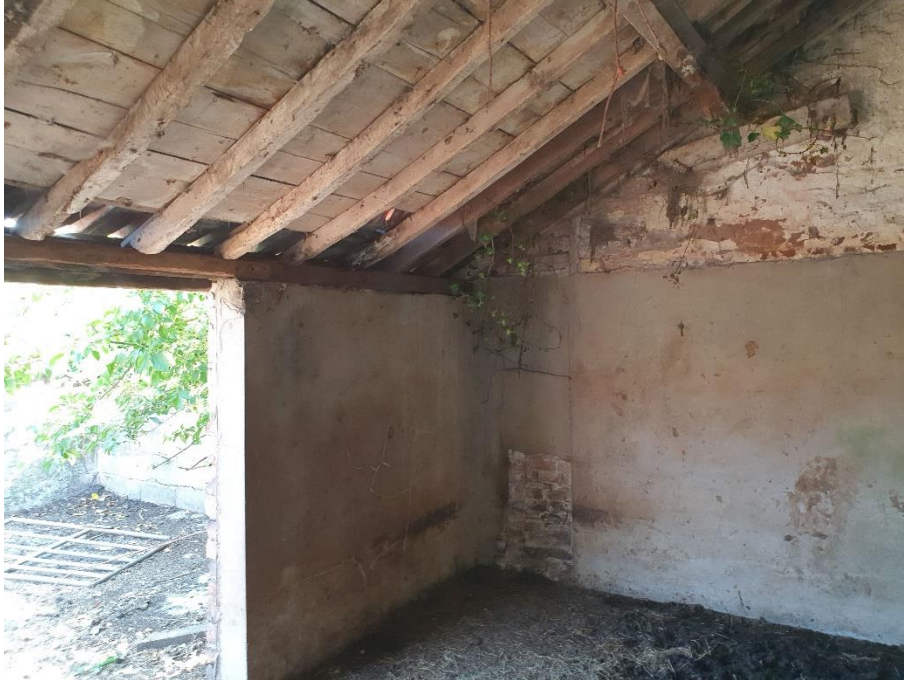
Part of the arch is obscured by the rafter. The top of the rafters are supported on a wall plate which is consistent with the lean to being a later addition. There is a wooden door in half of the arch opening. The stonework is in good condition internally. See photos 2716, 2840 and 2854

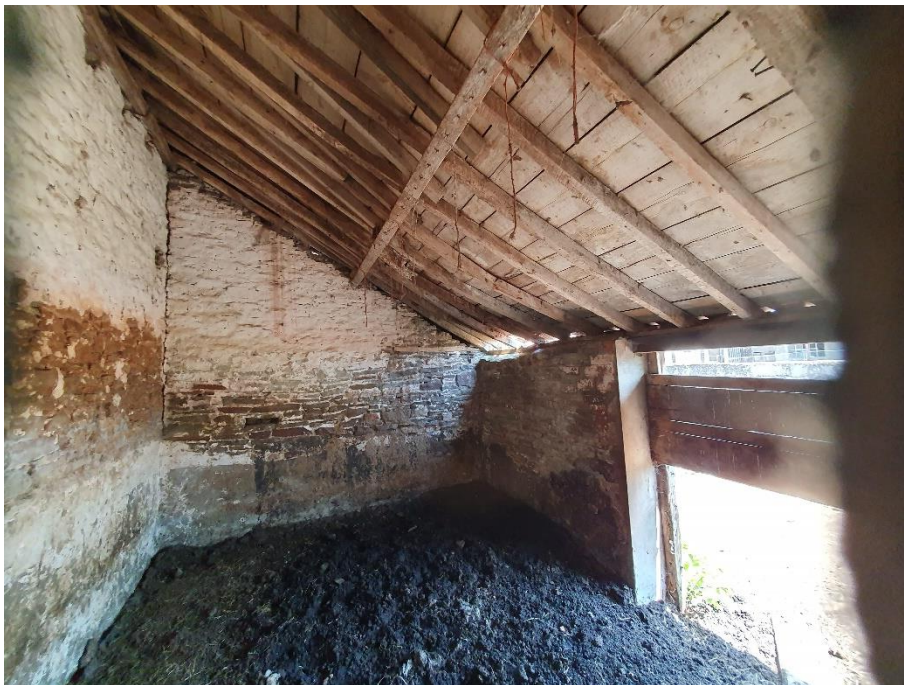
Photo 2728

The lean to roof has central purlin and rafters, it is also boarded under the tiles. There is a deflection in the purlin and some of the rafters are badly deflected see photo 2728

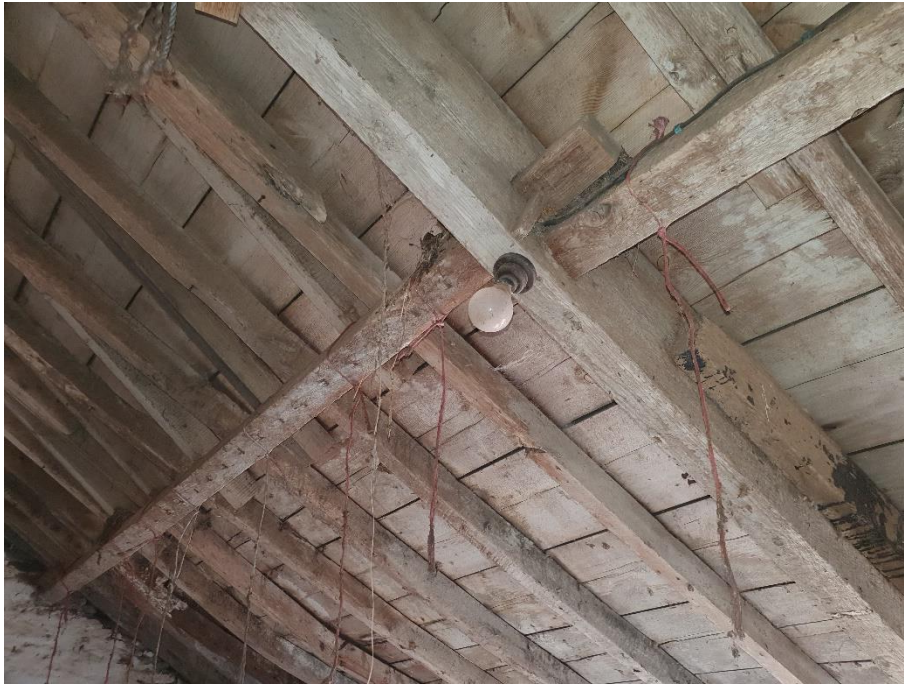
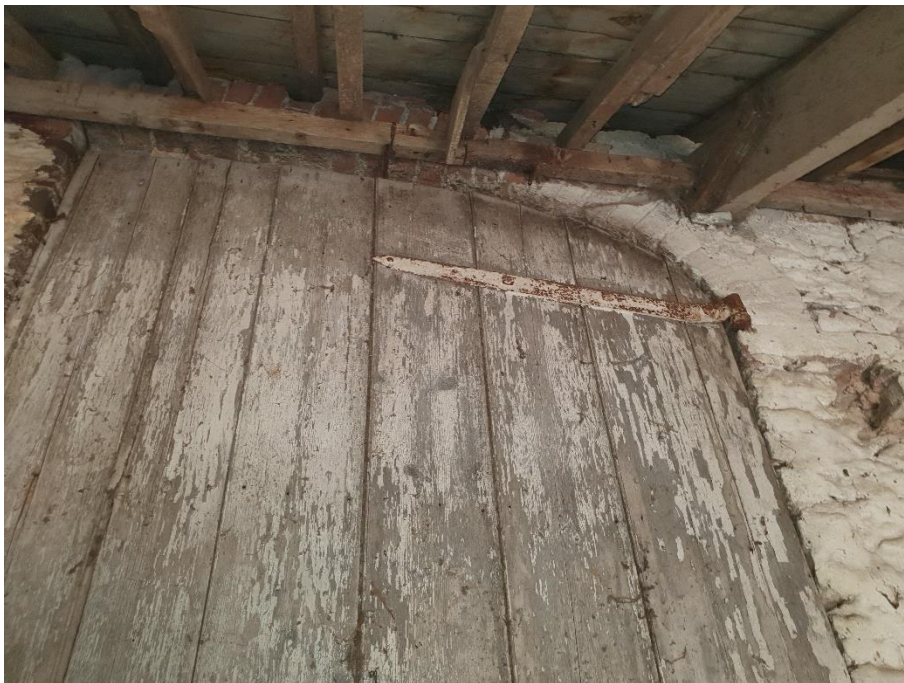
The purlins are fixed to a larger rafter in the center of the roof see photos 2819 + 2929
