**EDGECOMBE GARAGE
Abson Road,
Abson, Wick, Bristol BS30 5TT**

**STRUCTURAL REPORT
ON
GARAGE BUILDING**

Date of inspection

28th November 2023

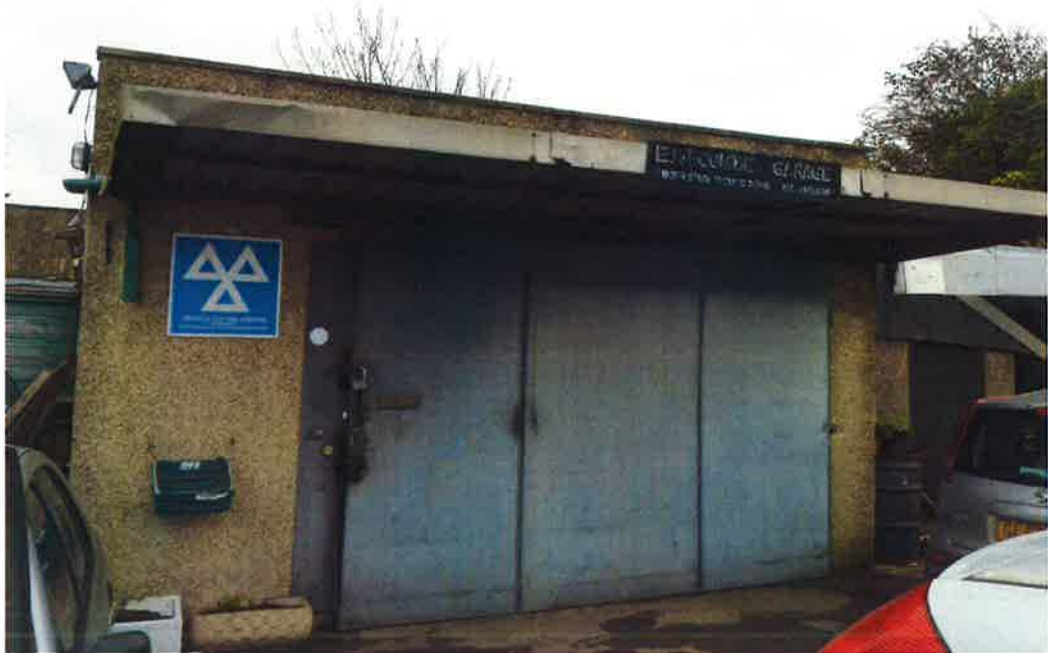
1: Front Elevation

Most of the walls comprise rendered blockwork and brickwork. The render is a mixture of original pebbledash, smooth cement plaster and painted roughcast. The original limestone pebbledash is discoloured in places.

The walls appear to be in good condition throughout.

The front workshop wall contains a large sliding metal door, opening from north to south, providing full access to the front workshop. To the south of this, on this same elevation, is a timber personnel door which gives access to the office.

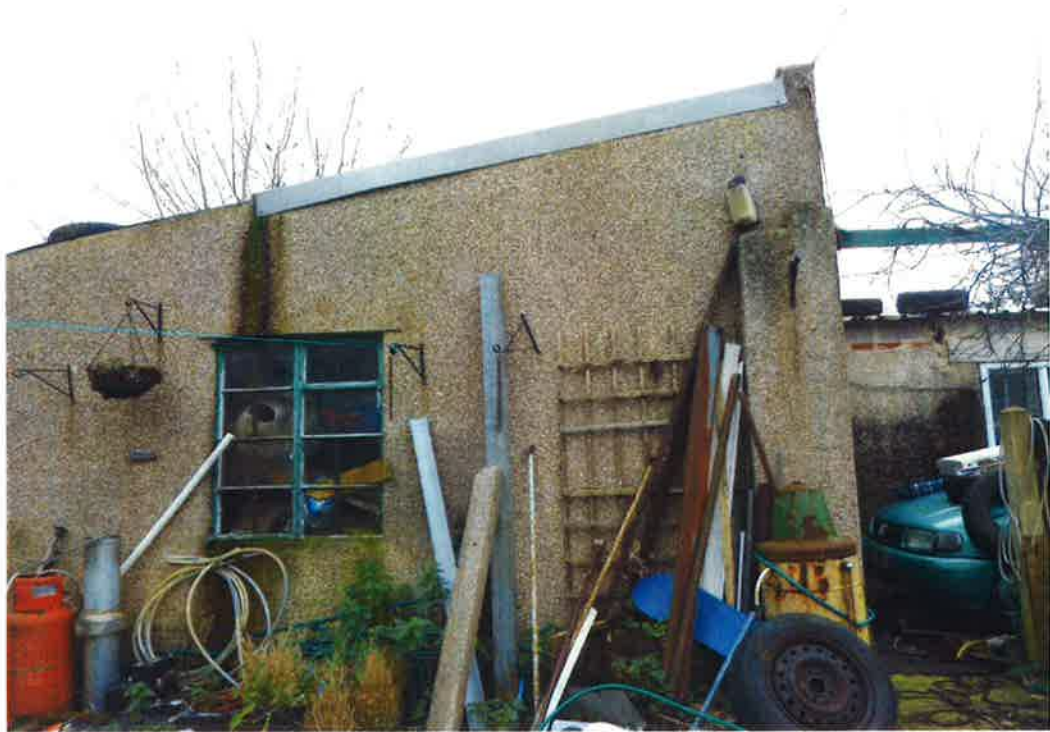
3: North Elevation of Workshop 2

The projecting back workshop has a single-width up-and-over metal garage door facing west.

There are three windows facing north which serve the two workshop areas. The front two have precast concrete lintels above. There is a single window facing east, which serves the back workshop stores. There is a single window facing south, which is for the garage office.

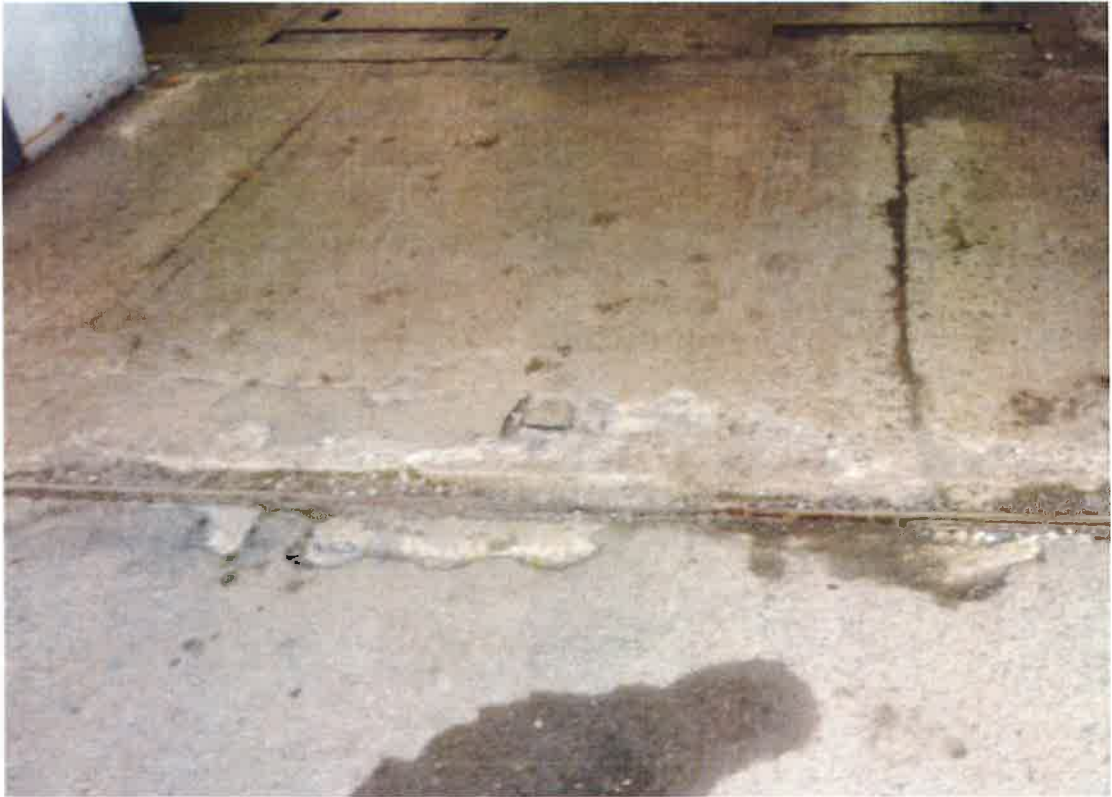
5: Floor Slab at Main Entrance

Although these floors have been in service as a garage for many years, they appear in good condition with no sign of settlement, significant cracking or distress.

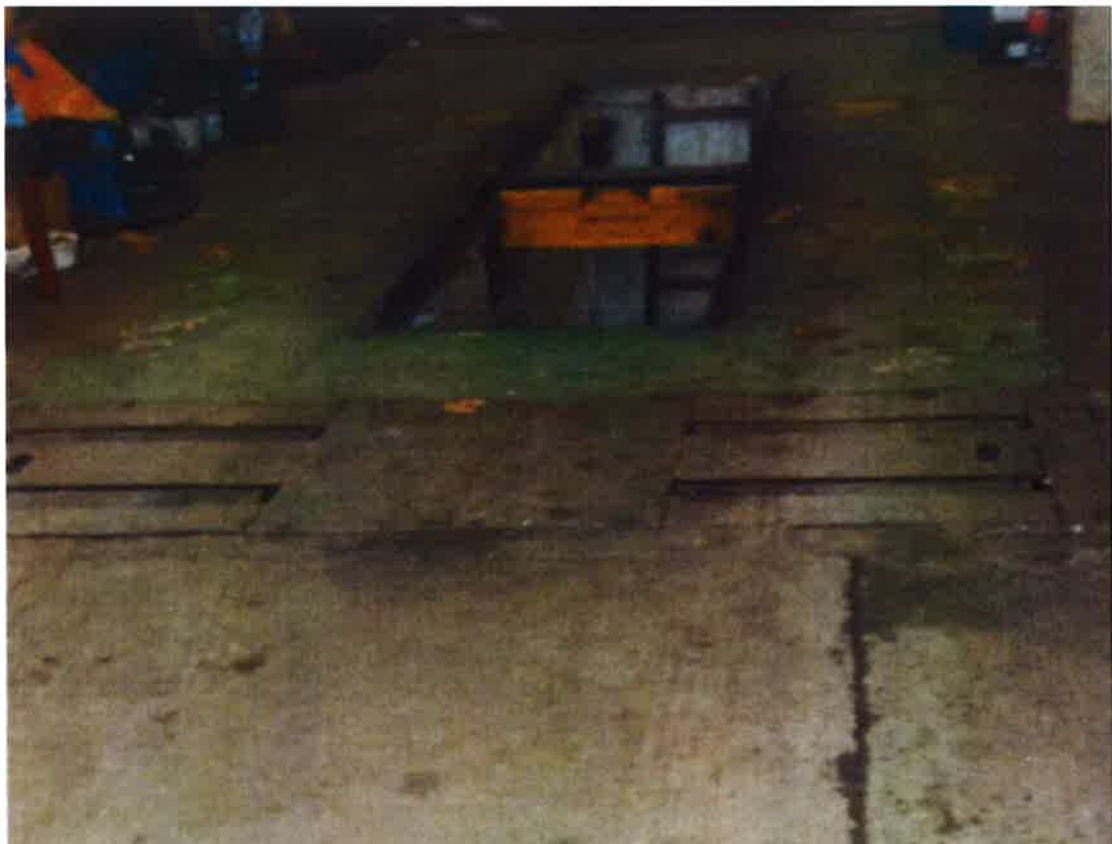
6: Front Workshop Slab and Service Pit

The workshop floors are concrete throughout. The front one has a vehicle service pit measuring 3.7m long x 0.8m wide x 1.4m deep. The walls of this pit, which act as retaining walls, have no significant cracks and show no evidence of lateral movement or settlement.

- Creation of below-ground storage areas and/or a wine cellar within the existing service pits.

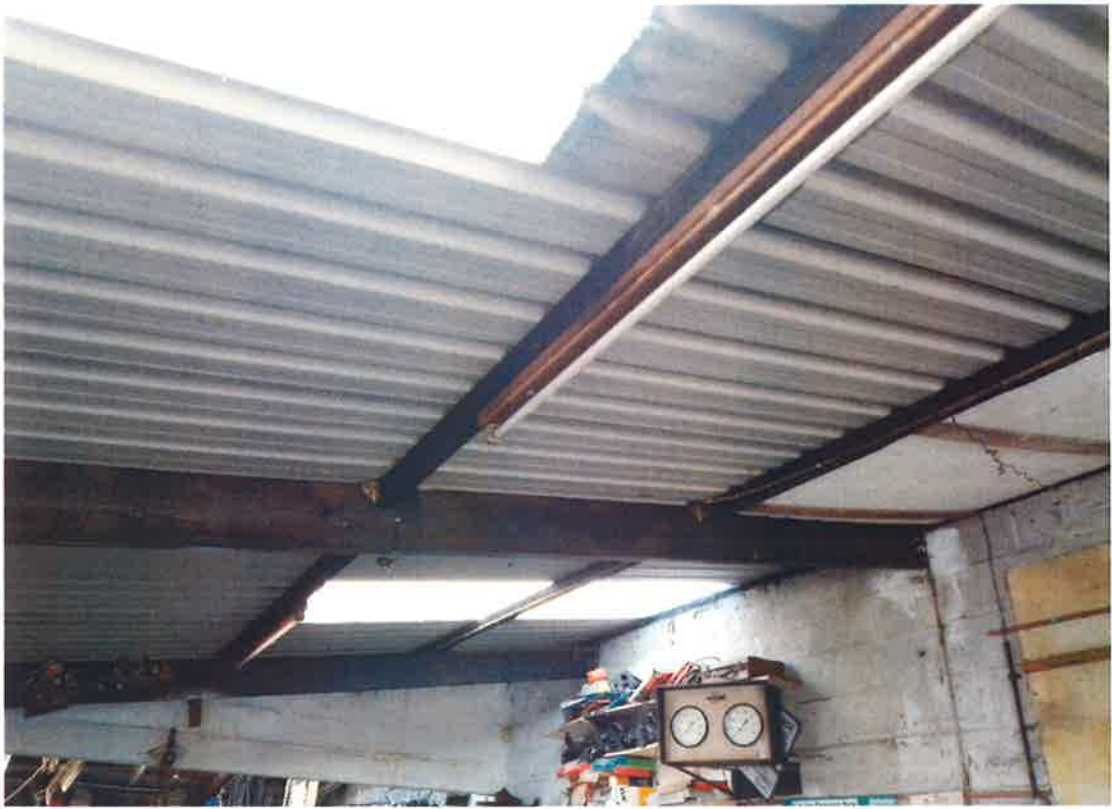
7: Front Workshop Roof Structure

The front workshop roof sheeting is carried directly on longitudinal timber purlins, 80mm wide x 60mm deep. These are supported on the end walls plus a set of three inclined timber roof beams. These beams measure 230mm deep x 80mm wide and span across the 5.5m width of the workshop. Most of the connections between purlin and roof beam have been made using metal joist hangers. Both the purlins and roof beams appear to be in good condition throughout, showing no visual evidence of decay, structural distress or excessive deflection.

At present the garage buildings are in a good state of repair. The roof structure is adequately sized for the current loadings, evidenced by the absence of significant deflections throughout the primary and secondary timber elements. The roof would benefit from the addition of vertical restraint straps around the eaves, allowing the counterweights above to be removed.

Due to the sloping orientation of the roof beams, any new horizontal ceiling would need to be added below. Keeping this ceiling structurally separate from the existing roof would eliminate any possible effects of cold bridging. The resulting ceiling void would provide the opportunity for further maximising thermal insulation performance.

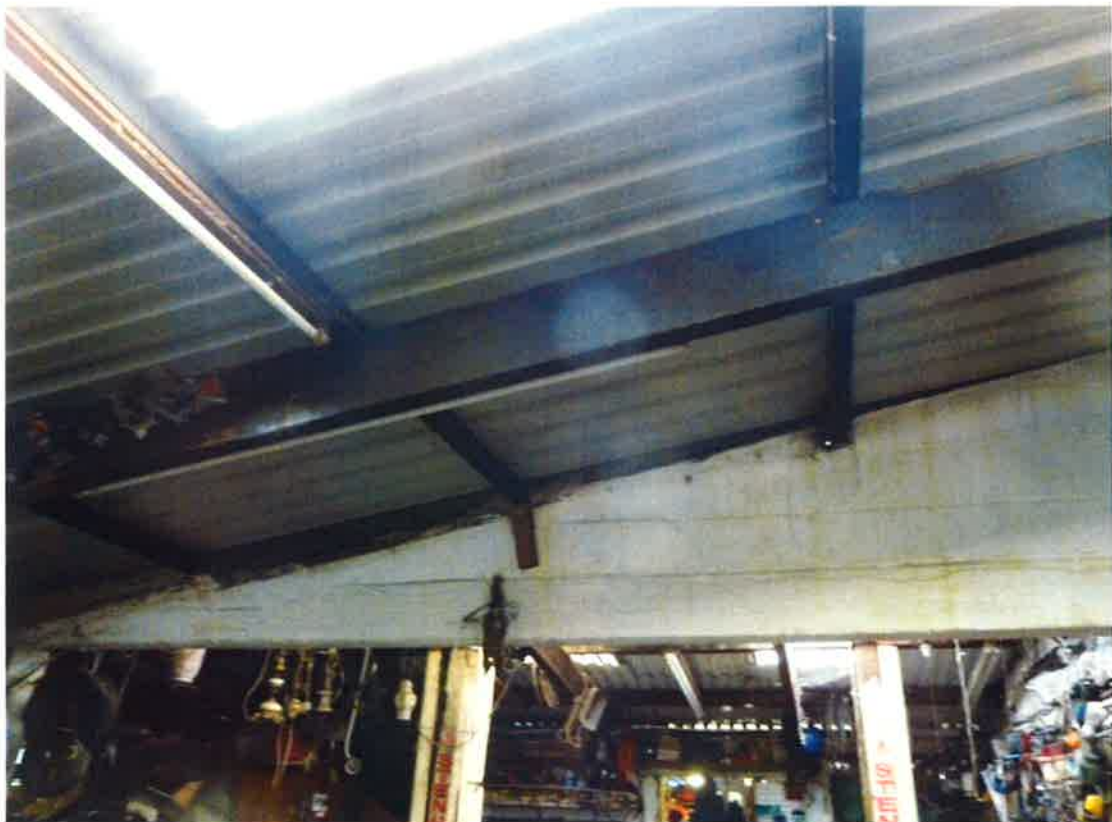
8: Concrete Lintel Between Workshops

The opening between the front and back workshop areas is formed by a 230mm deep x 170mm wide cast in-situ reinforced concrete beam. This beam is continuous across the external up-and-over garage door of the back workshop.

These walls and lintels are mostly painted white. They appear in good general condition with no evidence of significant cracking or movement.

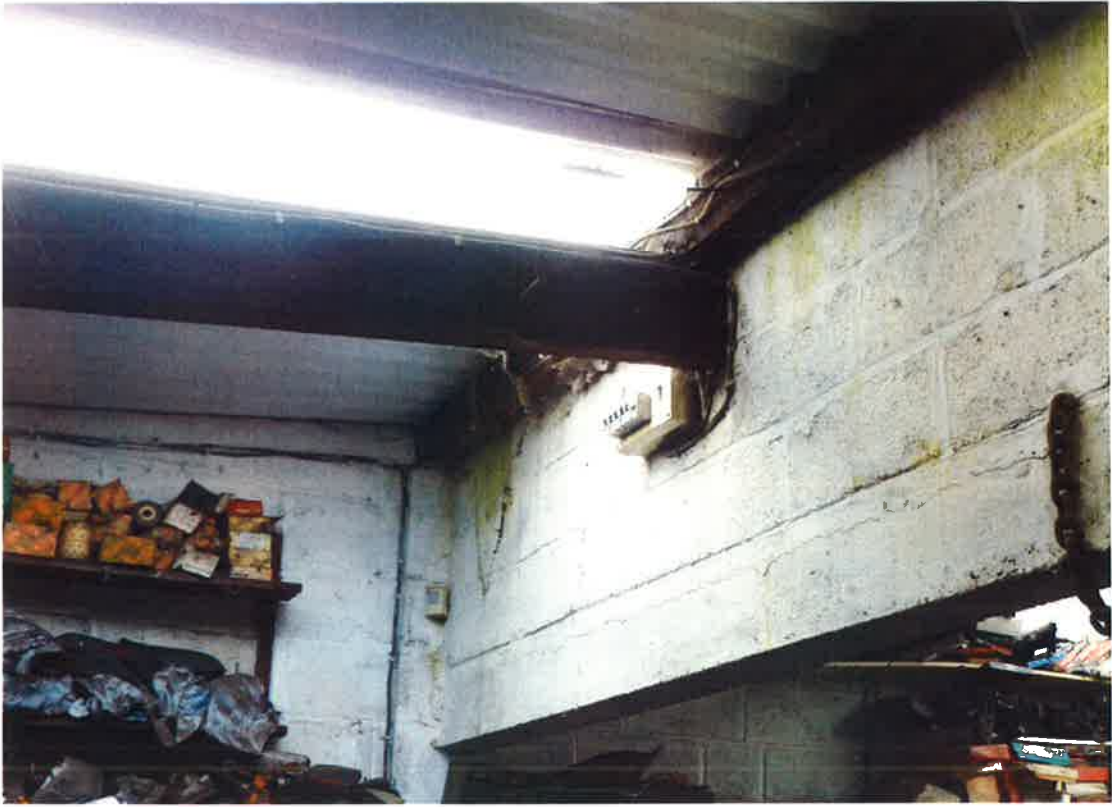
9: Back Workshop Roof Structure

The back workshop roof has 125mm deep x 75mm wide timber purlins equally spaced at approximately 1.35m. Intermediate roof support is provided by a series of four timber raking beams. These measure 230mm deep x 75mm wide and are set a varying spacings from 1.3m to 1.8m. In this workshop the purlins run over the top of the intermediate beams, leaving the latter unnotched which is structurally advantageous. Similar to the front workshop, all roof timbers appear to be in good condition, free of decay, structural distress and excessive deflection.
