**Method Statement to discharge condition 5 of Listed Building
Consent for the barn at Old Tong Farm**

Application ref: 23/02139/LBC

Document Ref: MS-25Q-01

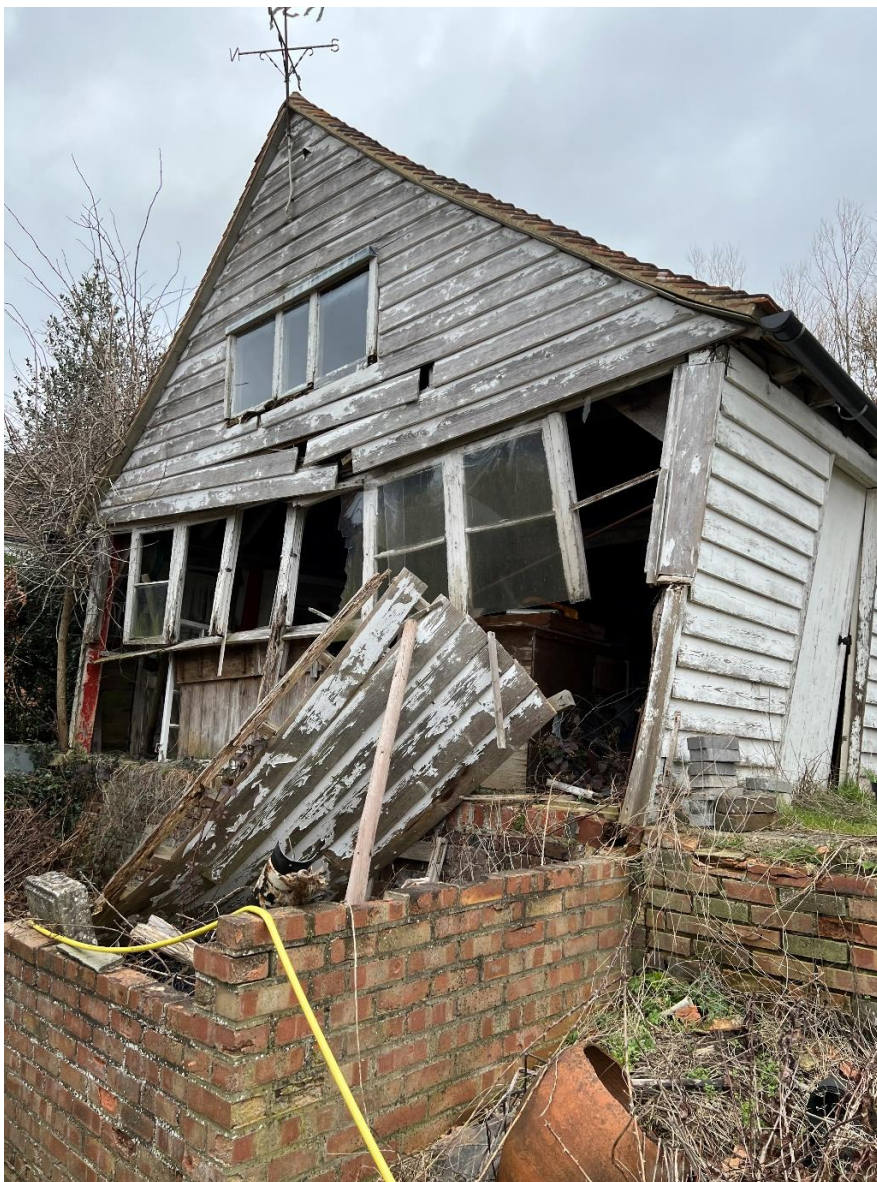
Fig 1: South elevation of dilapidated barn at Old Tong Farm

The building has severely racked towards the east and is currently only prevented from total collapse by the modern stable structure at its east supporting the frame at the eaves. This modern stable structure will be demolished as part of the approved works, so some extensive temporary propping will need to be carried out to the existing building prior to this stable block being demolished.
