Our Ref: PM/5646

25th March 2024

RE: RECONSTRUCTED OUTBUILDING, OLD TONG FARM, TONG ROAD, BRENCHLEY

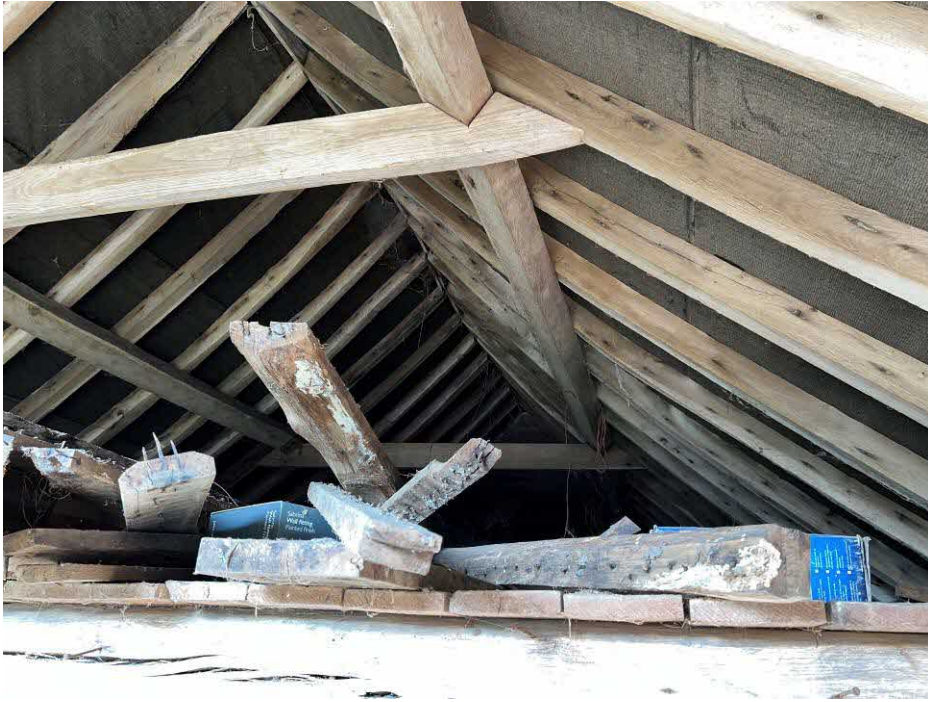
Plate 1 – Internal View of Roof Structure

The outbuilding is detached and comprises a pitched gabled roof with clasp purlins (see plate 1 at the rear of this letter report). The rafters are approximately 80x90mm deep at 450mm centres that span from the eaves plate to a thin ridge board and are supported along their length by 130mm wide x 110mm deep purlins. The purlins are generally supported by horizontal collars on the main frame locations, although no collar is present to truss 4 (refer Anthony Hicks drawings for grid references). Diagonal bracing timbers were present to the underside of the rafters.

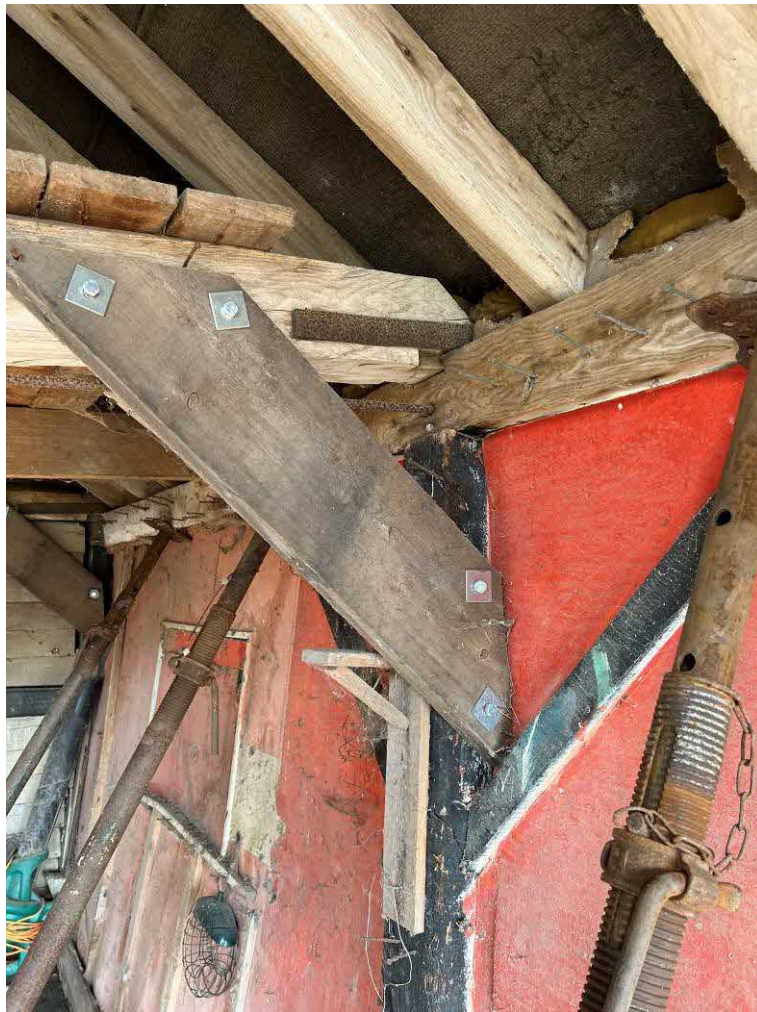
Plate 2 – Modern Softwood Knee Brace

The collars are mortised and tenoned into the principal rafters and the rafters are placed alongside the three principal tie beams as opposed to being mortised and tenoned into the top of the ties. A positive connection is required between these two elements, so all principal rafters should be bolted to the tie beams with 2No. M12 diameter bolts. The tie beams are approximately 145mm wide x 175mm deep and are supported by principal posts (sizes varies - 150x130-150mm). The base of these posts could not be seen and appear to be set into the concrete substructure and are likely to be decayed. Modern softwood knee braces have been added and these have been bolted to the side of the tie beams and posts (see plate 2).

As a result, we feel that the posts and knee braces require replacement with more substantial sizes. These have been calculated as 200mm x 175mm posts that are jowelled to 200mm square above the level of the knee brace. The knee braces should be a minimum of 70x120mm and should be connected to the post and tie beams with mortise and tenon joints with 2No. stainless dowels per tenon. The knee braces will also need to be lower to ensure they are effective (900mm below the tie beam).

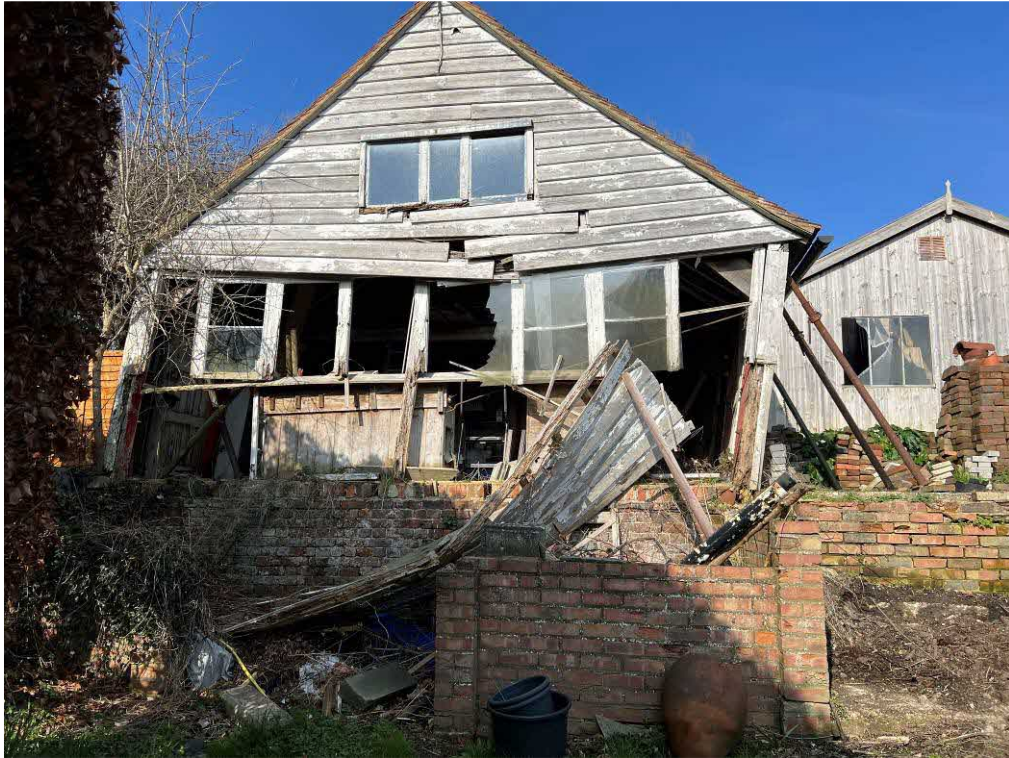
Plate 3 – South Elevation Showing Degree of Racking

As noted in Anthony Hicks method statement, the barn has severely racked towards the east (see plate 3) and is currently reliant on an adjacent outbuilding to prevent collapse. Our preliminary calculations suggests that the existing posts and knee braces are well undersized with calculated deflections in the excess of 50mm.
