# CONSULTING ENGINEERS

## RE: MOORBRIDGE FARM

### 1.0 Introduction

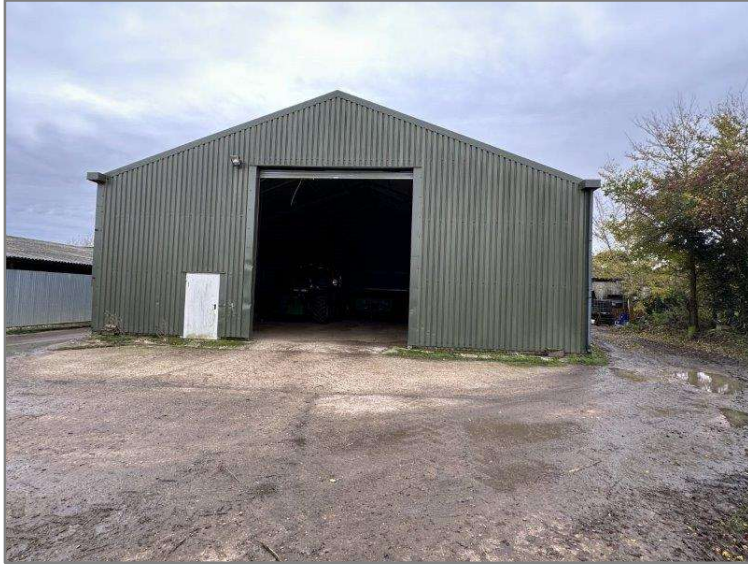
Barn 1 is a precast concrete portal frame construction, rectangular in plan with a span of approximately 15.85m and length of 26.55m formed by 6 bays of 4.425m length. Photo 1 shows the front elevation, Photos 2 and 3 the sides and Photos 4 and 5 general views of the inside of the barn. The portal rafters sit on a concrete corbel at the top of the column and are connected by a steel bolt, refer to Photo 6, there is a simple plate connection at the eaves, refer to Photo 7. The tops of the portal frame columns are tied by an eaves beam which may also serve as a precast concrete gutter, refer to Photo 8.

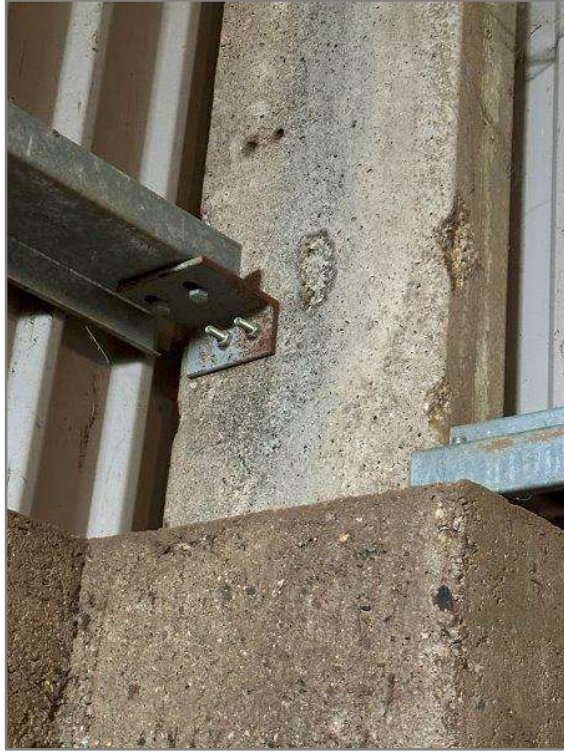
Photo 9

The building has a low level blockwork wall to the long elevations with corrugated metal sheeting above, the sheeting is supported on a mix of precast concrete and cold rolled metal purlins. The purlins are connected to the columns by angle brackets, refer to Photo 9.

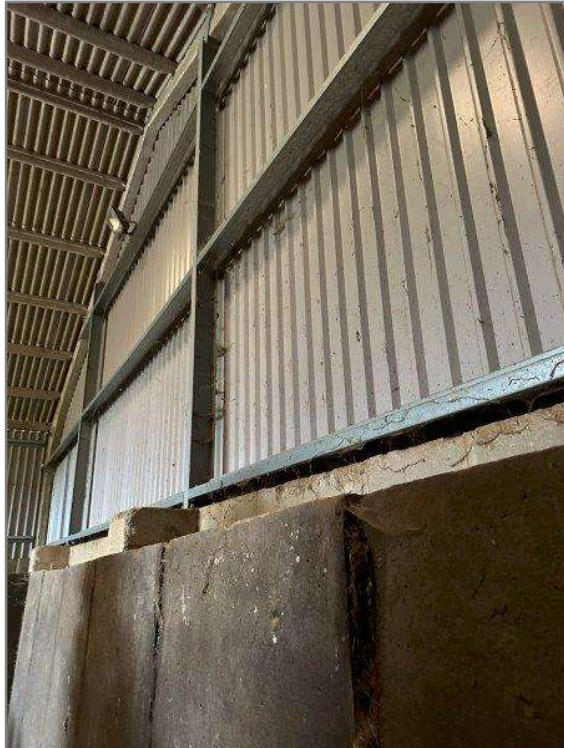
Photo 10

The roof is a corrugated cement board supported on concrete purlins. The rear bay of the building is open to the left and rear with the blockwork wall and cladding returning on the line of the last but one portal frame with the cladding supported on cold rolled steel purlins spanning between the concrete portal frame and intermediate steel gable posts, refer to Photo 10.

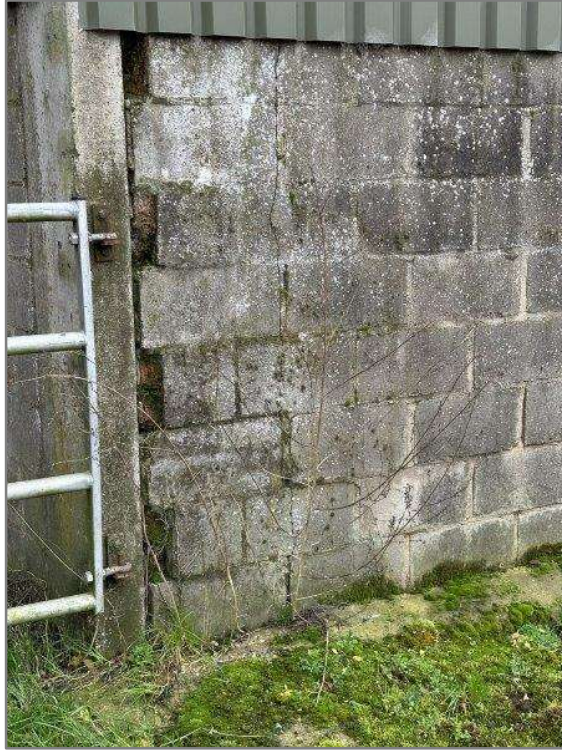
Photo 13

The building appeared to be in good condition with no major structural defects apparent. There was a vertical crack visible to the external blockwork wall at 450mm from the end portal frame, refer to Photo 13, and further vertical cracks in the middle of the third bay from the front, refer to Photo 14.

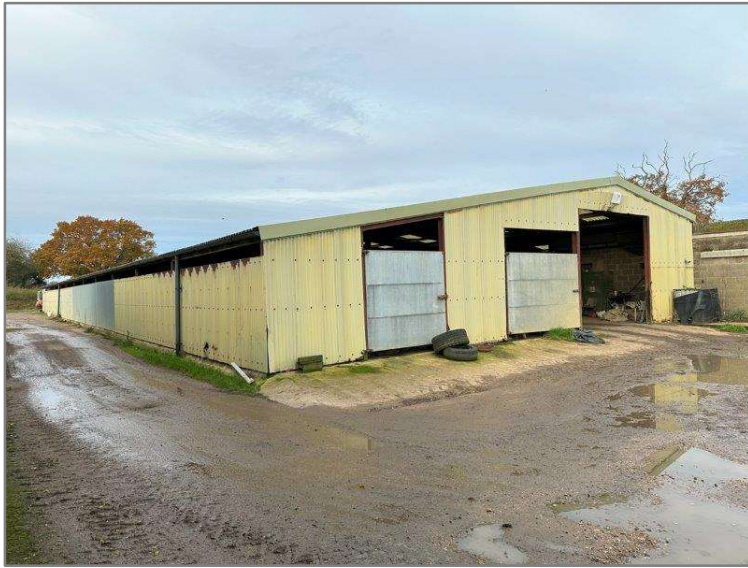
Photo 15

This barn is a steel framed structure with corrugated metal cladding to the sides and corrugated cement sheeting with plastic roof lights to the roof. The structure of the building is formed by a central series of steel portal frames at 4.57m centres with a span of around 10.35m and appears to have been extended to either side by around 6.5m with a steel mono pitch lean to formed of rectangular posts and beams to give an overall size of approximately 54.8m x 23.35m, Photos 15 – 17 show the external elevations and 18 – 19 the internal view.

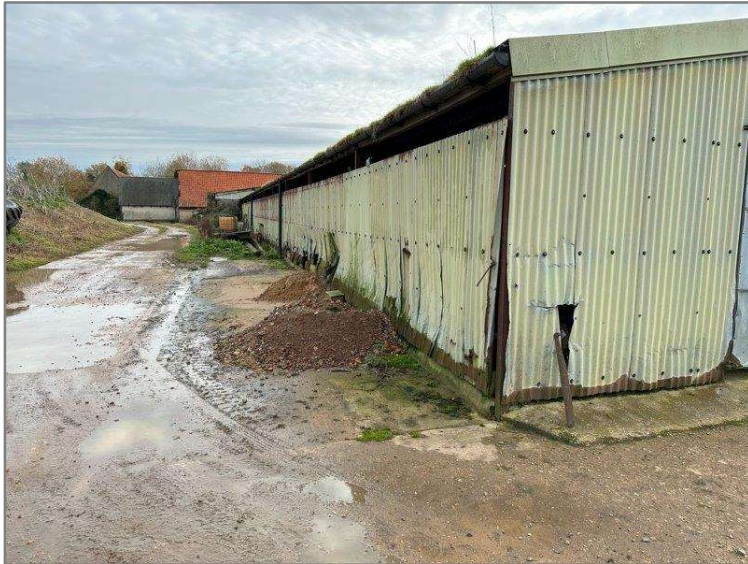
There is damage to the cladding to the rear and right hand side of the building which can be seen in Photo 17

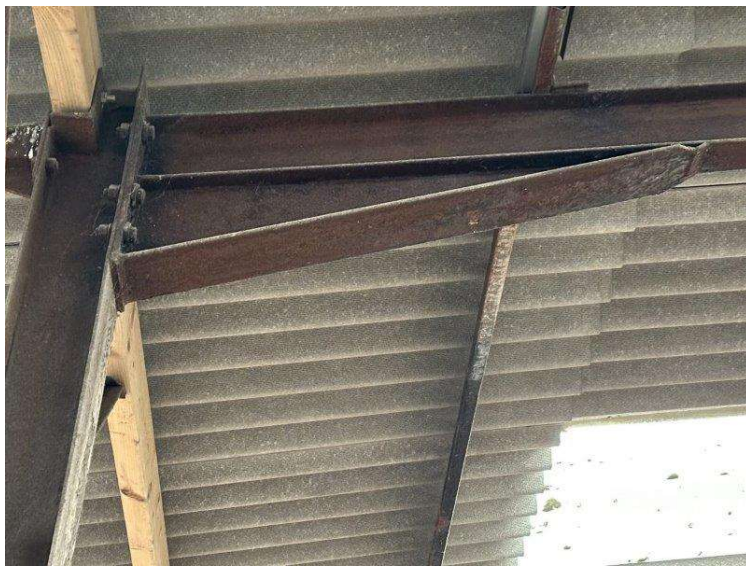
Photo 20

The steel portal frame is formed of columns which are 152x152 UC sections and rafters which are 152 x 89 UB sections, there are haunches at the bolted eaves and ridge connections, refer to Photos 20 and 21. The lean to elements are formed of 75x75 steel box section rafters supported on an edge, two internal 75 x 75 steel columns and the portal frame column, refer to Photo 22, except for the first bay which is a continuation of the steel portal frame construction, refer to photo 23. Roof purlins are generally steel except for that between the tops of the portal frame columns which is timber as can be seen in Photo 23, there are diagonal stays between the columns and this eaves purlin and diagonal bracing in the plane of the roof in the third bay from the front and rear. The side sheeting is supported by timber purlins which are connected to the steel columns by steel brackets, refer to photo 24.

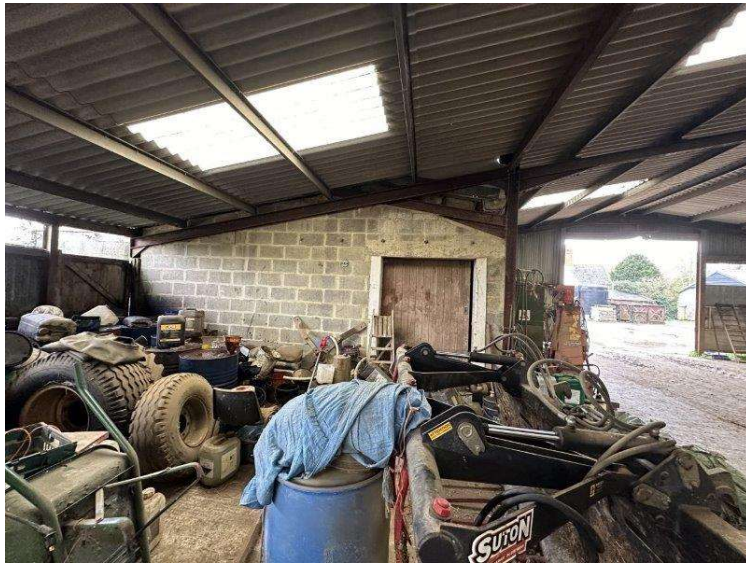
Photo 25

To the front right hand side the building abuts another blockwork structure, refer to Photo 25. The gables are formed of steel posts around the door openings with timber purlins supporting the cladding. There is some mechanical damage to the posts either side of the door, refer to photo 26.

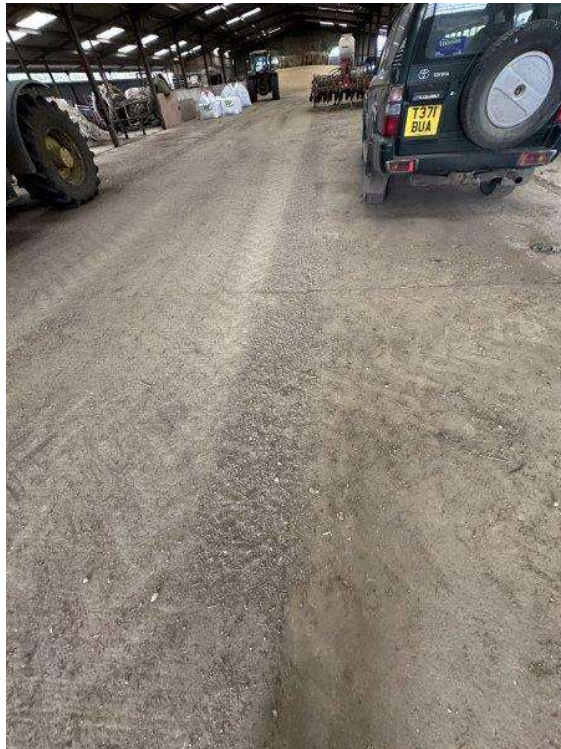
The floor slab is concrete, divided into bays, and there is some evidence of wear of the surface of the slab in two lines, most likely due to vehicles, refer to Photo 27 and some localised cracking around a joint in the 5<sup>th</sup> bay from the front, refer to photo 28.
