DJC/TJL/6289

13 July 2020

BARLEY GREEN FARM BARN – STRUCTURAL INSPECTION REPORT

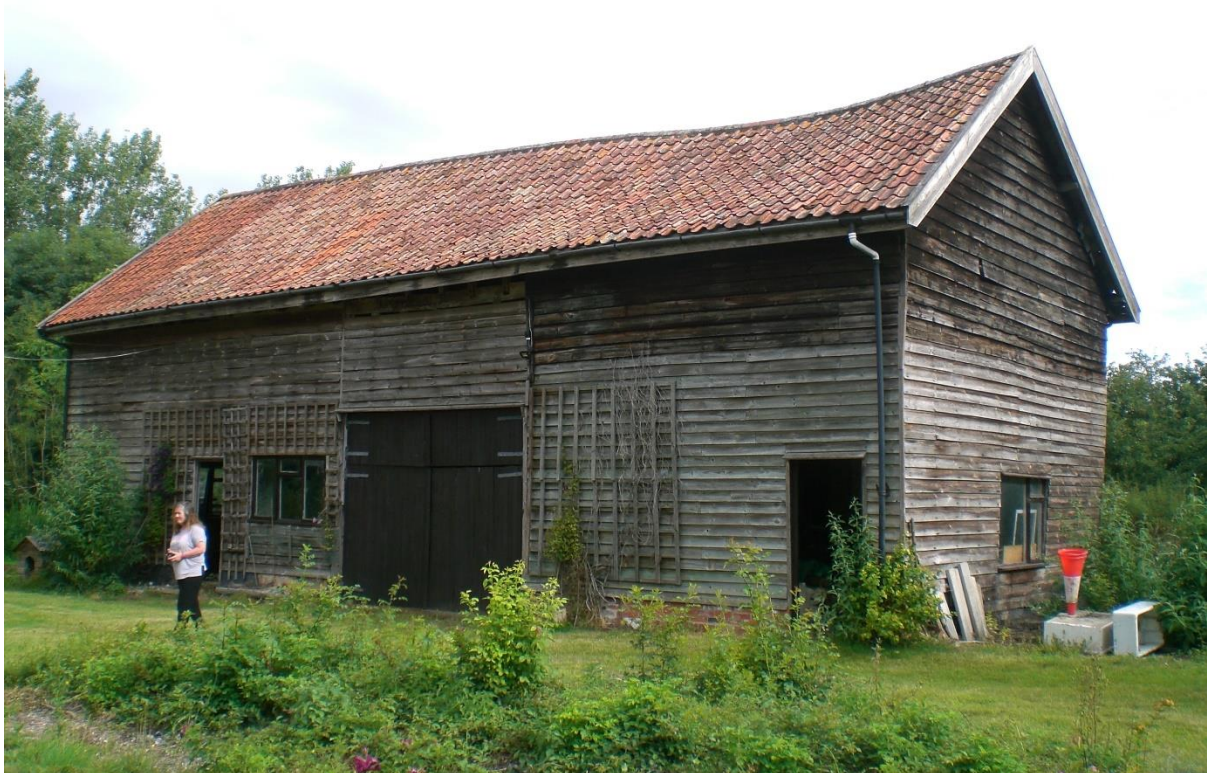
Photograph 1

The property is a substantial detached timber framed Barn with a first floor at either end and a full height void centrally. The property is constructed off a low height masonry wall before the historic timber barn springs off a plate. The indications on site revealed that approximately one-third of the left hand end of the structure appears to have been rebuilt with modern masonry being used for the stud wall and modern timbers being used in some areas throughout the structure. See Photograph 1.

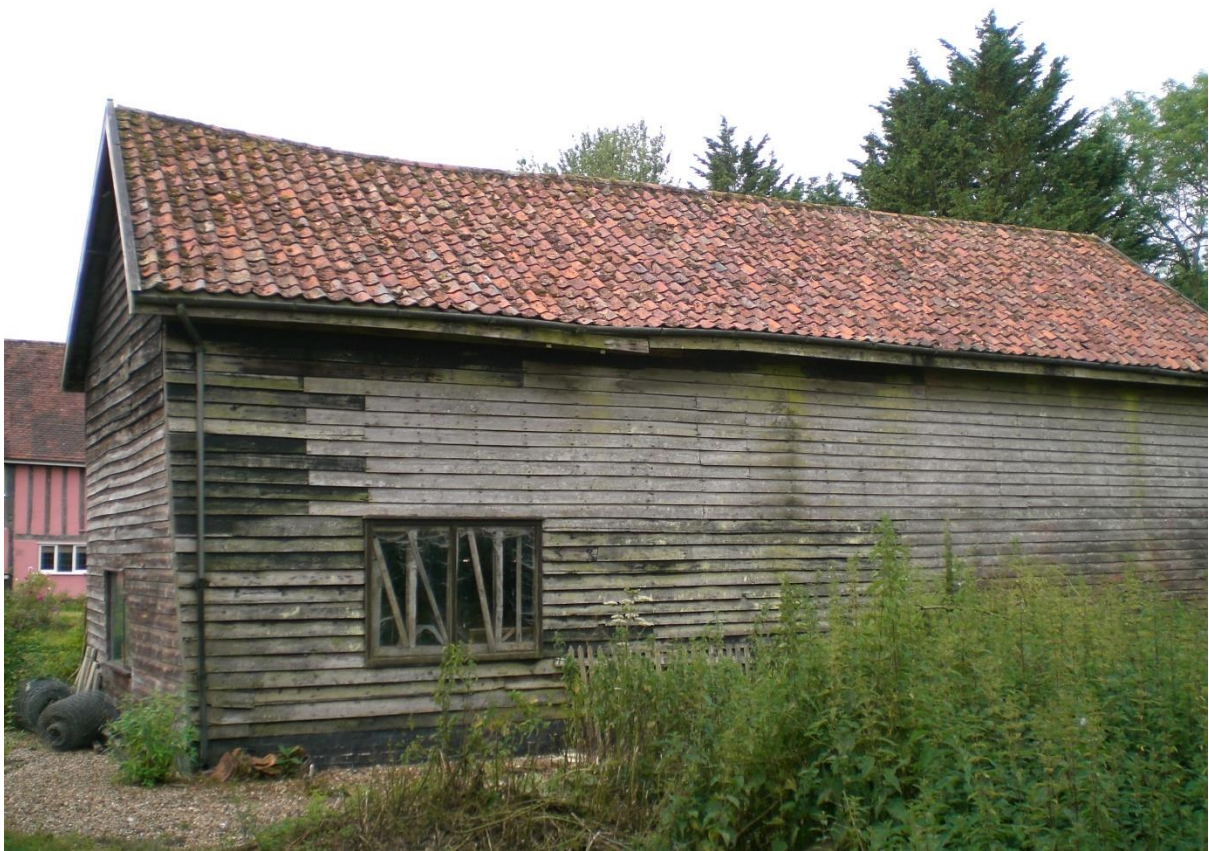
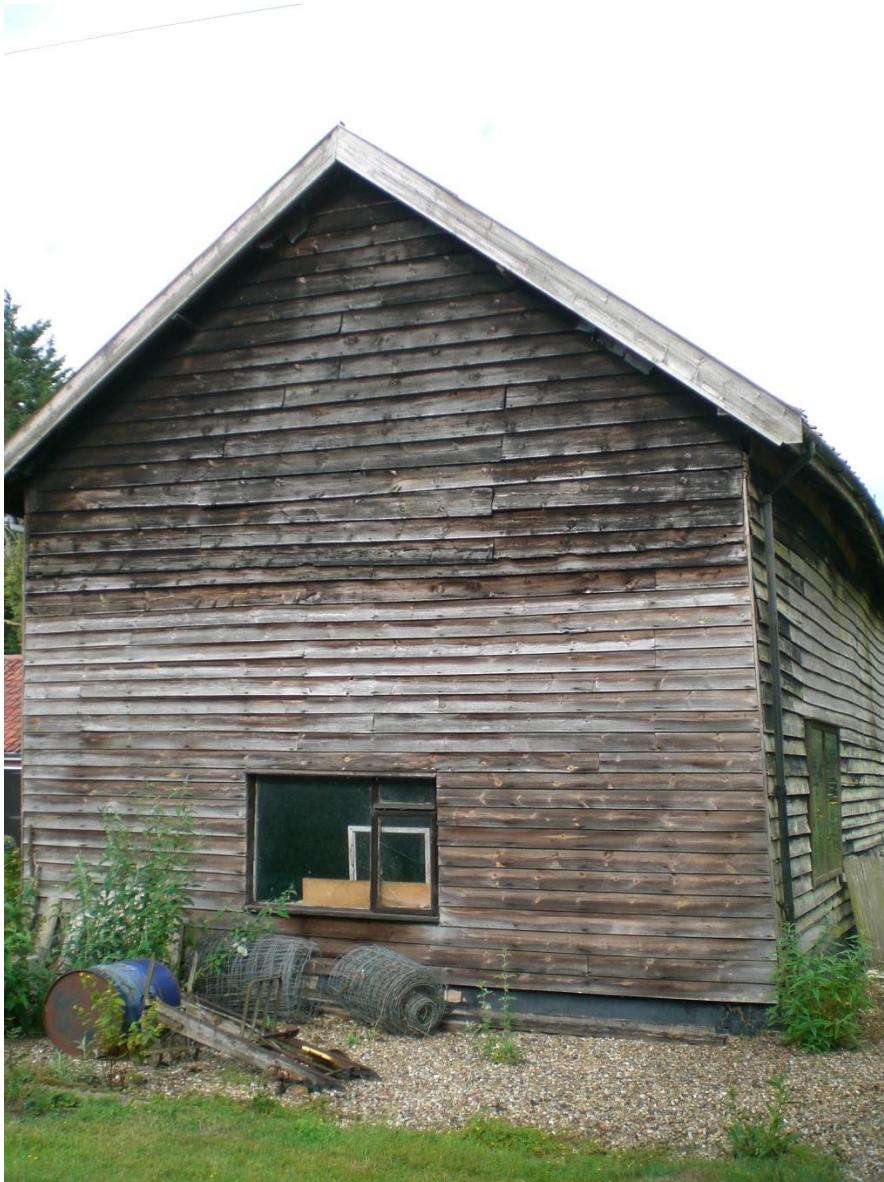
Using a spirit level, it was possible to see that the property leans to the side and forwards. The front and rear elevations lean forward approximately 10-30mm at the left gable. Approximately plum centrally and approximately 30mm at the right gable. The left and right gables lean to the right approximately 30mm at the front elevation and between 100 & 75mm to the rear elevation. It was noted that the rear leaned in some areas varied front to rear e.g. the rear left-hand corner leans forward by approximately 50mm, whereas the front left-hand corner leans forward by approximately 10mm per metre. See Photographs 2 and 3.

1. When the refurbishment works are undertaken a review of all the timber elements should be taken and where incidents of rot or significant beetle infestation, these should be replaced before treating the whole timber structure.
2. As mentioned above, additional timber bracing elements should be included within all the external and internal walls to stop the further racking of the structure.
3. The right internal truss should be reconstructed with a principle rafter over it and suitable tying into the wall plate.
4. The strutting to the ridge in the voided areas should be formalised to prevent sideways thrust on the tie members.
5. Areas of disintegrated masonry should be replaced using a sympathetic material.
6. All drain water goods should discharge to the drainage system to out fall away from the property.

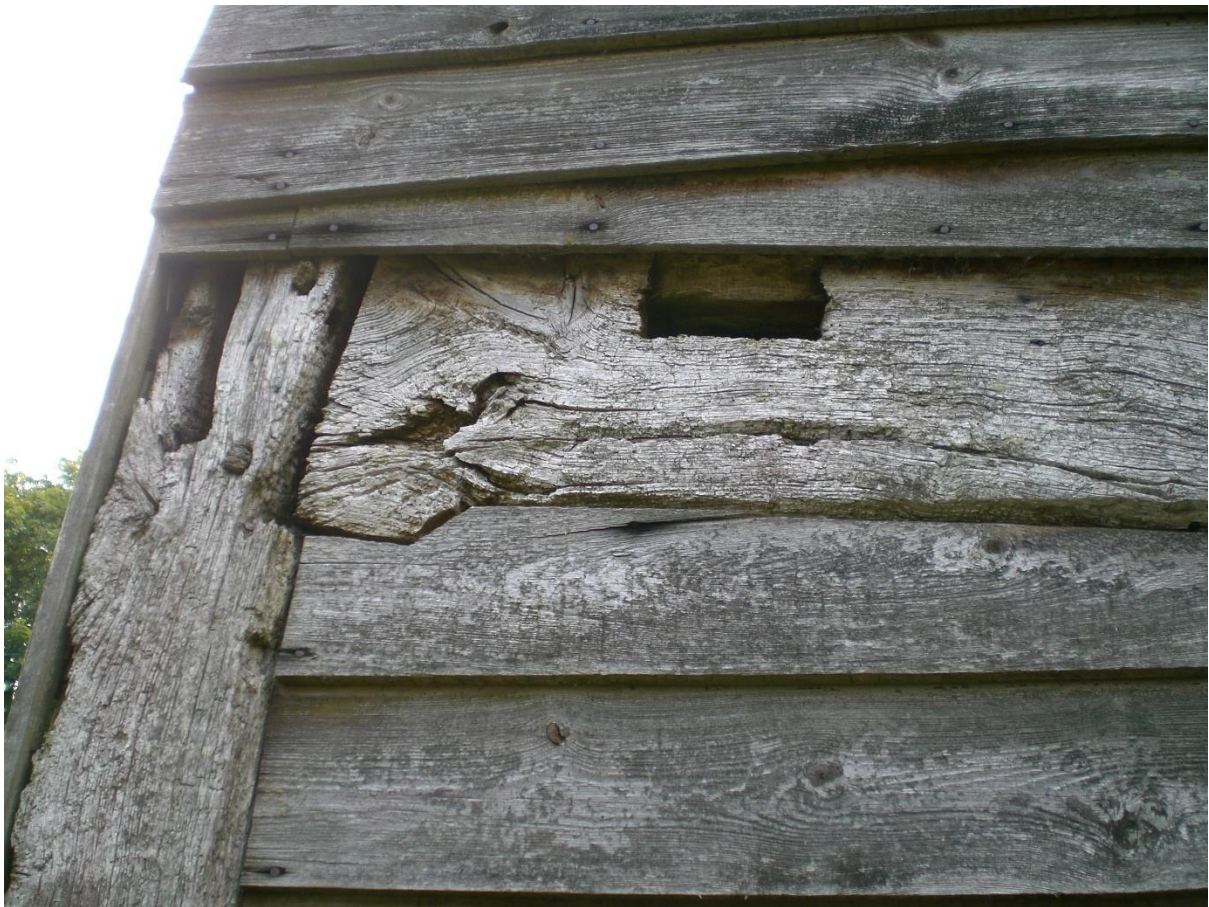
Photograph 4

At each corner of the left gable, the underlying timber frame has been left exposed. These have suffered from weathering although no softening or rot appears to be present. See Photograph 4.

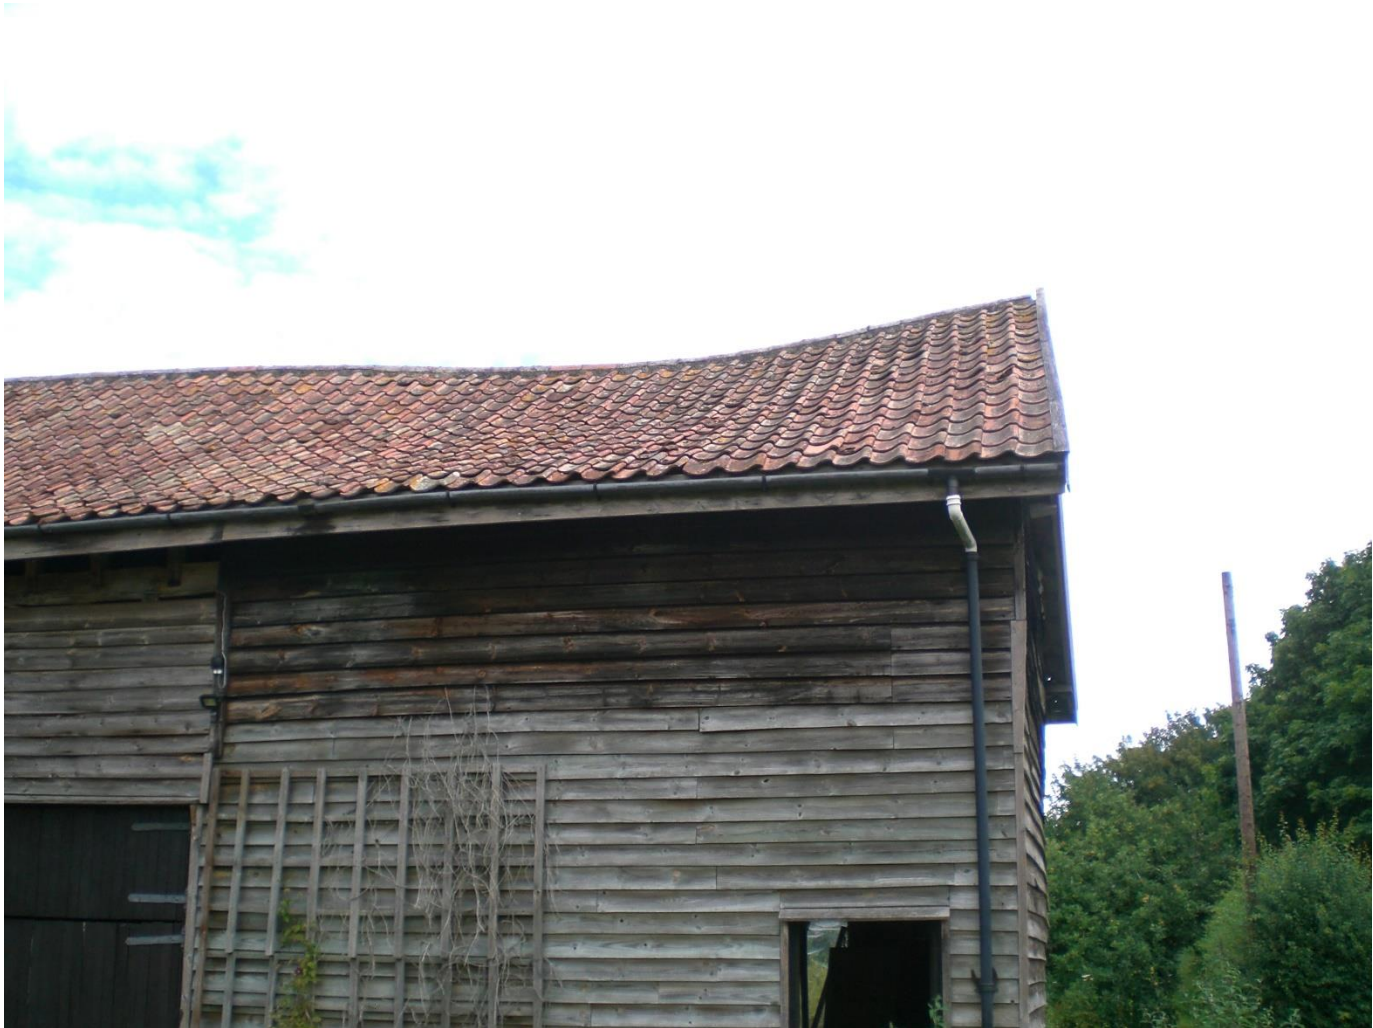
Photograph 5

An inspection of the roof revealed that it dips suitable at approximately a third width of a roof towards the right-hand end. See Photograph 5.

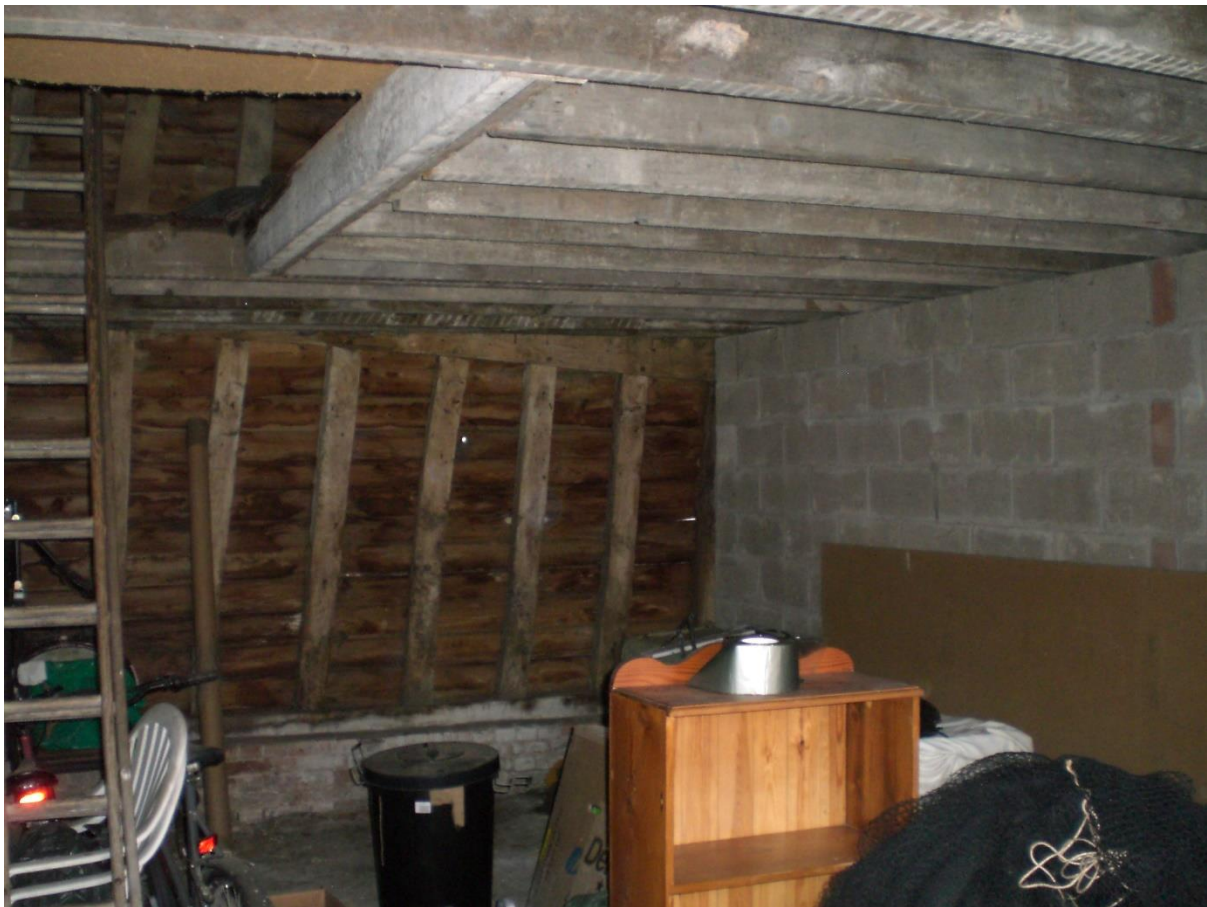
Photograph 6

An inspection of the left ground floor room reveals that this has been formed with modern blockwork to the gable and the central internal walls. The room is subdivided by an open timber framed wall to support the first floor. The inspection revealed that the main timber frame elements along with a significant number of the principle timbers appear to be historic and supported off a modern fletton wall plate. The floor had been constructed from modern timbers with fibre board over. See Photograph 6.

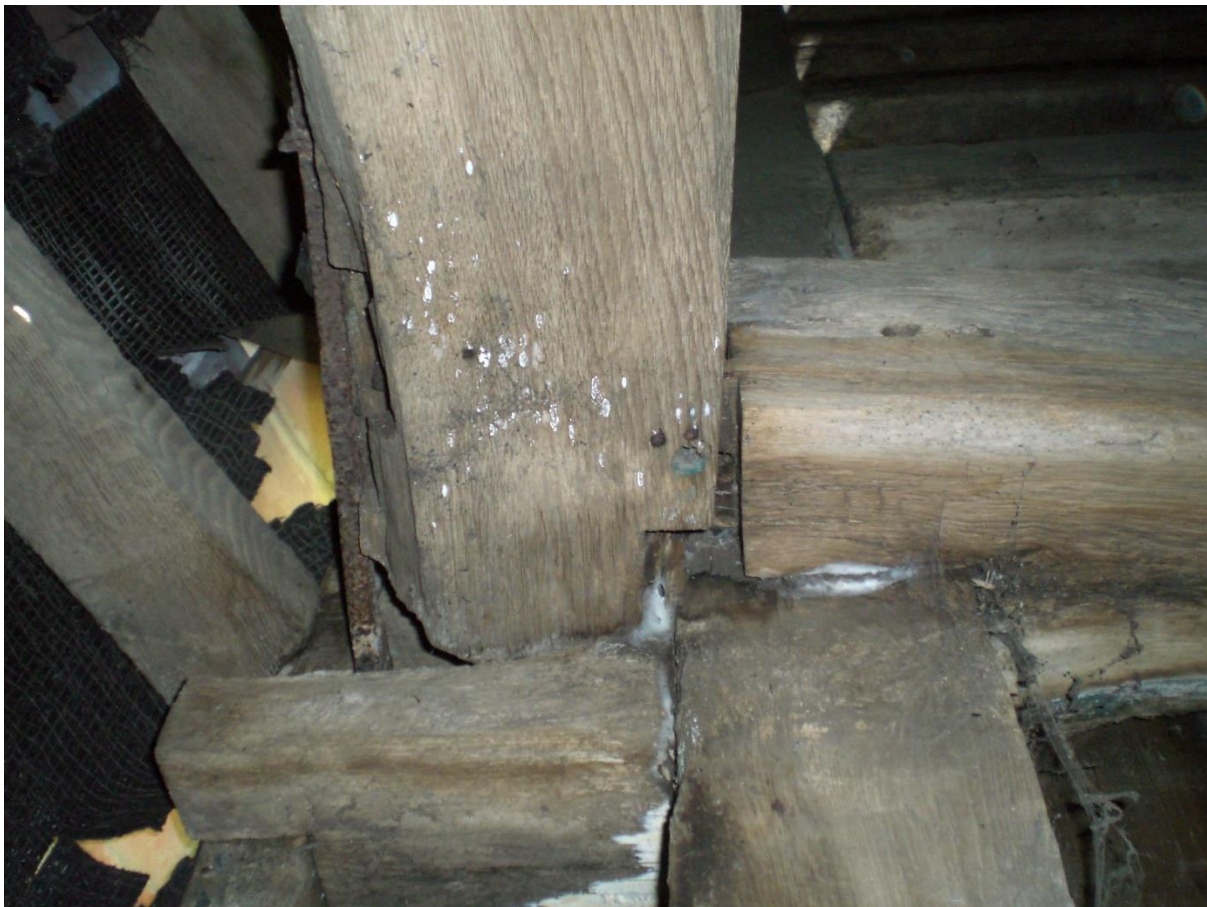
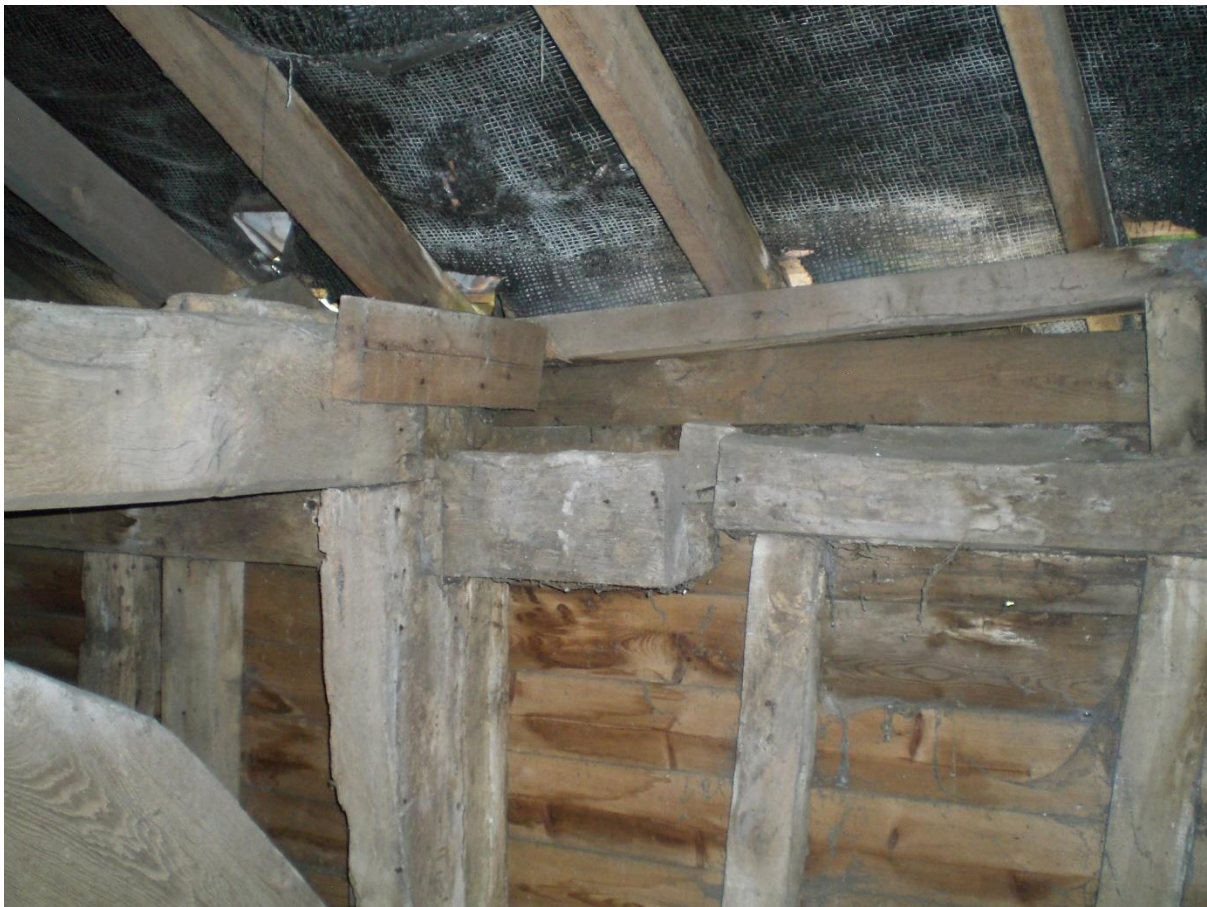
The first truss from the right hand gable has been constructed with the principle rafter approximately 400mm to the left of it and the tying to the wall plate both front and rear appears to have slipped with between 25 and 50mm movement to the front, where as to the rear the tie has slipped approximately 200mm leading to movement of the wall plate that has caused the joint to shear inwards. See Photograph 7 & 8.

An inspection of the tie member reveals that it deflects to the right approximately 25 to 50mm due to the thrust on the struts up to the ridge line.
