# **Barn at Barley Green Farm, Stradbroke, Suffolk**

## **Heritage Asset Assessment**

# Barn at Barley Green Farm, Laxfield Road, Stradbroke, Suffolk

## Heritage Asset Assessment

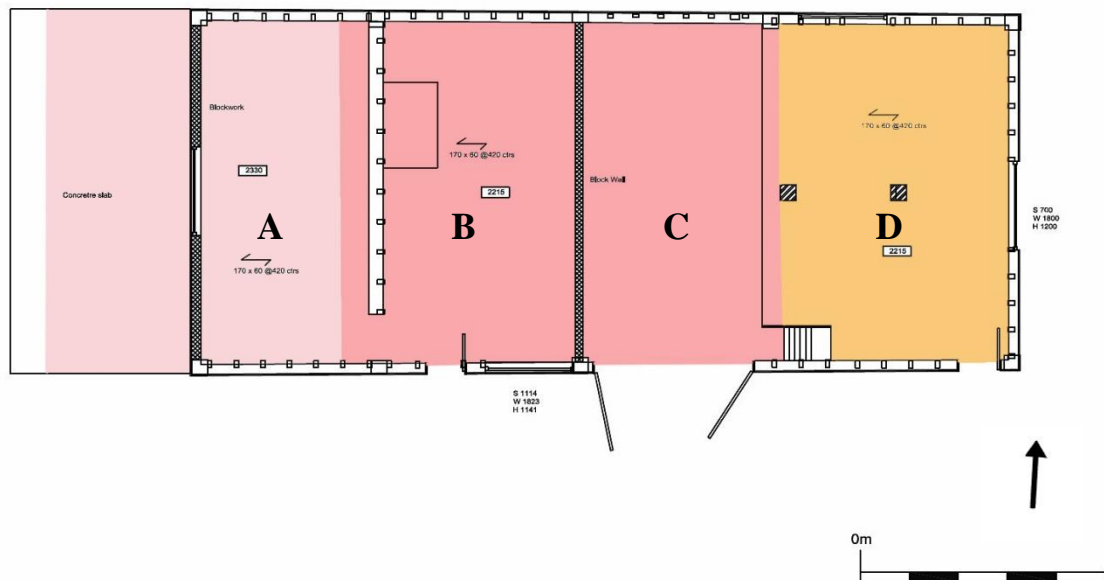
**Figure 8**

**Ground plan by Brooks Architects Ltd. adapted to indicate the four original bays in colour with the site of the demolished bay on the west. Scale in metres.**

**The high-quality timber frame in red was built in the late-16<sup>th</sup> century as a two-bay threshing barn (dark red) with a floored section on the west that probably formed a stable with a possible ‘court hall’ or lodging on its upper story (light red). Only one bay (A) of this floored section now remains, with at least one and possibly two additional bays to the west since demolished. The two-bay threshing barn (B-C) was entered from the south in bay C but was built against an older structure to the east that was rebuilt in the early- to mid-17<sup>th</sup> century as the eastern bay of a three-bay barn (bay D in brown). Bays B and C were probably designed to extend a previous barn on the site of bay D but may have adjoined another type of building such as a gatehouse.**

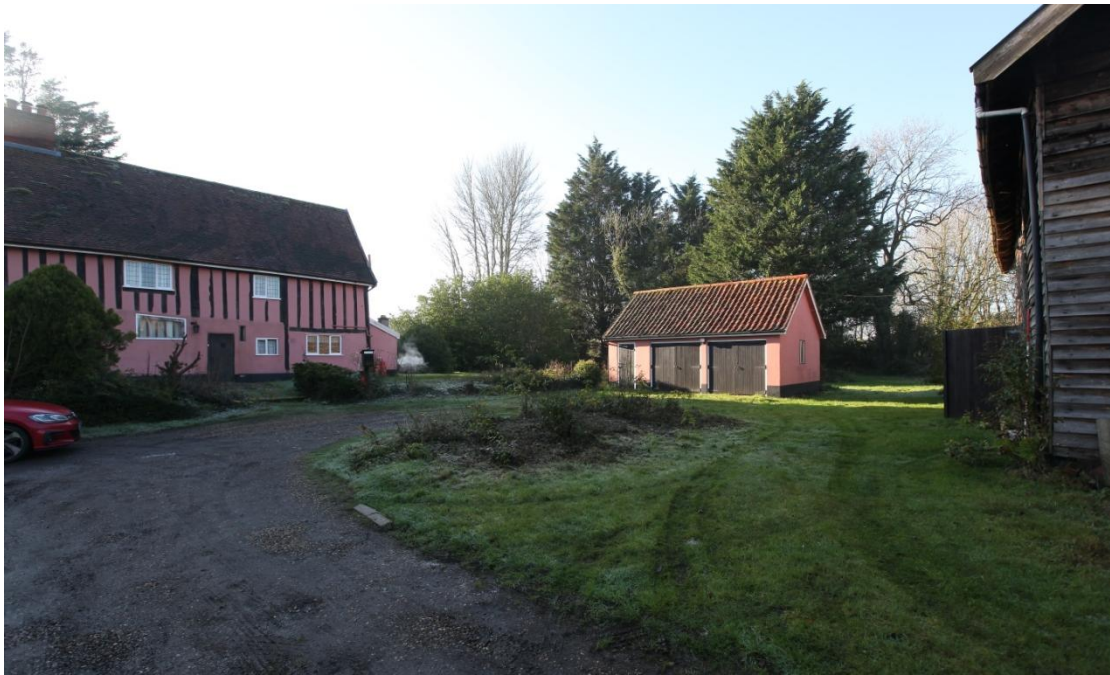
**Illus. 1. The ‘base court’ from the east formed by the grade II-listed 16<sup>th</sup> century house (3) on the left, the modern garage (2) in the rear and barn (1) to the right. Both the barn and house appear to have faced this yard through which the house was approached from the green. The two buildings are broadly contemporary, with the service bay of the house to the right of its central hall and its chimney bay and parlour on the left.**

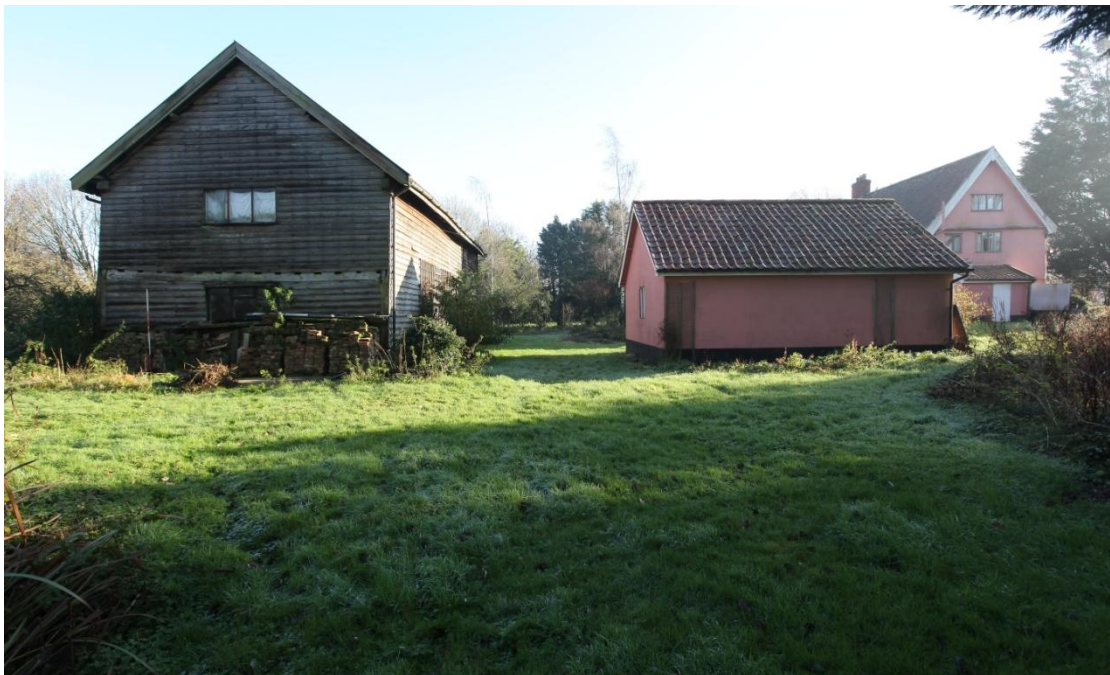
**Illus. 2. A view of the site from the west showing the modern garage (2) between the barn (1) on the left and the grade II-listed house (3) in the rear to the right. The barn’s low-pitched pantiled roof is a late-19<sup>th</sup> or early-20<sup>th</sup> century replacement of the original, which would have been steeply pitched like that of the house for peg-tiles or thatch. Until its truncation in the mid-20<sup>th</sup> century the barn continued into the foreground, stopping just short of the pond visible at bottom left.**

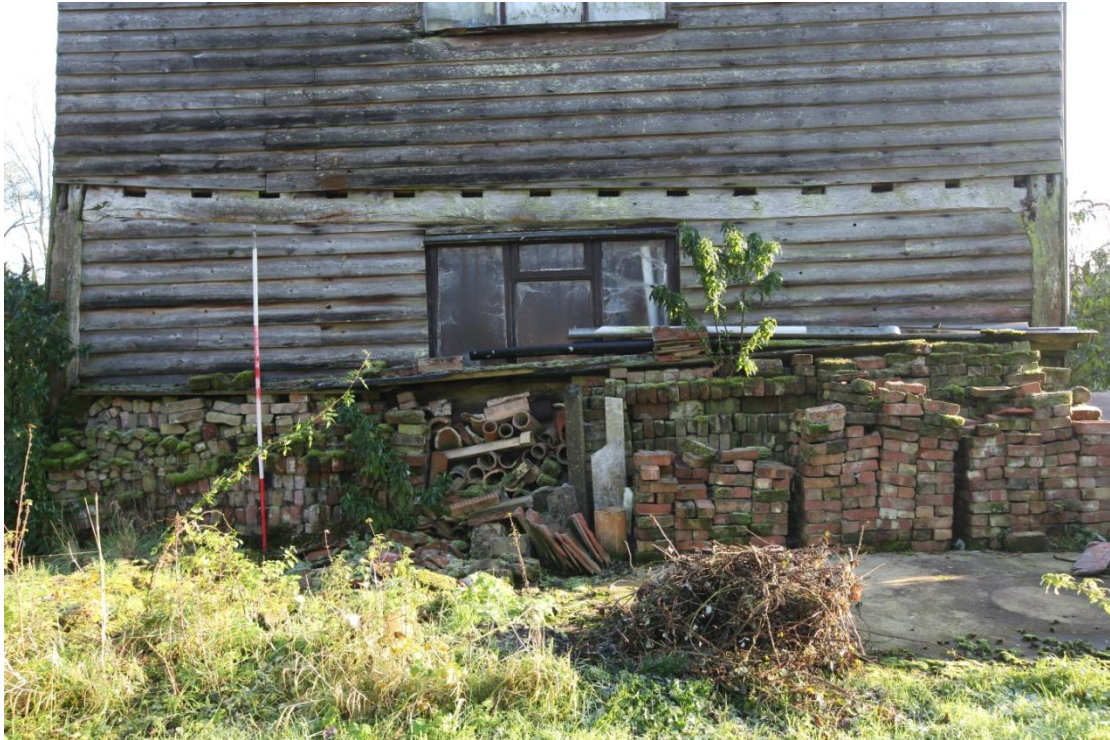
**Illus. 3. The western external gable showing its modern glazed windows and renewed cladding with a full complement of joist mortices in its chamfered binding joist for the ceiling of a demolished bay that extended into the foreground. The joints have diminished shoulders as found in high-quality carpentry of the mid-16<sup>th</sup> century and later (as shown in illus. 20). Pegged mortices for projecting mid-rails are also visible in the present corner posts.**

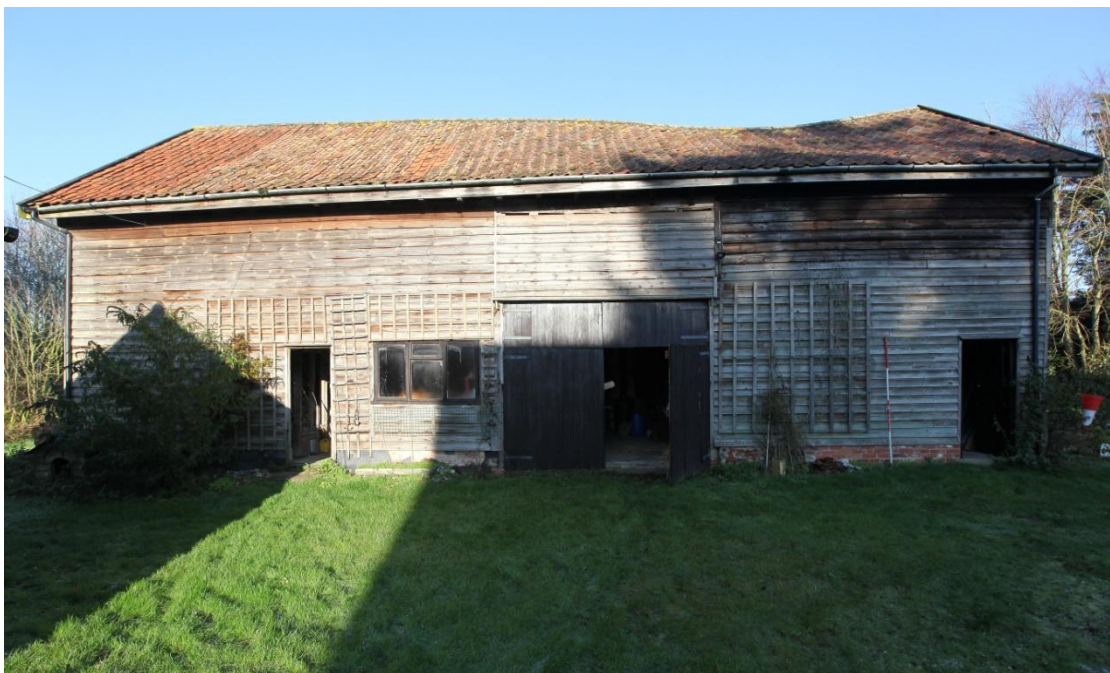
**Illus. 4. The southern facade of the barn (1) showing its pantiled roof and late-20<sup>th</sup> century weatherboarding with a small section of tarred weatherboarding to the loft in bay D on the right that may survive from the late-19<sup>th</sup> or early-20<sup>th</sup> century refurbishment. The outline of the original full-height doors to the main entrance in bay C is visible above the present double doors of the late-20<sup>th</sup> century.**

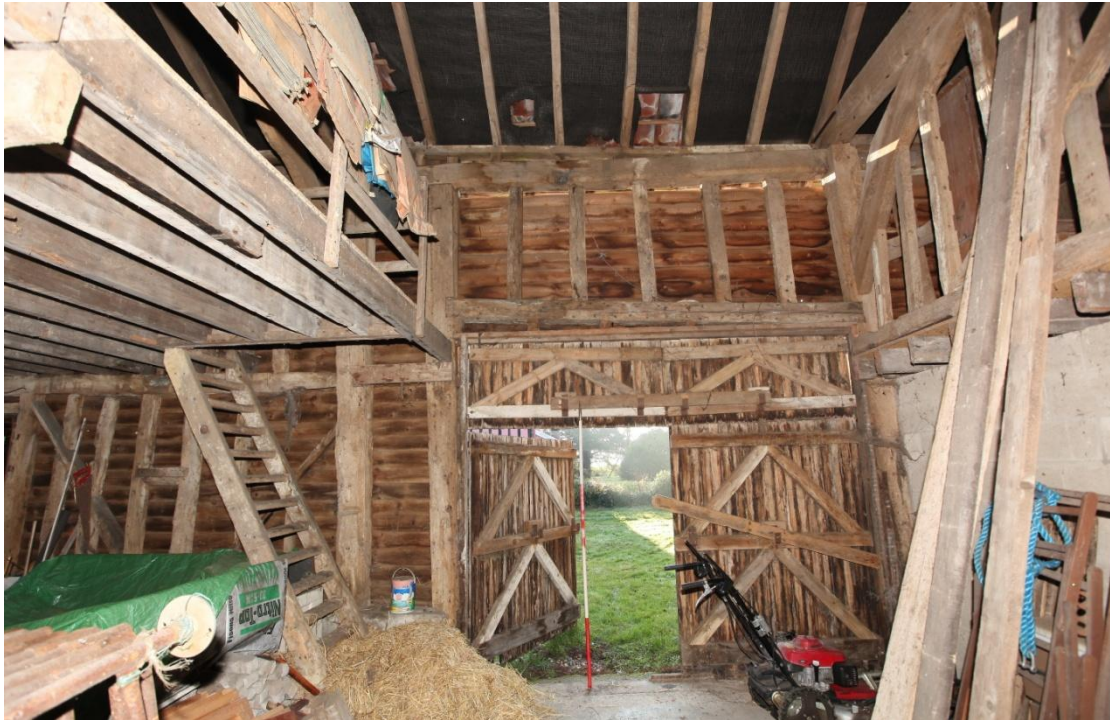
**Illus. 5. The southern interior of the threshing bay (C), now with a modern concrete floor and 20<sup>th</sup> century storage lofts of tall-sectioned softwood joists on both sides. The original doors rose to the roof-plate but unusually were defined by a single large post 18 inches to the right of the bay's arch-braced storey post on the left. The eastern loft in bay D on the left projects into the bay by the same extent.**

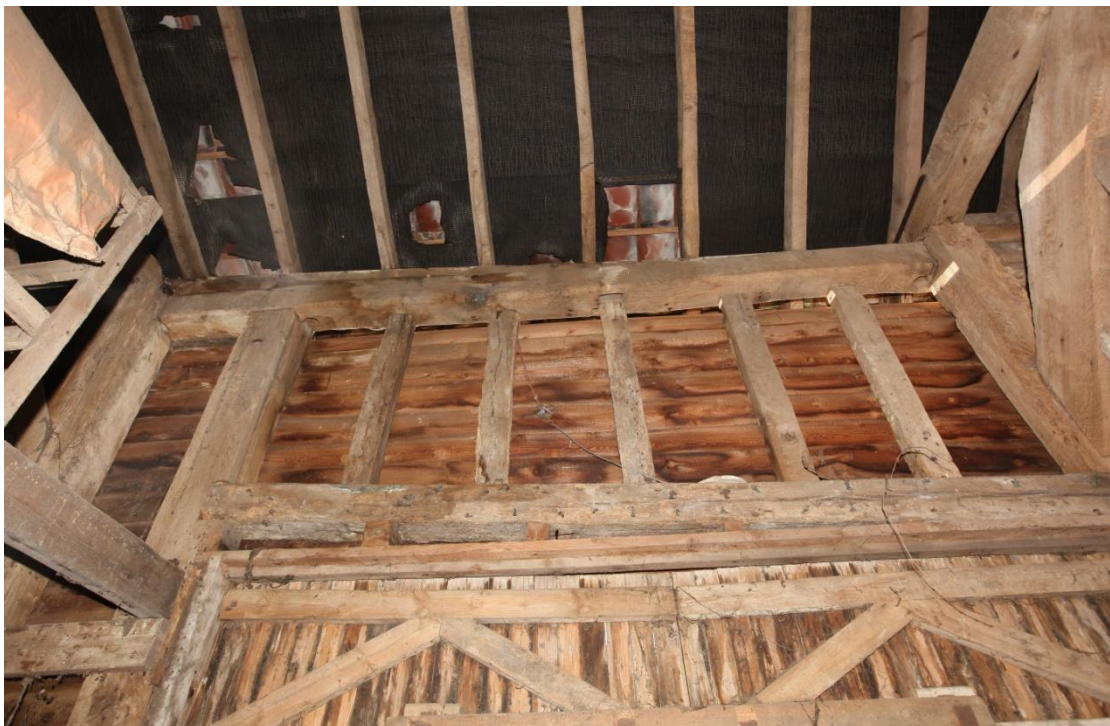
**Illus. 6. The southern roof-plate of the threshing bay (C) showing inserted re-used studs above the present door lintel (nailed rather than pegged to the plate). The circular holes at both ends secured the pin hinges of the original doors in a manner rarely seen in south Suffolk where iron hinges were the norm. The jamb post on the left was thought necessary to stabilise the corner post which abutted an earlier structure.**

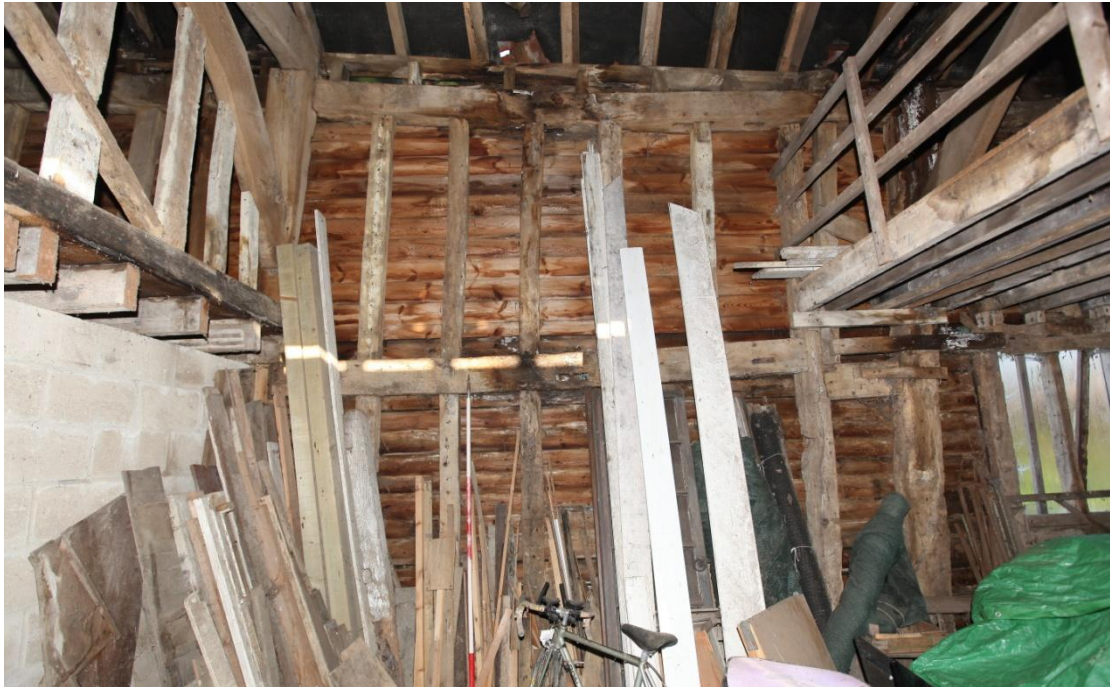
**Illus. 7.** The northern internal wall of the threshing bay (C). In contrast to the southern elevation the roof-plate here contains pegged mortices for original studs that formed a solid wall with a small central door beneath a mid-rail. A short section of original mid-rail survives to the right (under the loft) but the framing to its left consists of re-used timbers that were inserted to block a secondary doorway rising to the roof-plate. An original stud and a section of wall brace are visible above the original mid-rail.

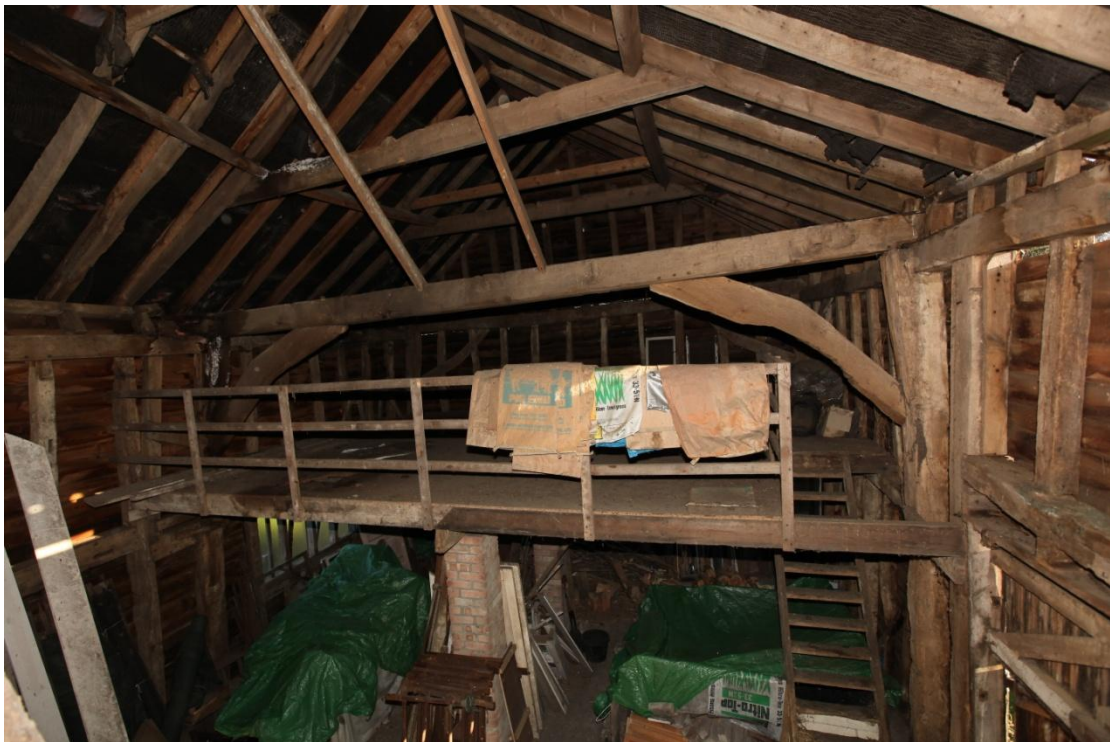
**Illus. 8.** The intact arch-braces and tie-beam of the open truss to the east of the threshing bay (C) showing the 20<sup>th</sup> century loft in bay D beyond. The present clasped-purlin roof structure consists of re-used rafters with pine purlins and nailed collars in the typical manner of the late-19<sup>th</sup> and early-20<sup>th</sup> centuries.

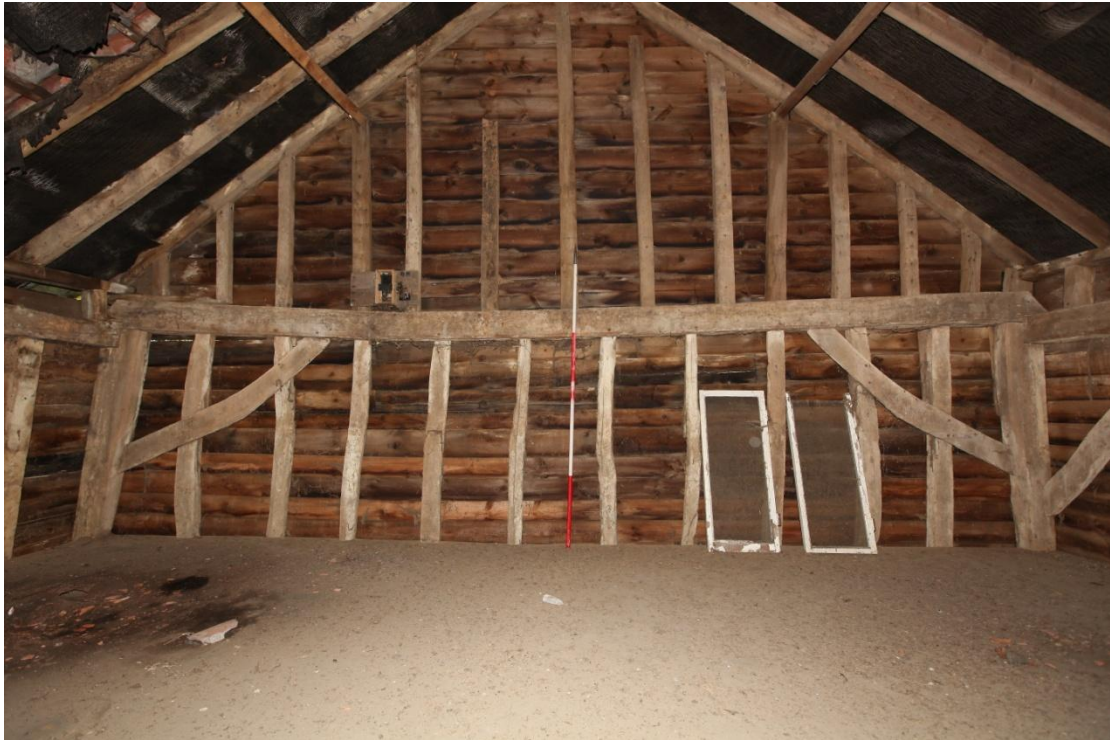
**Illus. 9.** The eastern internal gable from the 20<sup>th</sup> century loft in bay D. The framing of this bay is very different to that of bays A-C with much narrower and more widely spaced studs. It dates from the 17<sup>th</sup> century and evidently replaced an older structure against which bay C was originally built in the late-16<sup>th</sup> century. The lower and most of the studs above are pegged to the tie-beam and original to the fabric, as are the internally trussed corner braces.

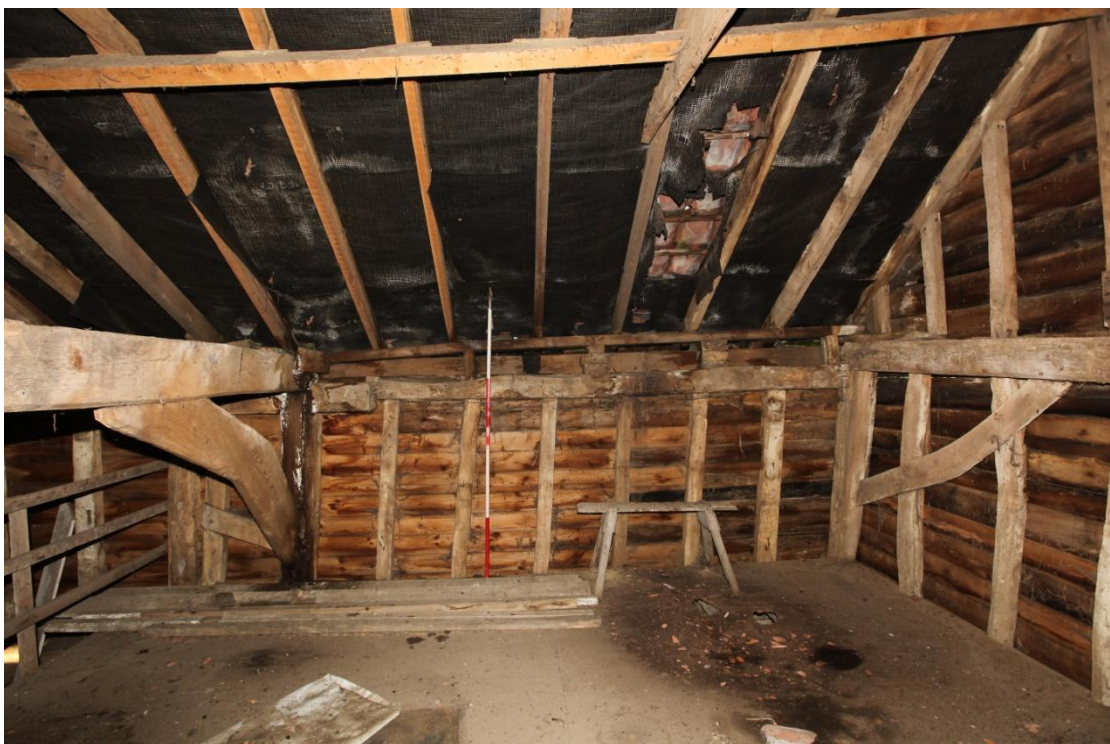
**Illus. 10.** The northern internal wall of the eastern bay's loft (D) which retains its original narrow studs with a trench for a missing corner brace on the right. A crude scarf joint links the roof-plate to the earlier plate of bay C on the left (see illus. 11).

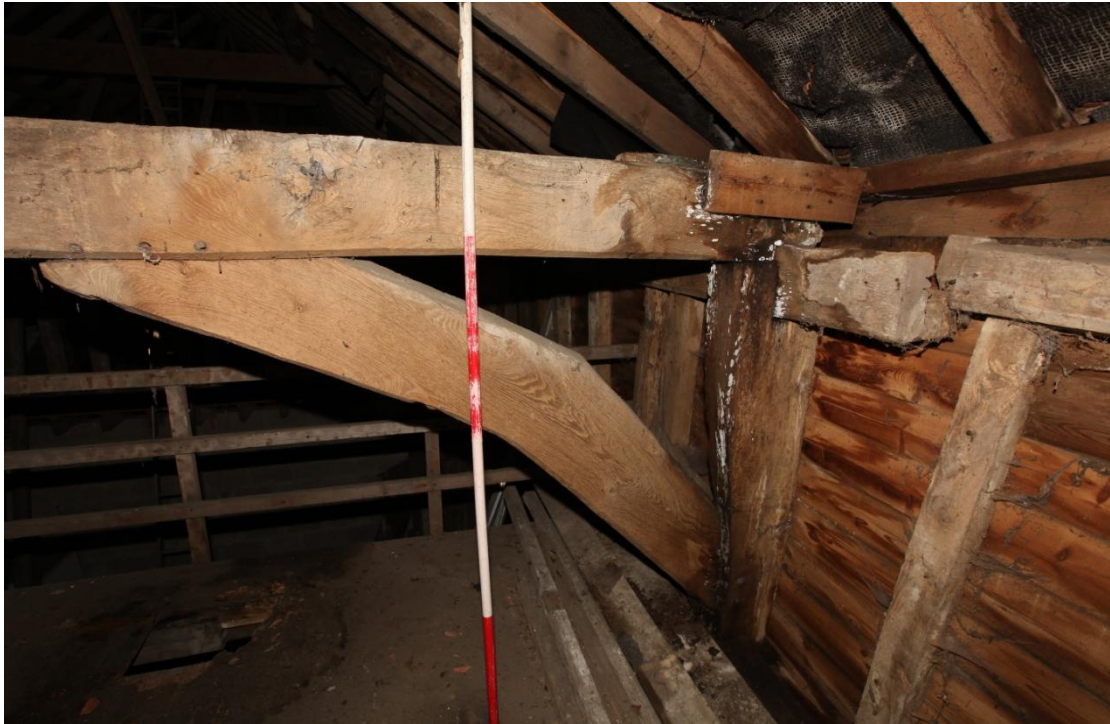
**Illus. 11. The north-eastern corner post of the threshing bay (C) showing its heavy original arch-brace and the crude joint linking its roof-plate to that of the separate, later structure of the eastern bay (D). This consists of a simple tenon with a housed soffit but lacking a peg that projects from bay D in bay C. An identical joint lies in the southern plate. A large unpegged mortice 13 inches in height lies just above mid-rail level in the eastern face of the storey post. A similar but smaller mortice is visible in the southern post but at a slightly higher level. Both must relate to the predecessor of bay D.**

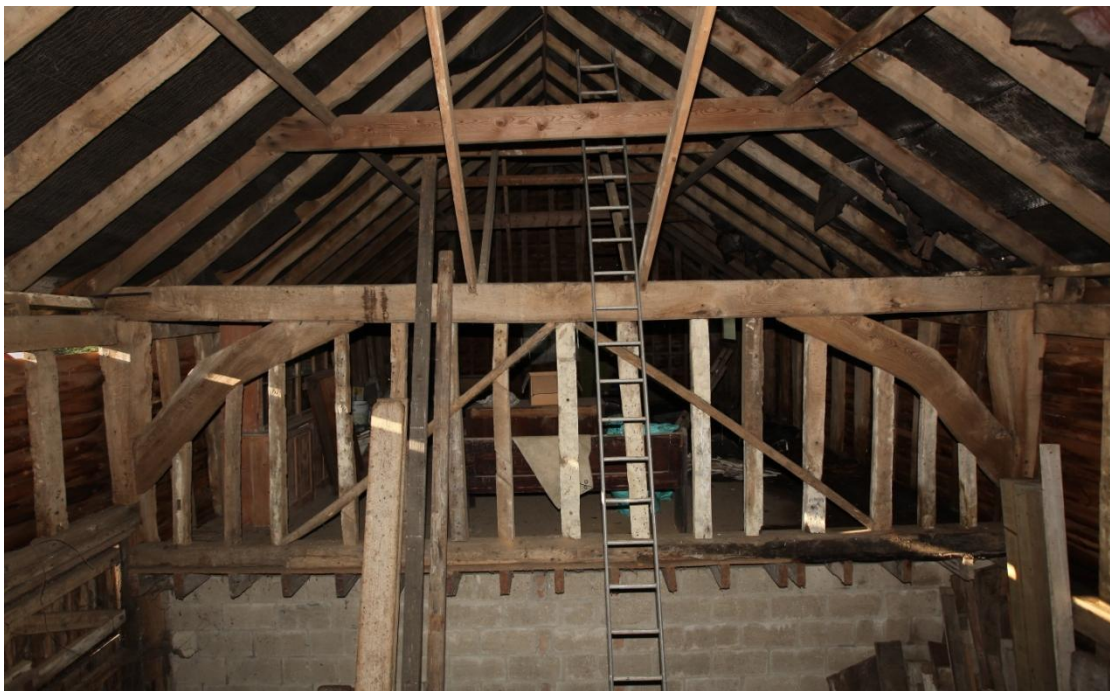
**Illus. 12. The open truss to the west of the threshing bay (C) showing its impressive arch-braces with the 20<sup>th</sup> century loft in bays A and B beyond (supported on block-work). The structure is a very impressive 23.25 ft in total width and its tie-beams lack mortices for queen or crown posts – indicating the original roof contained side-purlins.**

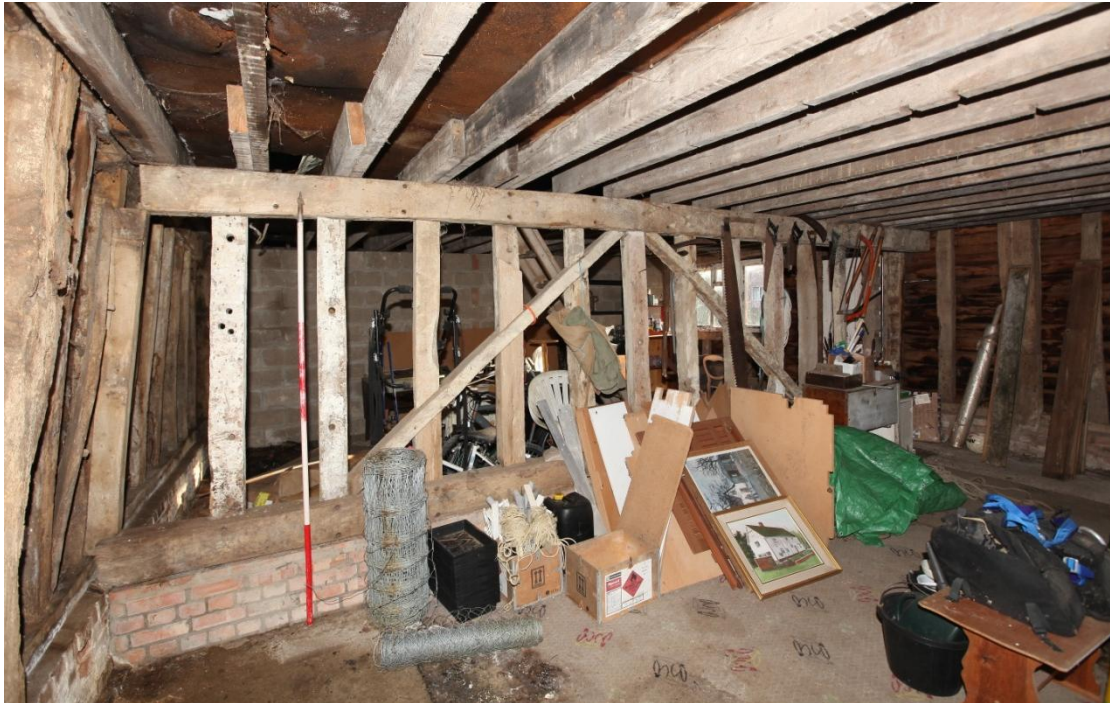
**Illus. 13.** The ground-floor partition beneath the 20<sup>th</sup> century loft in bays A and B, as seen from bay A to the west. This consists entirely of re-used timber interrupted by diagonal primary braces and dates from the late-19<sup>th</sup> century but now rests on a 20<sup>th</sup> century brick plinth. It incorporates the mid-rail of the original partition between bays A and B (i.e. the floored stable and the threshing barn) which was initially tenoned to the storey posts approximately 0.5 m to the west of its present position.

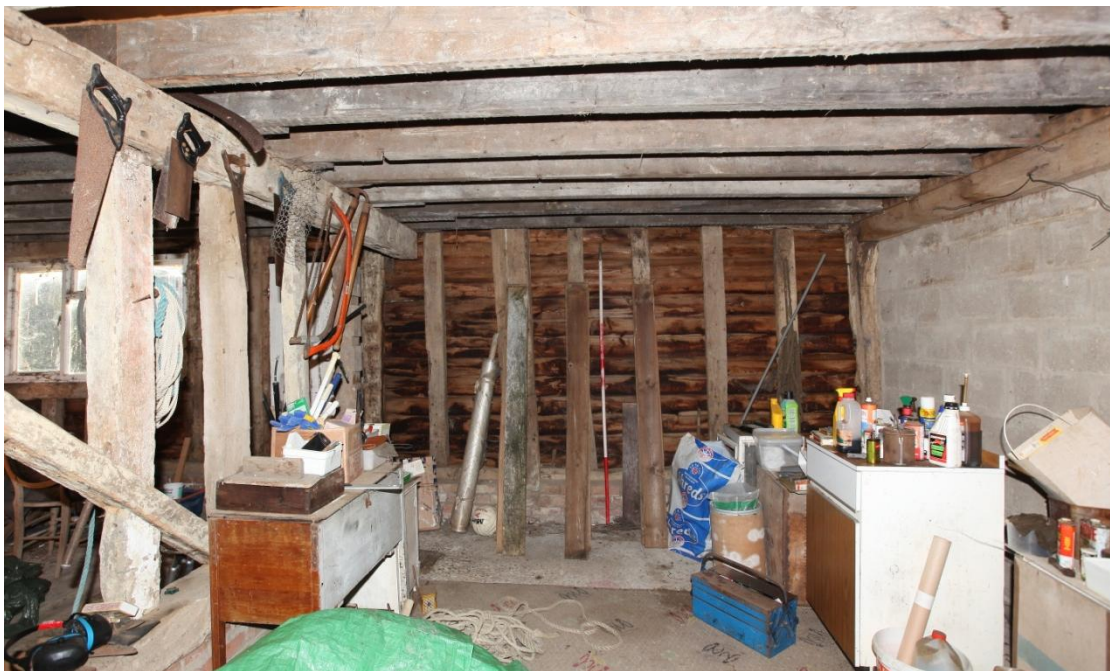
**Illus. 14.** The southern internal wall of the narrow westernmost bay (A) showing its storey post approximately 0.5 m to the right of the present partition on the left. The chamfered binding joist above the cement block-work of the gable to the right contains mortices for missing ceiling joists matching those in illustration 3, and the southern mid-rail contains evidence for an original door and window (illus. 15). Although this bay contained a ceiling initially the present tall-sectioned joists date from the 20<sup>th</sup> century.

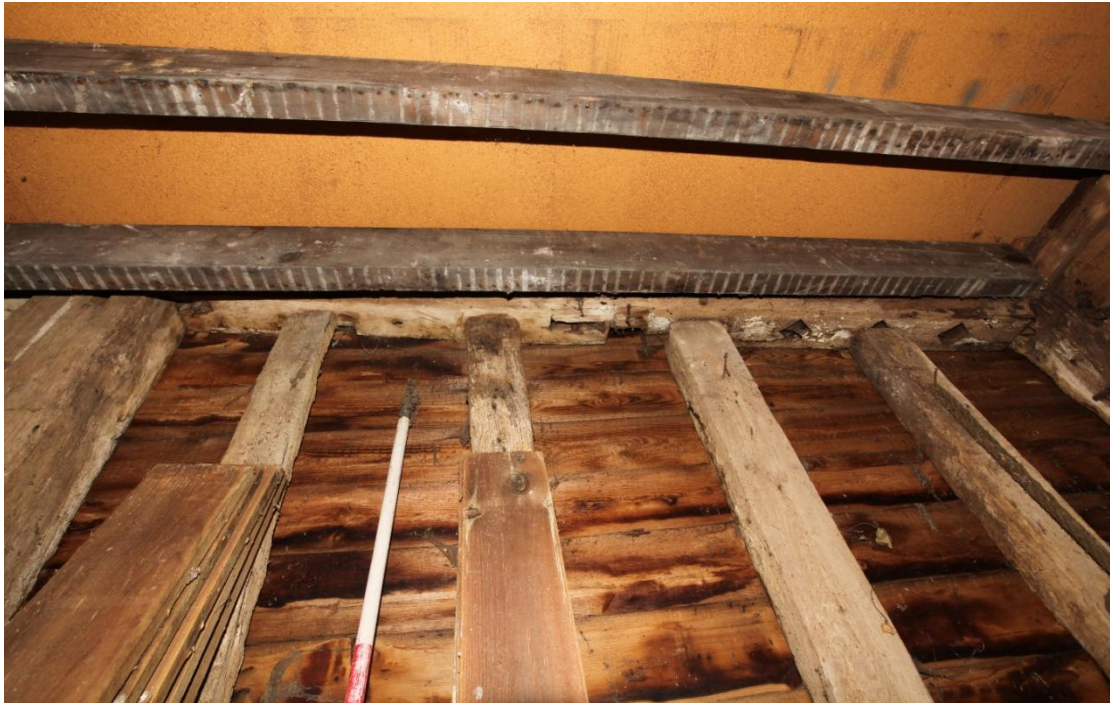
**Illus. 15.** The underside of the original southern mid-rail of bay A (illus. 14) showing three empty diamond mullion mortices for an original window to the right and a gap for an original entrance door against the storey post to the left. None of the four studs occupy their original positions, but the present corner post on the right contains a pegged mortice for the window sill. A small pegged mortice abutting the post held the missing door jamb. Of the four windows the bay this is the only one with three rather than four mullions and without a shutter groove – as the door restricted space.

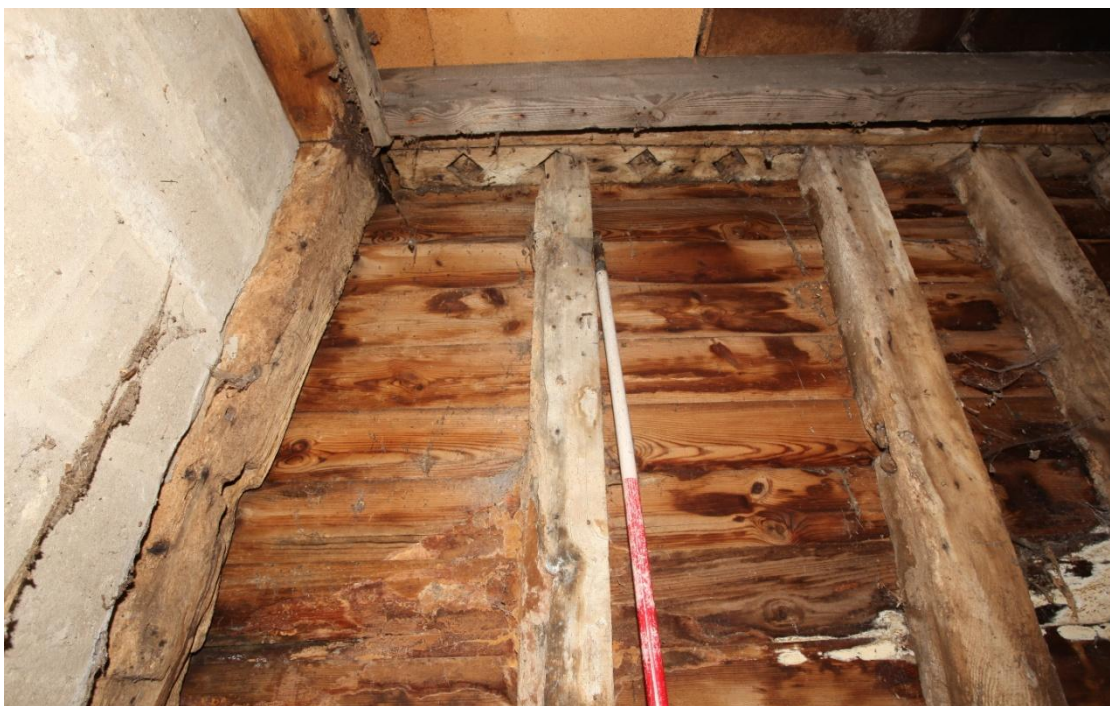
**Illus. 16.** The underside of the northern mid-rail of bay A showing evidence of another original window with four diamond mullions immediately opposite that in illustration 15. The corner post on the left and the stud on the right contain pegged mortices for the sill and a narrow groove for a sliding shutter is visible in the underside of the mid-rail.

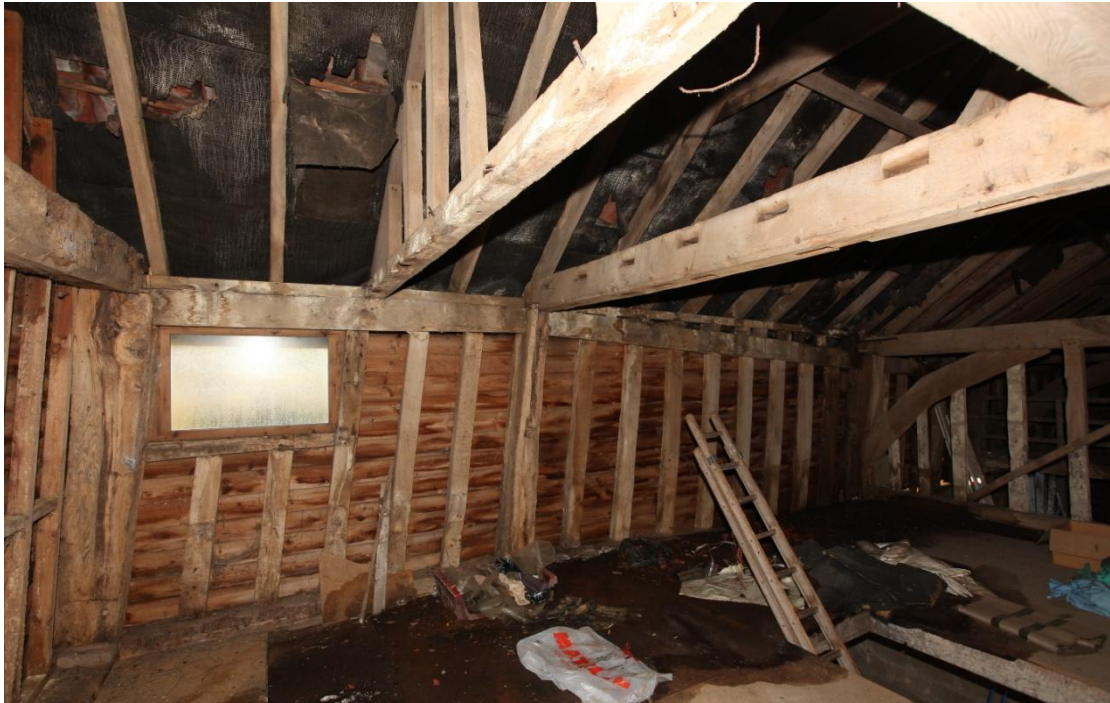
**Illus. 17.** The northern internal wall on the loft in bays A and B showing the position of an original first-floor window occupied by the modern glazed window to the left (with a detail in illus. 18 below). The tie-beam that divides the two bays on the right contains empty pegged mortices for a missing solid wall against the threshing barn in bays B-D and joist mortices for a missing first-floor ceiling in bay A.

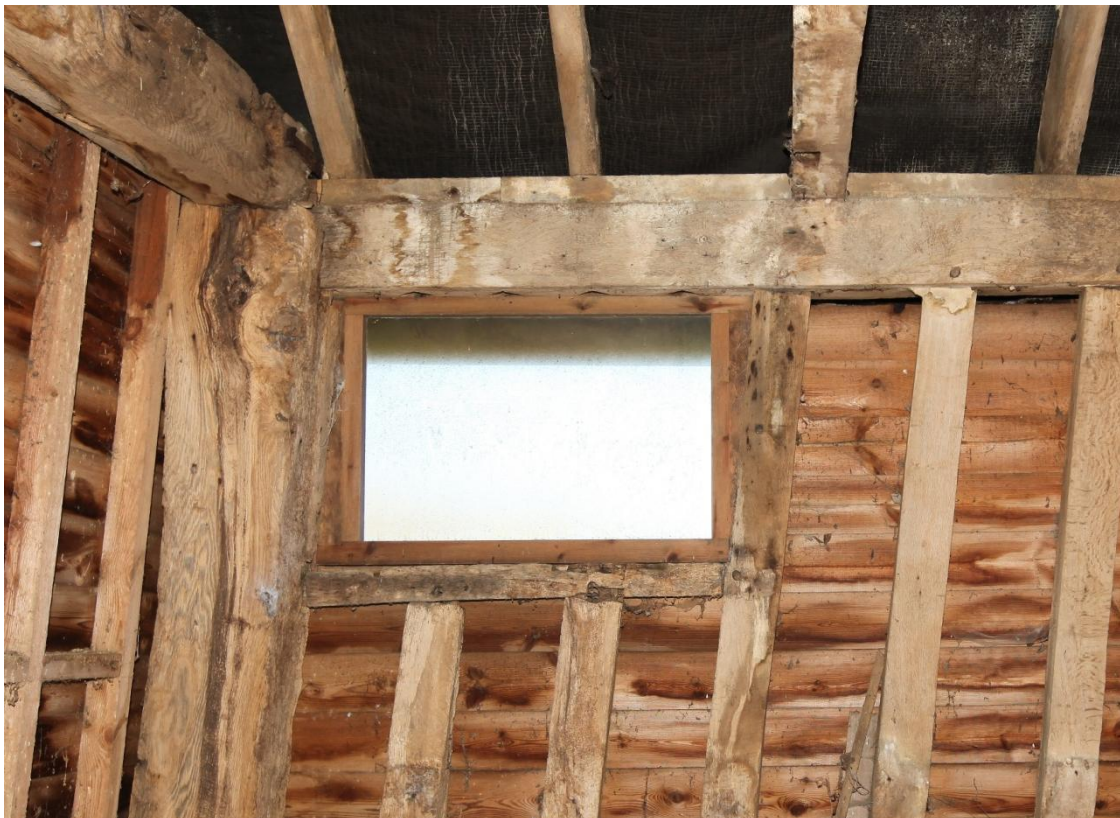
**Illus. 18.** The original first-floor window in the northern wall of the westernmost bay (A) which retains its original pegged sill with a narrow groove in the roof-plate for a shutter sliding to the right and four empty mortices for missing diamond mullions.

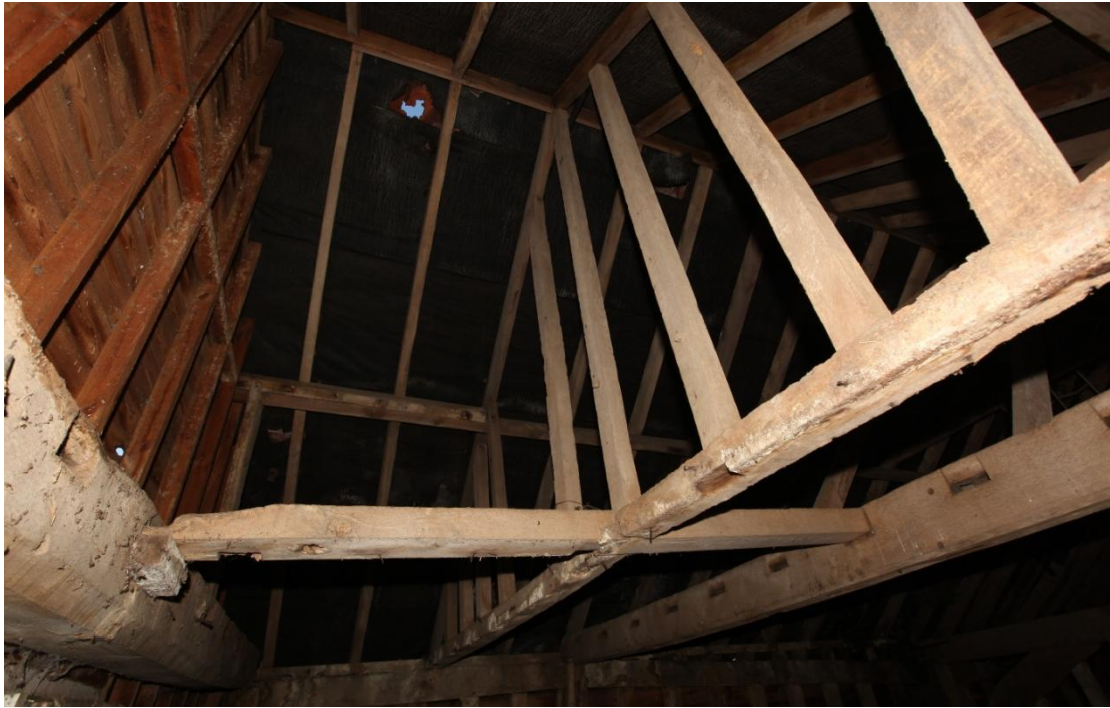
**Illus. 19. The single ostensibly original first-floor ceiling joist that survives in the westernmost bay (A), tenoned between the tie-beam of the missing partition against the threshing barn on the right and the neatly chamfered and stopped binding joist that now forms the tie-beam of the gable on the left (seen from the south). This was incorporated into a later partition possibly of the 18<sup>th</sup> century that may have enclosed a narrow stair opposite the southern entrance door to this bay.**

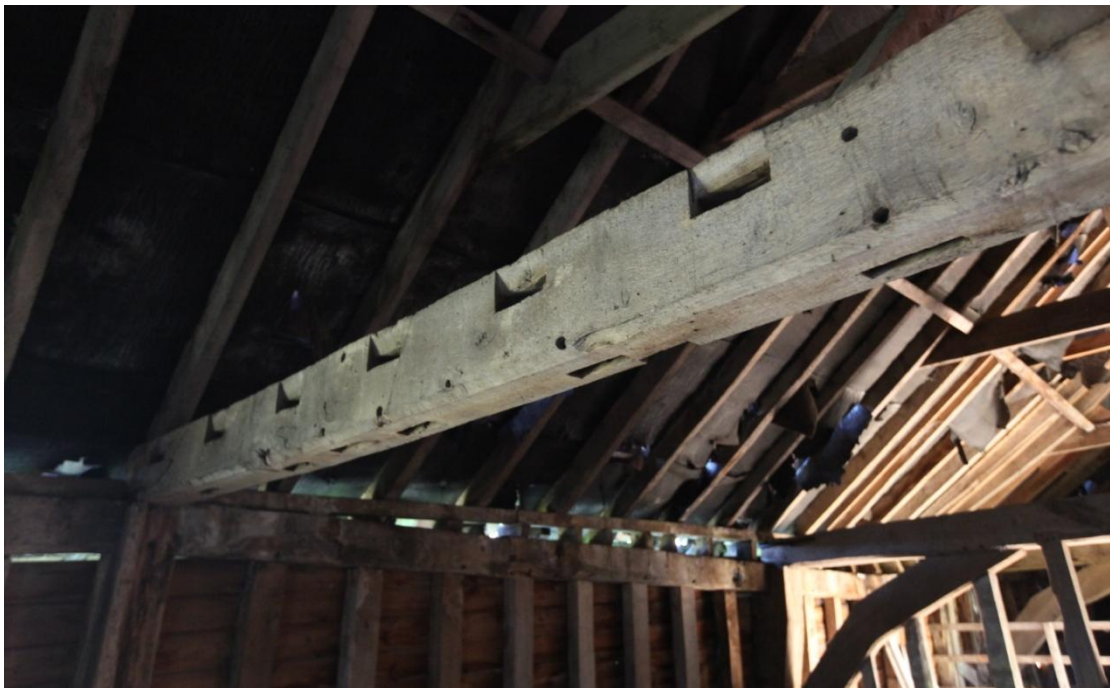
**Illus. 20. The western face of the tie-beam between the floored bay (A) to the left and the three-bay threshing barn in bays B-D showing its neat chamfer and pegged stud mortices for a missing solid partition. The joist mortices held soffit tenons with diminished shoulders in a style normally found only in high-quality domestic ceilings between the mid-16<sup>th</sup> and mid-17<sup>th</sup> century when tall sectioned joists became the norm.**

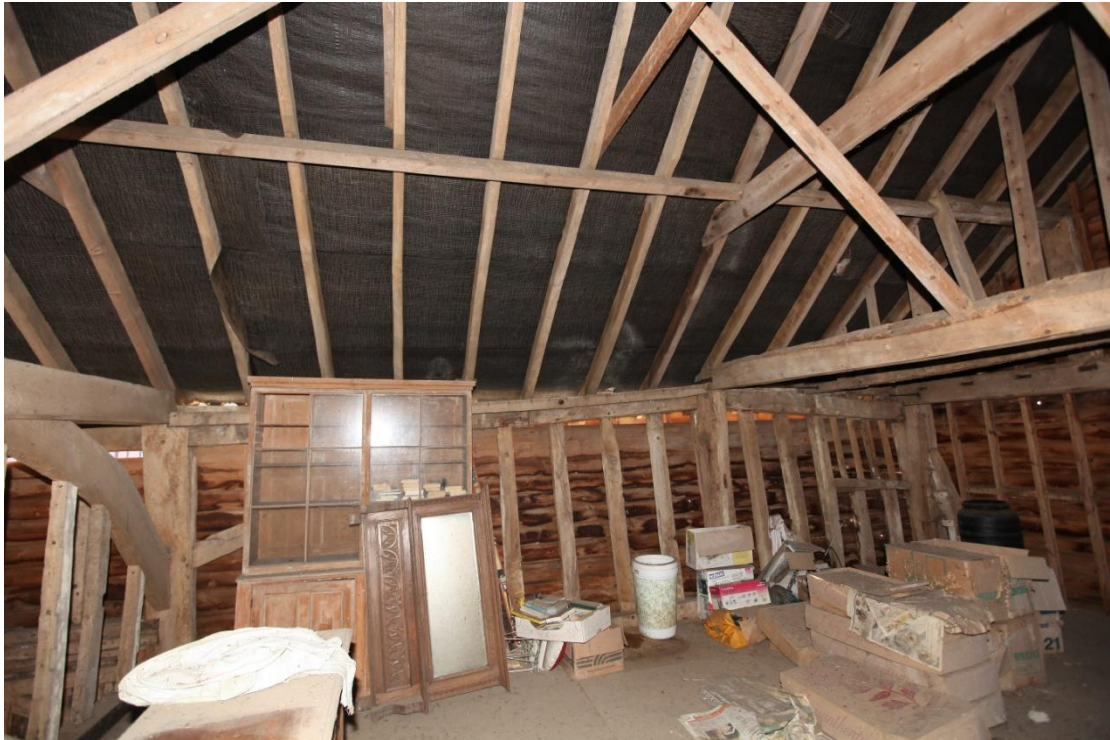
**Illus. 21. The southern internal wall of bays B and A on the loft showing their intact framing with a window to the right and an original internally trenched brace to the left. Bay B was originally part of the threshing barn while the narrow bay A contained ground and first-floor rooms with ceilings that both extended beyond the present gable.**

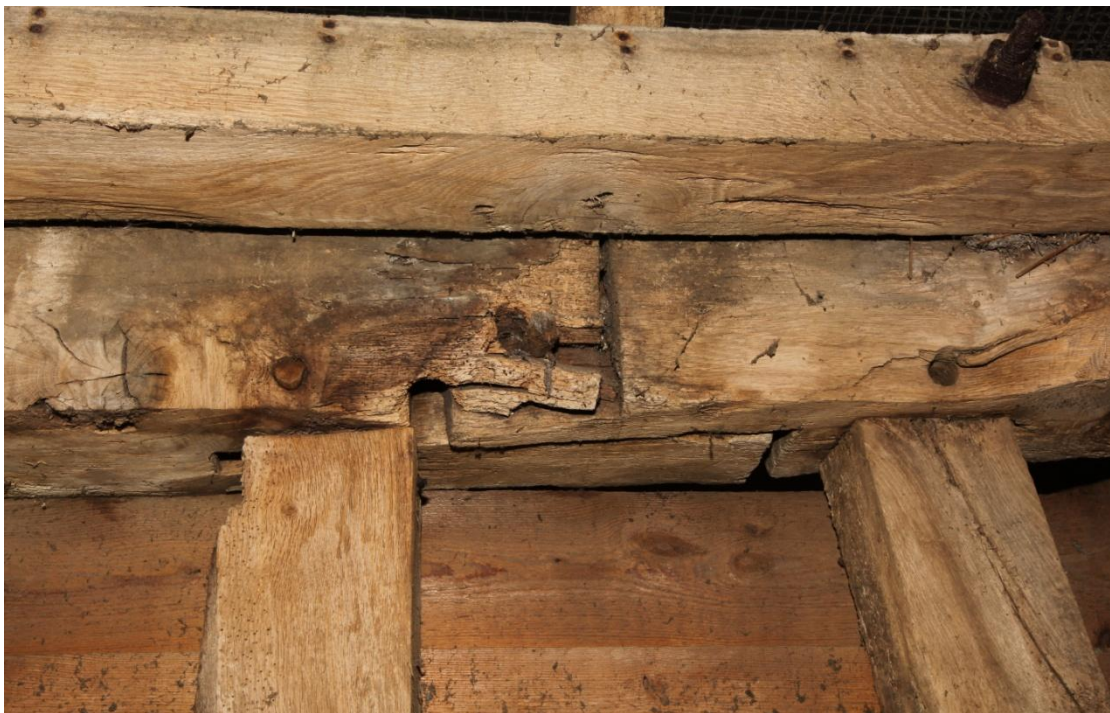
**Illus. 22. A detail of the short face-halved and bladed scarf joint of late-16th and 17th century form in the southern roof-plate of bay B (to the right of the cabinet in illustration 21). Joints of this type first appeared in the final years of the 16<sup>th</sup> century and replaced the earlier edge-halved and bridled form. It would be interesting to know which form was used in the farmhouse to establish whether the two buildings are exact contemporaries. The bolted reinforcing plate above is a 19<sup>th</sup> or 20<sup>th</sup> century addition.**

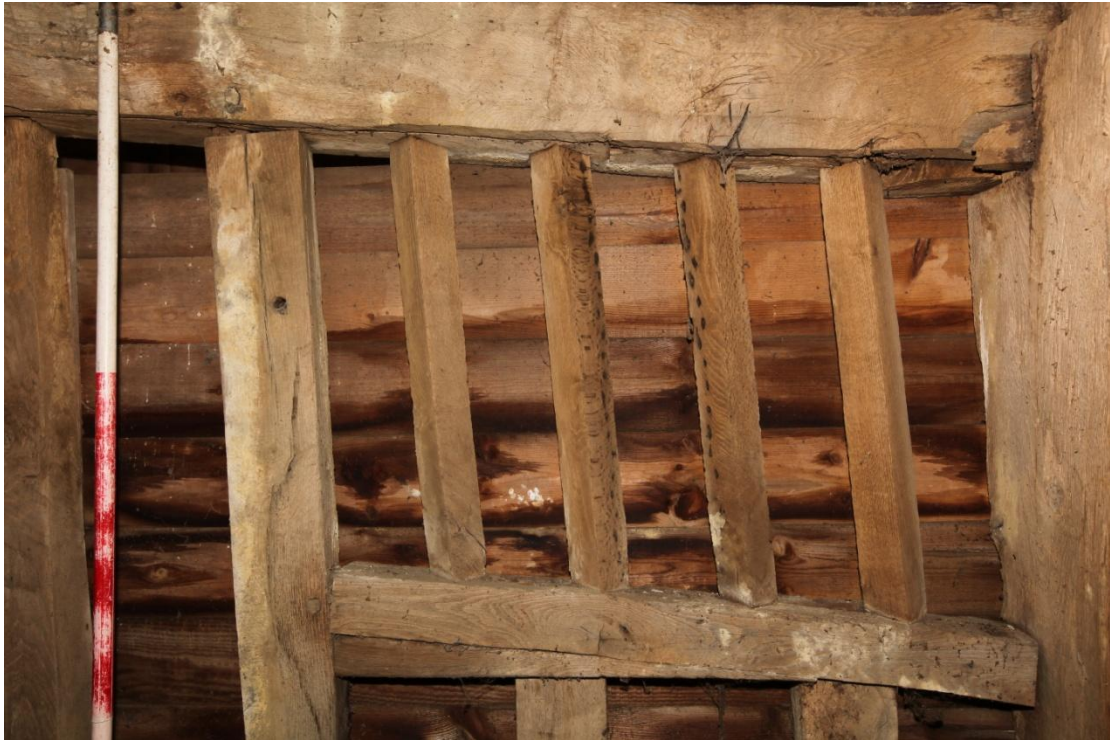
**Illus. 23.** A detail of the intact first-floor window in the southern wall of the westernmost bay (A) with the 12-inch wide storey post that now forms the corner of the truncated building to the right. The original diamond mullions are uncommon survivals even in normal domestic contexts and are rare in barns. The nails flanking the central light are usually found in conjunction with leaded panels of glass and could be explained by the insertion of such a panel here when the rest of the window was blocked.

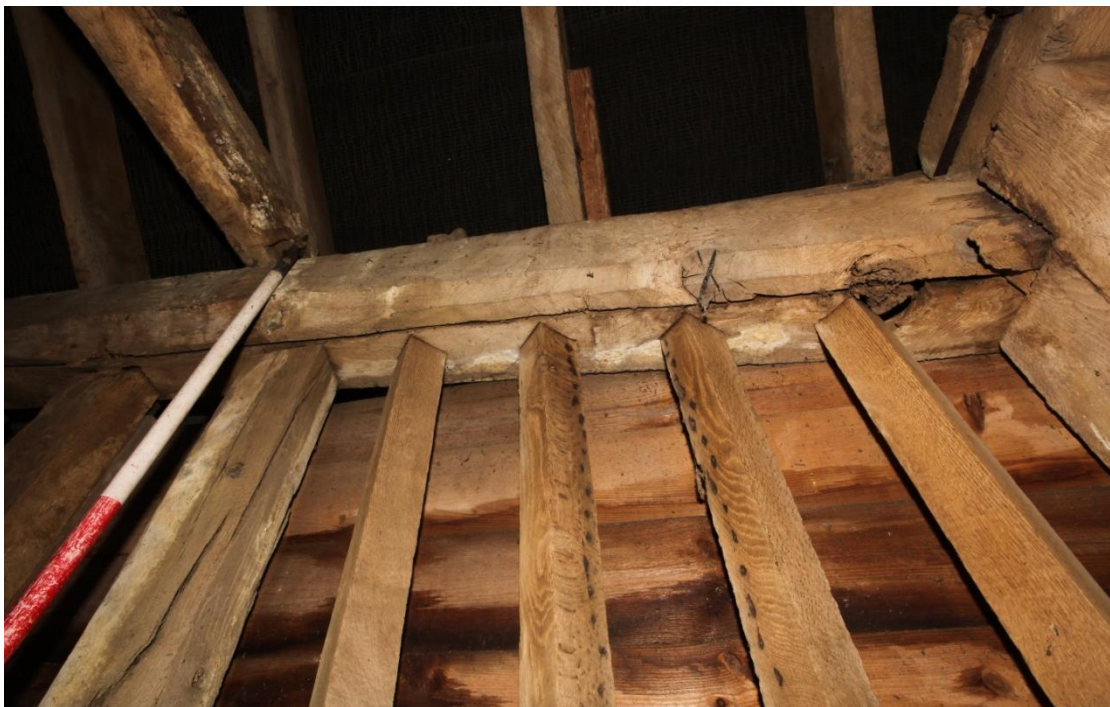
**Illus. 24.** The roof-plate above the southern window in illustration 23 contains a very narrow quarter-inch groove for a sliding internal shutter. Narrow grooves of this kind are usually seen only in high-status domestic houses which possessed finely made shutters of thin imported wainscot instead of the thick planks used in most cases.
