LEVEL 3

Your survey report

5A Northgate
CHICHESTER
PO19 1BA

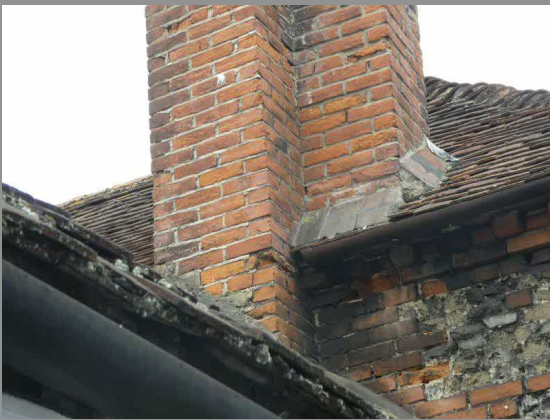
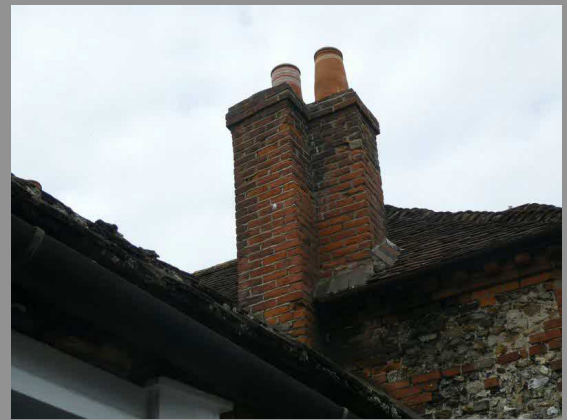
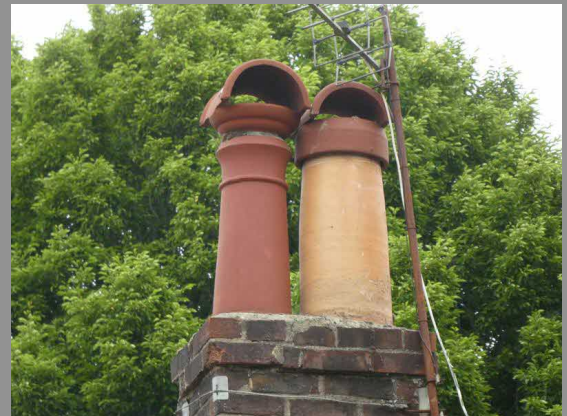
Cement fillets shrink, crack and become porous in time allowing damp penetration, and this has happened with cracks at the base of the flashing. It would be best replaced with more flexible and durable lead flashings but this is unlikely to be permissible.

There is a second, "semi detached" chimney. Generally the stack is in fair condition although there is some minor deterioration to the mortar joints some re-pointing, frost damaged bricks and closer inspection of the top of the stack at the same time is advised. The chimney is attached to the neighbouring property and you should discuss the implications of this with your legal adviser.

A building of this age does not have a modern lead tray inserted just above the roofline. This is likely to allow the transmission of moisture within the roof void, but does not necessarily mean that this is more than a property of a chimney of this age.

Condition rating 2. These works should be carried out soon.

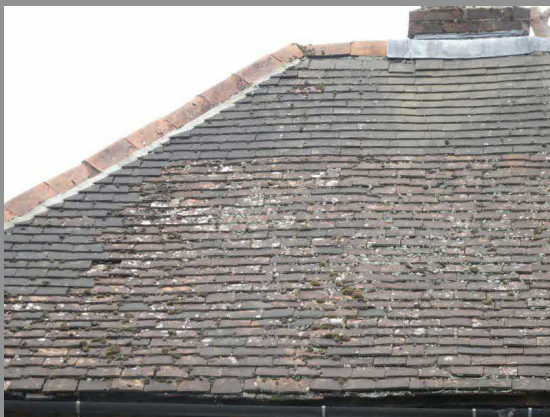
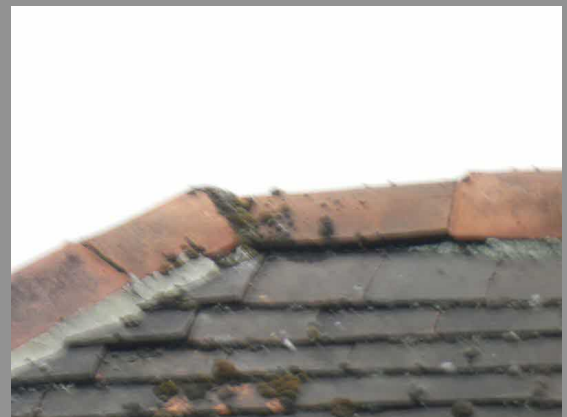
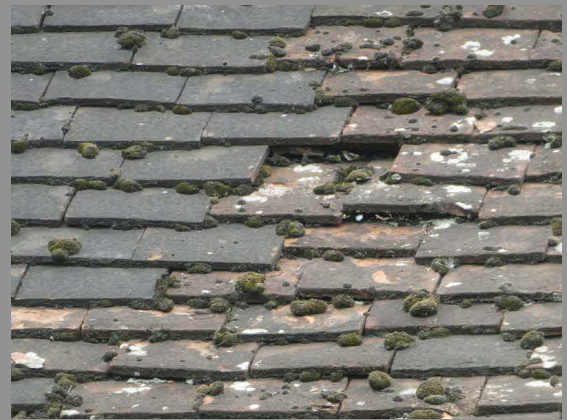
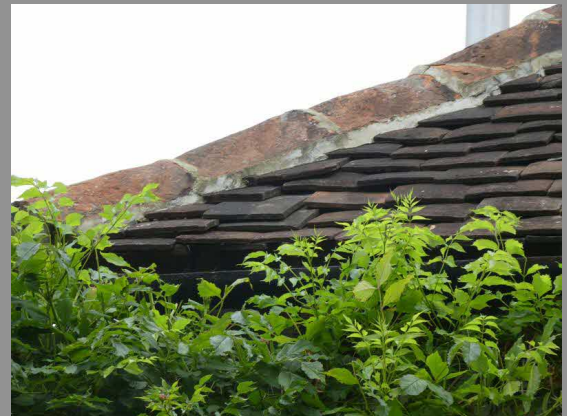
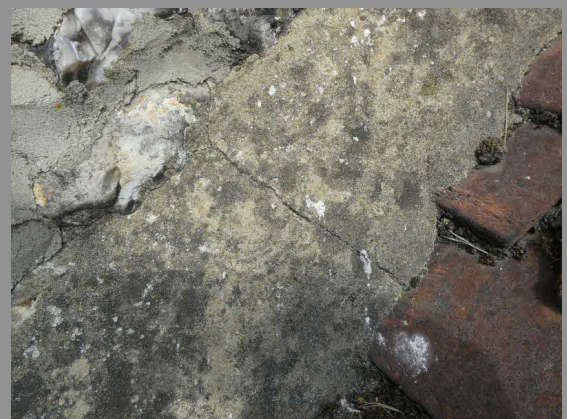
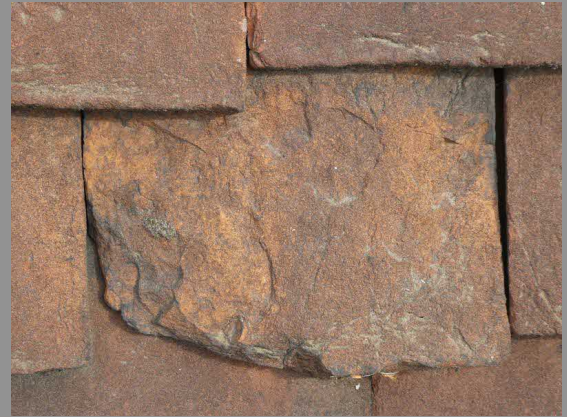
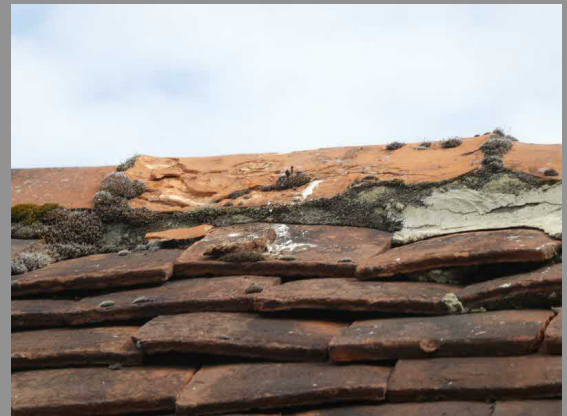
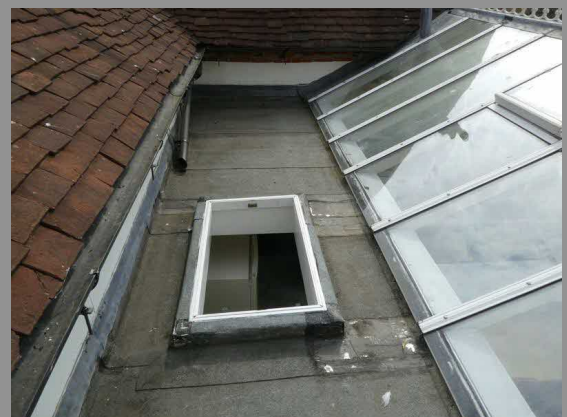
The roof covering has a number of slipped, missing, broken tiles and frost damaged ridge tiles which should be replaced. These defects will lead to deterioration of internal elements possibly including timber decay. The covering now needs a thorough overhaul to leave sound and weatherproof. You should arrange for quote for these works to be prior to committing to the sale.

There is a general unevenness to the roof surfaces which is probably due to displacement of roof timbers over a number of years. This is not an unusual defect in a roof of this age and it is unlikely to progress significantly.

Cement mortar fillets close the junctions between roof surfaces and adjacent walls. As with the chimney mortar fillet, the cement is cracked and needs repair.

Condition rating 3. These investigations should be carried out immediately.

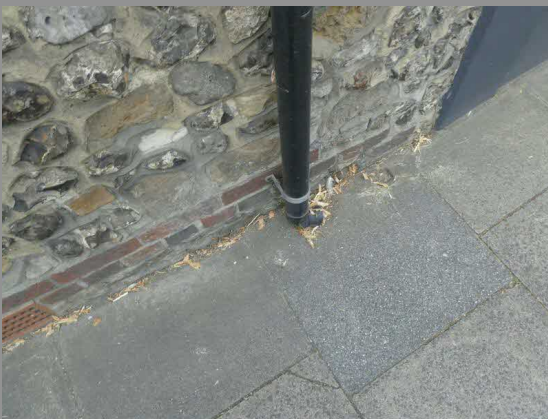
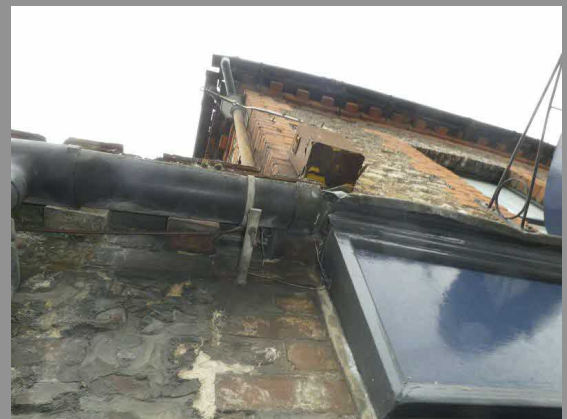
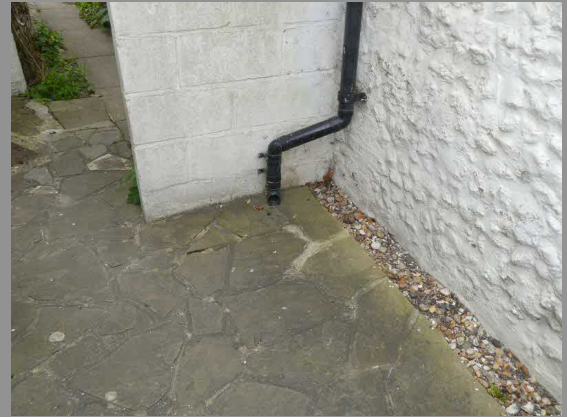
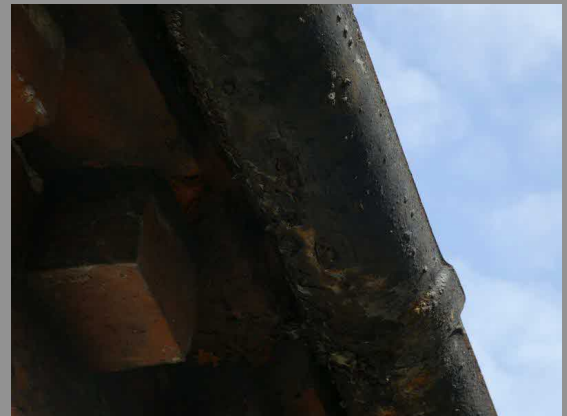
The property has a combination of PVCu and cast iron gutters and downpipes. It was not raining at the time of inspection, but there was evidence that there are defects with staining at gutter joints. The rainwater goods should be water tested to establish their full condition

The cast iron goods appear to be in poor condition with corrosion and these are now reaching the end of their useful life. These will require ongoing maintenance and, eventually renewal.

The use of PVCu gutters is unlikely to be permissible under the listed buildings restrictions and all the rainwater goods are likely to need to be replaced with metal goods which could be costly.

The rear downpipe discharges over the flat roof over the rear of the kitchen/dining room. This places an unnecessary burden on the flat roof cover and can lead to premature failure. The downpipe should be extended so that it discharges directly into the nearby gutter/downpipe. The drain within the flat roof is not properly finished and needs upgrading.

Condition rating 2. These works should be carried out soon.

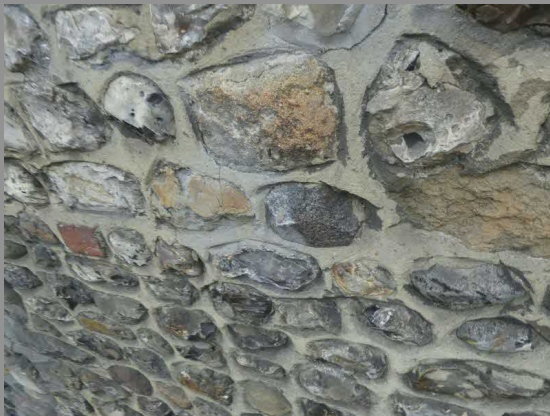
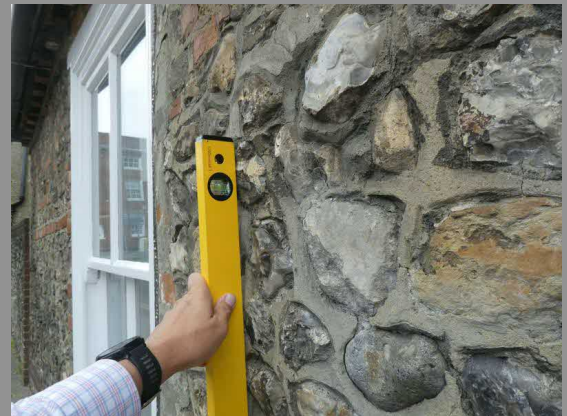
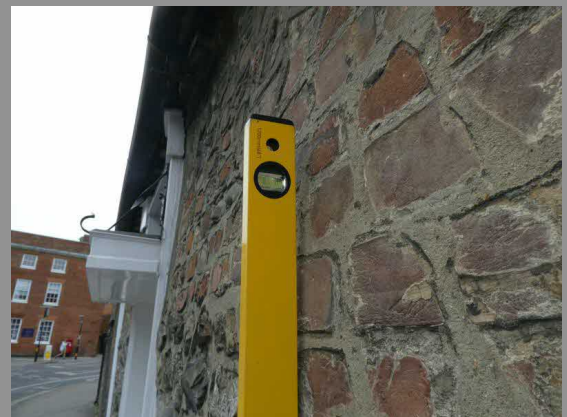
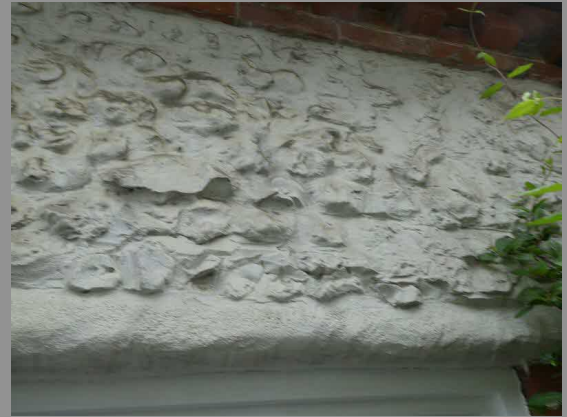
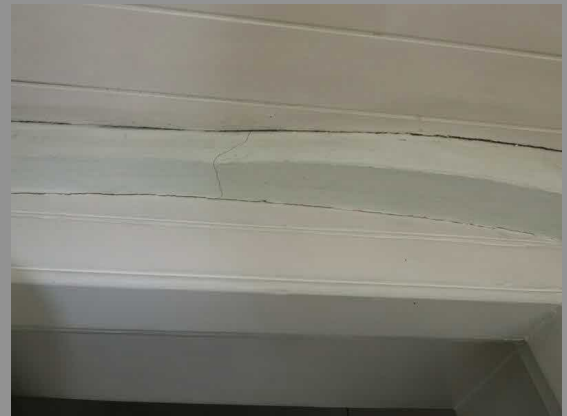
There is some minor cracking visible, but this is believed to be as a result of the differential thermal movement which should be repointed. Some previous localised repointing has been carried out using cement mortar which is inappropriate as it will damage the softer bricks over time. Repointing should be carried out with traditional lime mortar and you should seek the advice of a heritage brickwork specialist.

The rendered wall surfaces appear in basically satisfactory repair, although subject to some minor cracking and loss of key in some of areas where visible beneath the climbing plants. This is due to shrinkage and general deterioration of the render material. Damaged render can cause dampness and these areas will need to be made good prior to the next redecoration.

There are a number of climbing plants attached to the house. Whilst these are unlikely to cause serious harm to the walls, they will be allowing moisture to be trapped against the wall which could cause deterioration and damp penetration. It is recommended that plants and shrubs be cut back to ensure that foliage does not project over windows, air vents, rainwater goods etc.

Condition rating 2. These works / investigations should be carried out soon.

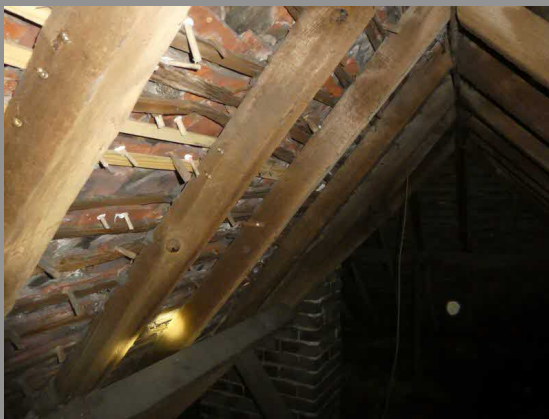
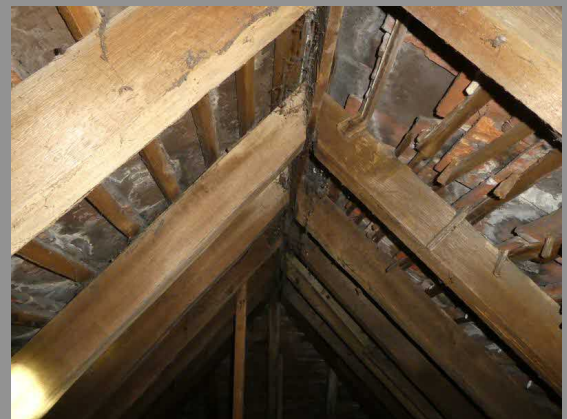
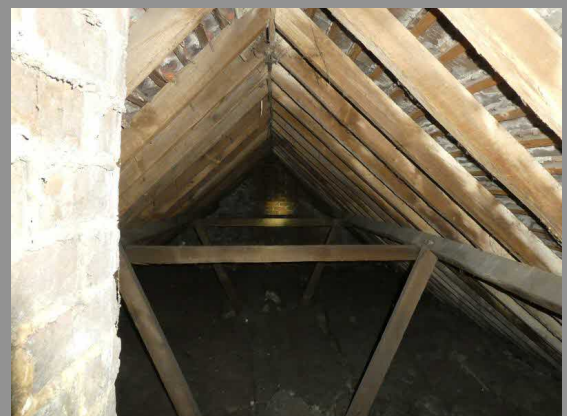
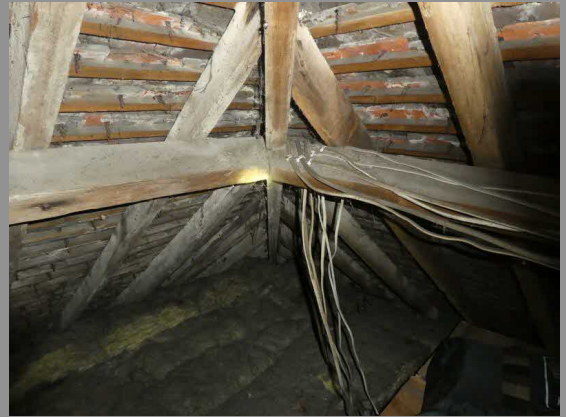
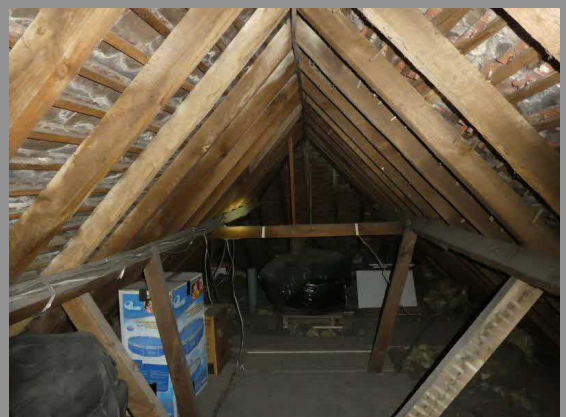
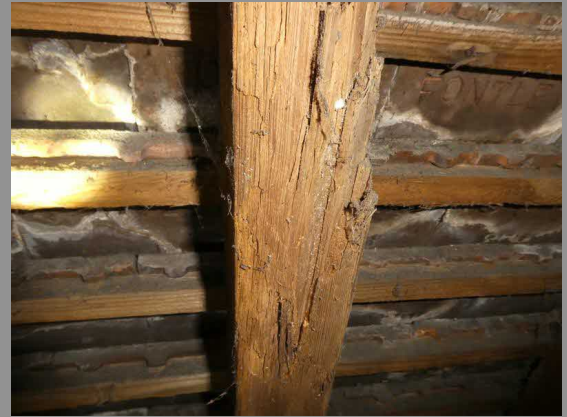
The extractor fan from the WC appears to be venting into the roof void. This could cause condensation to form in the roof void and should be vented externally.

Condition rating 3. These investigations should be carried out immediately.

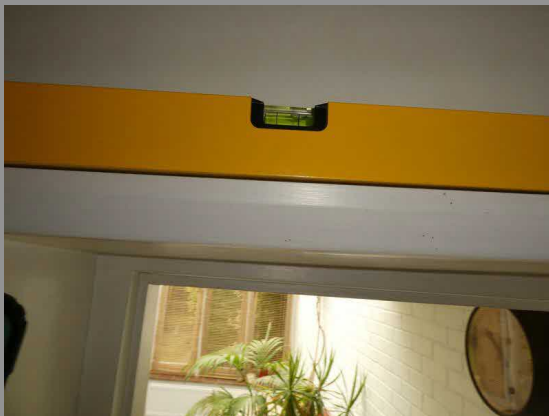
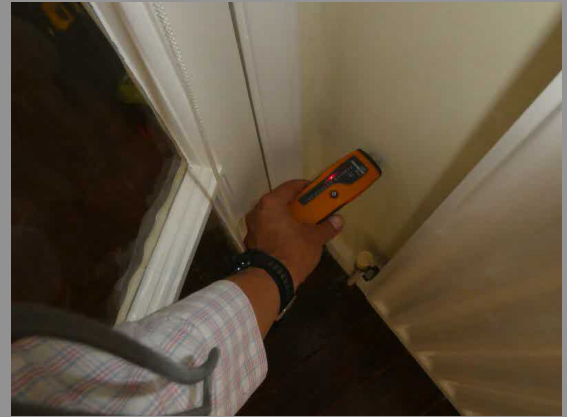
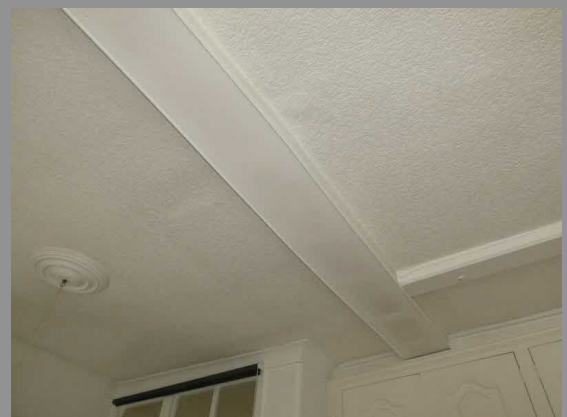
There are timber lintels in both bedrooms which may have been where a load bearing walls have previously been removed. The lintel are deflecting and there are gaps in the lining paper along the side the of lintels, suggesting recent movement. This is probably due to inadequate support being provided. This may be serious and you should now obtain a report from a Structural Engineer which should include a detailed analysis of the cause of the defect, and the works that are required to remedy the problem and associated costs. This investigation should be carried out prior to the commitment to purchase.

Condition rating 3. These investigations should be carried out immediately.

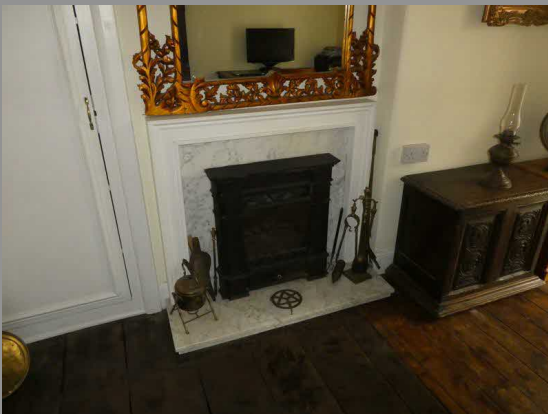
Photo - 97

A load-bearing chimney breast has been removed from the sitting room. The loads from above should have been provided with some form of support although this is now concealed within the fabric of the building and we cannot confirm either its adequacy or existence. Unsupported chimney breasts are potentially hazardous and you should seek confirmation either through enquiry with the local authority Building Control department or physical investigation that appropriate support has been installed. If you cannot confirm that there is correct support, this will now need to be installed to prevent the risk of collapse. Any remedial work will require local authority approval. This action should be undertaken before commitment to purchase.

Condition rating 3. These investigations should be carried out immediately.

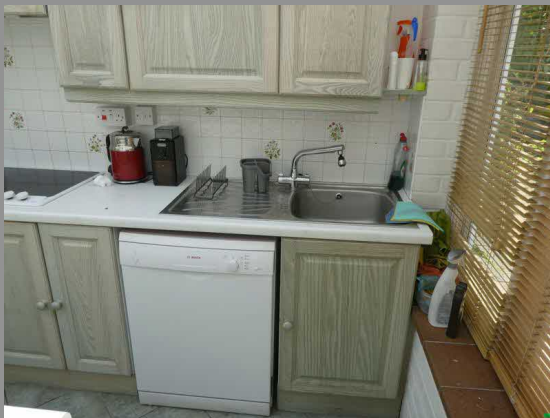
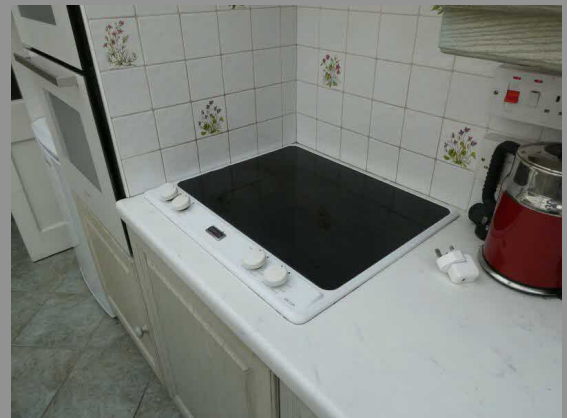
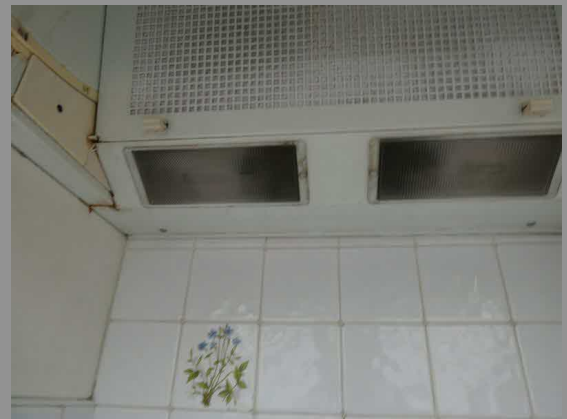
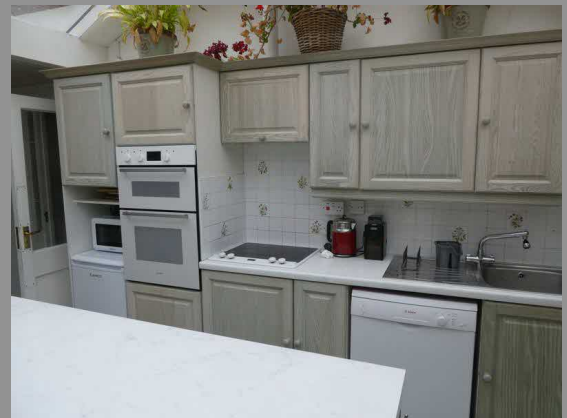
The flexible sealant around the worktops is in poor condition and should be renewed. Defects may be present in concealed areas and we recommend that you inspect these as a precaution.

Condition rating 2. These works should be carried out soon.

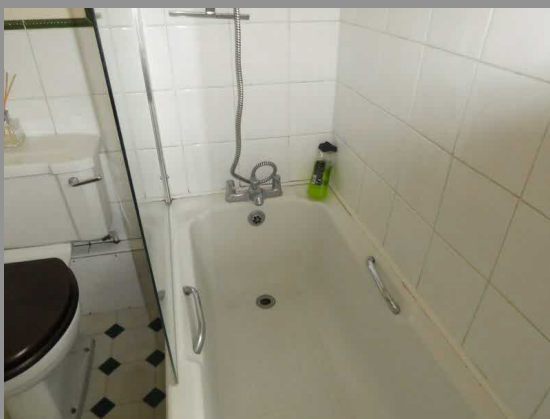
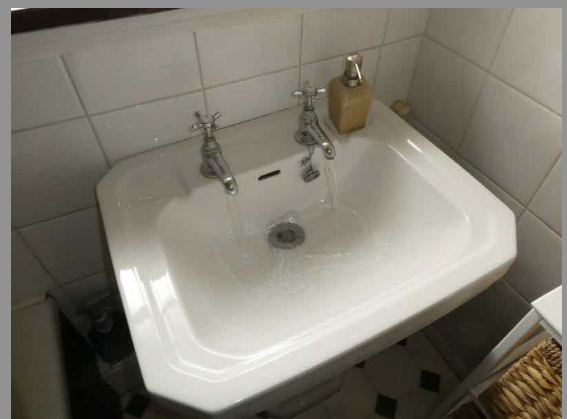
It should be noted that there is no mechanical extract fan in the bathroom, and the installation of a fan is advised to prevent a build up of moisture in the atmosphere.

Condition rating 2. These works should be carried out soon.
