Arboricultural Report

Tree Condition Assessment

Site
210 Dover Road
Walmer
Deal
Kent
CT14 7NB

Ref: SA/2192/23

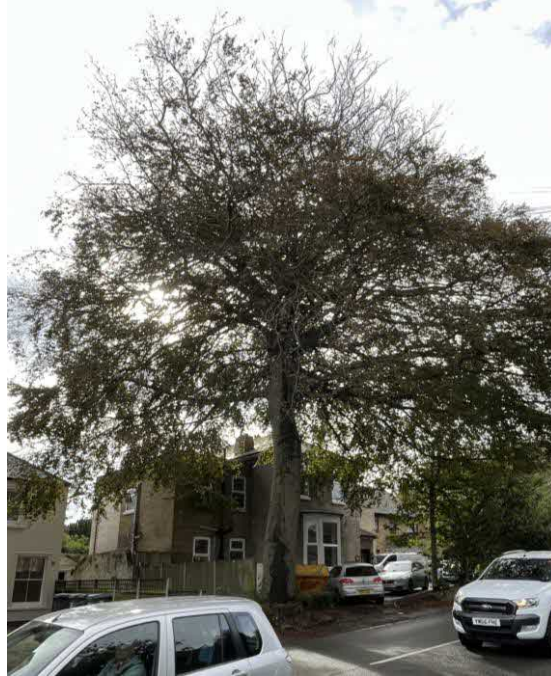
4.1.1 A mature, single-stemmed purple leaved Beech located on the property frontage.

Photo 1: General view of tree

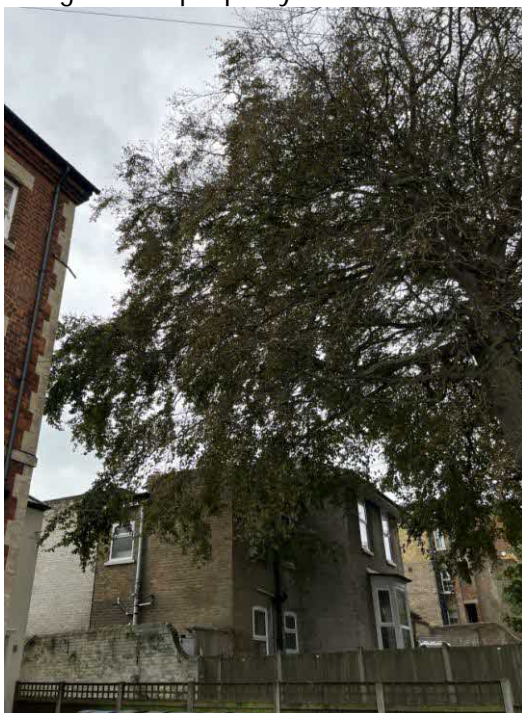
4.1.2 The main stem divides at 7m to form an open and balanced primary branch structure, with the canopy extending the full width of the main road and across the frontage of the neighbouring property which is used as resident's parking.

Photo 2: Showing overhang to neighbour's property.

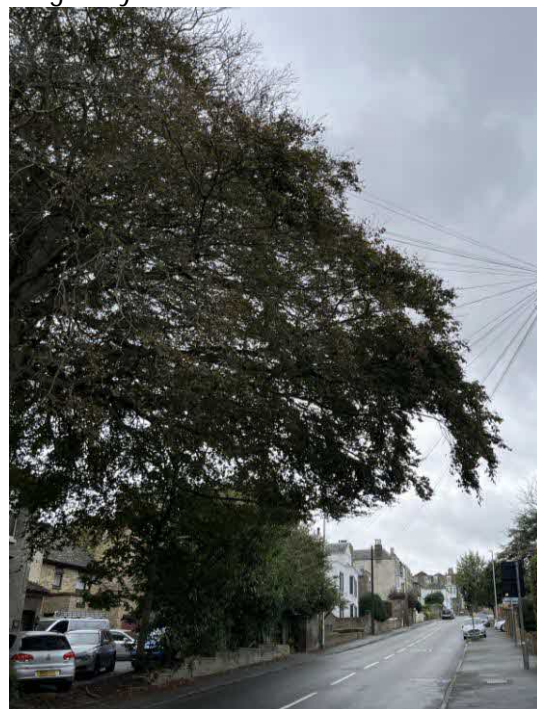
Photo 3: Showing tree in relation to highway.

- 4.1.9 The canopy clearance over the highway is at approximately 5m, providing just about sufficient clearance for double-decker buses, although high sided vehicle damage was noted on one lower branch to the south-west.

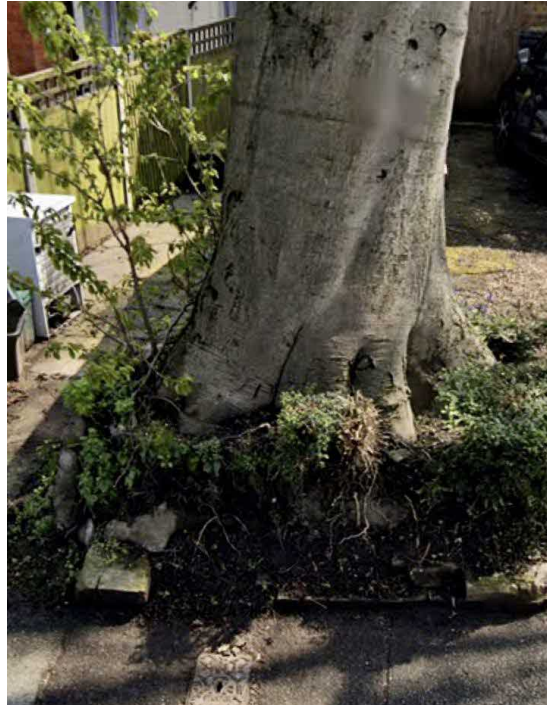
4.1.3 The tree was originally planted within a walled planter that has subsequently been removed as the tree has increased in size. This has resulted in a dense root mass developing at the base of the stem due to natural growth having been restricted by the planter during the early years of tree establishment.

Photo 4: Root mass at base of tree

- 4.2.5 The movement of branches growing through the phone lines also presents a risk of damage to the lines during strong winds.
- 4.2.6 The root mass at the stem base, resulting from the removed walled planter, does not present any structural concern and no evidence of basal decay or dysfunction was noted.

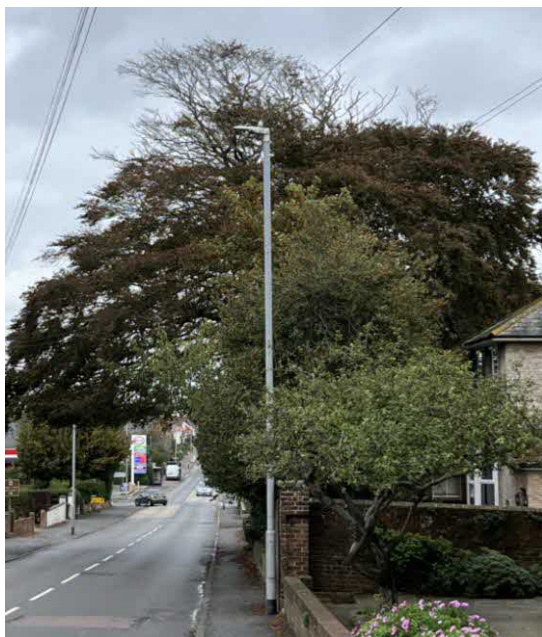
4.1.4 The upper canopy is showing signs of decline, evidenced by: small leaf size; early leaf fall; development of deadwood; development of 'stag-headed' branch structure with formation of lower canopy.

Photo 5: Showing loss of vigour through upper canopy viewed from south.

- 4.2.7 The tree is at a transition stage between full maturity and late-maturity. This is a natural process known as retrenchment, which involves a reduction in vigour through the upper canopy and the development of a smaller more compact canopy structure.

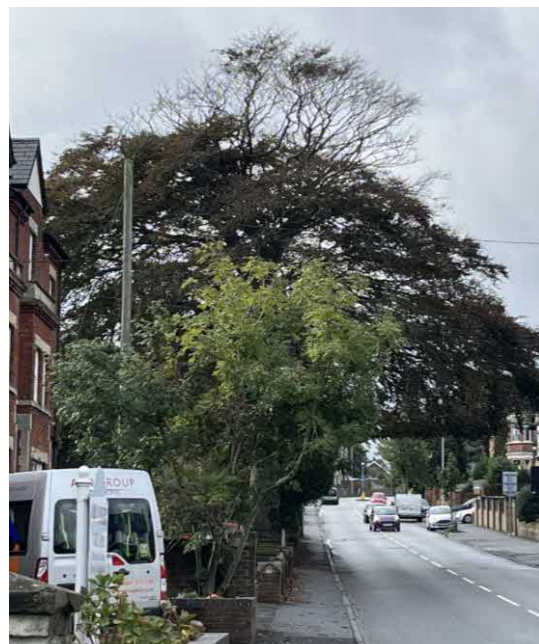
Photo 6: Showing loss of vigour through upper canopy viewed from north.

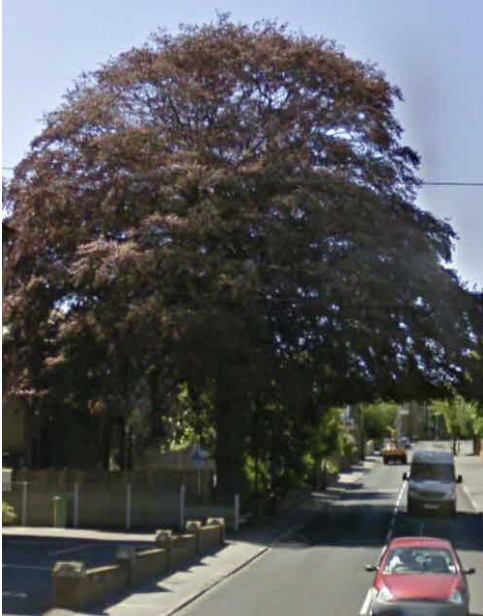
- 4.1.5 Google Streetview photographs are available from 2009, these show that the decline in upper canopy health has been progressive since at least 2009, with the June 2009 photograph showing a full canopy with only a minor loss of vigour through the upper section; and the May 2014 photo showing a notable decline, with this decline progressing over subsequent years.

Photo 7: Google Streetview - June 2009

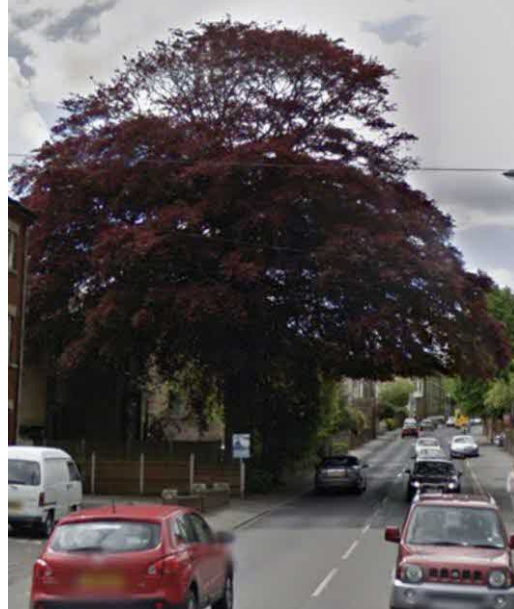
Photo 8: Google Streetview - May 2014

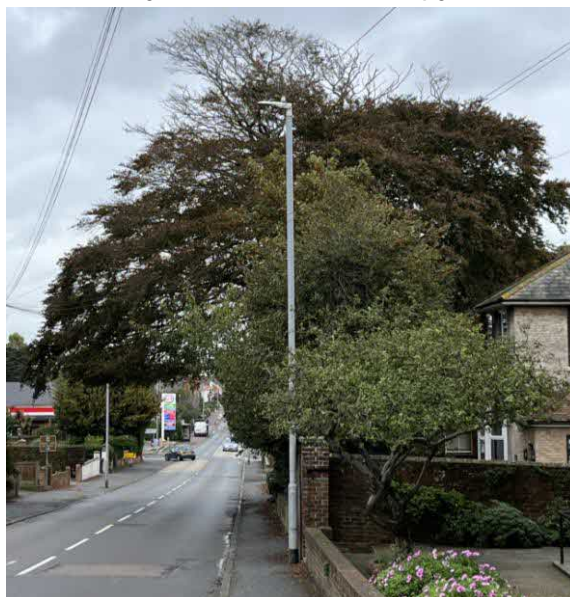
- 4.1.6 Reduced leaf size, canopy density and early leaf fall were also noted through the northern section of lower canopy, this also potentially a sign of reduced vigour.
- 4.1.7 The lower branches of the canopy over the neighbouring property are at 3m from ground level, windows to the adjacent flats are at positioned at ground level, at 4.5m and at 7.5m. The radial canopy spread is currently within 2m of the building.
- 4.1.8 The radial spread has also developed over the roof of no. 210, with pendulous branches now being very close to the roof of the building.

Photo 9: Asymmetric lower canopy over house.
