Arboricultural Hazard Assessment

Site Address:	10 Elm Field Drive Brandesburton YO25 8RR	Client:	Stuart Draper
Report Ref:	EFDB01-24	Report Date:	11th March 2024
Author:	Laurence Smith BSc (Hons) Arb, M Arbor A	Signed:	<i>Laurence Smith</i>

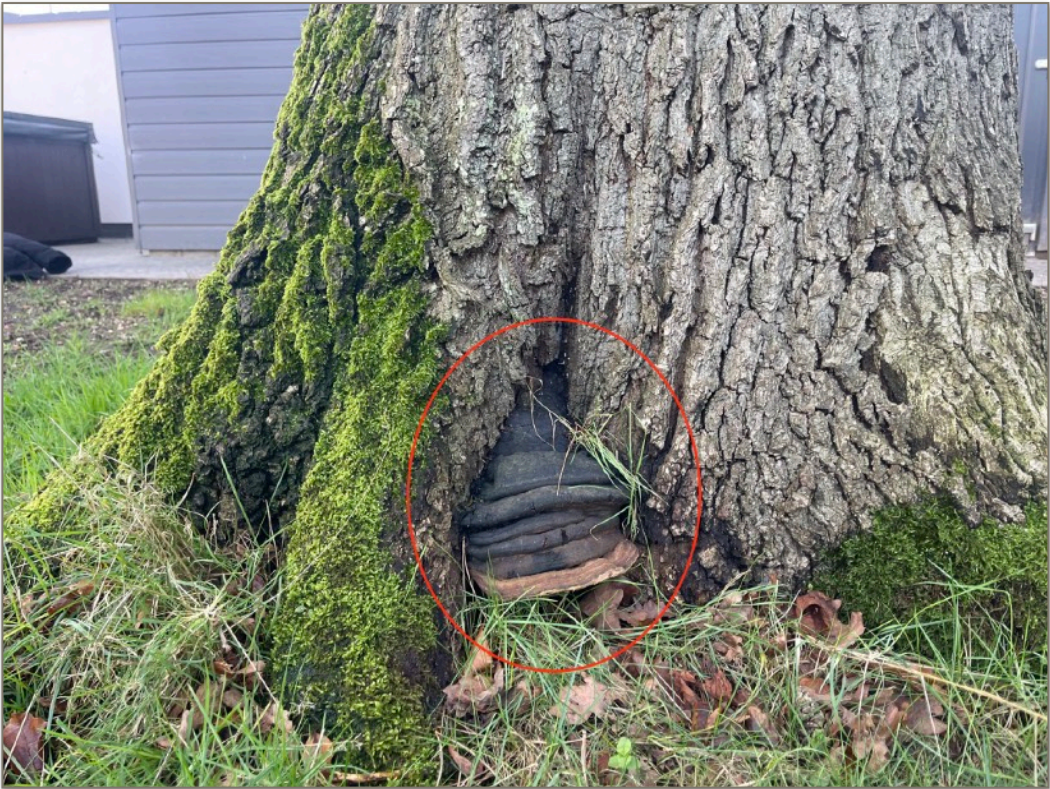
The Oak tree (T1), however, displayed the fruiting body of *Ganoderma australe* between buttressing on the western aspect of the tree stem (Figure 1). This Fungi is considered both parasitic and saprobic given its ability to attack both living and dead cells. In addition, it can breach reaction zones resulting in the breakdown of lignin within the cells known as white rot. Significant colonisations can result in failure via wind throw or stem collapse.

Given the lack of significant observable pruning wounds or open cavitation close to the stem base, it is reasonable to conclude that this decay has extended down the stem from a now occluded wound at a higher height. This would also suggest that all three regions of cambial dieback and soft timber are internally linked. This would constitute a considerable loss of internal structure. Should this tree fail at close to ground level it would likely impact the neighbouring property given the canopy bias in that direction (Figure 5).

Figure 1. Fruiting fungal body of *Canoderma australe*.

This rationale guided the probability of failure within the next 12 months to a value of 3. Assuming that the potential damages of the tree failure onto the neighbouring property would be equal to or over £20,000 the risk of harm is calculated to 1/3K which is considered unacceptable as it is imposed on a 3rd party. As such a recommendation has been made to remove the tree.

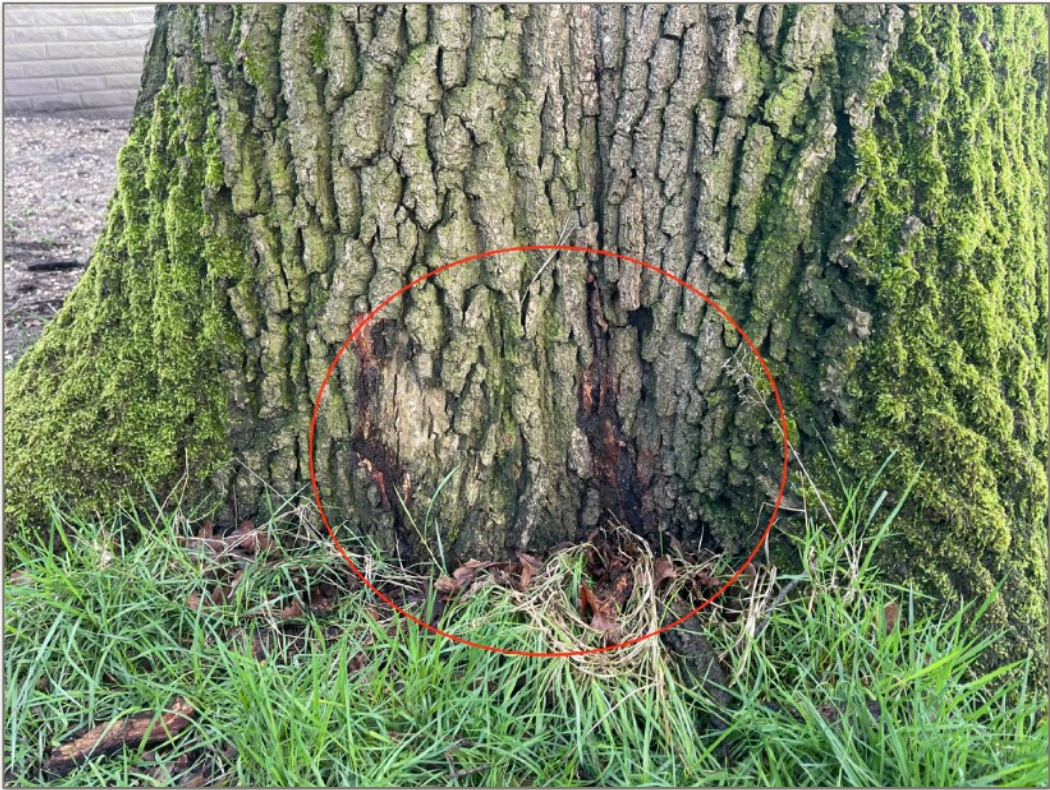
Although no further fruiting brackets were observed, on two further aspects of the tree, north (Figure 2) and eastern (Figure 3) the wood between buttresses was found to be soft with cambial dieback in the region. The southern aspect also displayed some darkening of the bark, however, it was not reasonable to conclude that this was a result of internal decay (Figure 4).

Figure 2. Cambial dieback and softening of bark and timber on the northern aspect.

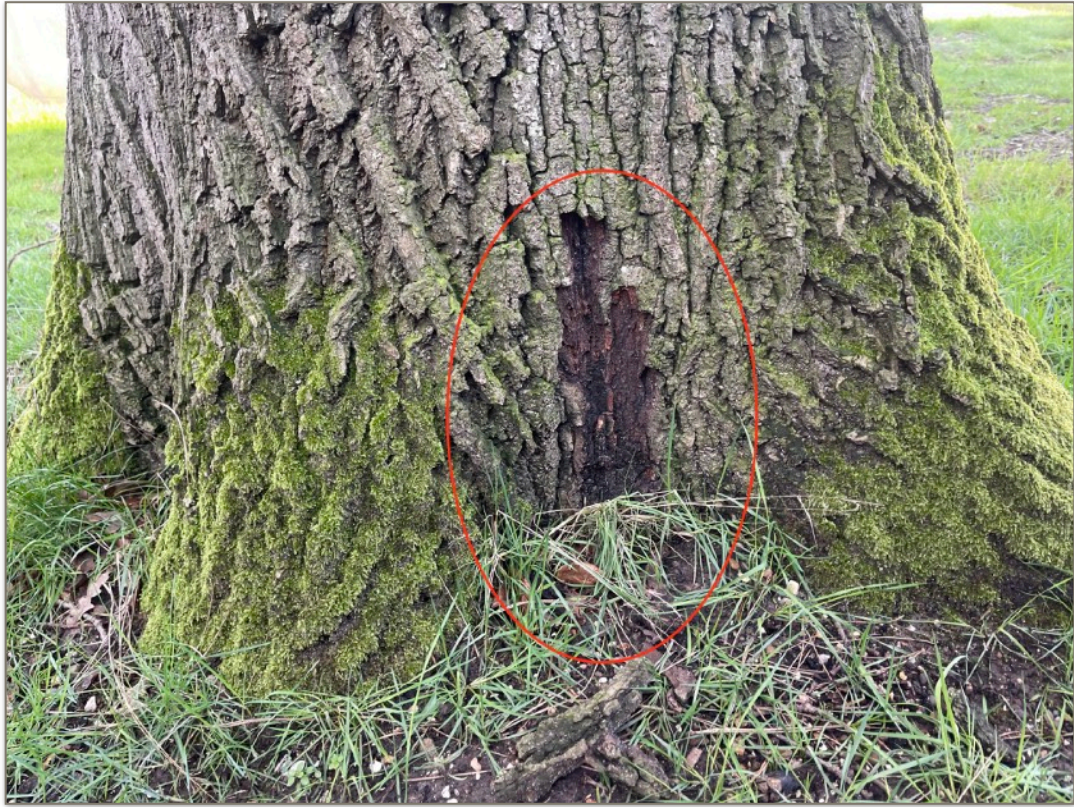
Figure 3. Cambial dieback and softening of bark and timber on the eastern aspect.

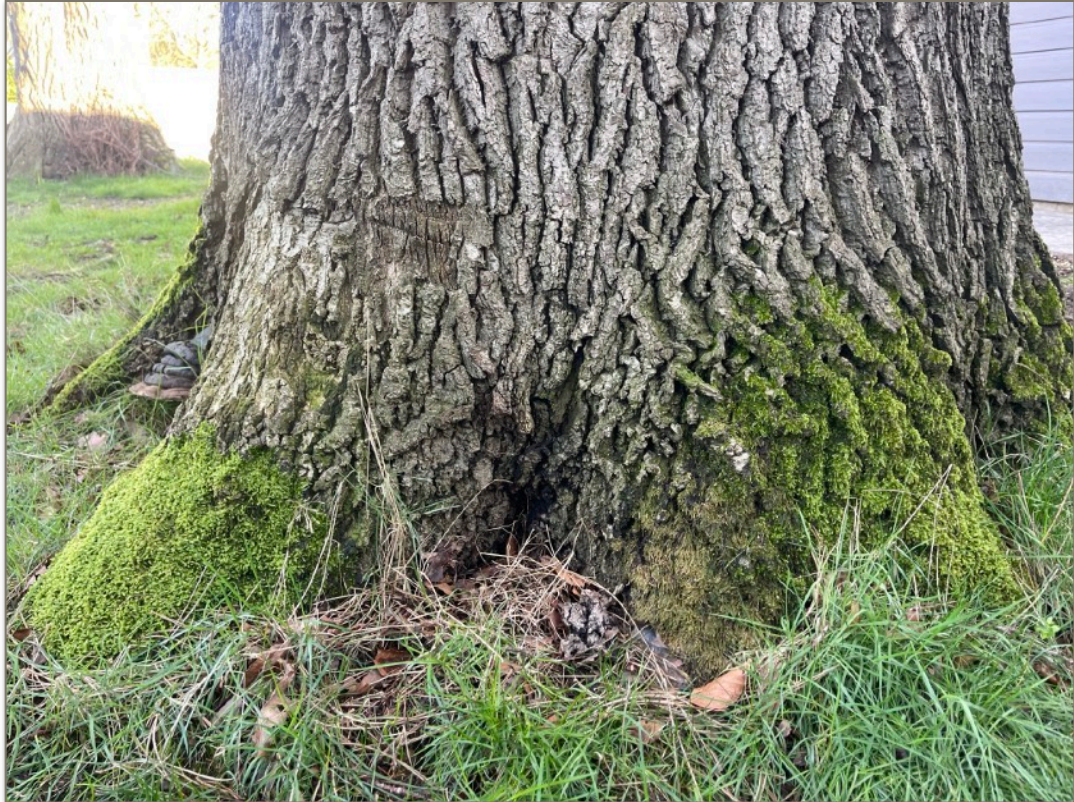
Figure 4. Darkening of the bark between buttressing.

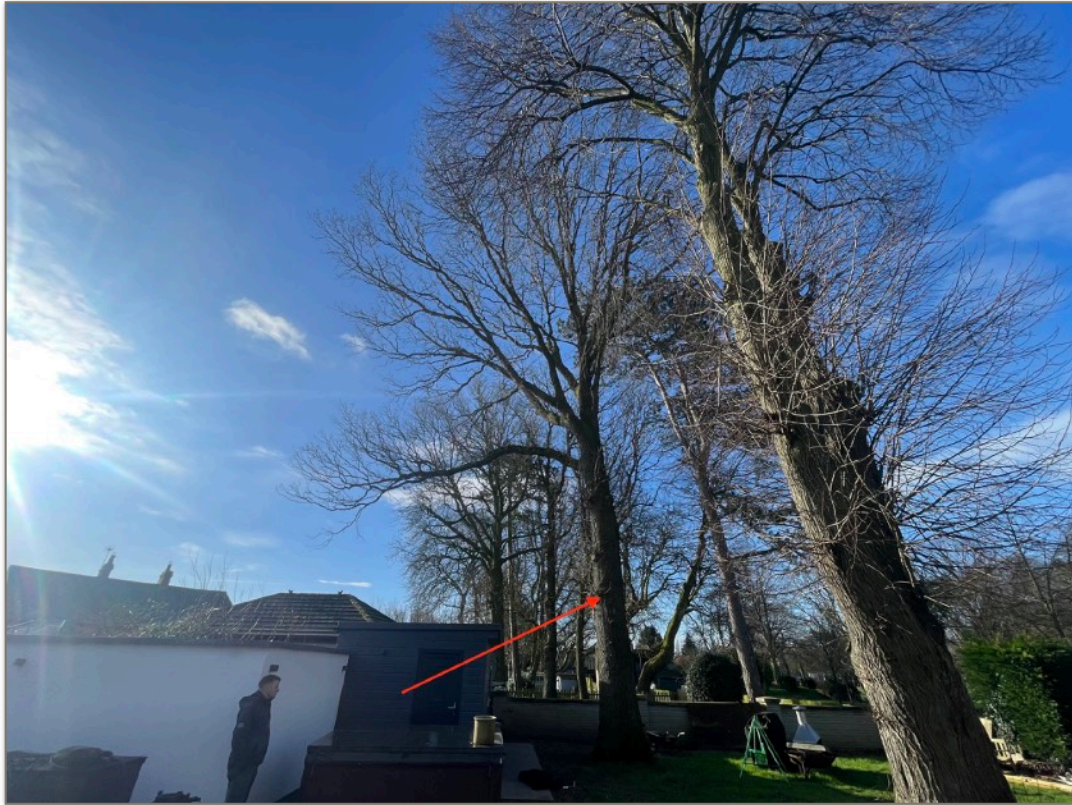
Figure 5. T1 highlighted by the red arrow displaying an asymmetrical canopy biased towards the neighbouring property.
