'VALENTINES'

**WELLPOND GREEN, STANDON
HERTFORDSHIRE**

PRELIMINARY ROOST ASSESSMENT

2024

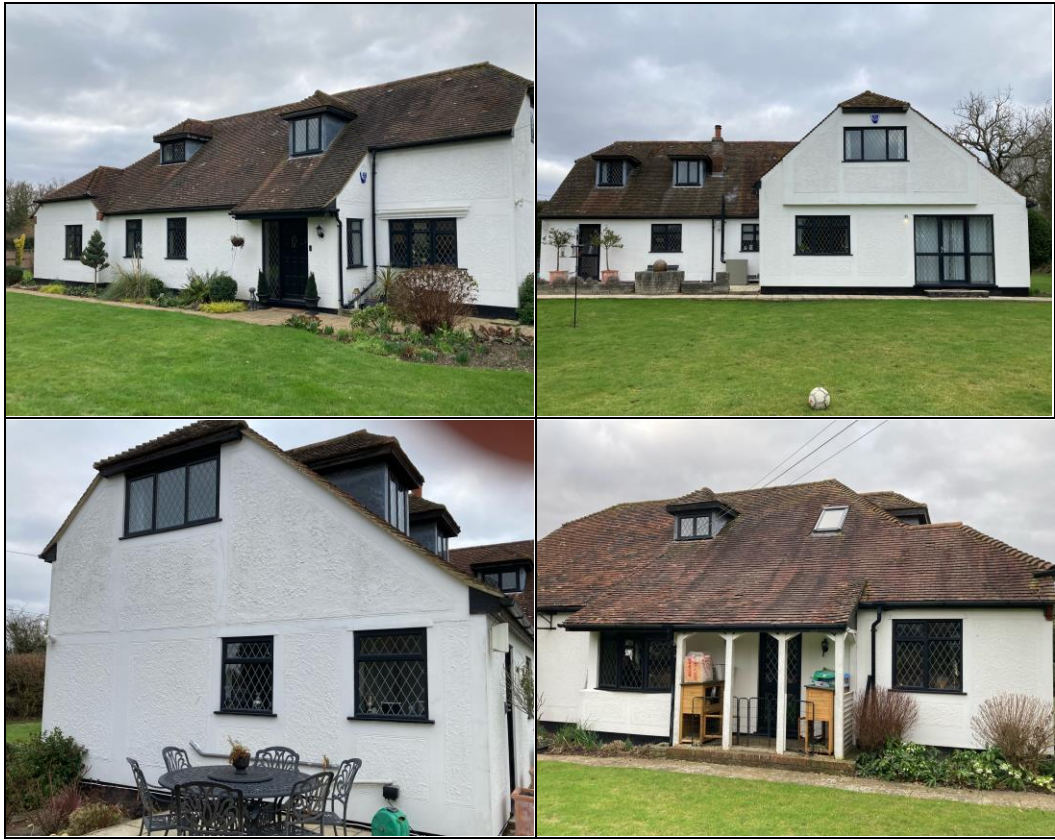
The property (see photographs 1 - 4 below) comprises a detached, single-storey house, dating from around 1910, with a full loft conversion. An extension, of unknown date, is also present on the rear elevation. Dormer windows, together with their associated flashings, are present on both the front and rear elevations (see photograph 5 below). All dormer flashings were found to be tight-fitting with no suitable gaps for bat access.

Photographs 1 - 4: Front, rear and side elevations

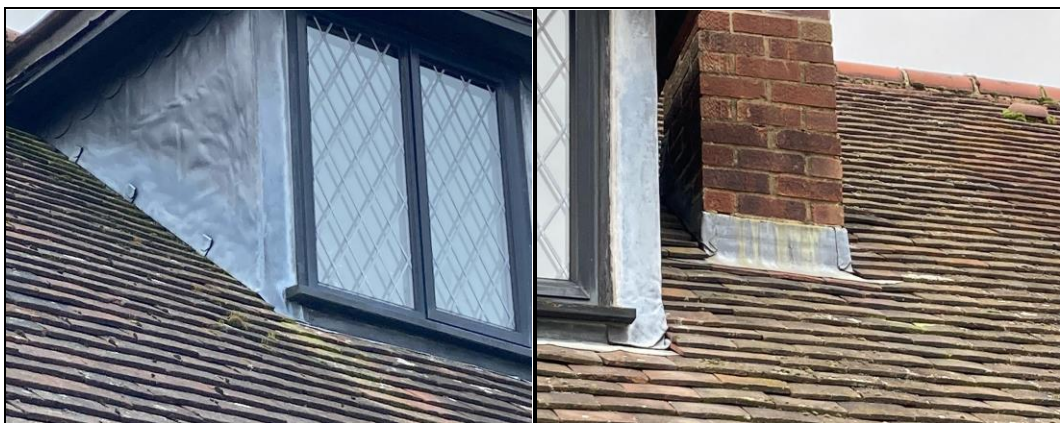
The house is of standard brick construction and the pitched, tiled roof has one chimney present on the rear elevation. This has standard metal flashing (see photograph 6 below) at its base which also appeared to be tight-fitting with the tiles and with no gaps visible from ground level.

Photographs 5 - 6: Close-fitting dormer flashings and chimney

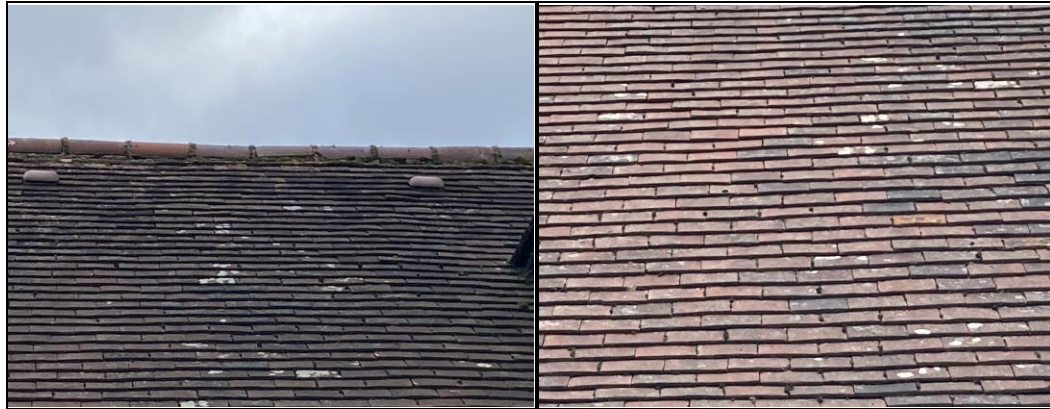
The roof tiles appeared to be in good condition throughout with no missing, raised or damaged tiles (see photographs 7 - 8 below) capable of allowing bat access into the roof.

Photographs 7 - 8: Roof tiles & ridge

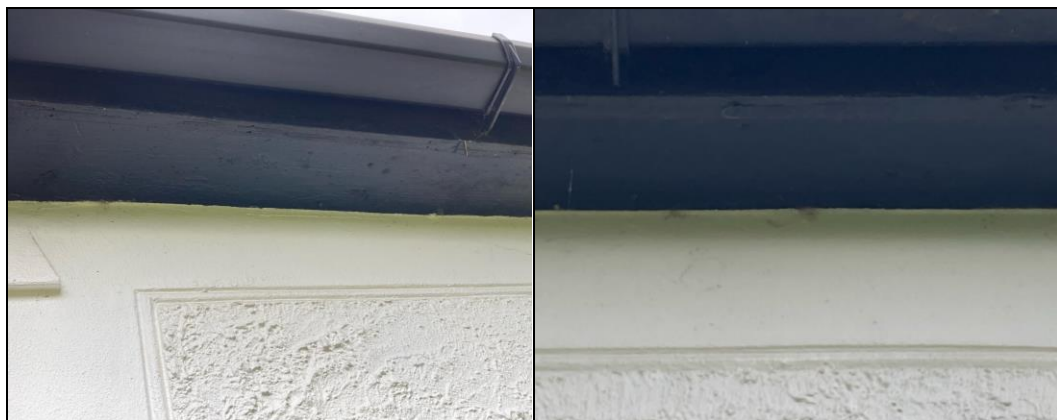
The various eaves, barge boards and soffits also appeared to be in excellent condition and were found to be tight-fitting with the walls (see photographs 9 - 10 below).

Photographs 9 - 10: Typical tight-fitting eaves/barge boards/soffits

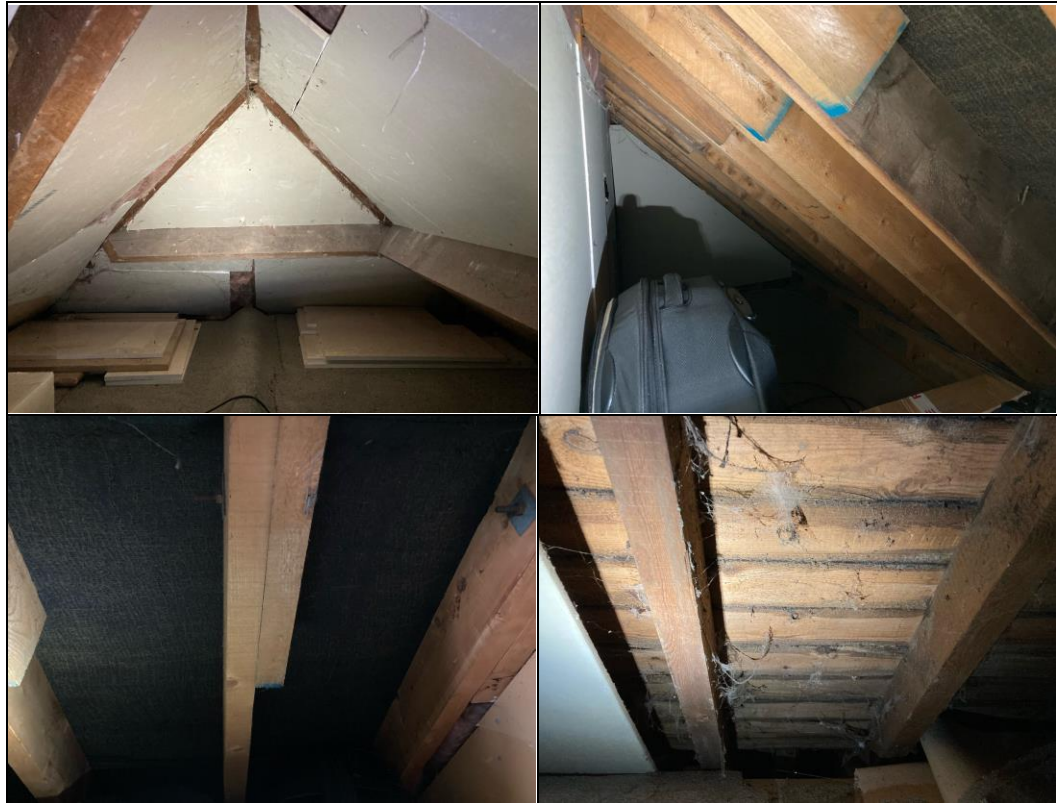
As a result of the extensive loft conversion, the only remaining voids (see photographs 11 - 12 below) are located in several separate sections above the eaves. These voids are used only for occasional storage.

The roof comprises rafters that are of modern sawn timber (see photograph 13 below) commensurate with the age of the property. There are no gaps or open mortise joints present that could provide potential roosting sites for bats.

The roof is both felt-lined, plasterboard-lined and lined with sarking in different places (see photograph 14 below). All of these materials are in excellent condition throughout.

Photographs 11 - 14: Internal roof voids at eaves

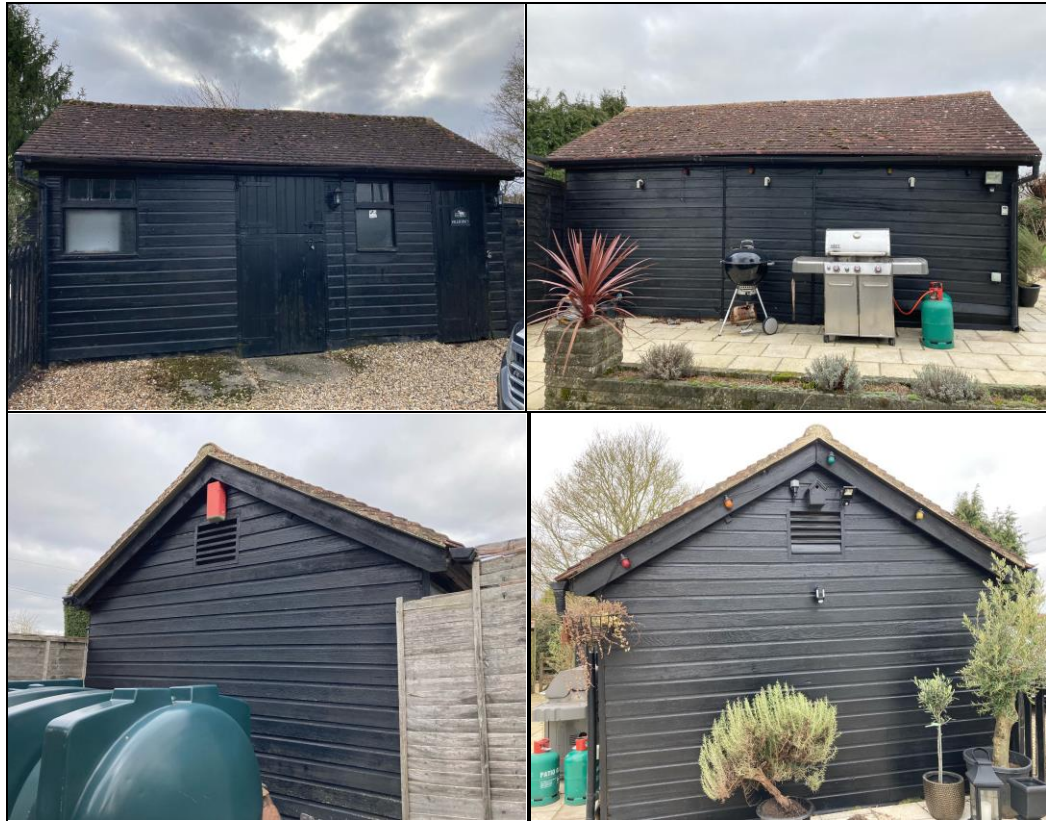
This building (see photographs 15 - 18 below) is a modern former stable unit that still retains the original half-split door on the front elevation, although it is now in regular use as a utility room and for sundry storage.

Photographs 15 - 18: Front, rear and side elevations

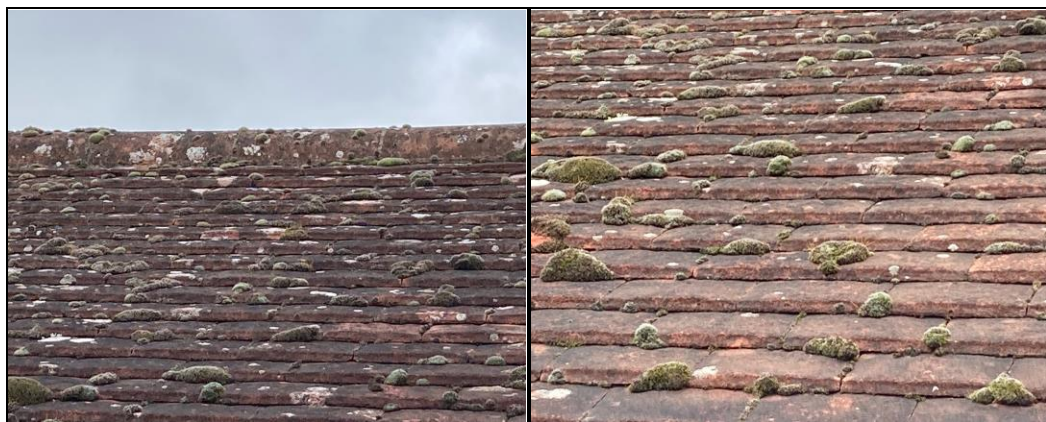
The building has a pitched, tiled roof (see photographs 19 - 20 below) which appeared to be in excellent condition throughout with no missing, raised or damaged tiles capable of allowing bat access into the roof.

Photographs 19 - 20: Roof tiles & ridge

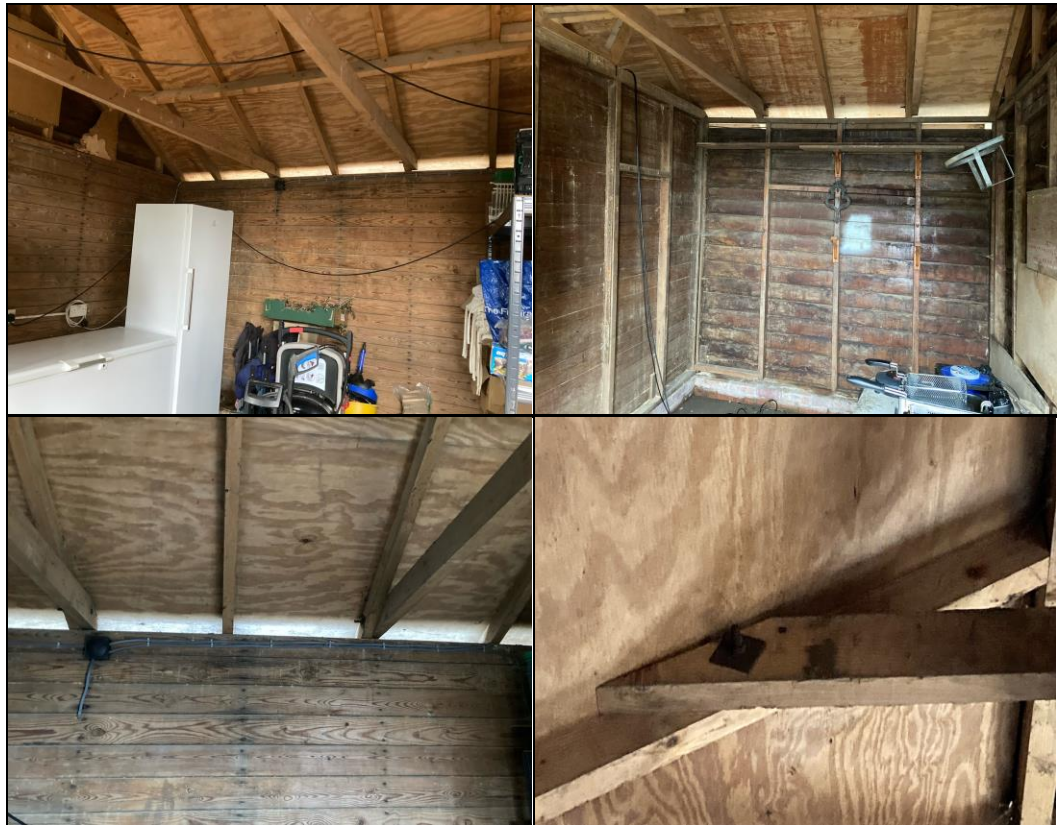
The roof is lined with wooden sheeting, (see photographs 21 - 24 below) but there is no loft void present and no roof insulation.

The tops of the walls at gutter level are open, leading to an extremely cold and draughty interior.

Photographs 21 - 24: Internal roof void

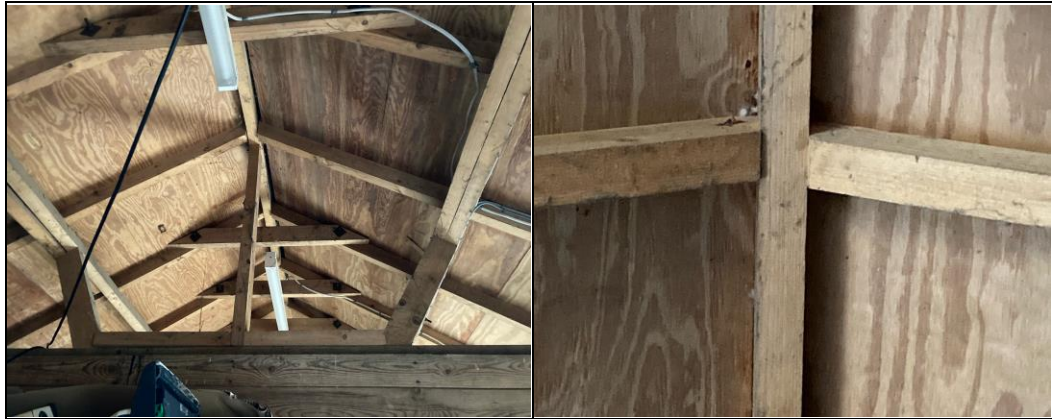
The narrow rafters (see photographs 25 - 26 below) are of modern-sawn timber, commensurate with the recent age of the unit, and lack any gaps, crevices or mortise joints that could afford potential roosting locations for bats.

Photographs 25 - 26: Central ridge beam & wooden boarding

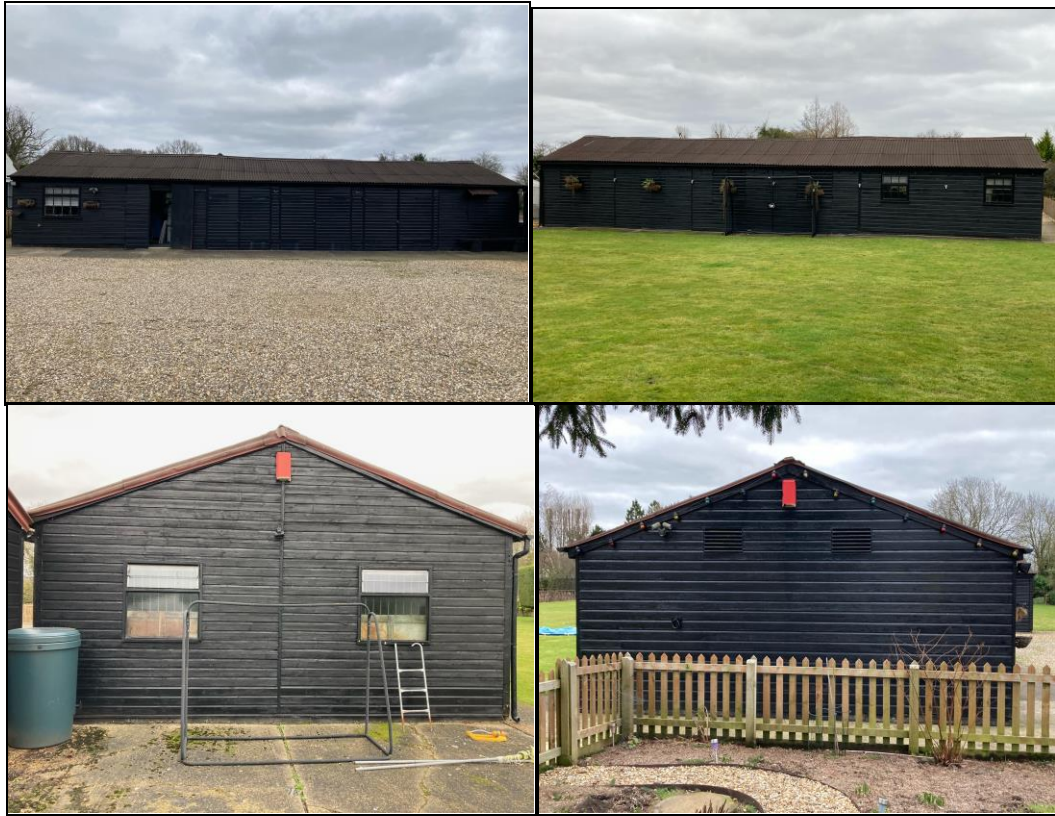
This building (see photographs 27 - 30 below) is a modern former stable unit, although it is now in use only for regular storage. It has wooden walls that are lined with boarding and one internal dividing wall that reaches the main ridge.

Photographs 27 - 30: Front, rear & side elevations

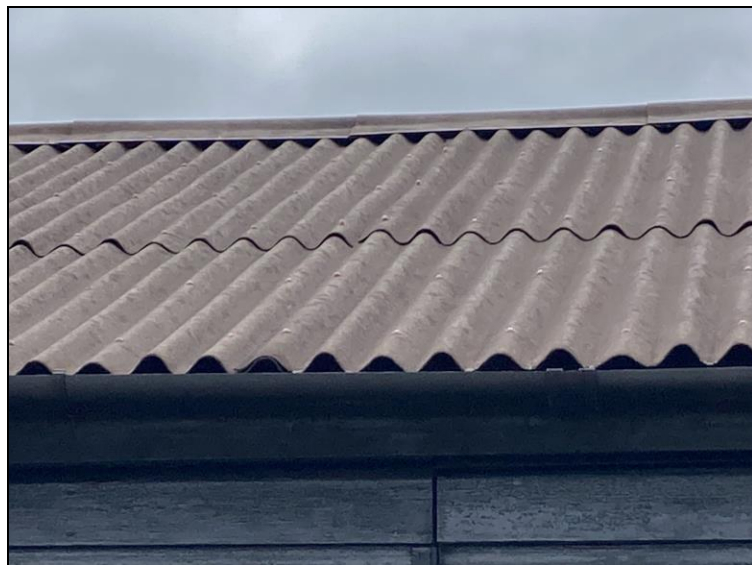
It has a pitched, corrugated bitumen sheet roof (see photograph 31 below) which appeared to be in excellent condition.

Photograph 31: Corrugated bitumen sheet roof in excellent condition

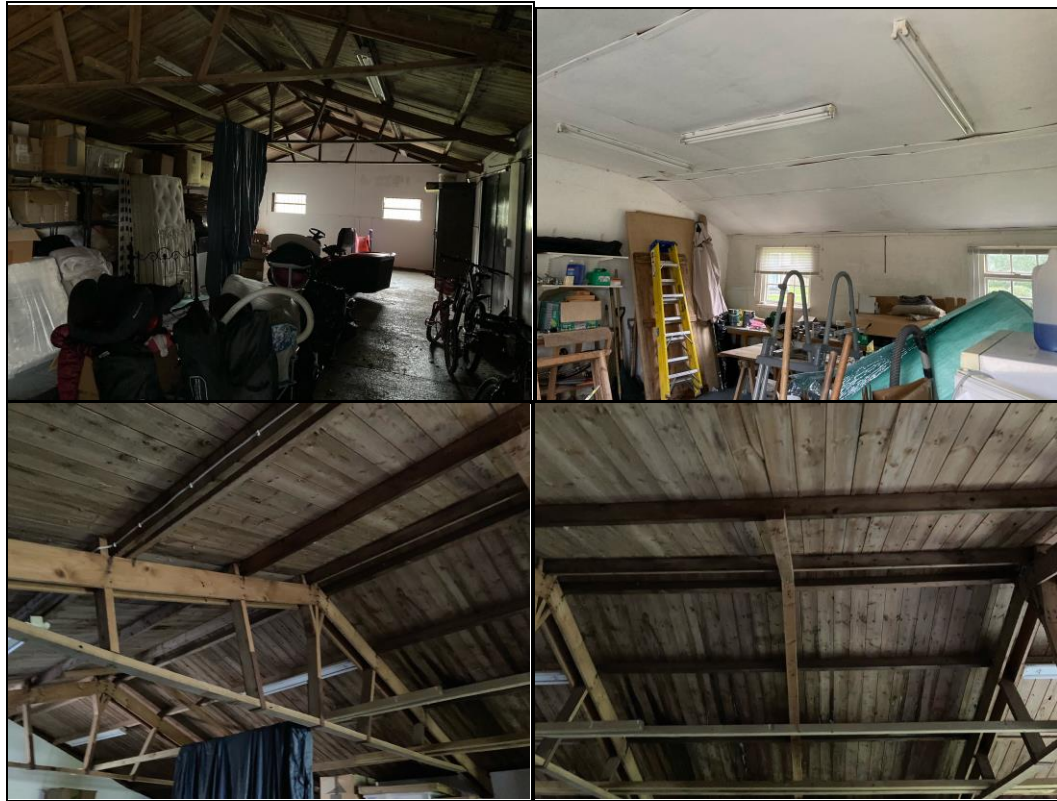
The roof is lined with wooden boarding (see photographs 32 - 35 below) but there is no loft void present, except at one end that is used as a small office/storage room, and no roof insulation.

Photographs 32 - 35: Internal roof void

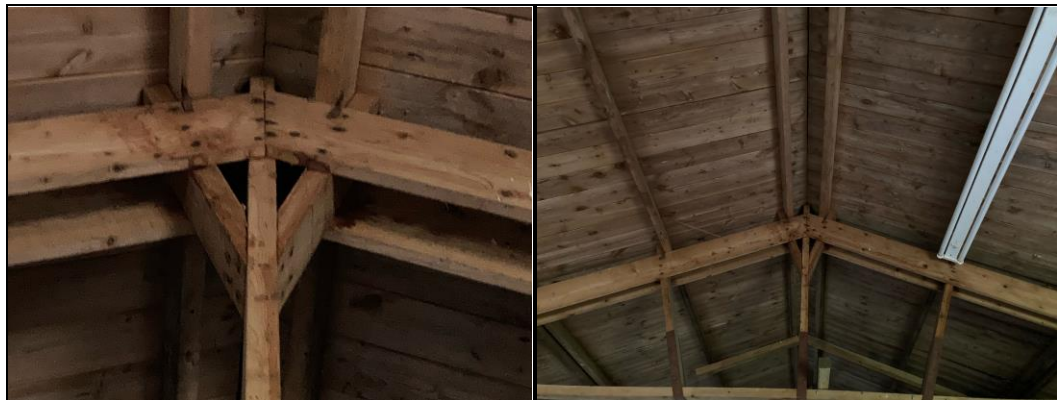
The narrow rafters (see photographs 36 - 37 below) are of modern-sawn timber, commensurate with the recent age of the structure, and lack any gaps, crevices or mortise joints that could afford potential roosting locations for bats.

Photographs 36 - 37: Narrow rafters & wooden lining

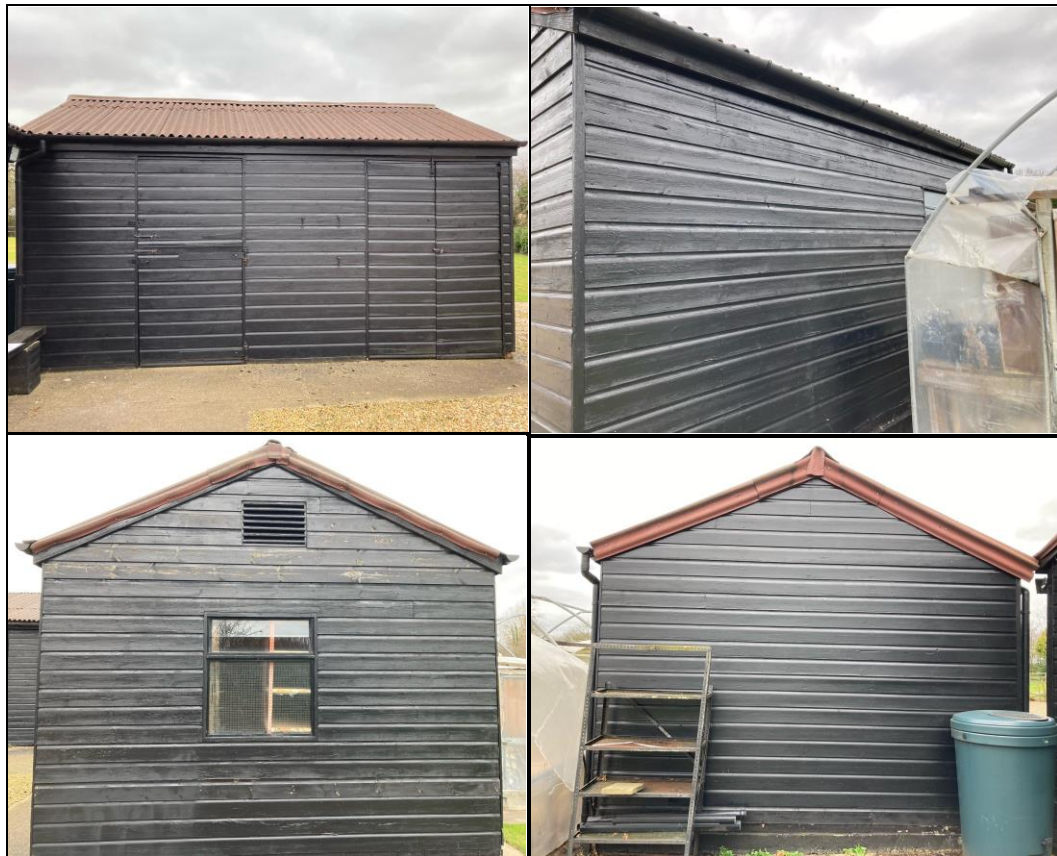
This small building (see photographs 38 - 41 below), located next to the main stable block, is a modern former stable unit, although it is now completely empty and unused. It has wooden walls that are lined with chipboard up to a height of approximately 1.25 metres and one internal dividing wall that reaches to gutter level only.

Photographs 38 - 41: Front, rear & side elevations

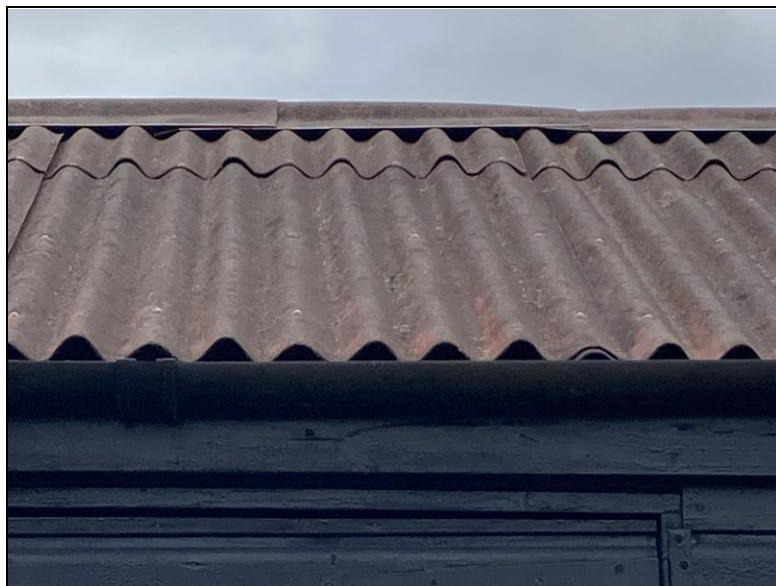
It has a pitched, corrugated bitumen sheet roof (see photograph 42 below) which appeared to be in excellent condition.

Photograph 42: Corrugated bitumen sheet roof in excellent condition

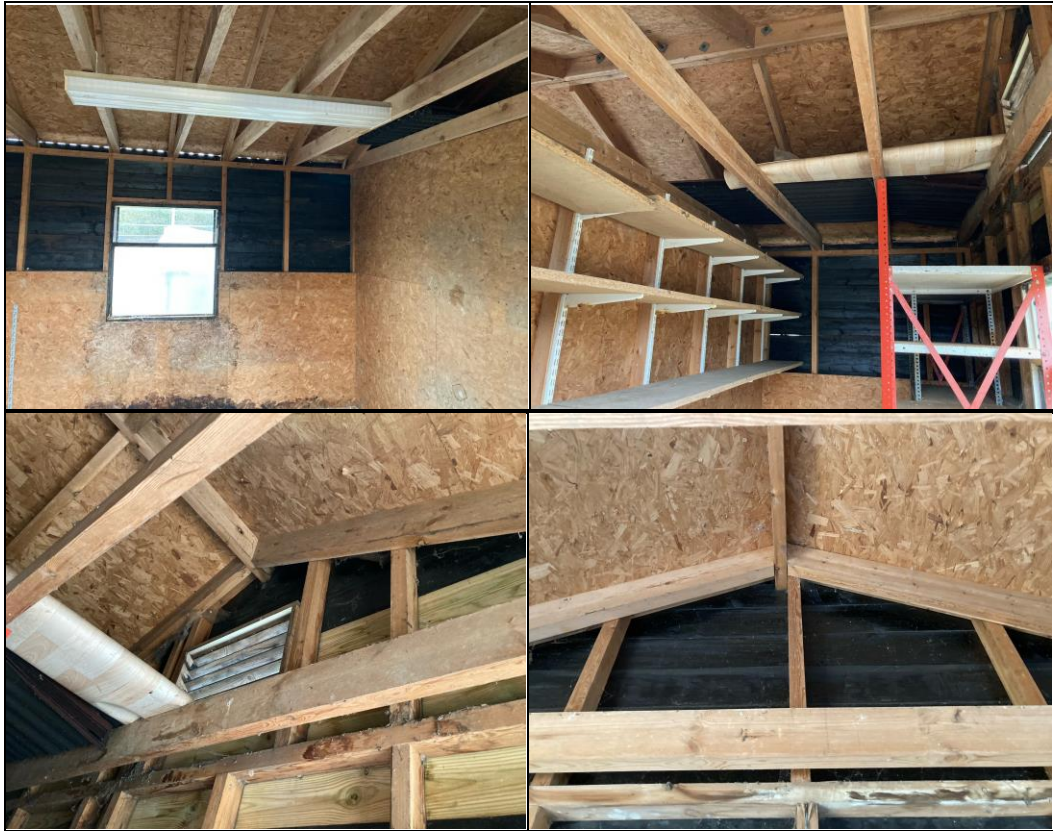
The roof is lined with chipboard (see photographs 43 - 46 below) but there is no loft void present and no roof insulation.

Photographs 43 - 46: Internal roof void

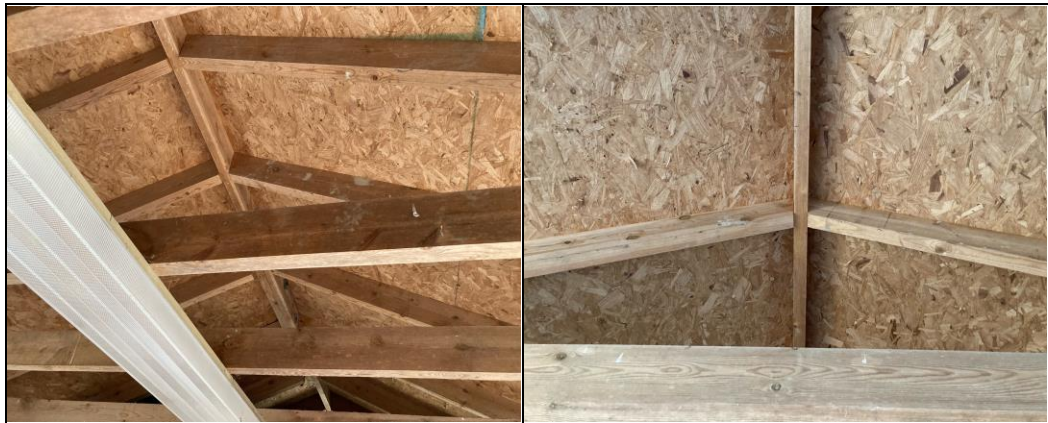
The narrow rafters and ridge (see photographs 47 - 48 below) are of modern-sawn timber, commensurate with the recent age of the structure, and lack any gaps, crevices or mortise joints that could afford potential roosting locations for bats.

Photographs 47 - 48: Narrow rafters & wooden lining
