QUINQUENNIAL INSPECTION REPORT
of

SAWBRIDGEWORTH EVANGELICAL CONGREGATIONAL CHURCH

Date of Inspection: 22nd November 2023

MC/cp/ss/C328/1
15th December 2023

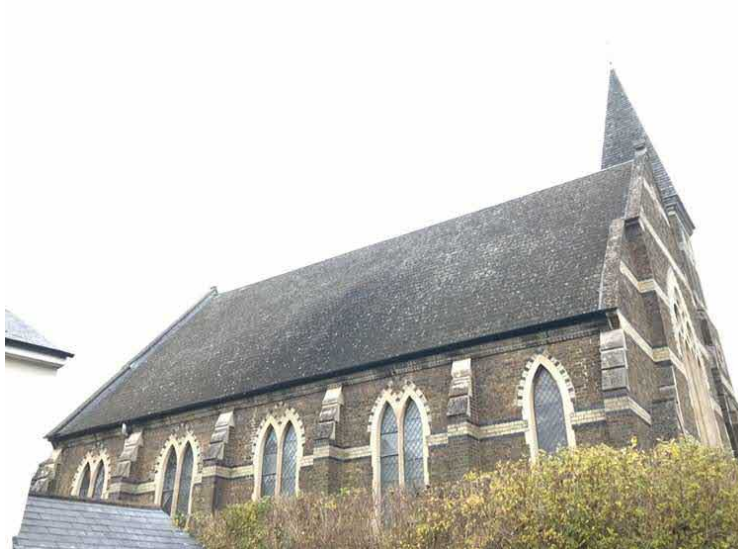
2.2 **Main chapel south elevation:** finished with eternit-type mineral slates, with lead flashings at parapets to the front and rear.

Condition: largely in good condition. There is one missing slate just below the ridge to the rear gable. The ridge tile here also needs repointing. There appear to have been several repairs to the front parapet flashing which currently appears to be in sound condition.

Repairs needed: replace missing slate and repoint ridge tile.

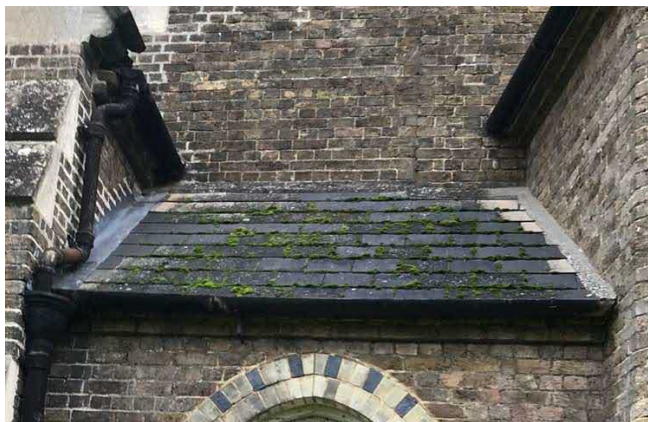
- 2.10 **Roof over rear store:** small single-pitched roof finished with fibrous tiles and cement fillets and lead flashings against surrounding walls.

Condition: appears generally in good condition, with only a large amount of moss present a concern.

Repairs needed: clean down roof covering and remove moss to prevent blocking-up of gutter.

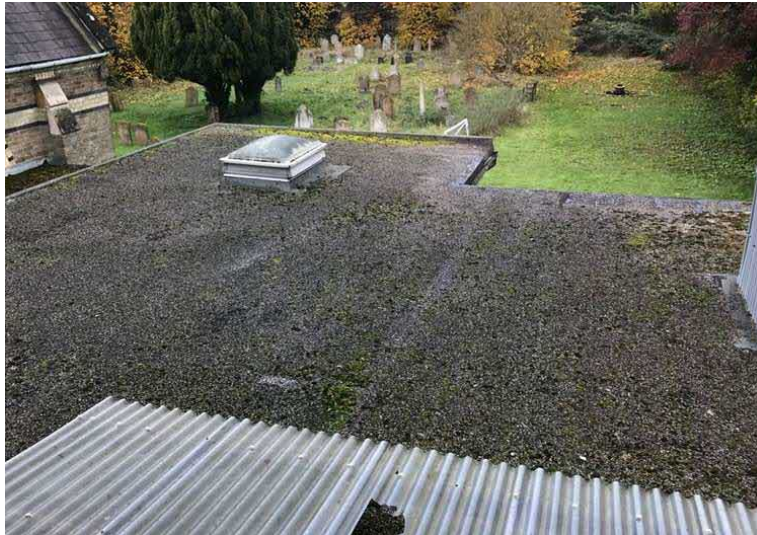
Condition: the felt roof finish appears to be largely in sound condition. However, there are areas of weakness and splits and cracks present even through the current shingle finish on top. There is a dip in the roof finish beneath the canopy between this roof and the rear of the schoolroom building which is likely being caused due to deterioration of the timber decking boards beneath the finish, which would be caused by a more major defect and deterioration of the roof covering in this area. The roof light appears to be well detailed and in good condition. The corrugated metal enclosure is industrial but functional, with some corrosion to fixing screws, but largely sound. An asbestos overflow pipe passes through.

Repairs needed: replace felt covering to flat roof and allow to replace areas of rotten decking board beneath and allow for minor structural repairs, depending on findings once works begin.

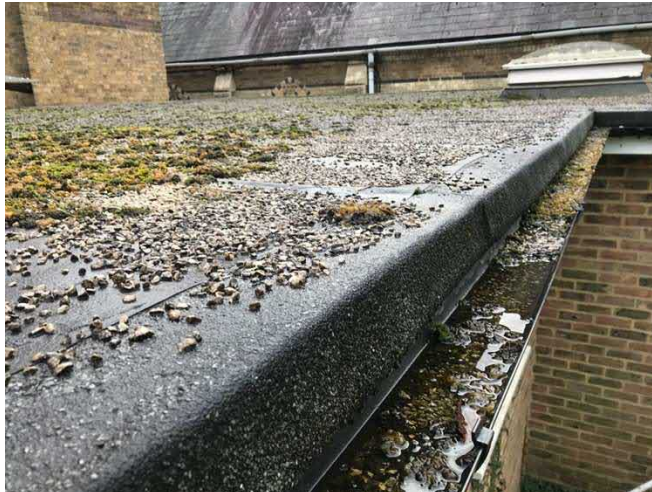
Condition: in good order. However, they require cleaning through.

Repairs needed: clean out gutters and downpipes.

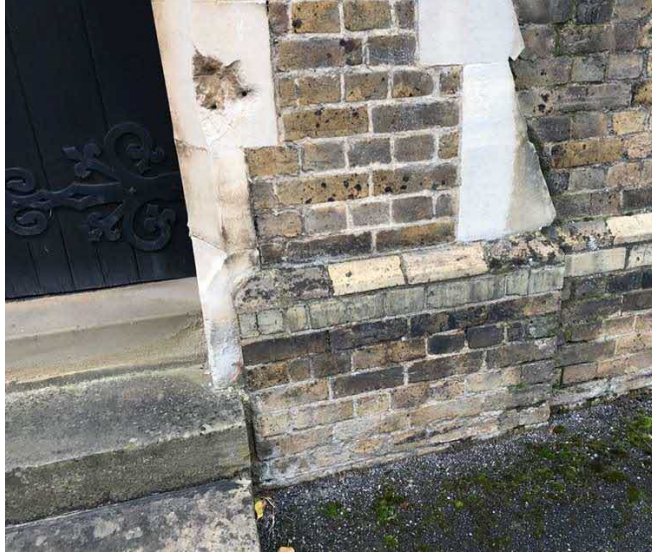
Condition: this elevation appears largely in good condition except for some eroded mortar joints at low level in areas and historic cracking evident which has previously been repointed. The stonework to the southern entrance door is in an acceptable condition, however there are areas of deteriorating surface and a damaged quoin to the reveal where a previous handrail has been removed.

Repairs needed: carry out repointing at low level to the brickwork and pare back soft areas of stone and apply a lime shelter coat.

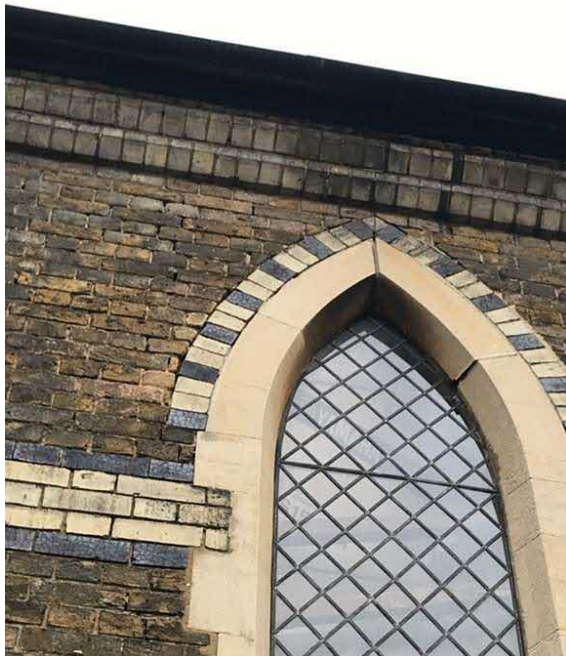
Condition: there is some deterioration and minor cracking over the arch to the easternmost window that requires repointing. This indicates a small amount of settlement or structural movement to the southeast corner.

Repairs needed: carry out repointing to east over stone window arch and monitor minor cracking for further movement.
