QUINQUENNIAL INSPECTION REPORT
of

SAWBRIDGEWORTH EVANGELICAL CONGREGATIONAL CHURCH

Date of Inspection: 22nd November 2023

**QUINQUENNIAL INSPECTION REPORT 2023
SAWBRIDGEWORTH EVANGELICAL CONGREGATIONAL CHURCH**

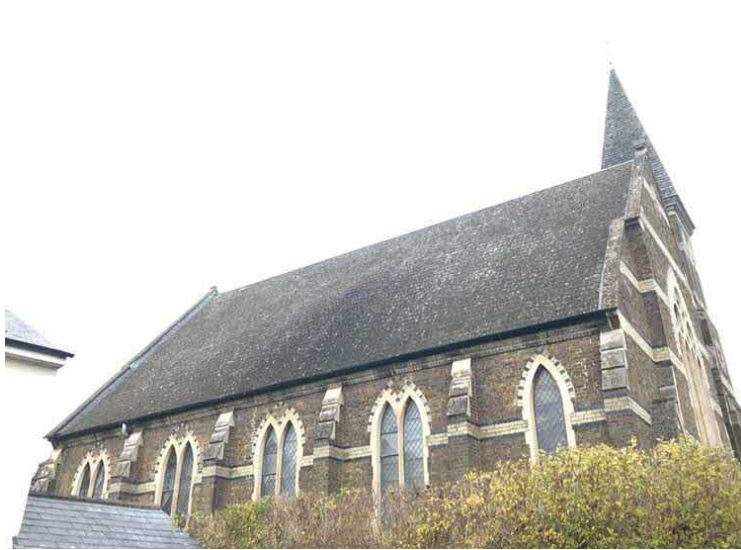
2.2 **Main chapel south elevation:** finished with eternit-type mineral slates, with lead flashings at parapets to the front and rear.

Condition: largely in good condition. There is one missing slate just below the ridge to the rear gable. The ridge tile here also needs repointing. There appear to have been several repairs to the front parapet flashing which currently appears to be in sound condition.

Repairs needed: replace missing slate and repoint ridge tile.

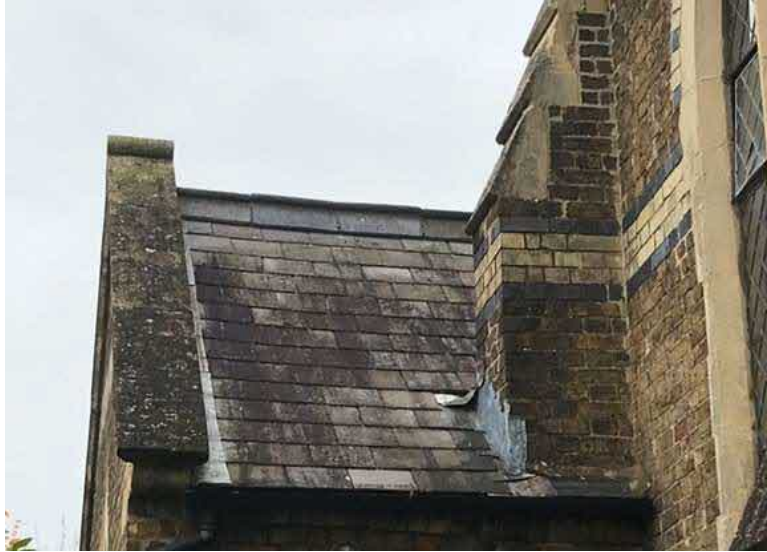
Condition: there is some minor deterioration of a few slates but nothing requiring repair at this stage. Generally the roof covering is in good condition.

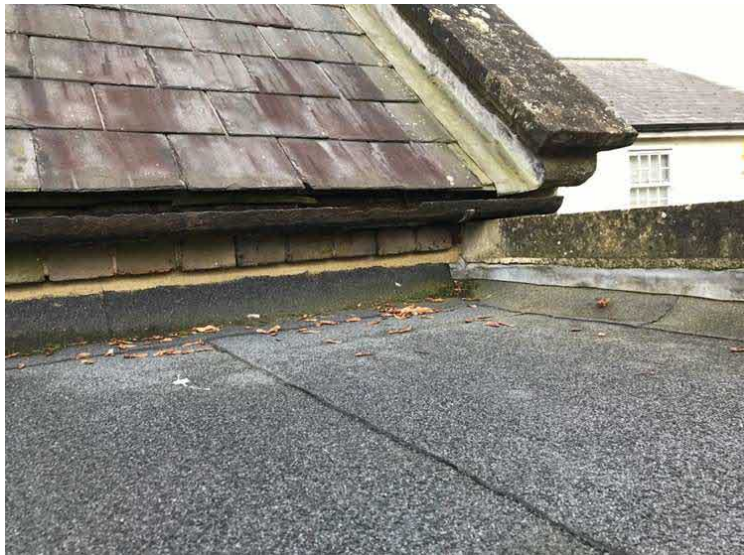
- 2.5 **Toilet off vestry:** this is an addition to the rear of the building, finished with a flat roof covered with bituminous felt over a timber deck.

Condition: this felt has been replaced recently and adequately pointed into the brickwork, with no obvious signs of defects or leaks internally.

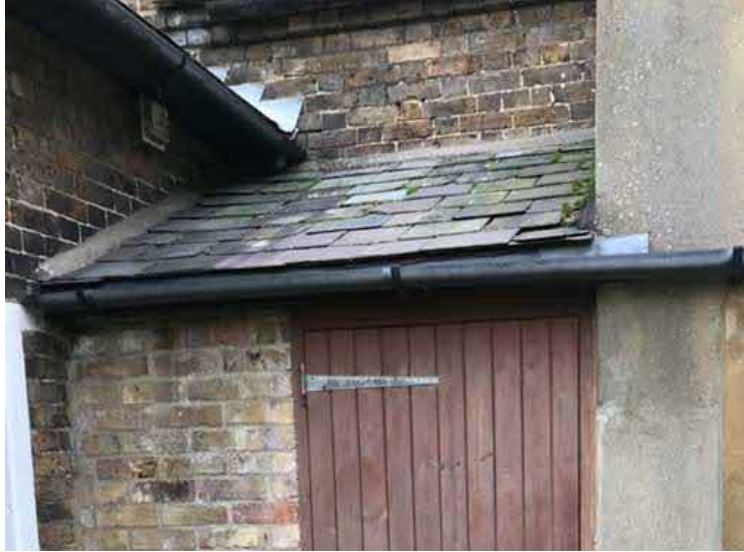
- 2.6 **External storage room next to vestry toilet:** a natural slate roof laid with a random mix of different types of slates, several of which appear to be old re-used slates, with mortar fillets at abutments to walls.

Condition: several slates are deteriorating, and some repairs are required in order to prevent water ingress in coming years.

Repairs needed: replace deteriorated slates.

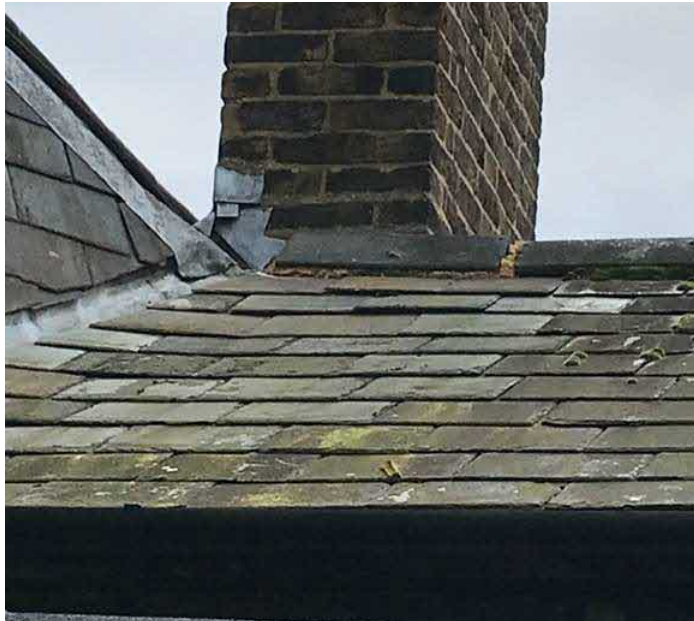
Condition: the tiles are in acceptable condition. However, there is a large amount of moss growth. A recently rebedded ridge tile has poorly finished mortar bedding which has come loose and slipped down the roof.

Repairs needed: clean down and remove moss from roof and rebed ridge tile with new mortar.

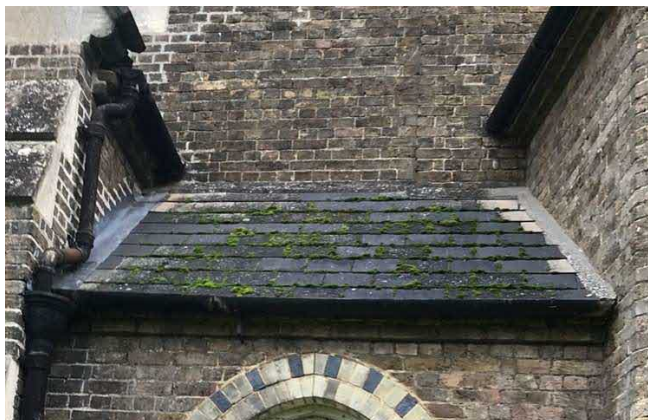
- 2.10 **Roof over rear store:** small single-pitched roof finished with fibrous tiles and cement fillets and lead flashings against surrounding walls.

Condition: appears generally in good condition, with only a large amount of moss present a concern.

Repairs needed: clean down roof covering and remove moss to prevent blocking-up of gutter.

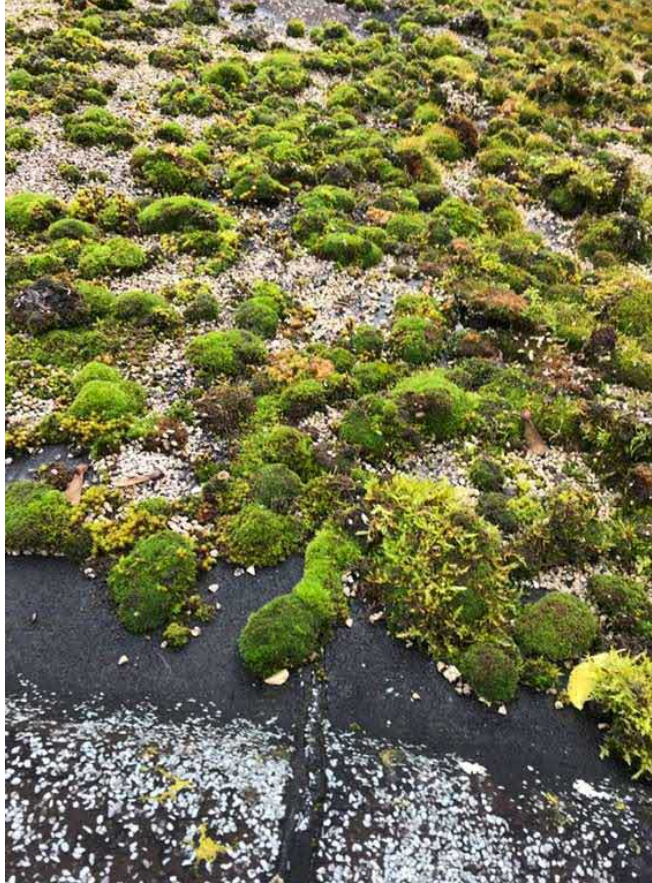
Condition: this roof finish is starting to deteriorate, with some cracks beginning to occur at junctions. There is a split in the lead at the upstand to the rear elevation at the felt joint, with another split in the corner and other signs of distress where the felt turns up to form the flashing. Some repairs are required in the short term with a complete renewal likely to be necessary within the next five years.

Repairs needed: carry out repairs to splits in roof finish.

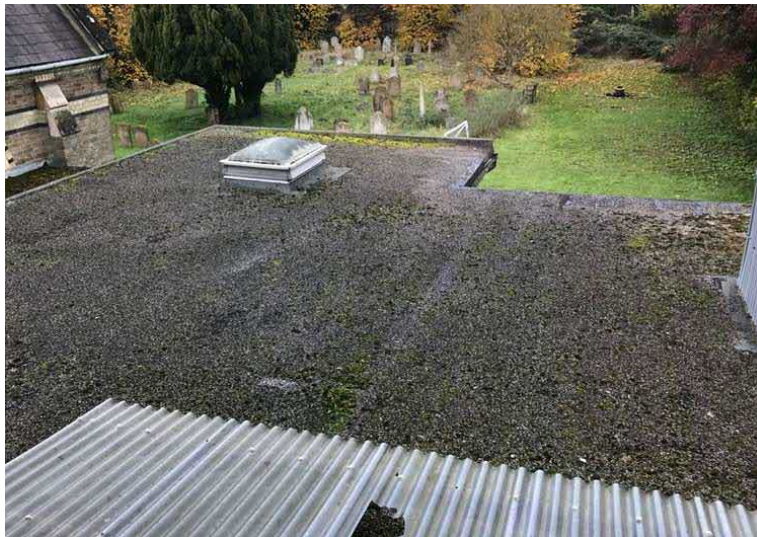
Condition: the felt roof finish appears to be largely in sound condition. However, there are areas of weakness and splits and cracks present even through the current shingle finish on top. There is a dip in the roof finish beneath the canopy between this roof and the rear of the schoolroom building which is likely being caused due to deterioration of the timber decking boards beneath the finish, which would be caused by a more major defect and deterioration of the roof covering in this area. The roof light appears to be well detailed and in good condition. The corrugated metal enclosure is industrial but functional, with some corrosion to fixing screws, but largely sound. An asbestos overflow pipe passes through.

Repairs needed: replace felt covering to flat roof and allow to replace areas of rotten decking board beneath and allow for minor structural repairs, depending on findings once works begin.

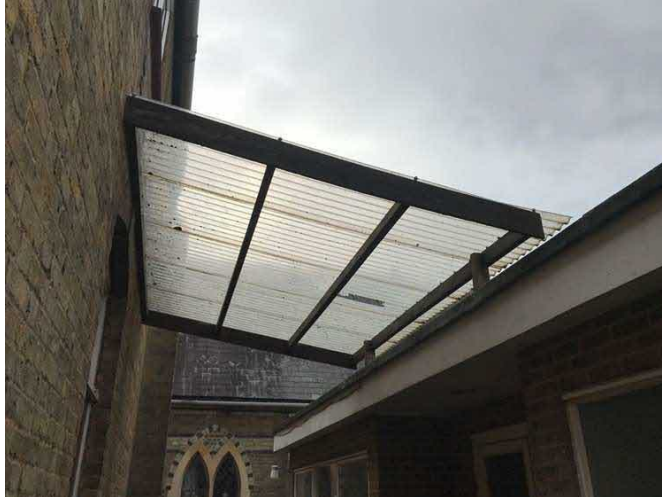
Condition: generally sound. However, one sheet of uPVC has been broken, likely by a falling tile from the schoolhouse roof.

Repair needed: clean down canopy and replace damaged section.

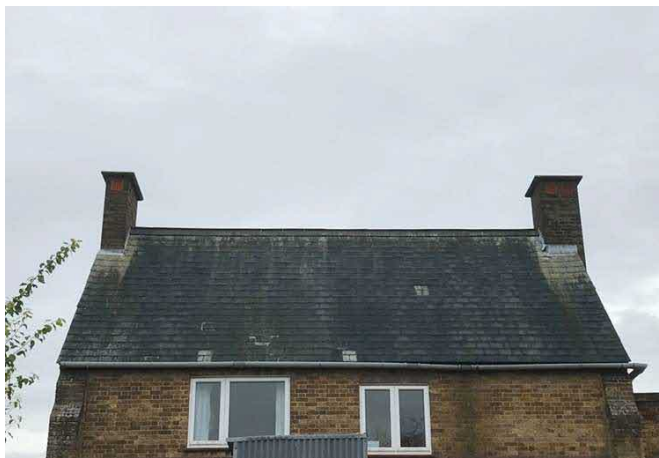
- 2.15 **Schoolroom roof:** a natural slate roof. The slates do not appear to originate from the United Kingdom and are likely to be Spanish. There are some signs of iron ore within the slates beginning to corrode in places. The roof is finished at the ridge with Staffordshire blue ridge tiles with lead flashings at abutments.

Condition: there are a number of slipped or missing slates to the rear slope and several others appear loose. The mortar joints between the ridge tiles appear to be open and in need of repointing. The lead flashings at the rear junctions to the chimneys both need some redressing where they are starting to come away from the chimneys. To the front there are a few broken slates to the south slope of the front projecting gable as well as one or two broken slates on the front slope itself. Access to the parapet gutter and valley was not possible, and so could not be confirmed the condition of this area.

Repairs needed: replace missing tiles, rebed ridge tiles and refix any loose and slipping tiles, refix and redress lead flashings as required.

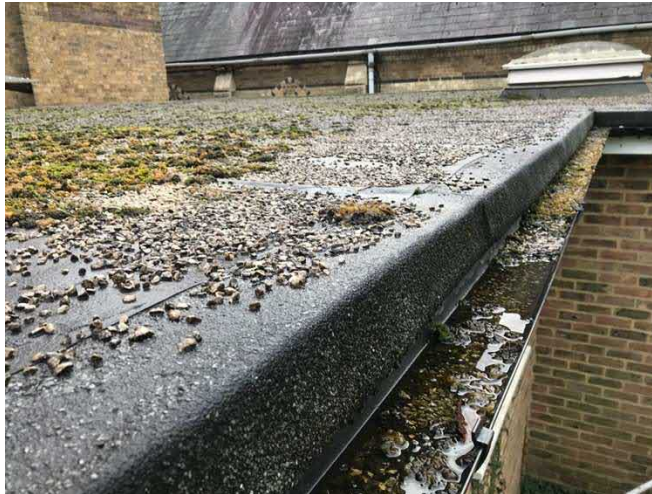
Condition: in good order. However, they require cleaning through.

Repairs needed: clean out gutters and downpipes.

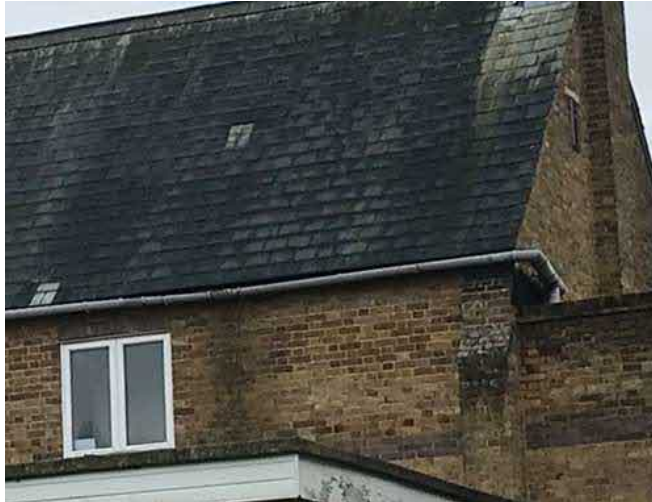
Condition: the uPVC gutters to the rear of the schoolroom are dropping in an area above the canopy. Cast iron ogee gutters to the front elevation have leaking and corroding joints.

Repairs needed: clean, reseal joints and redecorate cast iron gutters and refix uPVC guttering to the rear to provide adequate falls.

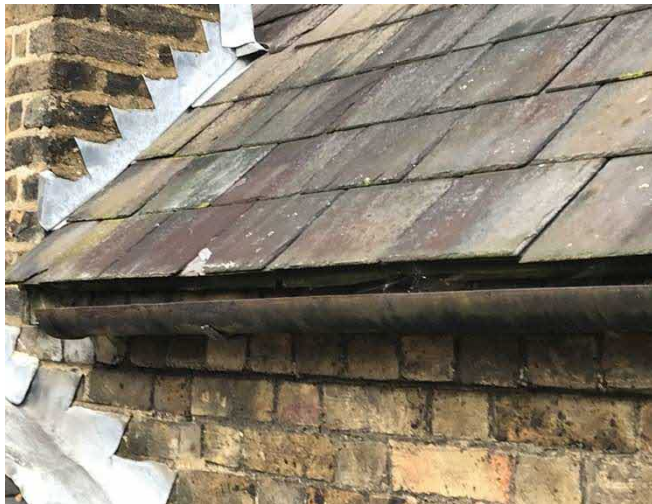
Condition: this gutter is heavily corroded in places and is missing a section over the boiler house.

Repairs needed: replace gutter.

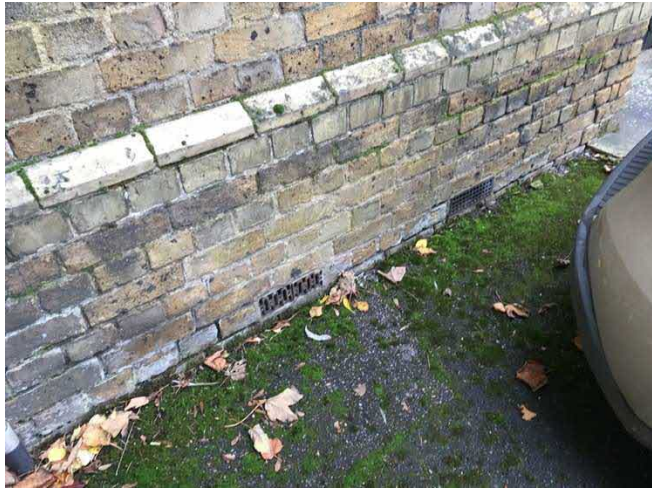
- 4.1 **North aisle hall east elevation:** of buff clay bricks with quite open and porous texture with burnt patches and a colour mix. There are denser and more uniform buff Cant bricks at the steps in the wall, forming banding and decorative detailing along with Staffordshire blue engineering bricks. Stone window and door surrounds forming cills and arched openings and a stone central triple quatrefoil window. There are two cast iron vents in the wall at low level providing ventilation to the underfloor void.

Condition: the cast iron vents at low level are just above external ground level, which creates a risk of water washing back into the vents below the timber floors. However, the tarmac does fall away from the wall. To the wall itself there are several open mortar joints in random places across this elevation.

Repairs needed: carry out patch pointing to the lower levels to the brick plinths at low level to the wall as required.

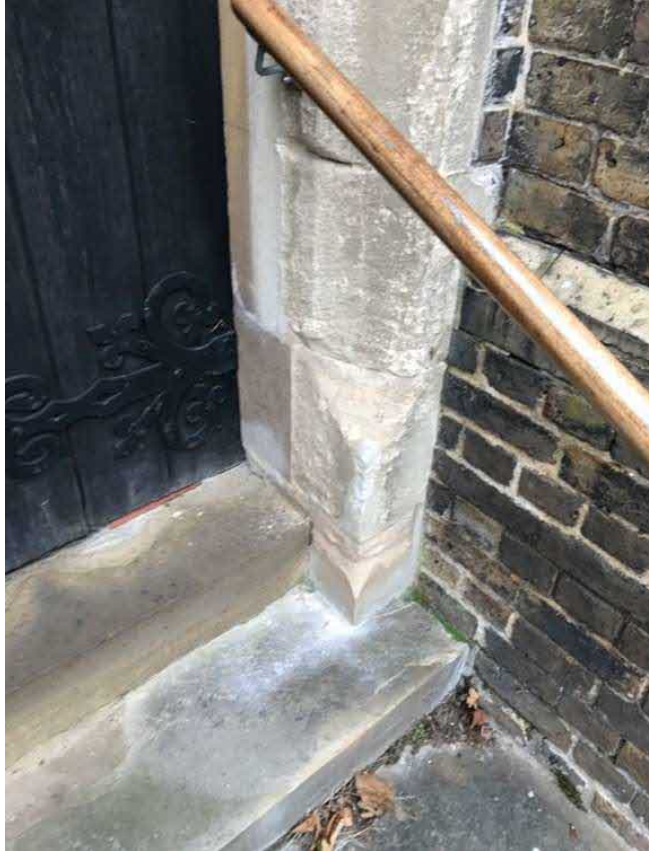
Condition: generally all in sound condition. However, at low level there are areas of pointing missing to the brickwork and to the stone surround of the main door. There are areas of heavy decay and deterioration.

Repairs needed: carry out repointing to the brickwork as needed and pare back soft areas of stonework and apply lime-based shelter coat.

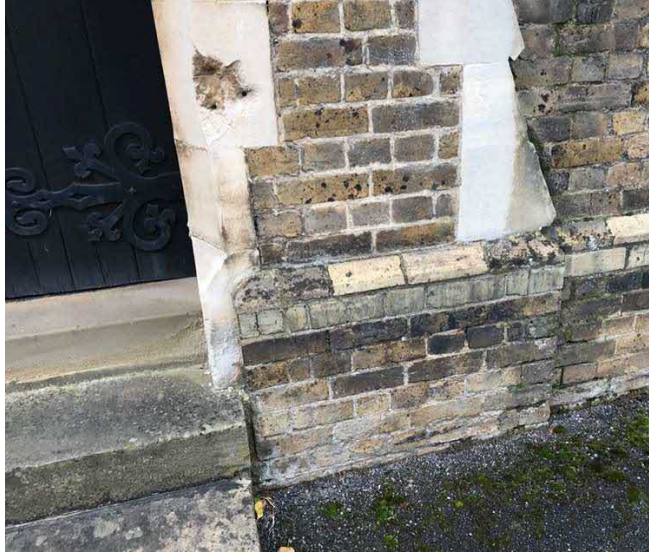
Condition: this elevation appears largely in good condition except for some eroded mortar joints at low level in areas and historic cracking evident which has previously been repointed. The stonework to the southern entrance door is in an acceptable condition, however there are areas of deteriorating surface and a damaged quoin to the reveal where a previous handrail has been removed.

Repairs needed: carry out repointing at low level to the brickwork and pare back soft areas of stone and apply a lime shelter coat.

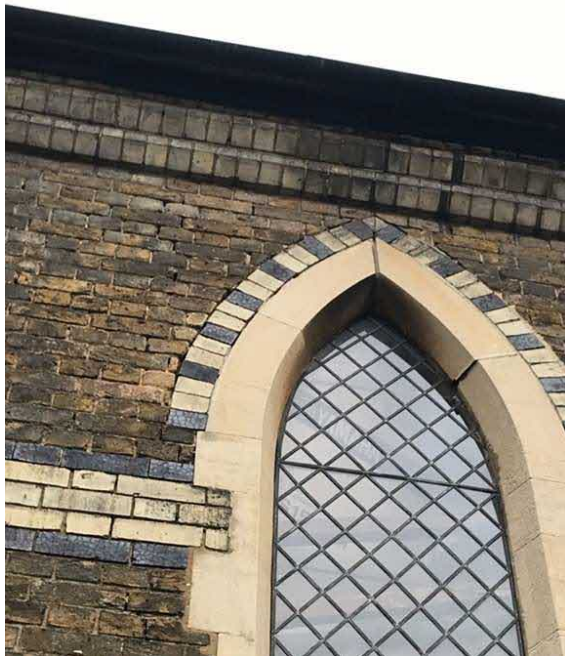
Condition: there is some deterioration and minor cracking over the arch to the easternmost window that requires repointing. This indicates a small amount of settlement or structural movement to the southeast corner.

Repairs needed: carry out repointing to east over stone window arch and monitor minor cracking for further movement.

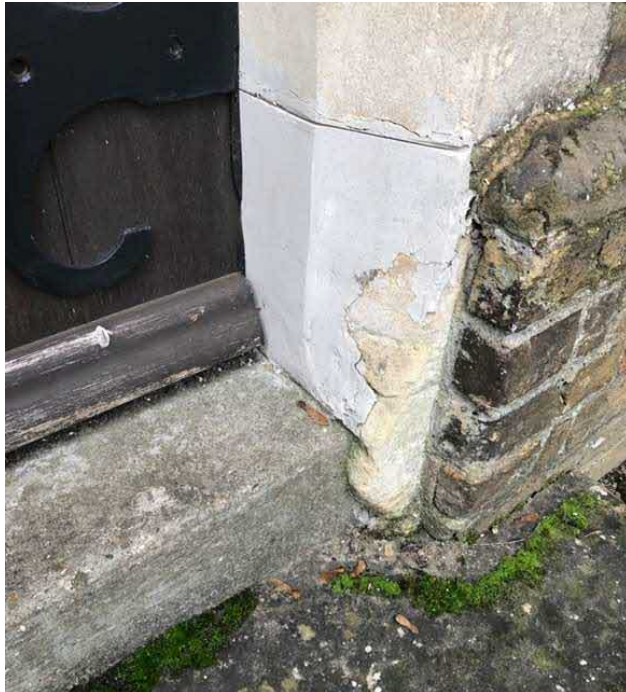
Condition: generally in good condition. However, there is some deterioration and decay of stone door surround at low level.

Repairs needed: remove poor quality historic repair to stone reveal and apply lime shelter coat throughout.

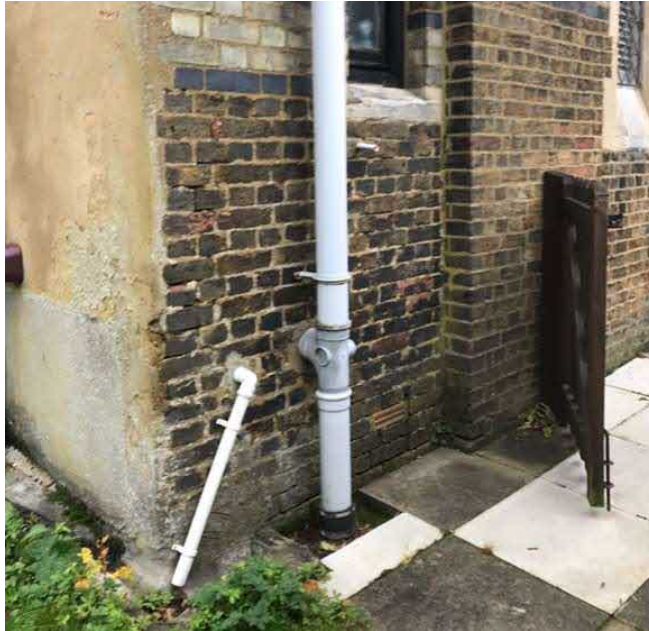
Condition: the surface of the render has cracked and is starting to deteriorate. The pointing to the brickwork on the south side is very poor and missing in many areas, particularly at low level.

Repairs needed: repoint brickwork to south wall and re-render wall to west.

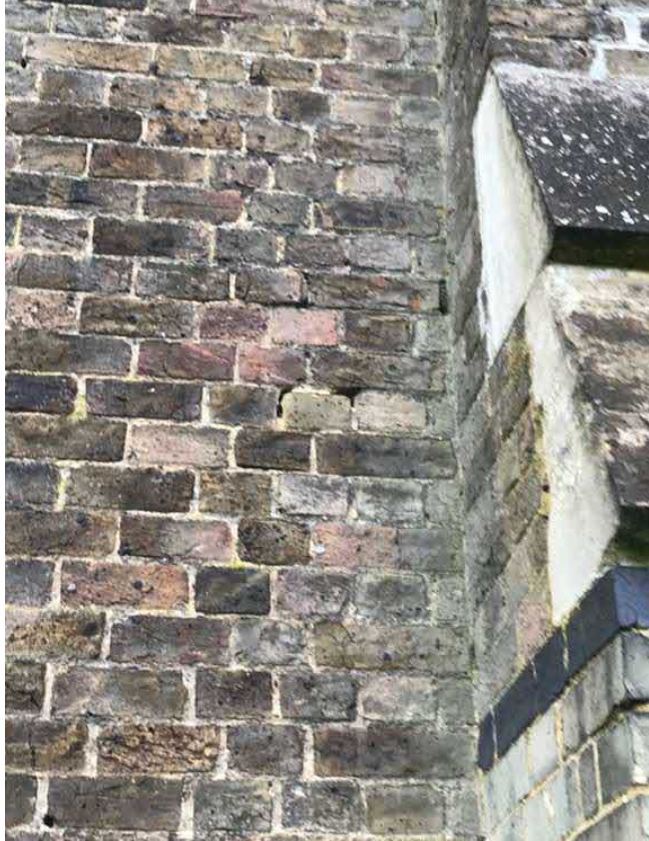
Condition: all in sound condition, with only small, isolated areas of pointing missing.

Repairs needed: carry out patch pointing where required.

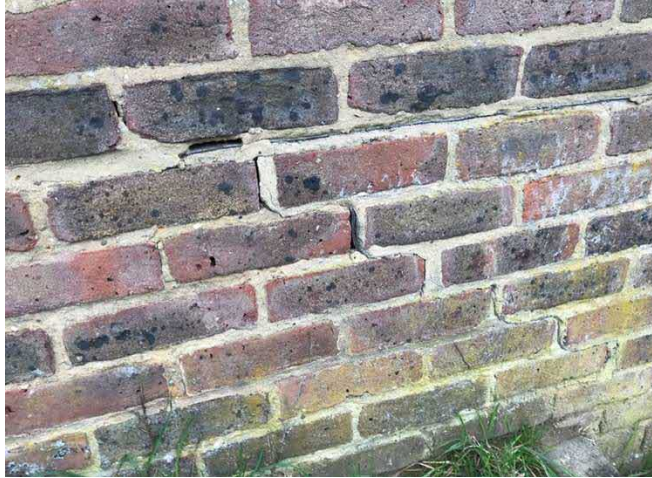
Condition: generally in sound condition. However, there are sections of pointing missing around the DPC.

Repairs needed: repoint areas of missing mortar around DPC.

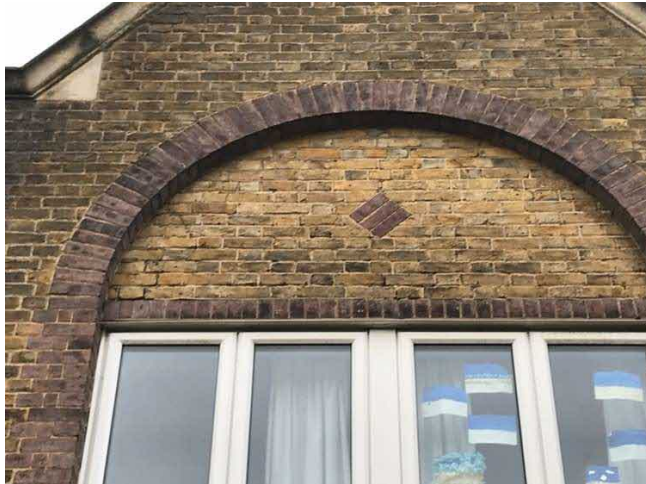
Condition: some of the stonework cappings and detailing are beginning to deteriorate, particularly below the gutters on the front elevation. The brickwork from which the walls are constructed is generally very porous, with many holes and voids, which accentuates damp problems internally. There are several areas of open mortar joints across the elevations where some repointing is required, including over the northern windows at first floor level to the front elevation, over the central window on the front elevation, over the steps on the west elevation and above the canopy on the west elevation. These walls have been built with a damp proof course present which is evident on the west elevation and in some areas along the front elevation. Damp problems internally would suggest that this damp proof course is not effective. Injecting a new damp proof course is likely to be of limited effect. There is minor cracking below the window to the front elevation where the stone pediment is located and the DPC below is also poorly pointed.

Repairs needed: replace deteriorated stone and allow to repoint areas of missing mortar across the brick elevations.

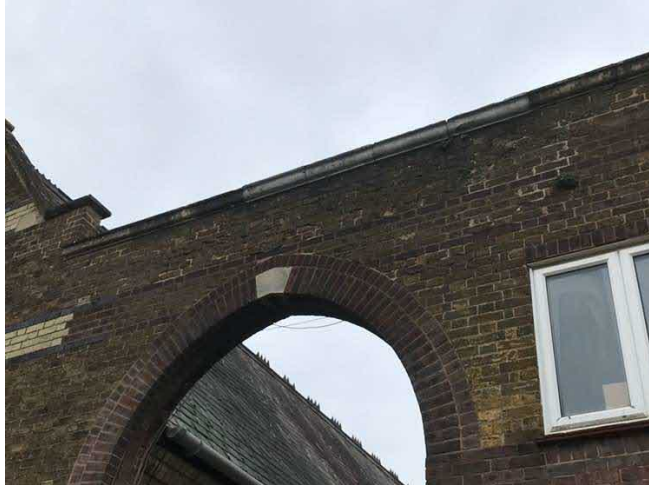
Condition: there has been repointing in various places over the years to the brickwork over this archway. There is currently some surface deterioration to the brickwork although not to the degree where any repair is required. Erosion is occurring on the capping stones and on both elevations, there is some plant growth from the face of the brickwork which will require periodic cleaning back.

Repairs needed: clean back plant growth and repoint as required to brickwork and stone cappings.

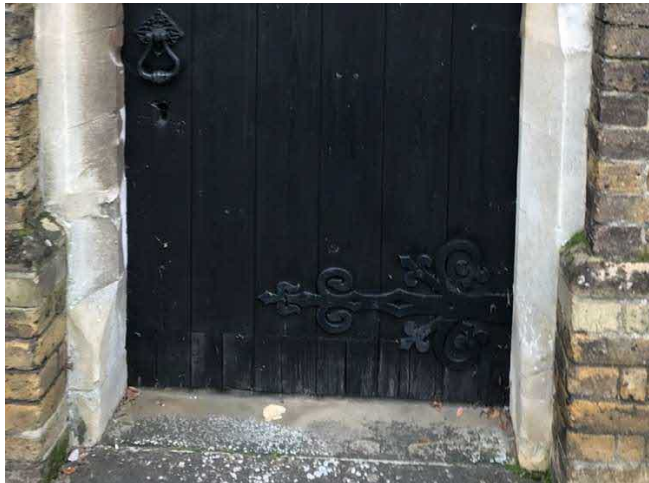
Condition: the door appears generally in good condition, however requires redecoration.

Repairs needed: redecorate door, including ironmongery.

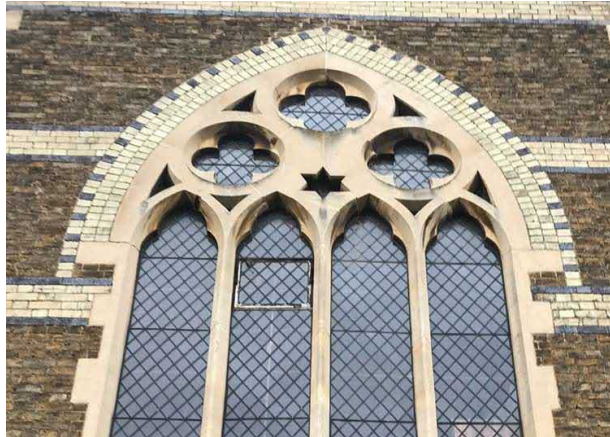
Condition: there is some unevenness to some of the leaded glazing due to some distortion and deterioration to the decorations of the opening light, however, generally still in sound condition.

Repairs needed: redecorate opening light.

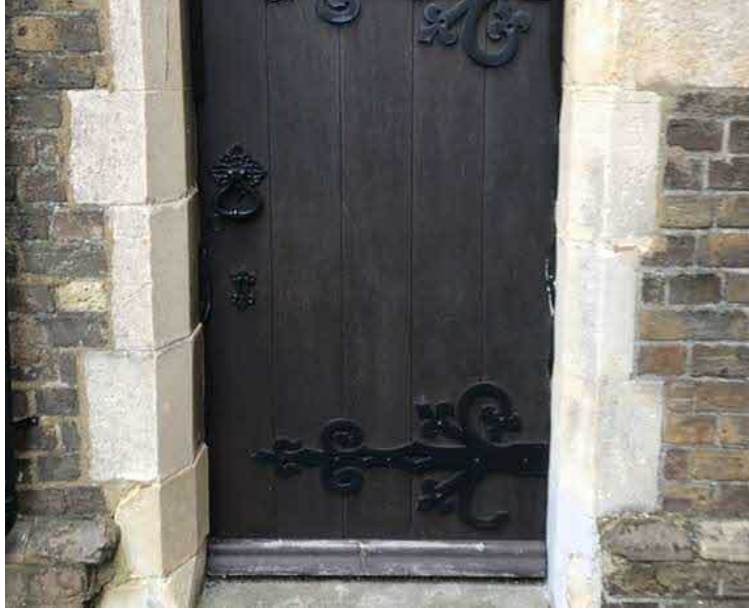
Condition: the door is generally in good condition. However, it requires redecoration and the weatherproof sealing reinstated as it has slipped out of the reveals.

Repairs needed: redecorate door and ironmongery and replace sealant around door.

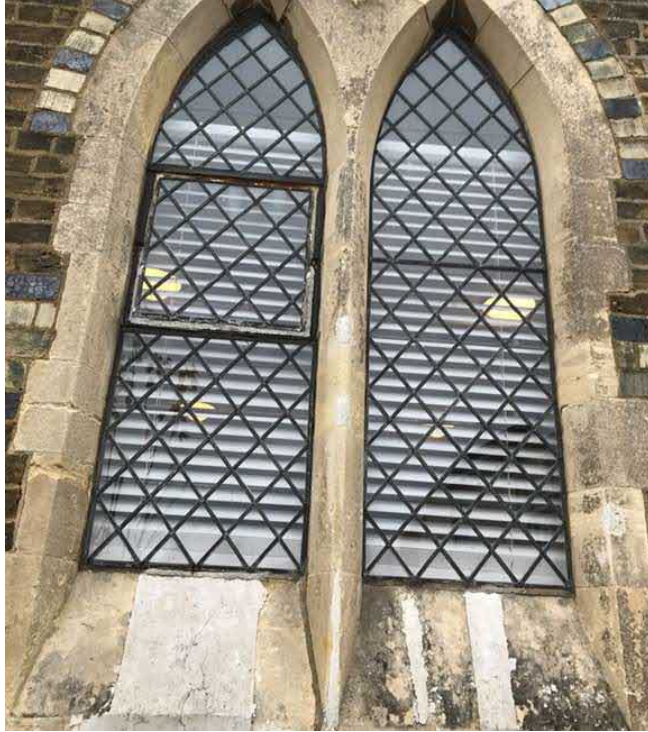
Condition: deterioration to the leadwork for this leaded light window is beginning to occur, although it is currently not at the stage where repairs are required. Some corrosion is starting to occur to the iron opening light. This will require redecoration.

Repairs needed: redecorate frame to opening light.

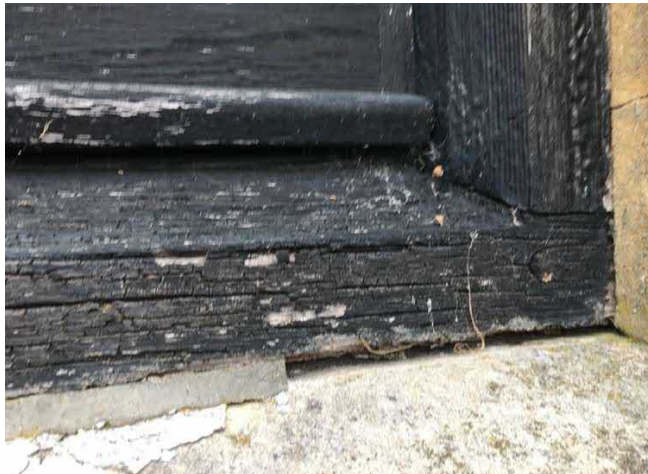
- 5.9 **Window to vestry toilet:** this is a timber framed, frosted glass window, with a slim double glazed unit set on a stone cill with a stone lintel.

Condition: the timber sub-cill is deteriorating, with softening occurring. The pointing beneath it has popped out to one section. I recommend redecoration and repointing. The cill is heavily deteriorated.

Repairs needed: repoint around timber frame and replace rotten sub-cill and redecorate window entirely.

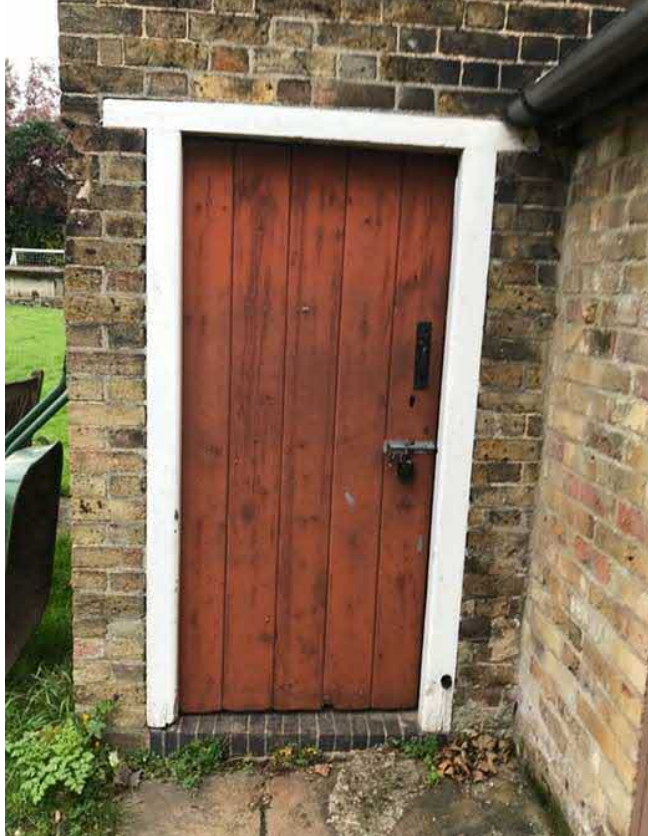
Condition: decorations to the store door is beginning to deteriorate and some deterioration to the base of the boiler room door is beginning to occur. Again, redecoration is required.

Repairs needed: redecorate doors and allow for minor repairs to the timber frame of the boiler house door at low level.

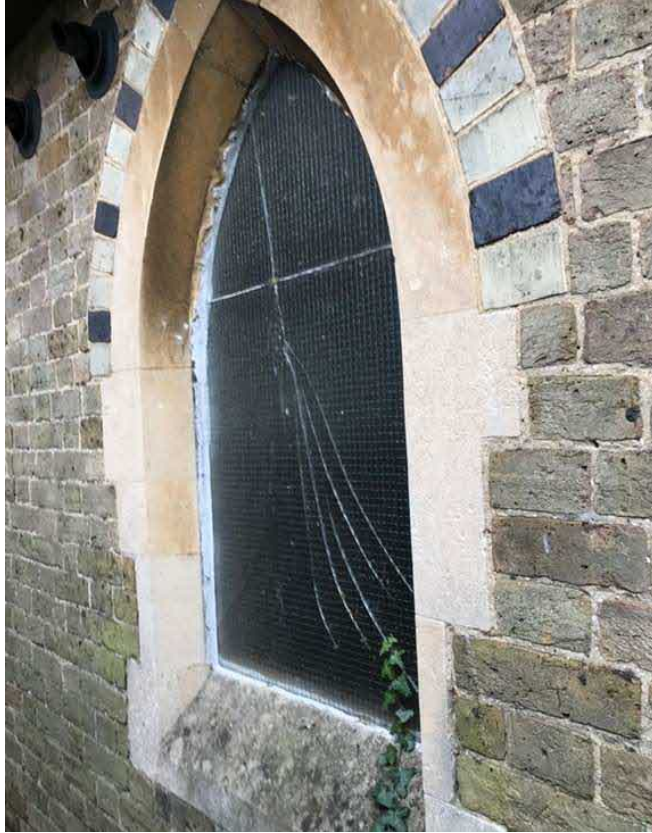
Condition: some of the putty is falling out and the glass is cracked and in need of replacement.

Repairs needed: replace glass.

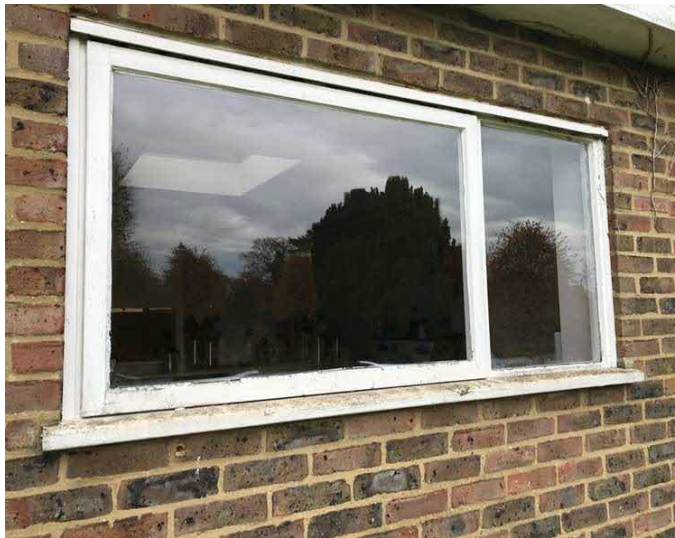
Condition: sound, but with deteriorating decorations. Redecoration is required. Putty to glazing needs replacing as it is loose and cracking and missing in many places.

Repairs needed: redecorate windows and replace putty to glazing.

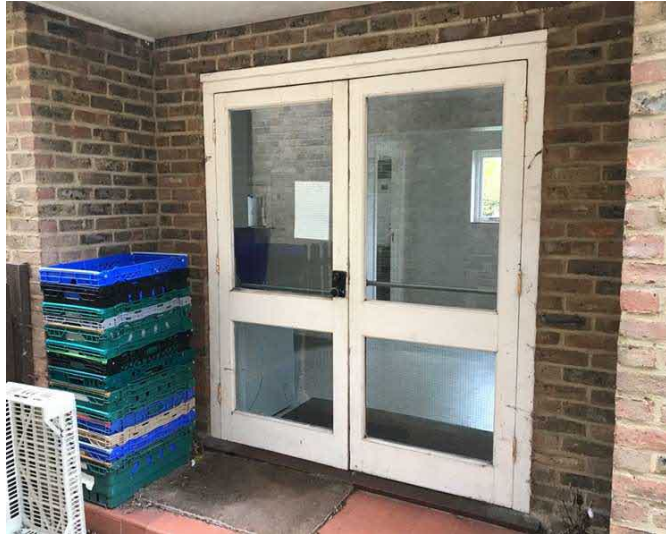
Condition: decoration is deteriorating and there is a cracked pane of glass to one of the doors.

Repairs needed: redecorate, including ironmongery, and replace cracked pane to door.

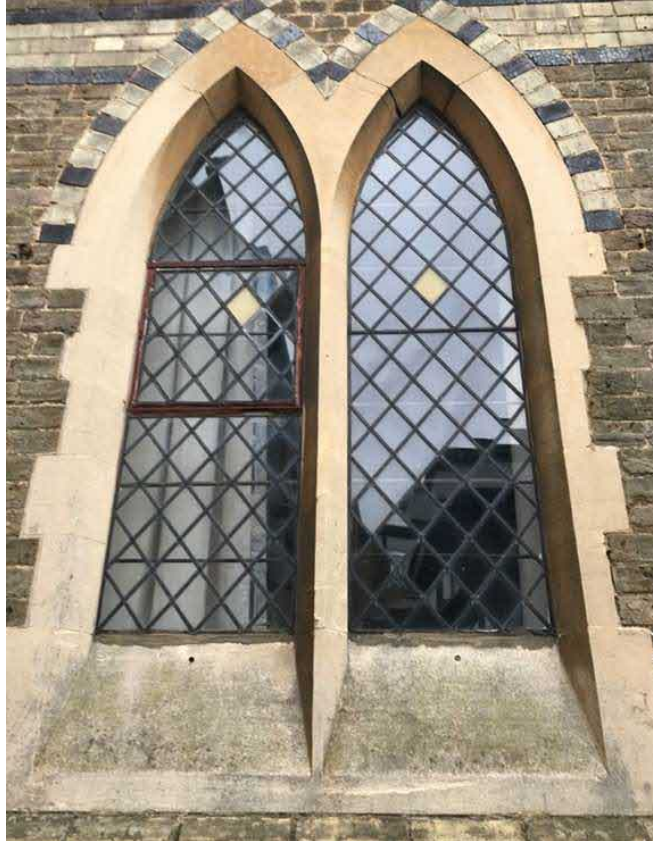
Condition: the leadwork is beginning to deteriorate, with some movement and distortion occurring. Renewal is likely within the next few years. There are two broken quarries which will need replacing. A half-hearted attempt has been made to redecorate the iron frames to the opening lights. This needs to be properly carried out to prevent corrosion causing further deterioration.

Repairs needed: replace broken quarries.

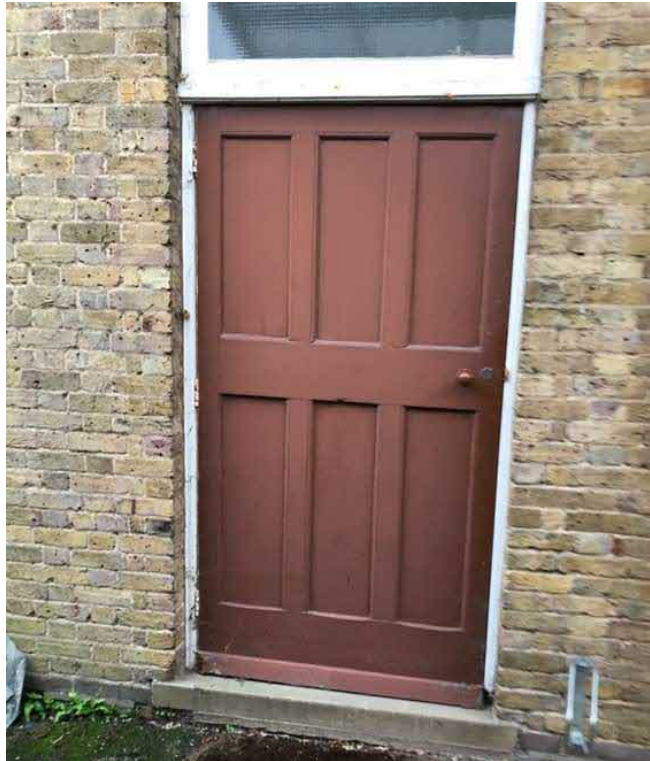
| 5.22 | Rear door to schoolroom: six panelled timber door with Georgian wired glazed window above. Condition: requiring redecoration and there is a small section of damage to the weather strip at the bottom of the door. | | | |

Repairs needed: redecorate door and apply timber repair to weather strip.

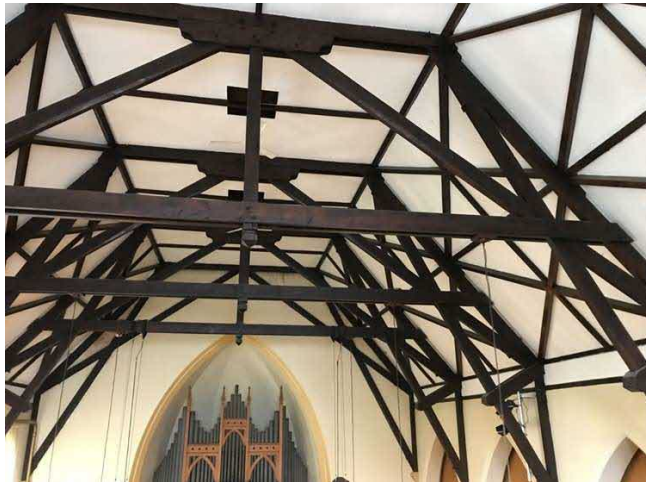
Condition: the roof structure itself appears to be in good condition with no evidence of significant movement or deterioration. There are several cracks in the ceiling sections between timbers due to general movement of the structure, but nothing of any significant concern or that requires repair at this stage. There are a couple of panels over the gallery that may need attention in the coming years.
