Tree Protection Monitoring Report Form

Site	Manor House, Linton
Date	12/03/2024
Visit by	Dan Brown (FdSc)
Type of Visit	Tree Protection Measures inspection
Purpose of Visit	Tree Protection Monitoring Visit
Observations	
<ul style="list-style-type: none"> Ground protection measures have been installed with scaffolding boards on top of chip as recommended in the Arboricultural Method Statement Tree Protection Fencing as been installed around the development with appropriate scaffolding supports, and with correct signage stating Tree Protection Zones. Alternative tree protection fencing has been installed along G2 due to the obstructions of ground levels, landscape and vegetation preventing installation of pole supports. 	
Actions/Recommendations	
<ul style="list-style-type: none"> Dates to be arranged where arboricultural supervision is required i.e. construction and removal of foundations where required. Schedule of site monitoring to be agreed upon.

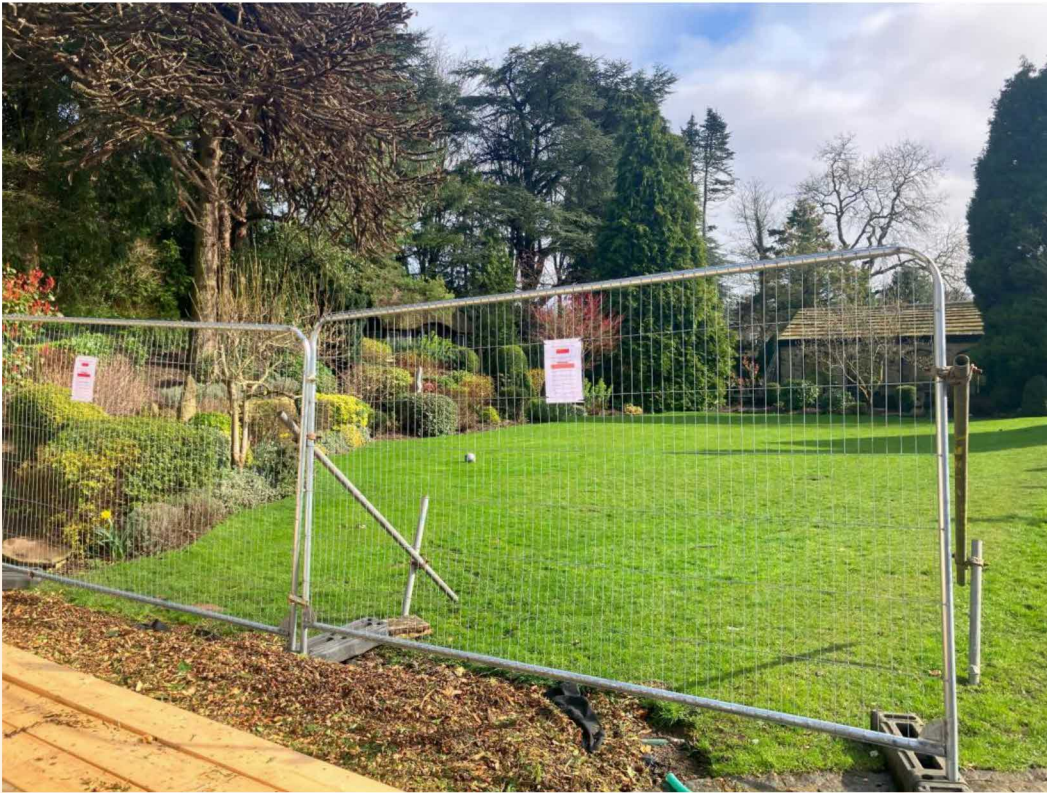
Photo 1: Facing southeast towards Tree Protection Fencing along east of building.

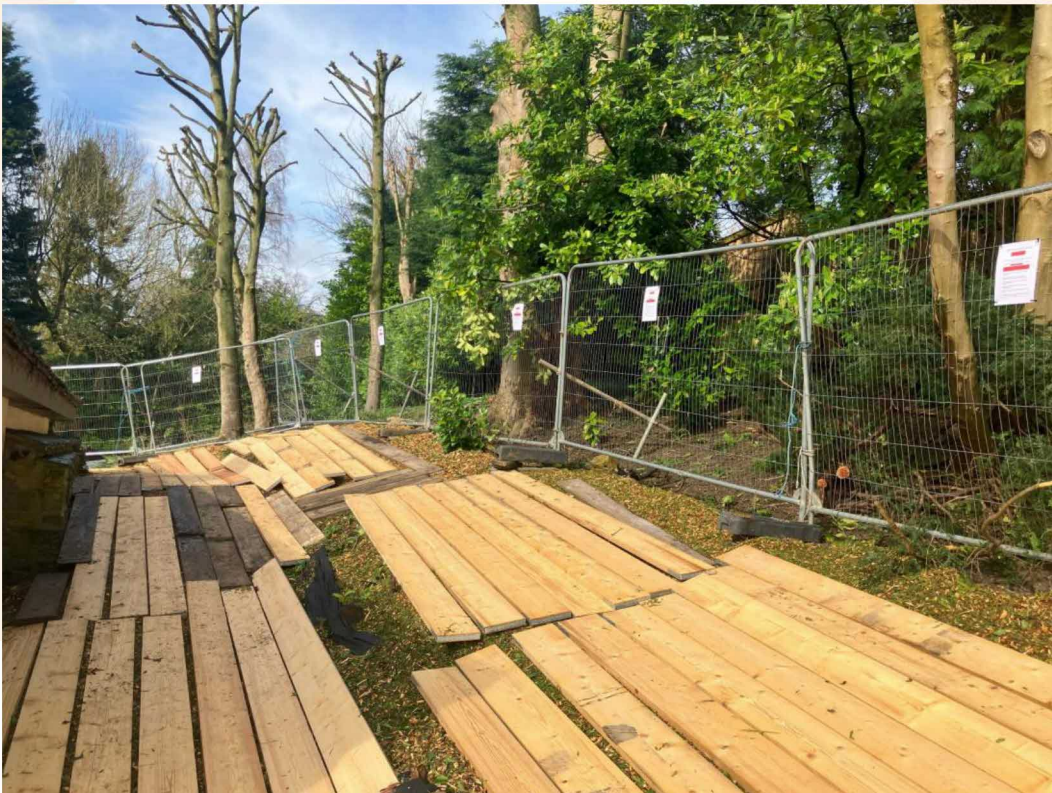
Photo 2: Facing north towards ground protection and tree protection fencing along back of building.

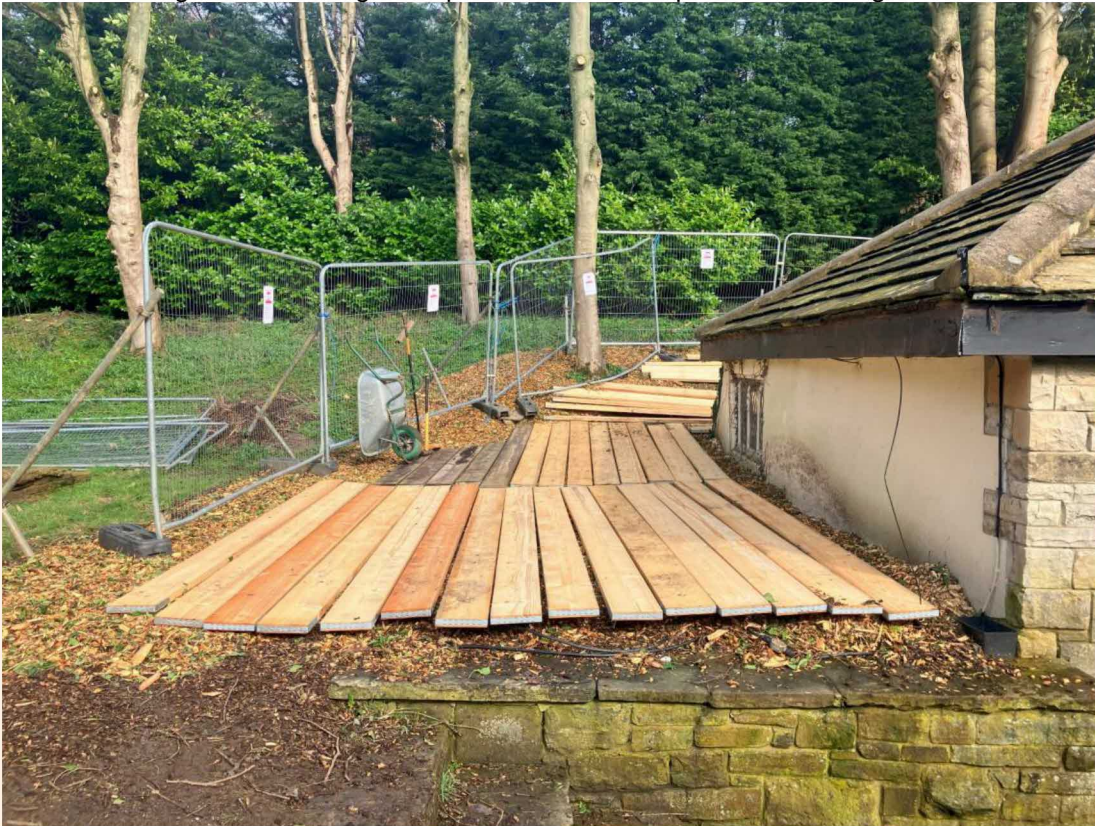
Photo 3: Facing east towards ground protection and tree protection fencing to the north of the building.

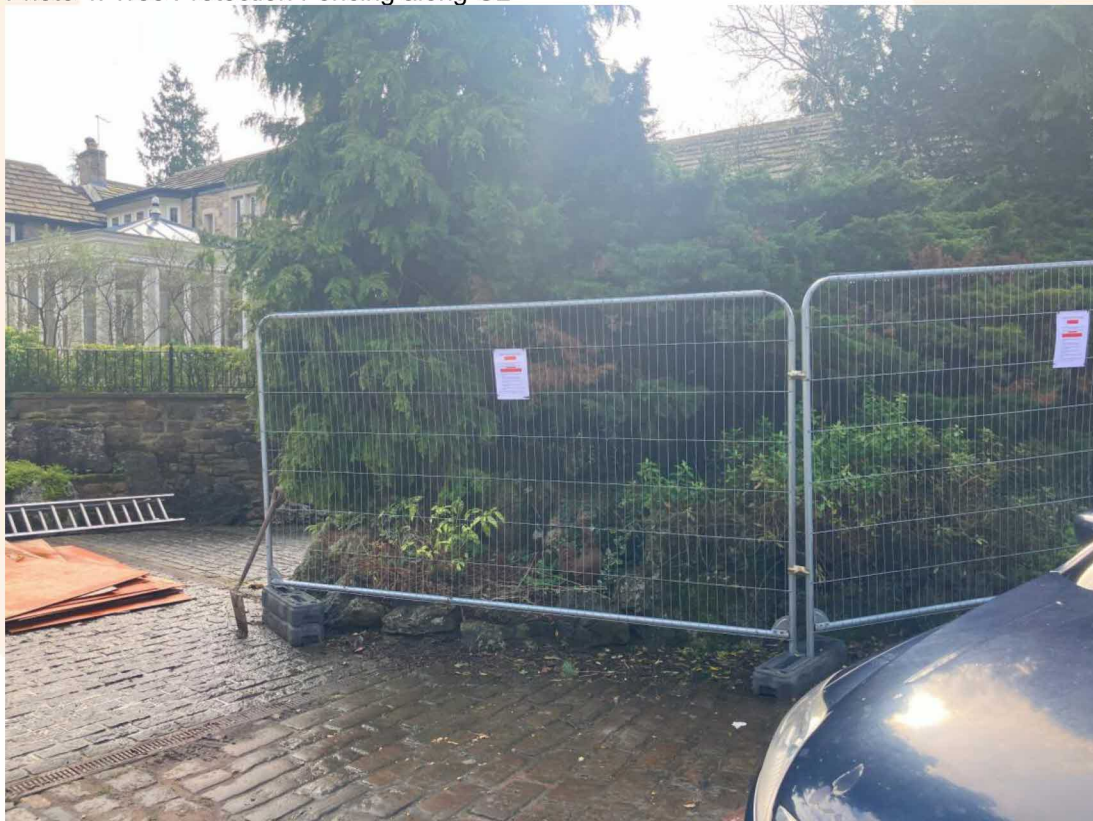
Photo 4. Tree Protection Fencing along G2

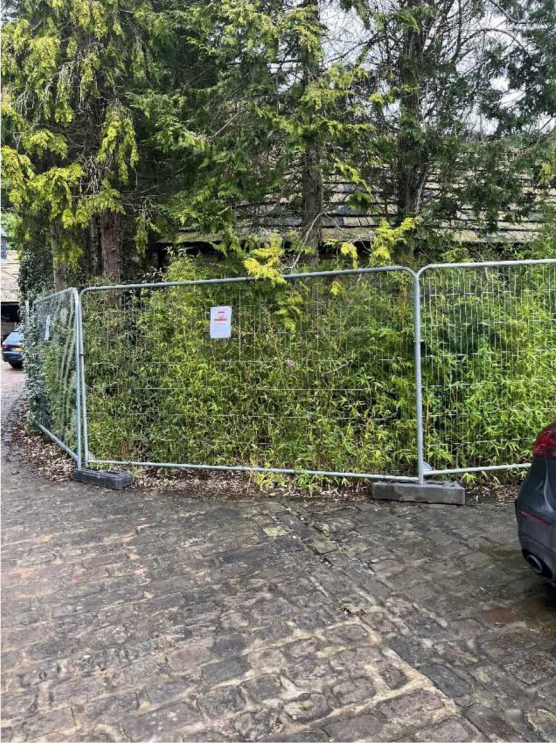
Photo 5. Further photos of Tree Protection Fencing along G2.
