# Arboricultural Constraints Report

For Hawthorn Gardens

April 2023

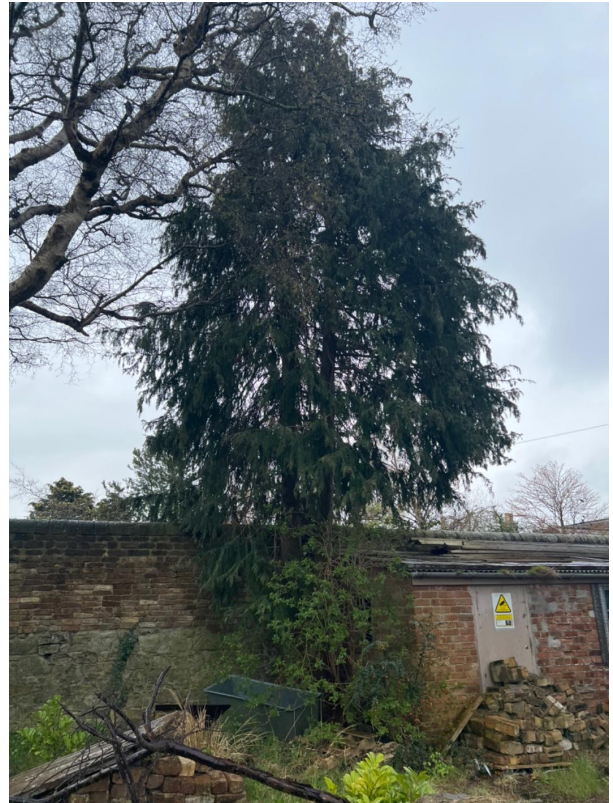
Leylandii Tree ID #2

Comments: tree in conflict with adjacent building and wall

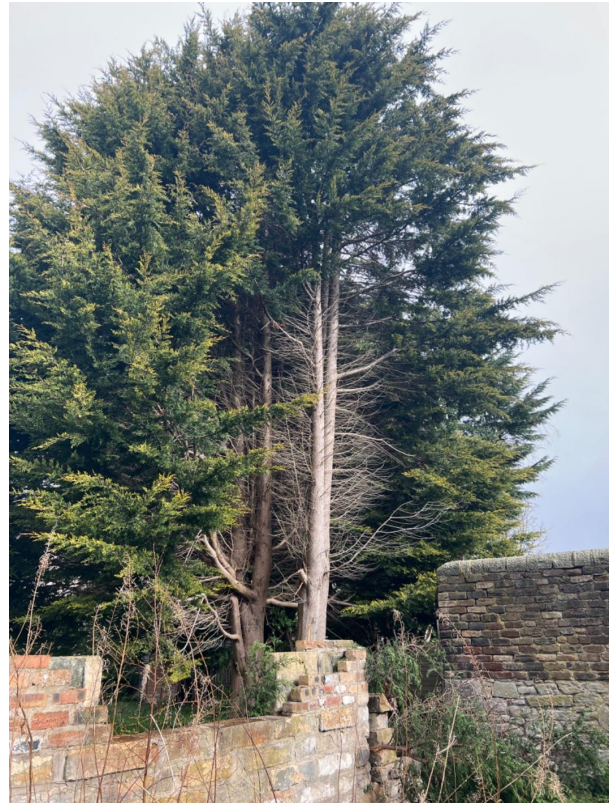
**Western Red Cedar Tree ID #3**

Southeastern side shows no foliage up to approx 13m, pruning cut at approx 3m suggesting removal of large parts of the foliage, sapwood exposed

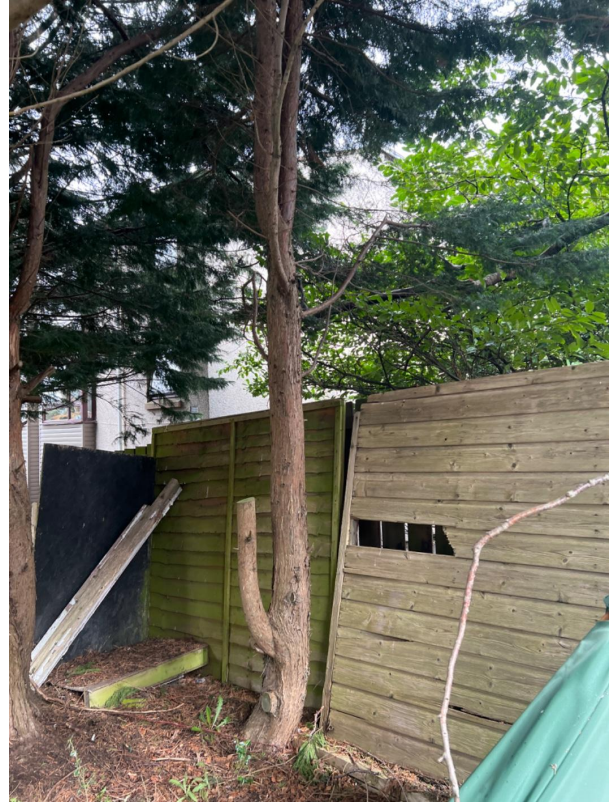
Leylandii Tree ID #7

Comments: Large stub at base, tree outcompeted by neighbouring specimen

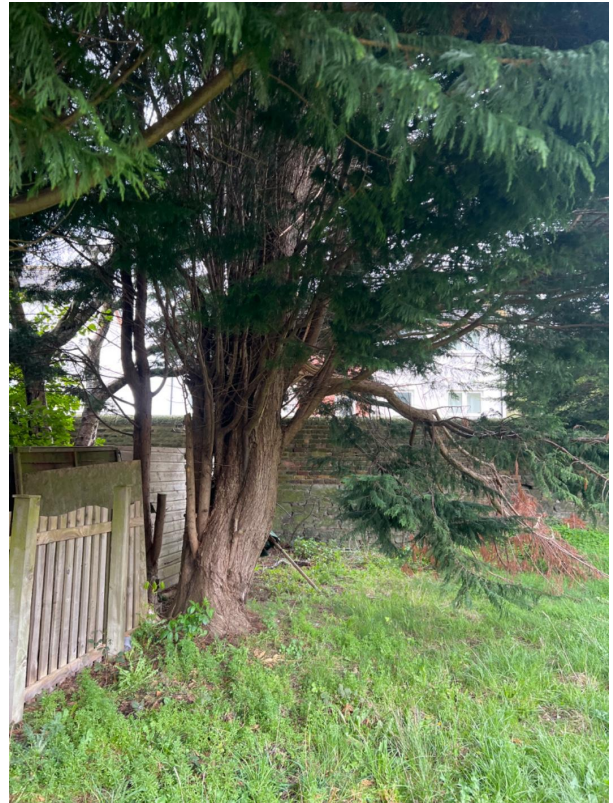
## Leylandii Tree ID #8

Comments: Stems forming inclusive union at 0.5m, tree adjacent to wooden fence, inspection restricted, branch snapped at southern aspect 3m height

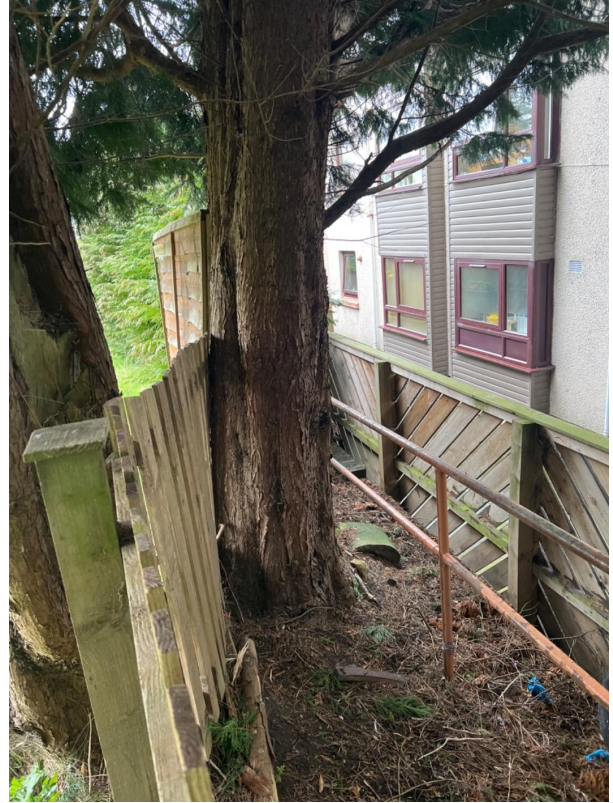
## Leylandii Tree ID #10

Comments: inclusive union at 2m,  
tree adjacent to  
wooden fence,  
inspection restricted,

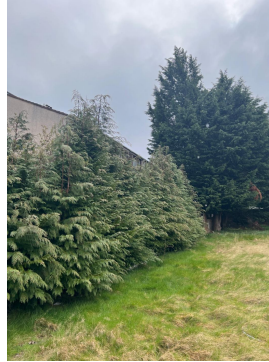
Hedge ID #1

Hedge Details	
Common Name:	Leyland cypress, Elder
Life Stage:	Young
Condition:	Good
Hedge Width [m]:	4
Estimated Remaining Contribution:	Long (>40 years)
Recommendations:	
Comments:	Densely planted high hedge
