MIKE MASSEY ASSOCIATES

BUILDING SURVEY

Property: 59 High Street
Oxford
TN14 5PL

Ref: MMA1112

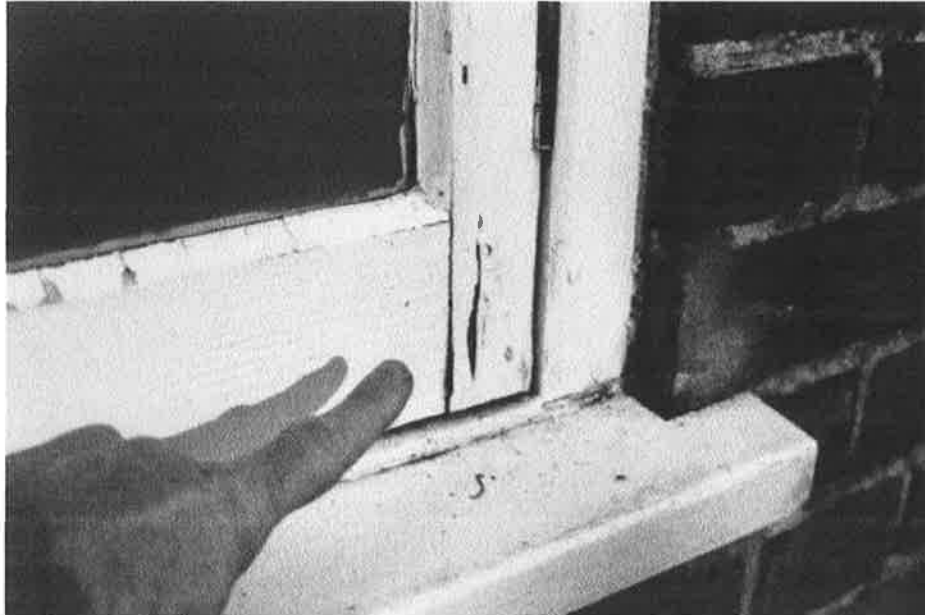
The windows appear to have been reasonably well maintained over the years but they appear to be of softwood construction. Softwood windows will decay quickly if rainwater is able to get through the paint and already the window to the front/left reception room is rotting to its bottom/right corner, and there is a further area of heavy wet rot decay to the window to the bathroom.

Whilst on the face of it these windows appear to be repairable we should advise you that once the areas of wet rot have been hacked away it is often found that there is very little sound wood remaining, so these windows may end up requiring replacement. There may also be other windows which are beginning to decay which will only be discovered once the paintwork is rubbed down and prepared for redecoration.
