Mr and Mrs Perks

Y Felin, Efail Rhyd, Llanhraeadr Ym Mochnant SY10 0DU

Structural Inspection

Inspection Report for Planning Application Support

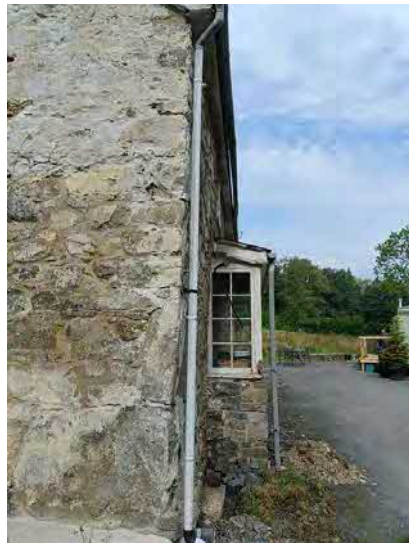
036

- 3.1.18 Appears to be a bulge and lean to the front elevation to the left hand side of the rectangular bay window (photo 36, 37)
- 3.1.19 Timber runner fixed to wall for the mono pitched canopy roof appears in poor condition with evidence of decay and wood boring insect

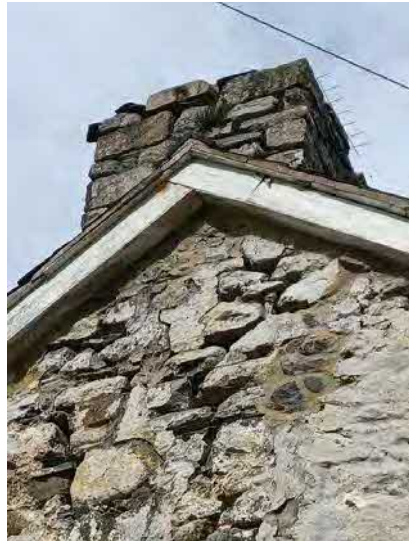
044

- 3.2.6 Stone chimney at the gable peak with open mortar joints and some plant growth (photo 44)
- 3.2.7 Open mortar joints in the stonework at the head of the gable (photo 44, 46)
- 3.2.8 Vertical cracking down the centre of the gable wall, full height from chimney to ground level. Fireplace located internally in this location (photo 45 – 53)
- 3.2.9 Gable wall appears to bulge significantly centrally for the full height (photo 54 – 57). It is not possible to establish if the wall leans out internally due to the presence of the large fireplace and chimney breast. It is possible the external bulge is due to separation of the outer stonework

Extensive areas of re-build / stabilisation and repairs are required to the side gable wall and chimney.

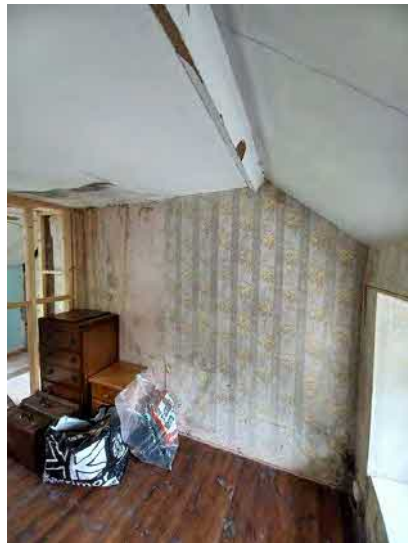
196

- 4.7.1 Floorboards original to the extension (photo 193 – 195)
- 4.7.2 Damp staining on chimney breast (photo 196, 197)
- 4.7.3 Damp staining on front wall (photo 198)
- 4.7.4 Wallpaper finish to walls. Painted plaster finishes to ceiling
- 4.7.5 10mm wide vertical crack full height on front elevation wall continues up through the ceiling (photo 199 – 203). Appears to be at junction of extension to property as observed externally

The cause of the water ingress is to be established and the defects rectified.
