## ***Cliff Face Inspection Report (including external structures)***

Property: The Chalet  
31 Fore Street  
Port Isaac  
Cornwall  
TR7 1DZ

Date: 31<sup>st</sup> May 2017

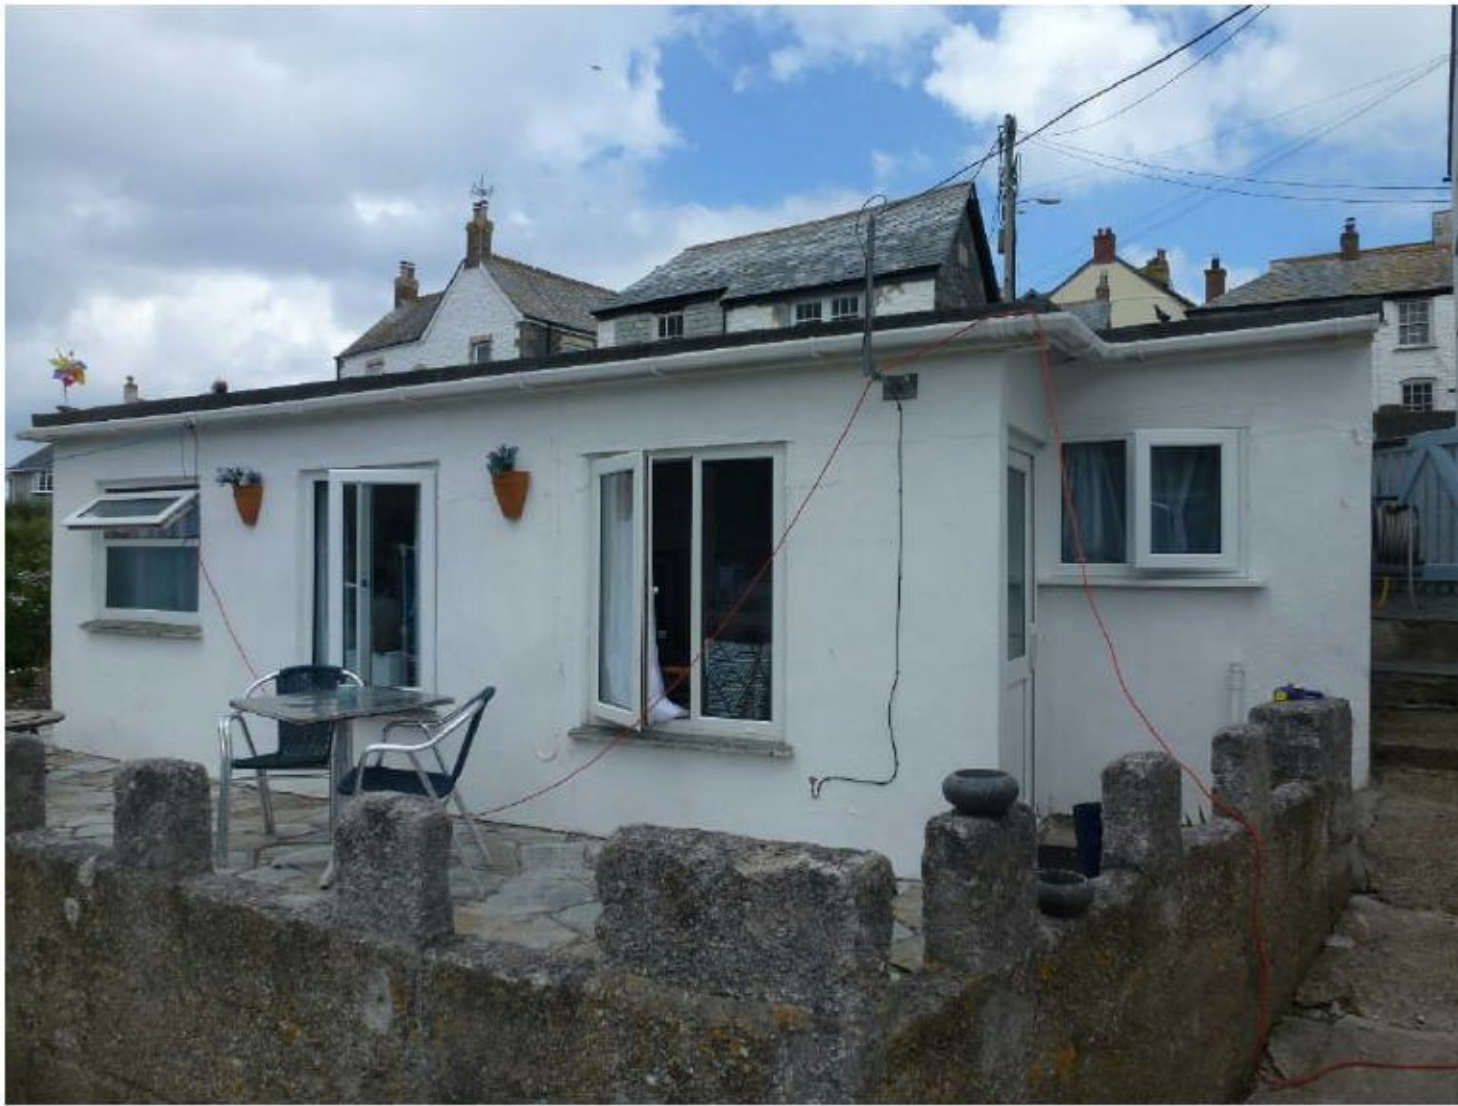
Photograph 2 – Main bungalow

The property is currently constructed of assumed blockwork which has been rendered supporting a flat and felted roof. The overall condition of the property would be regarded as good.

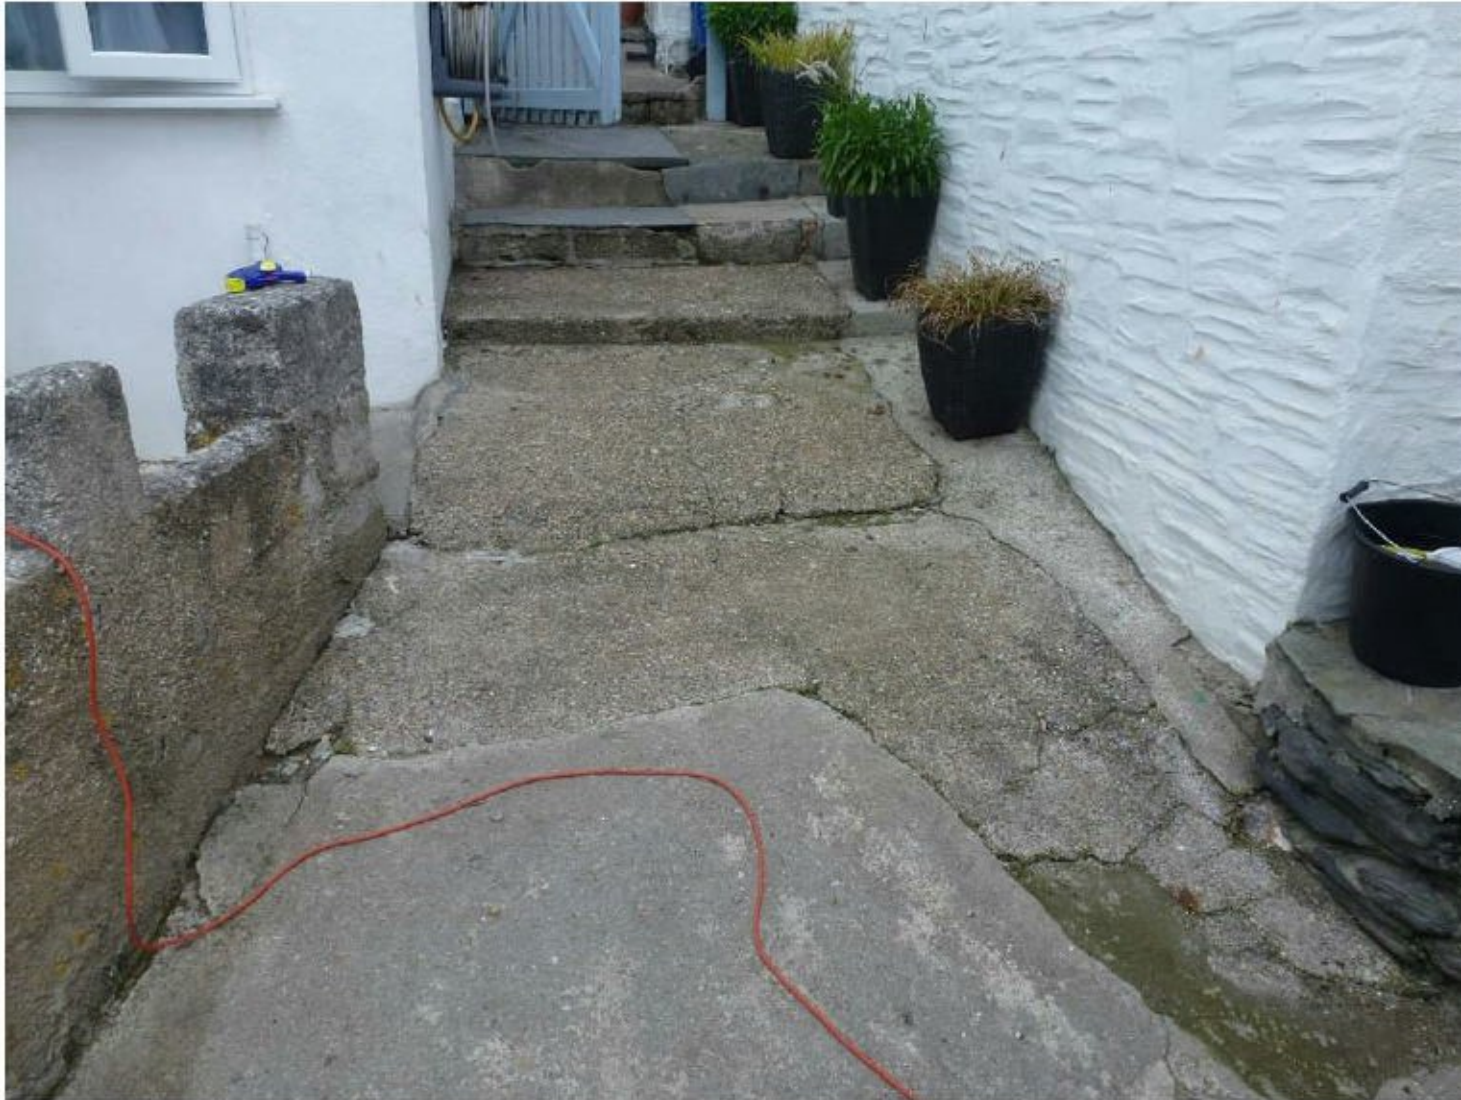
The main building north elevation is relatively close to the cliff face but is estimated at being approximately 4.0 to 6.0 metres away. No evidence of significant movement was noted to the main building in this area. Other parts of the footway were displaced horizontally by up to 25mm but this is likely due to poor construction coupled with poor drainage.

Photograph 4 – Old footway cracking to front and right of main bungalow

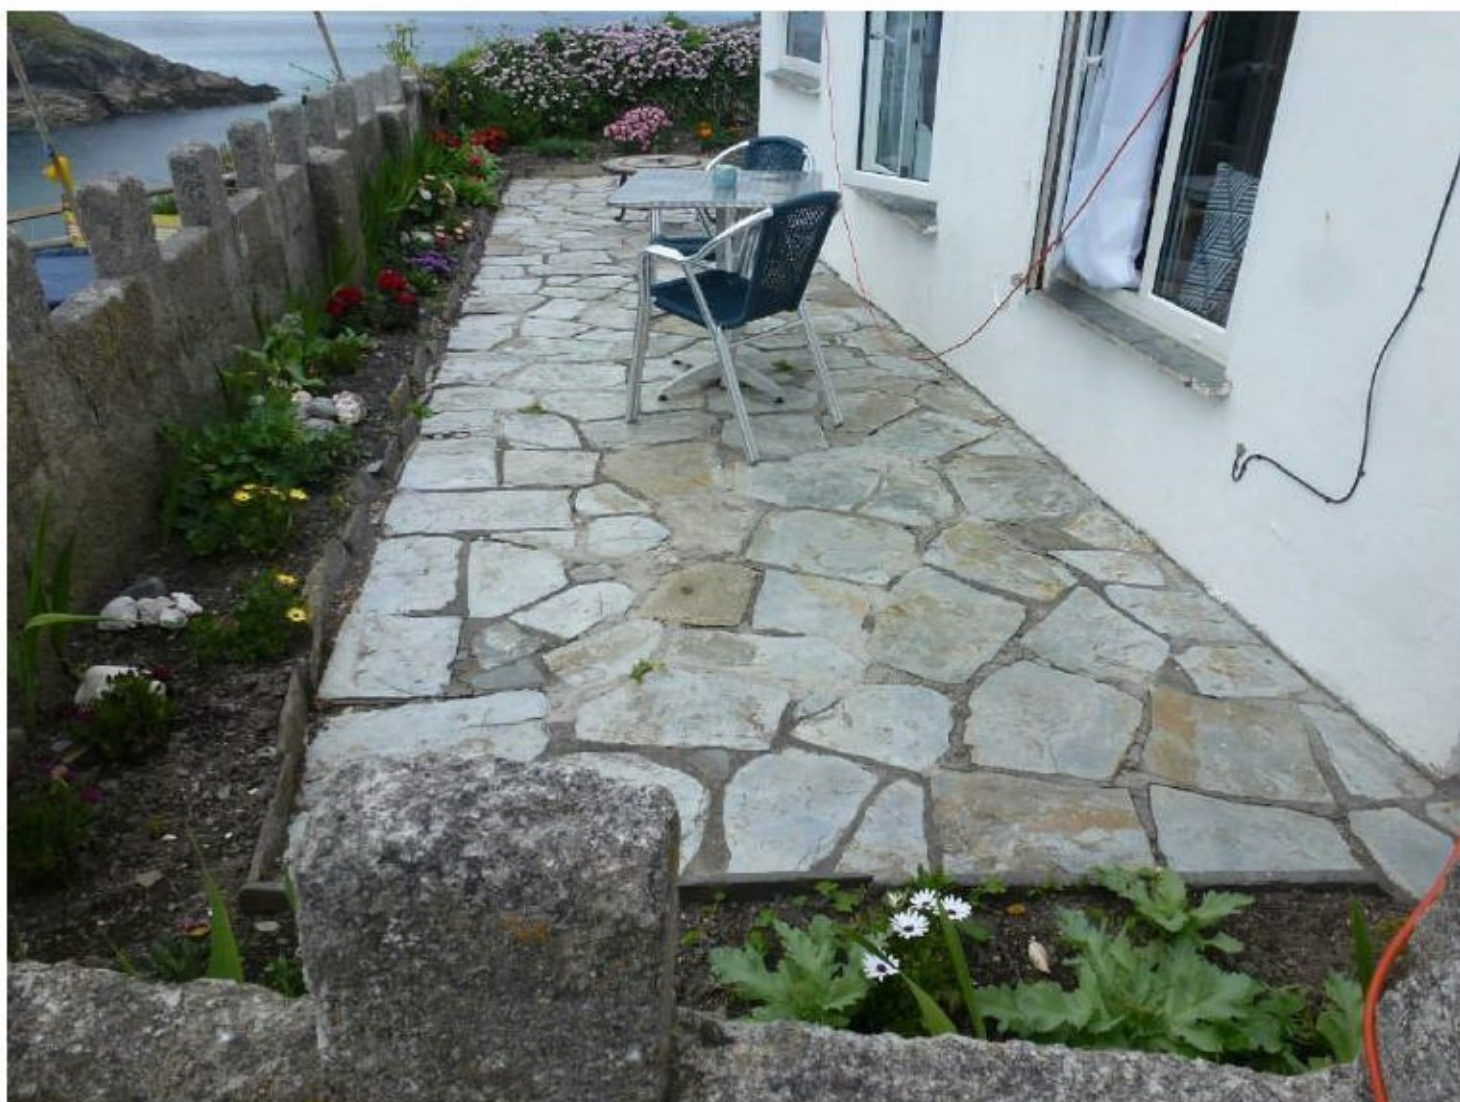
Photograph 5 – Footway in front of property in relatively good condition

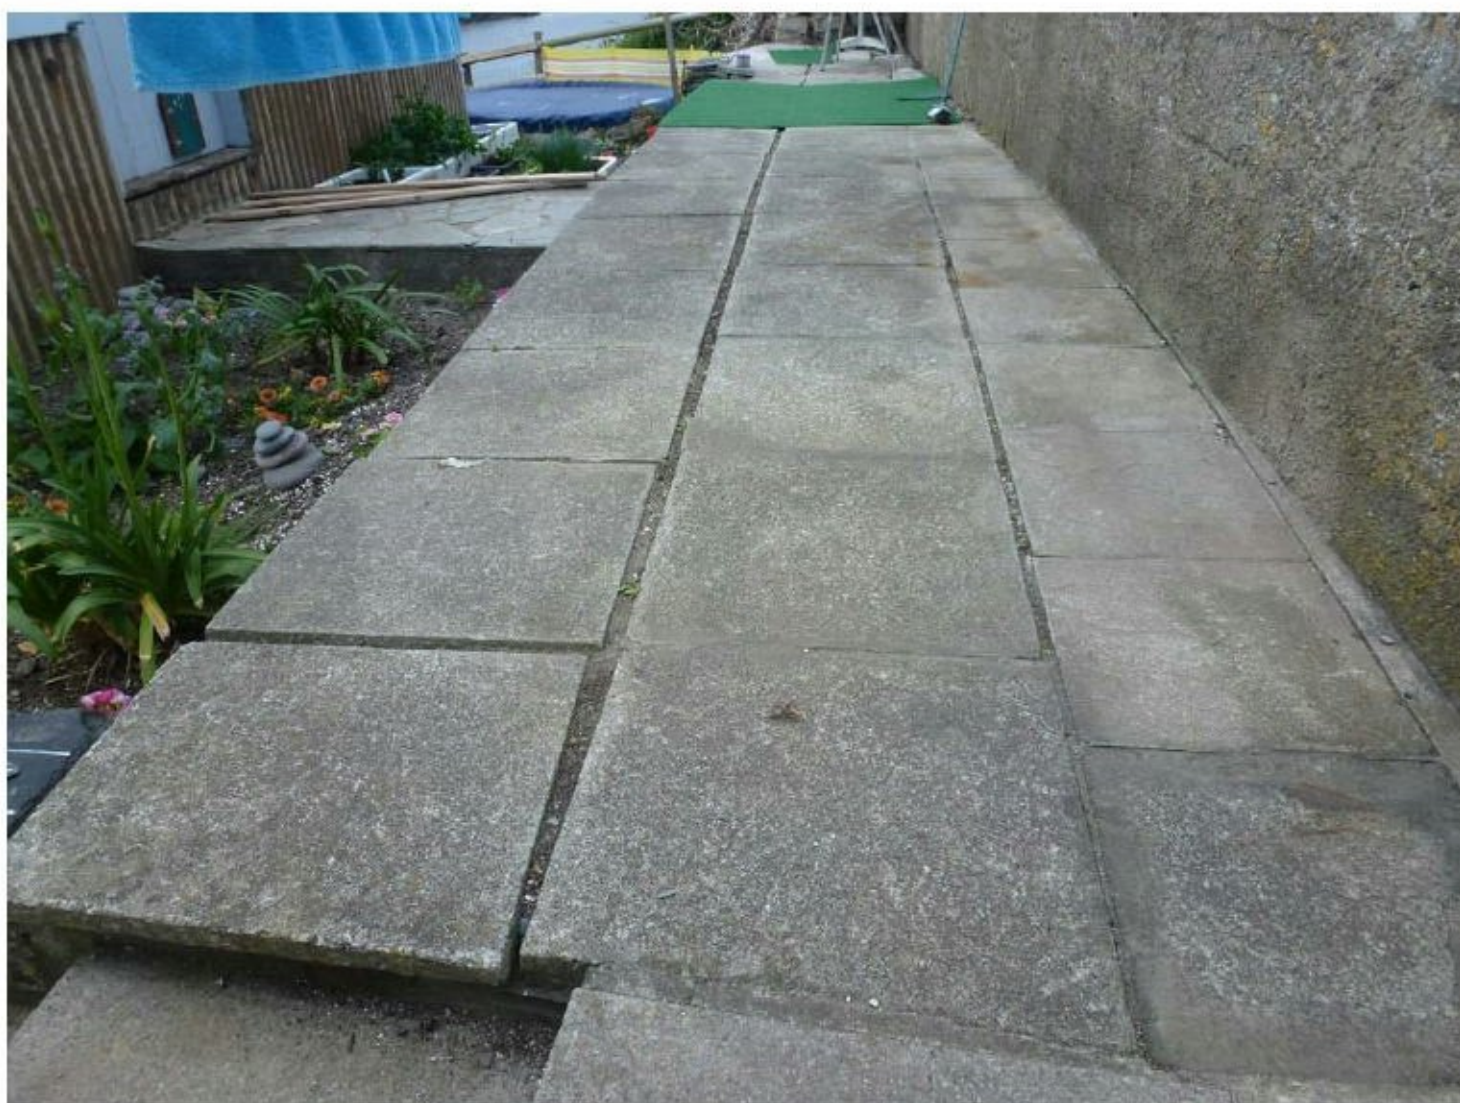
Photograph 6 – Footway in front of internal garden wall showing some signs of old lateral movement towards the cliff

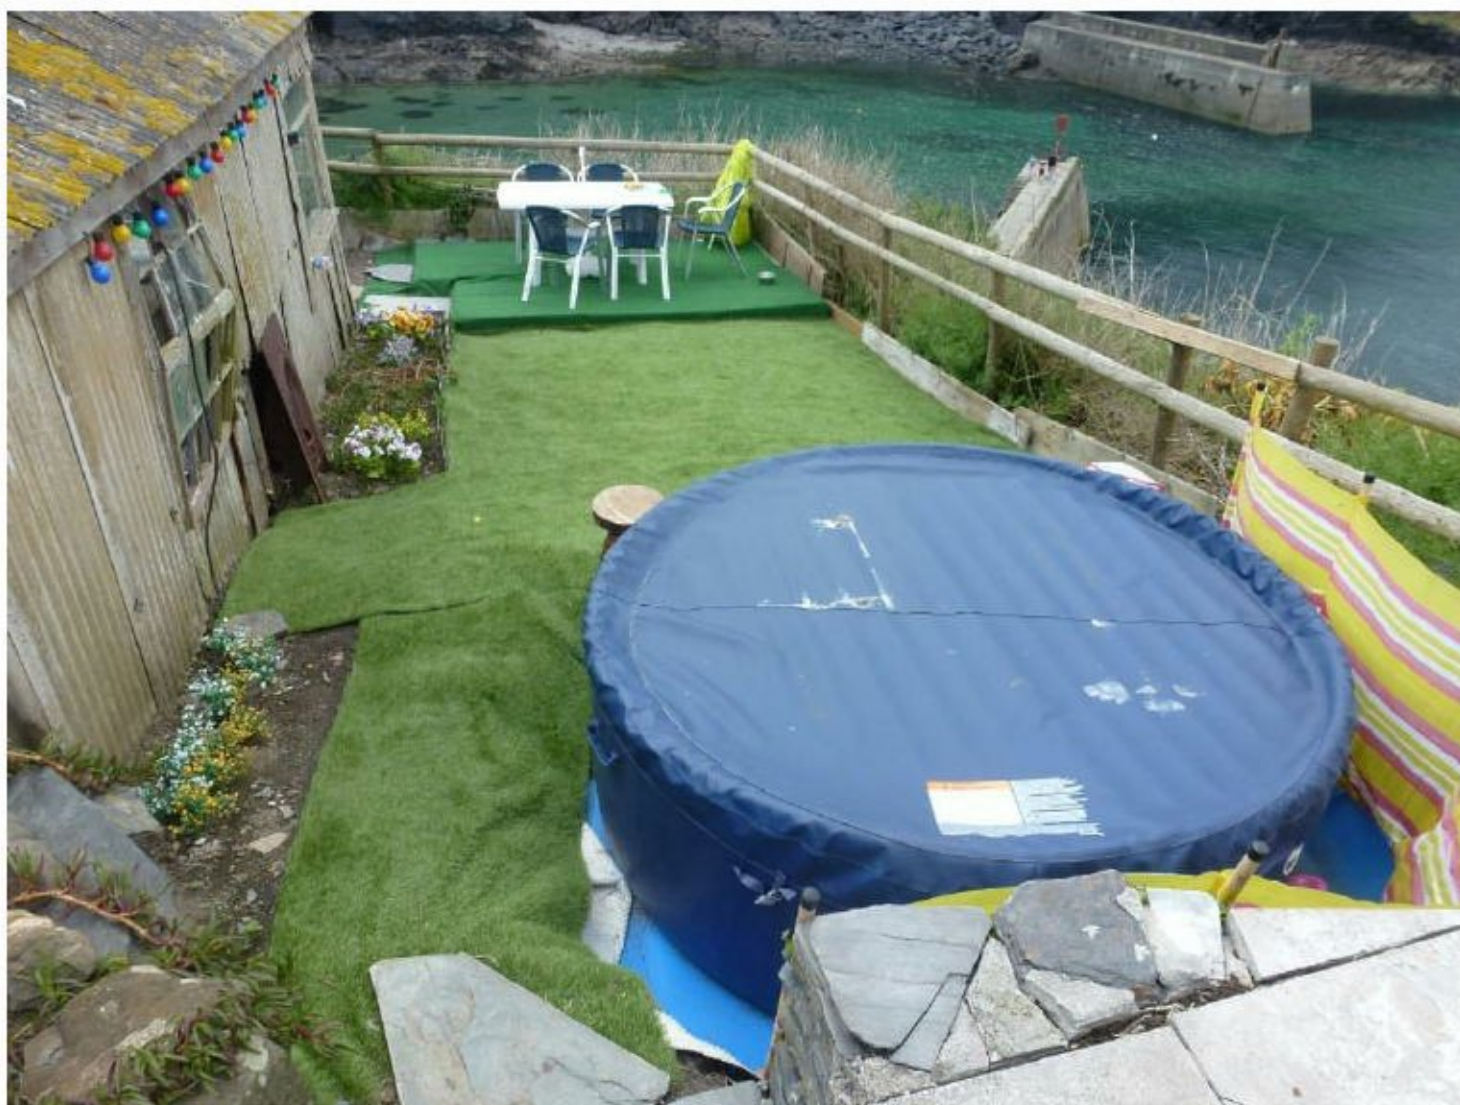
A rudimentary timber fence is constructed around the property. This was showing signs of age and significant wear and tear.

Photograph 7 – Fencing around north of site showing signs of age and wear and tear

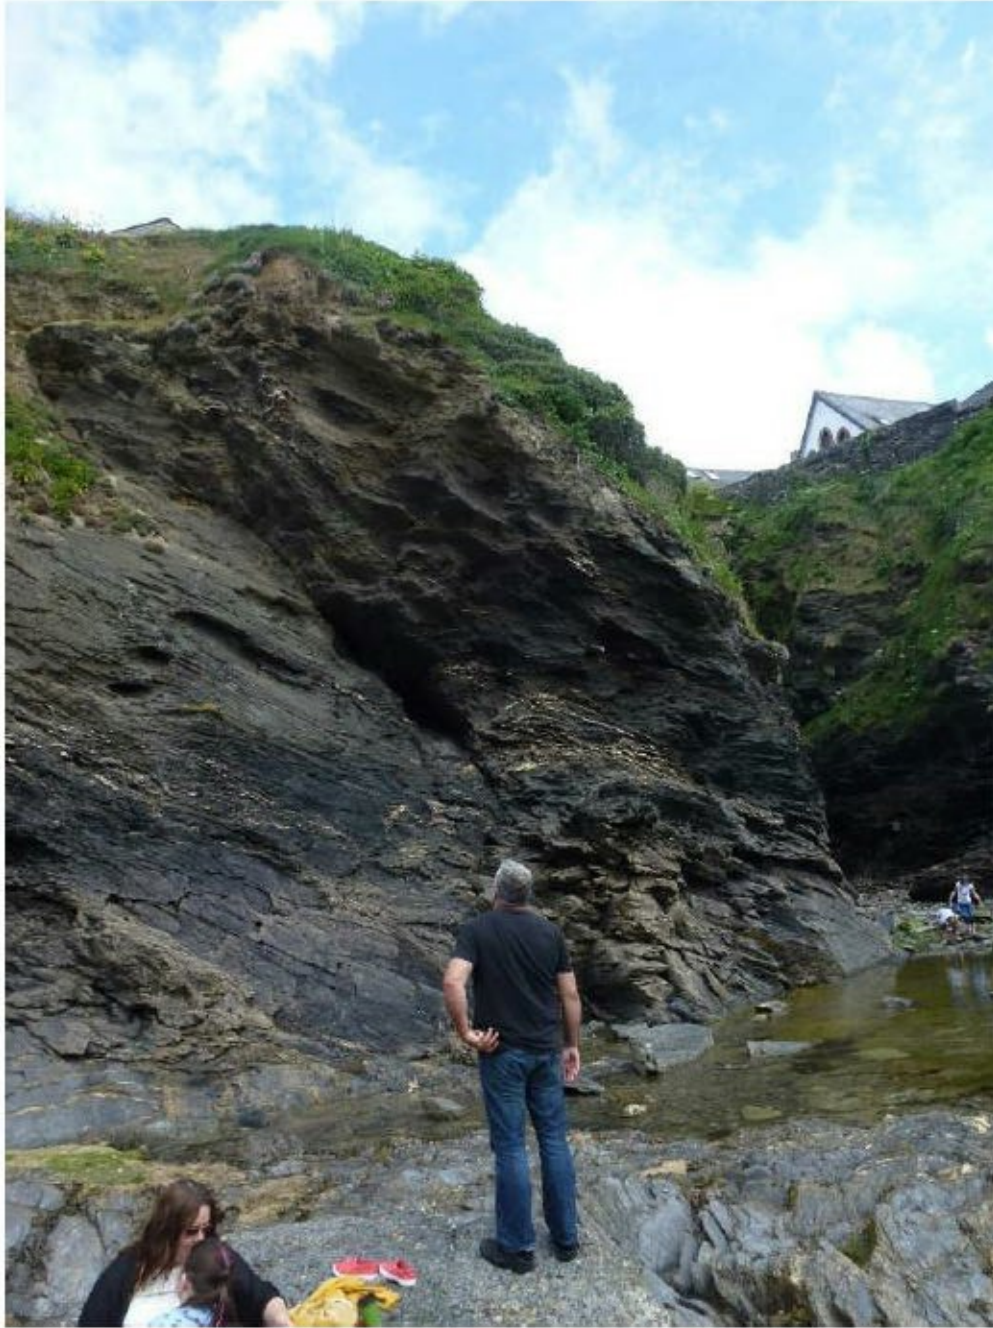
At the bottom at the sea level, the rock outcrop beach has large sections of eroded slate bedrock characterised by mid grey thinly bedded (less than 10mm) bedding planes. Rising up from the beach is a competent slate which is dark grey in colour and then changing to a dark brown to brown. The upper 2.0 to 5.0 metres is a less competent slate which is highly fractured and weathered. The broken down slate is then described as a shillet (slate and clay mixture) which has some minor vegetation in this zone with some topsoil in the uppermost areas near the top.

Photograph 8 - Main rock outcrop under property looking up (note tip of roof of timber shed to left side)

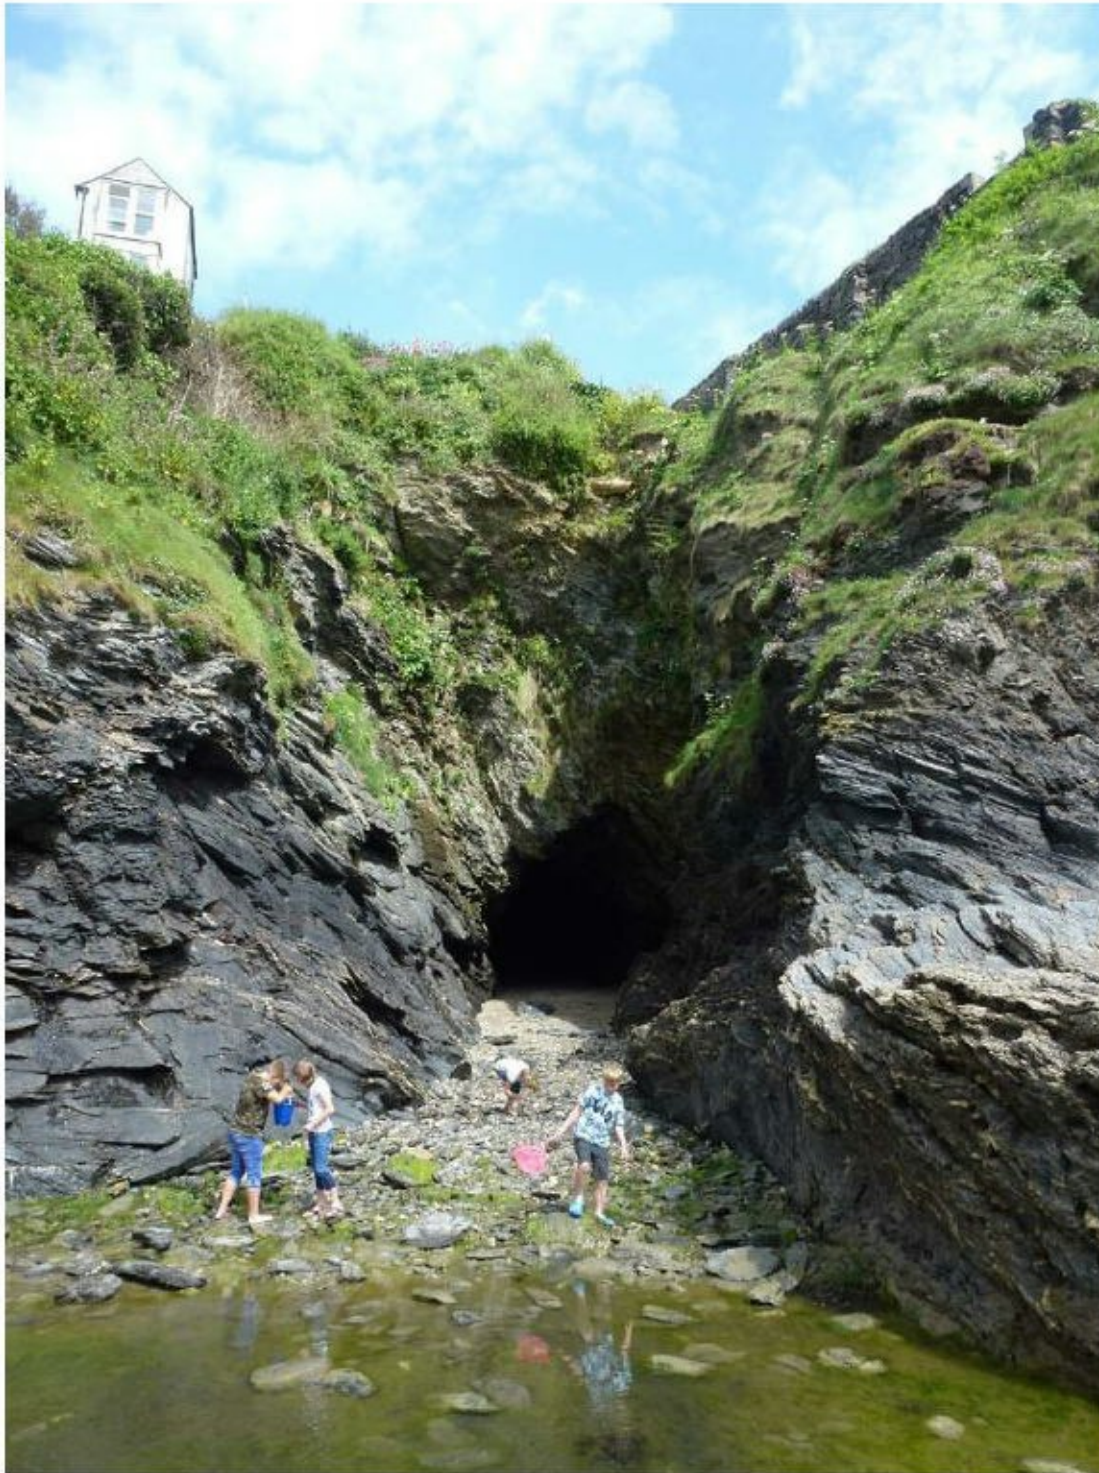
This area is characterized by a narrow cut back area of generally less than 10 metres width at the mouth down to zero with a small cave caused by water/storm erosion over thousands/millions of years. Some of the rock is highly weathered and undercut with some fresh rock faces (light brown areas) showing erosion is active in this area. However, there was no recent rock debris in the cove to suggest this was relatively recent.

Photograph 9 – Rock face to south on left of photograph with cave in centre

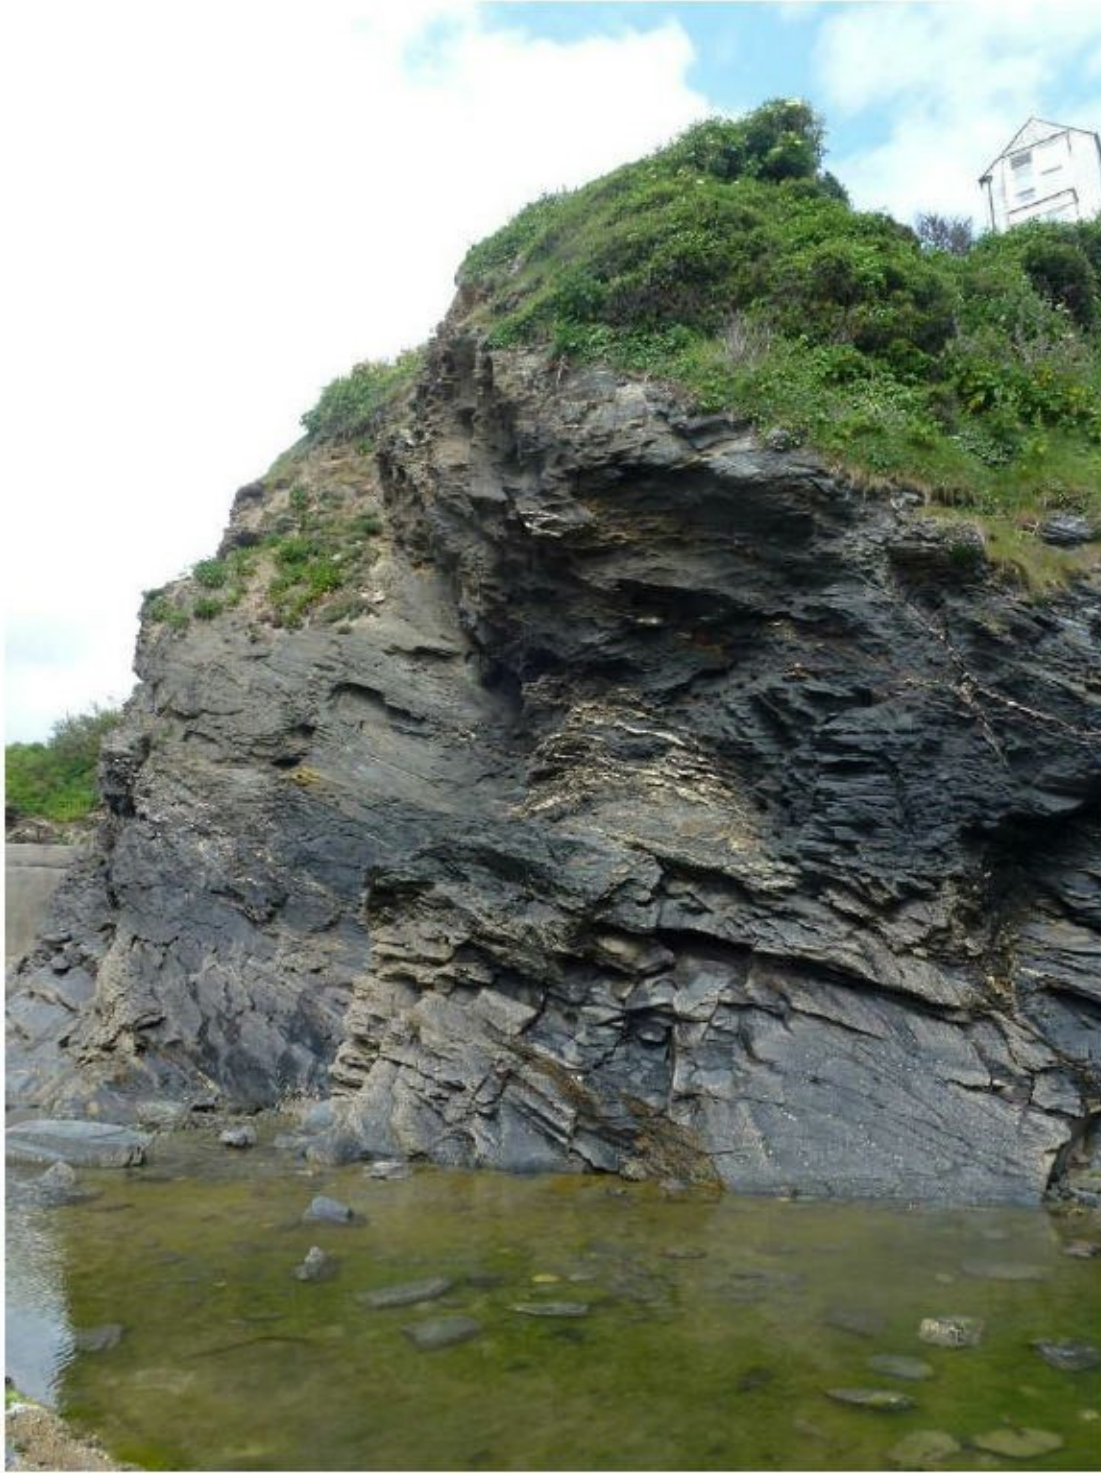
Photograph 10 – Northern eastern face

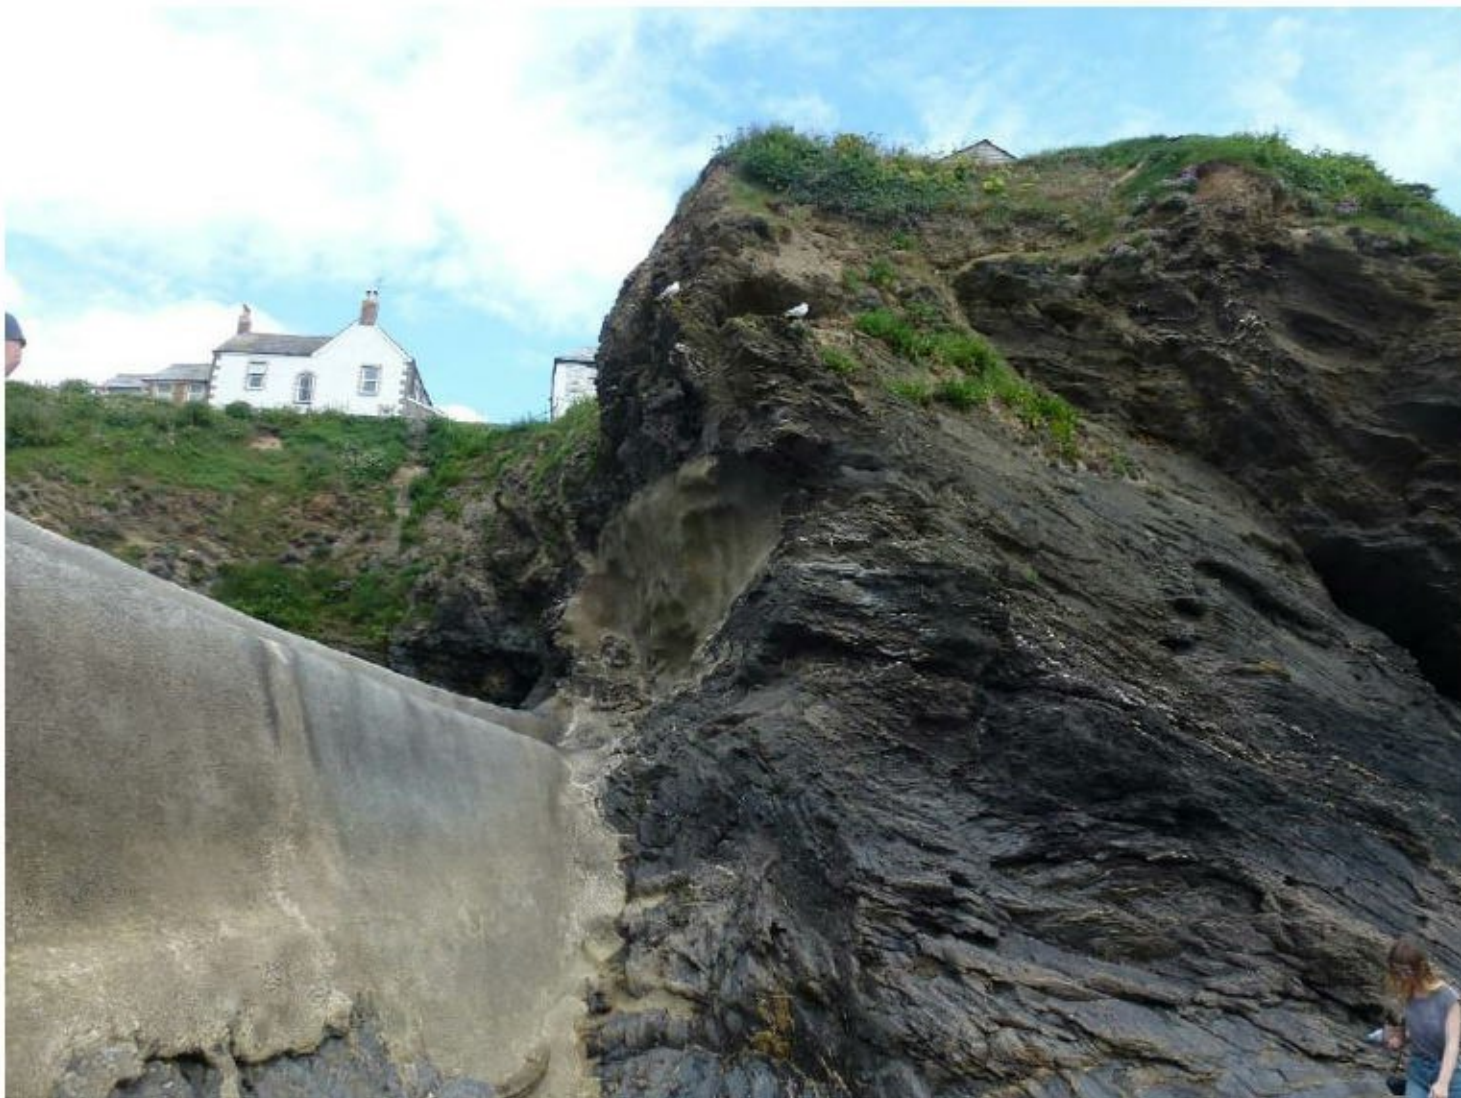
This area has a roughly rectangular cliff line generally facing west southwest. No significant recent erosion was noted in this area. There was no rock debris at the base of the cliff to suggest any recent instability. The upper reaches of weathered rock is partially vegetated generally in the top 1.0 to 2.0 metres near the cliff top. The western tip has a section of sprayed concrete that was undertaken in the past when the breakwater was improved.

Photograph 11 – Western face showing rock outcrop and concrete breakwater to the left

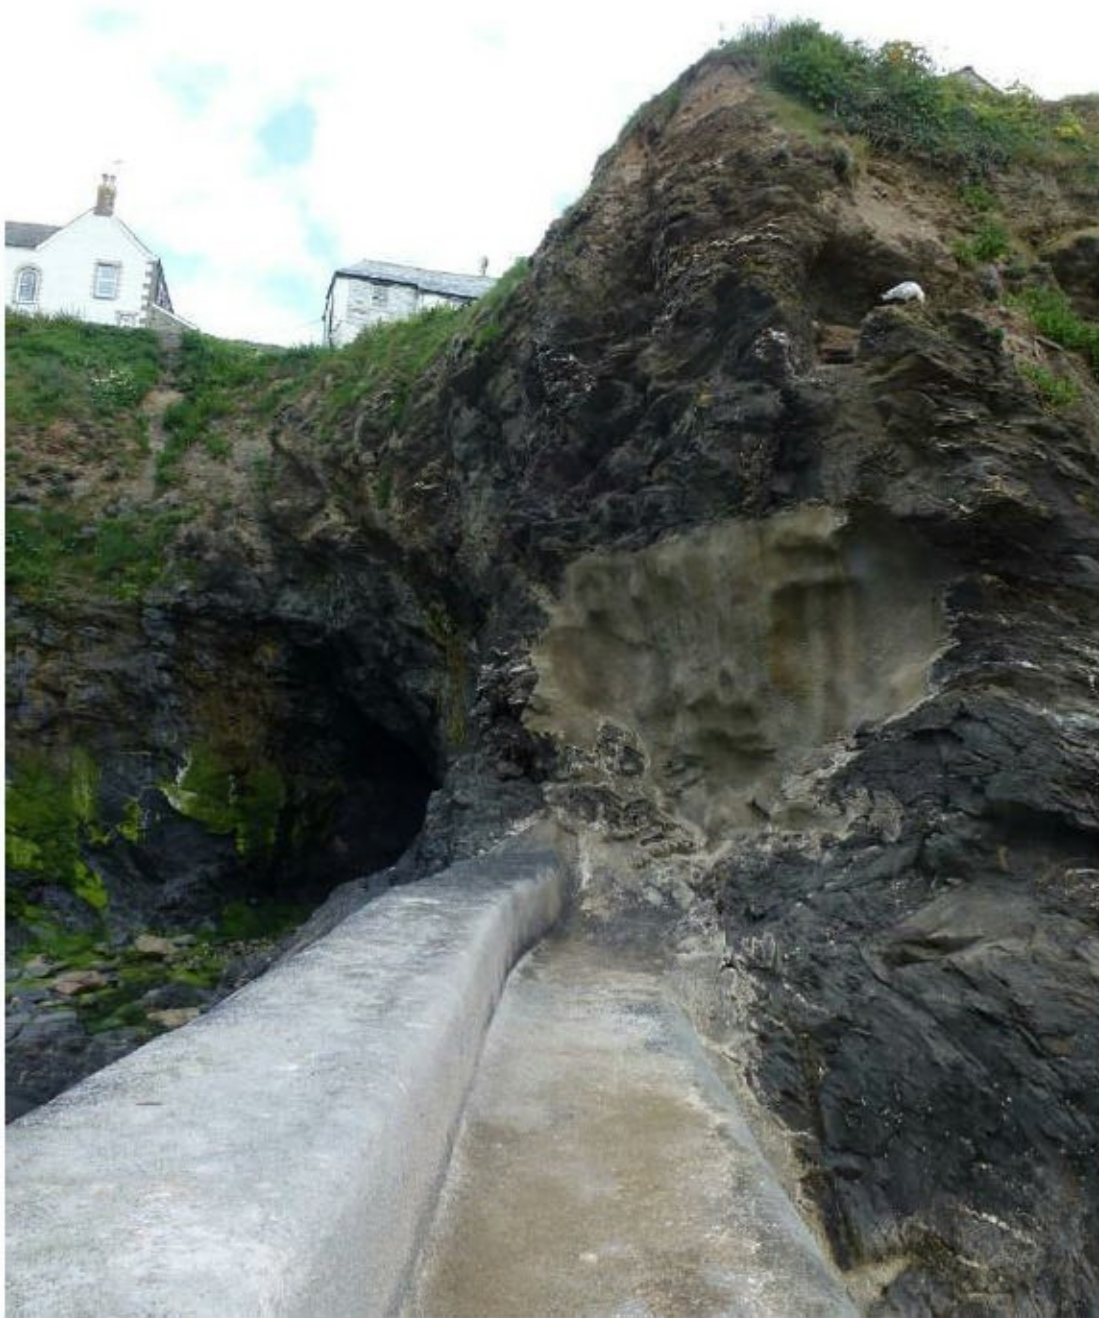
This area has a relatively vertical cliff line generally facing north. The upper reaches of weathered rock is partially vegetated generally in the top 1.0 to 1.5 metres near the cliff top. No recent falls of rock were noted to suggest instability of the rock faces.

Photograph 12 – Breakwater with north face beyond
