Geo Technical Report

Drainage Report

27 High Street,
Barford
CV35 8BU

27 High Street, Barford CV35 8BU - CCTV Survey Report : 19/01/24

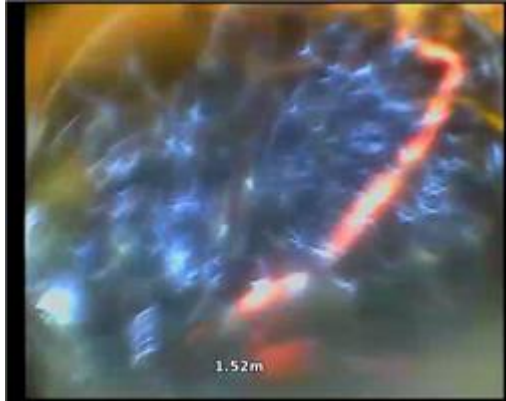
| Pos | Video Ref | Code | Description | Image |
|---|---|---|---|---|
| 01.52m | | SA | Survey abandoned CANNOT PASS | <p>Image Provided - Ref: 10_9999</p> |

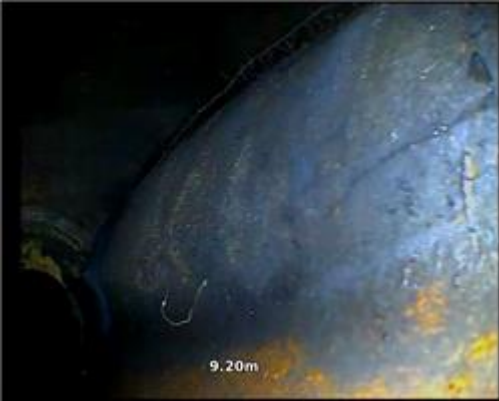
| Pos | Video Ref | Code | Description | Image |
|---|---|---|---|--|
| 09.20m | | MHF | Finish node type, manhole BURIED MH6 | <p data-bbox="962 309 1337 338">Image Provided - Ref: 13_9999</p> |
