Arboricultural Appraisal Report

Subsidence Damage Investigation at:

27 High Street
Barford
Warwick
CV35 8BU

CLIENT: Gateley Smithers Purslow
 CLIENT REF: 232777
 MWA REF: SUB240124-14973
 MWA CONSULTANT: Andy Clark
 REPORT DATE: 11/03/2024

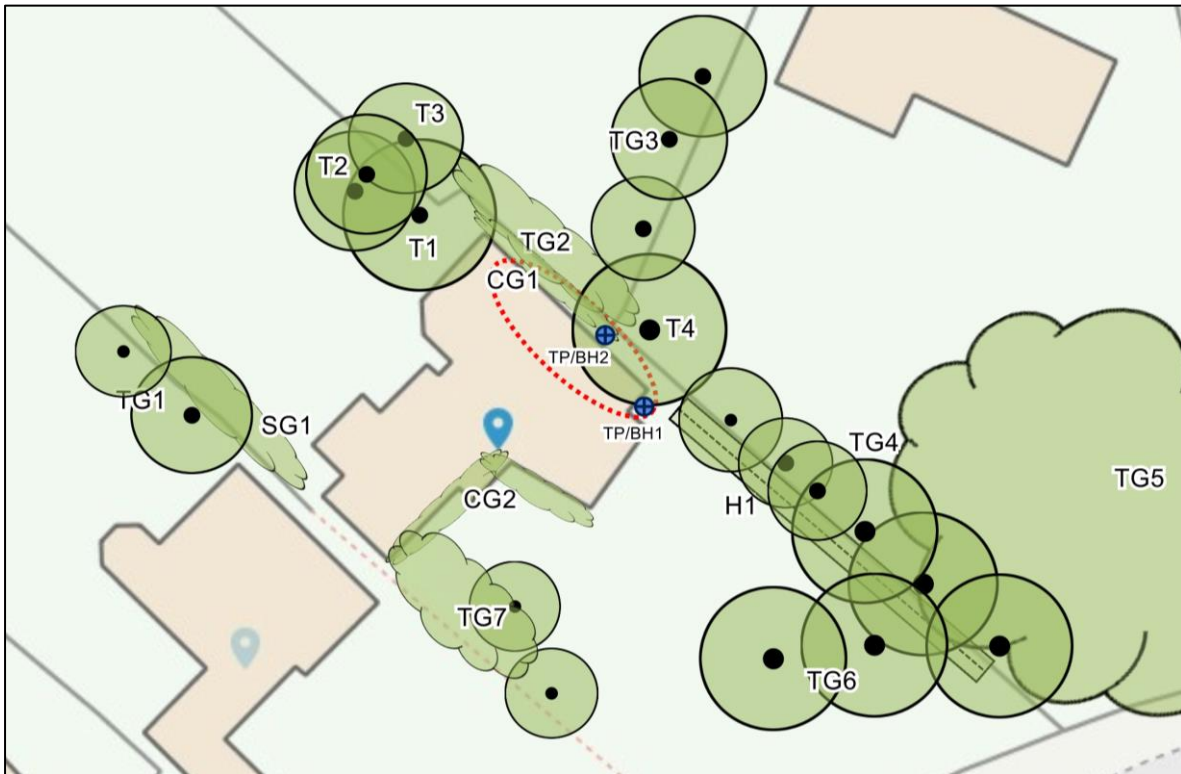
Site Plan

Approximate areas of damage

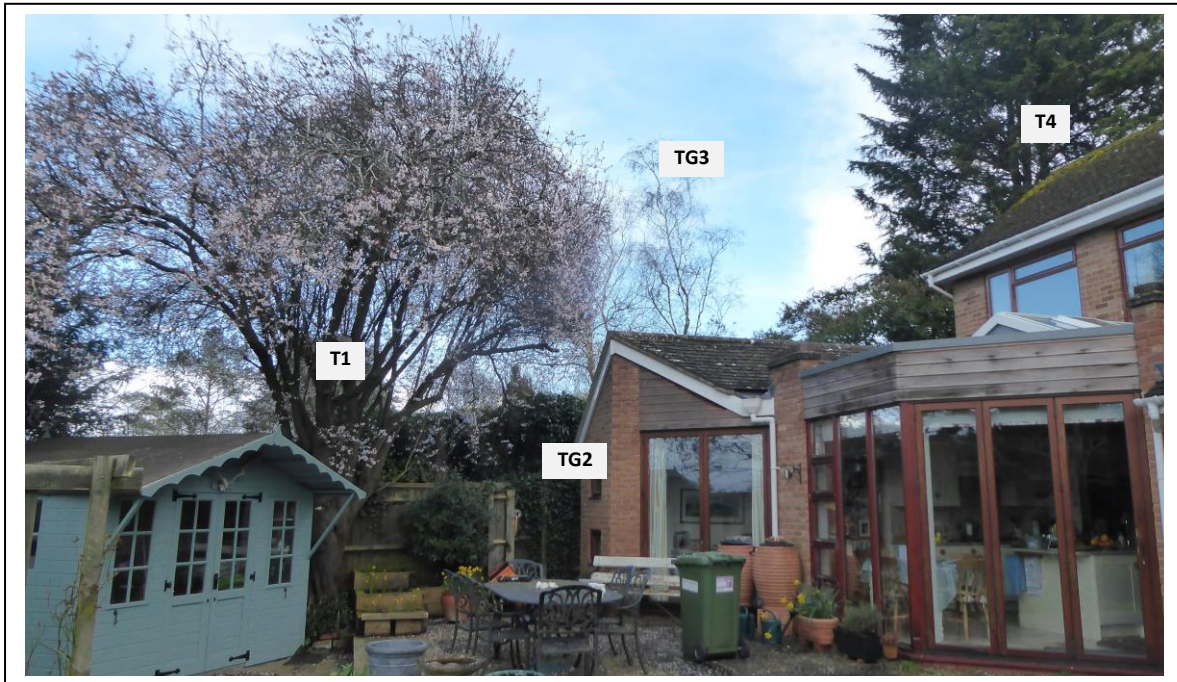
The origin of the Cypress roots will be either TG2 Cypress group or T4 Cypress both of which are within influencing distance of the building. The source of the tentatively identified either *Pomoideae* or *Prunus* roots is less clear. T1 Purple Leaved Plum is the most likely source, or other related vegetation not visible from the subject property garden [there is possibly a Cotoneaster beyond TG2].

View from rear of T1 Purple Leaved Plum, with TG2 Cypress group and T4 Cypress visible beyond [Birches of TG3 visible in distance]

If an arboricultural solution is to be implemented to mitigate the influence of the implicated trees/vegetation we recommend that Ivy growth CG1, the TG2 Cypress group, the T1 Purple Leaved Plum and the T4 Cypress are removed in the first instance (see Table 1). If movement persists, or if further evidence comes to light to confirm the involvement of other vegetation, then further works may be required.

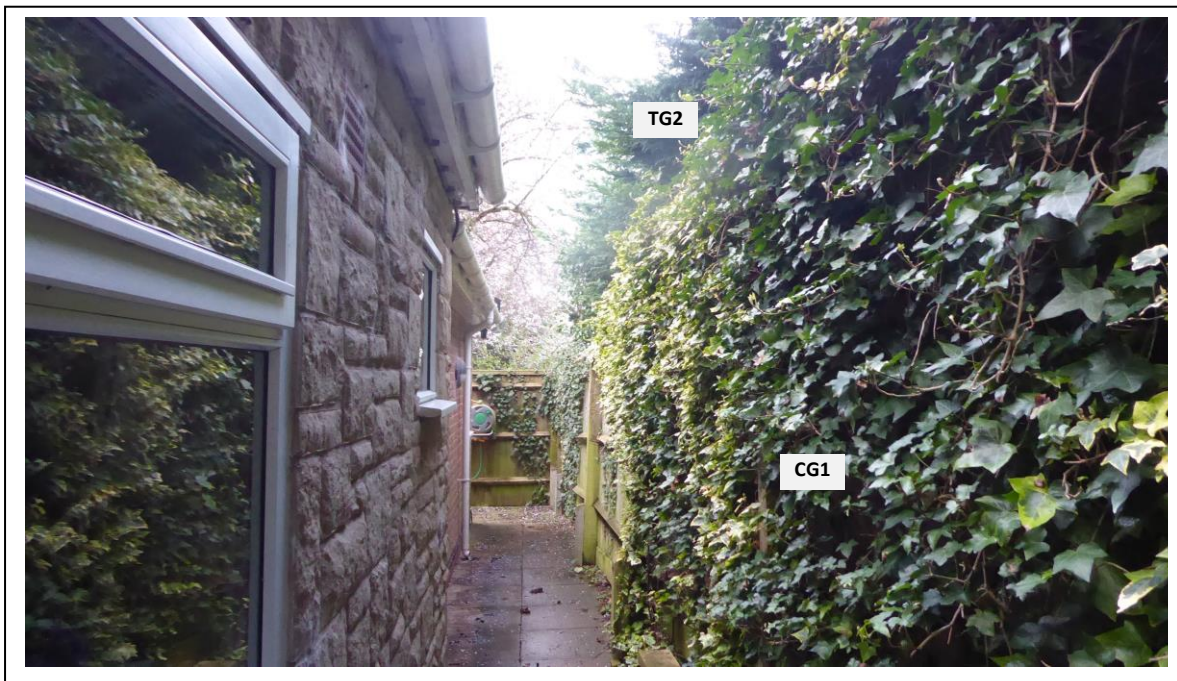
View of CG1 Ivy adjacent to addition, with TG2 Cypress group beyond

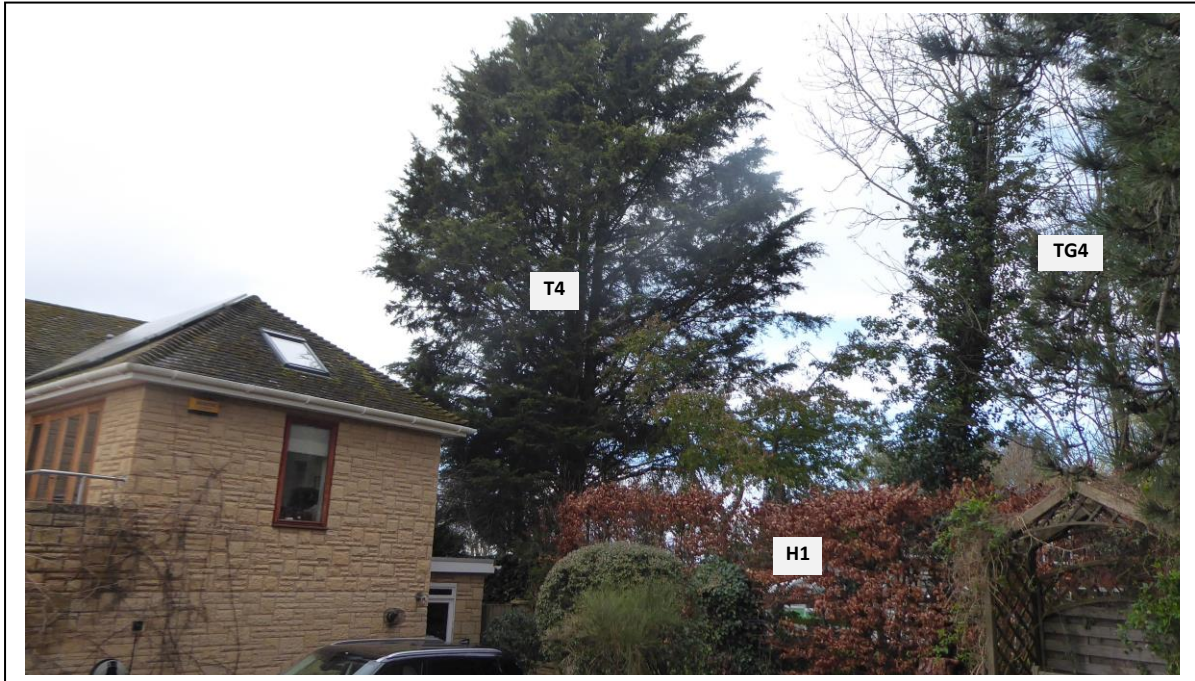
View from front of T4 Cypress, with H1 Beech hedge and TG4 group visible to foreground

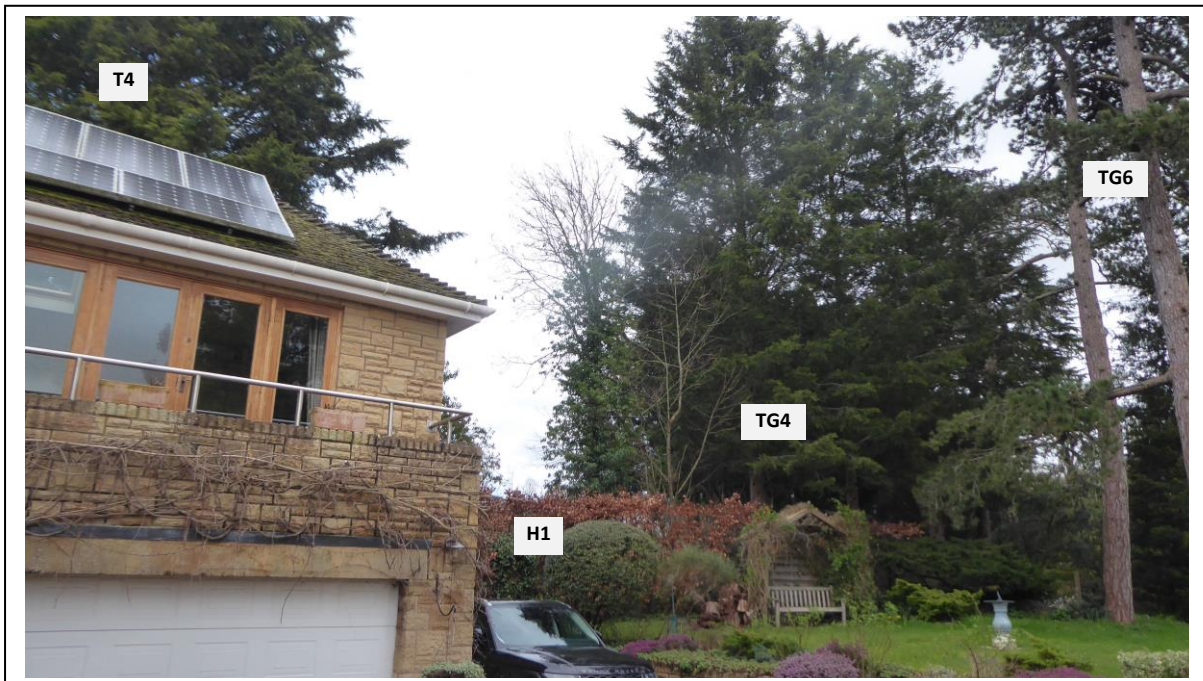
View of T4 Cypress, H1 Beech hedge, TG4 group and TG6 Pine group
