Geo Technical Report

Drainage Report

27 High Street,
Barford
CV35 8BU

Following your request, we attended site to undertake a site investigation comprising of a CCTV survey of the drainage system and trial hole / boreholes.

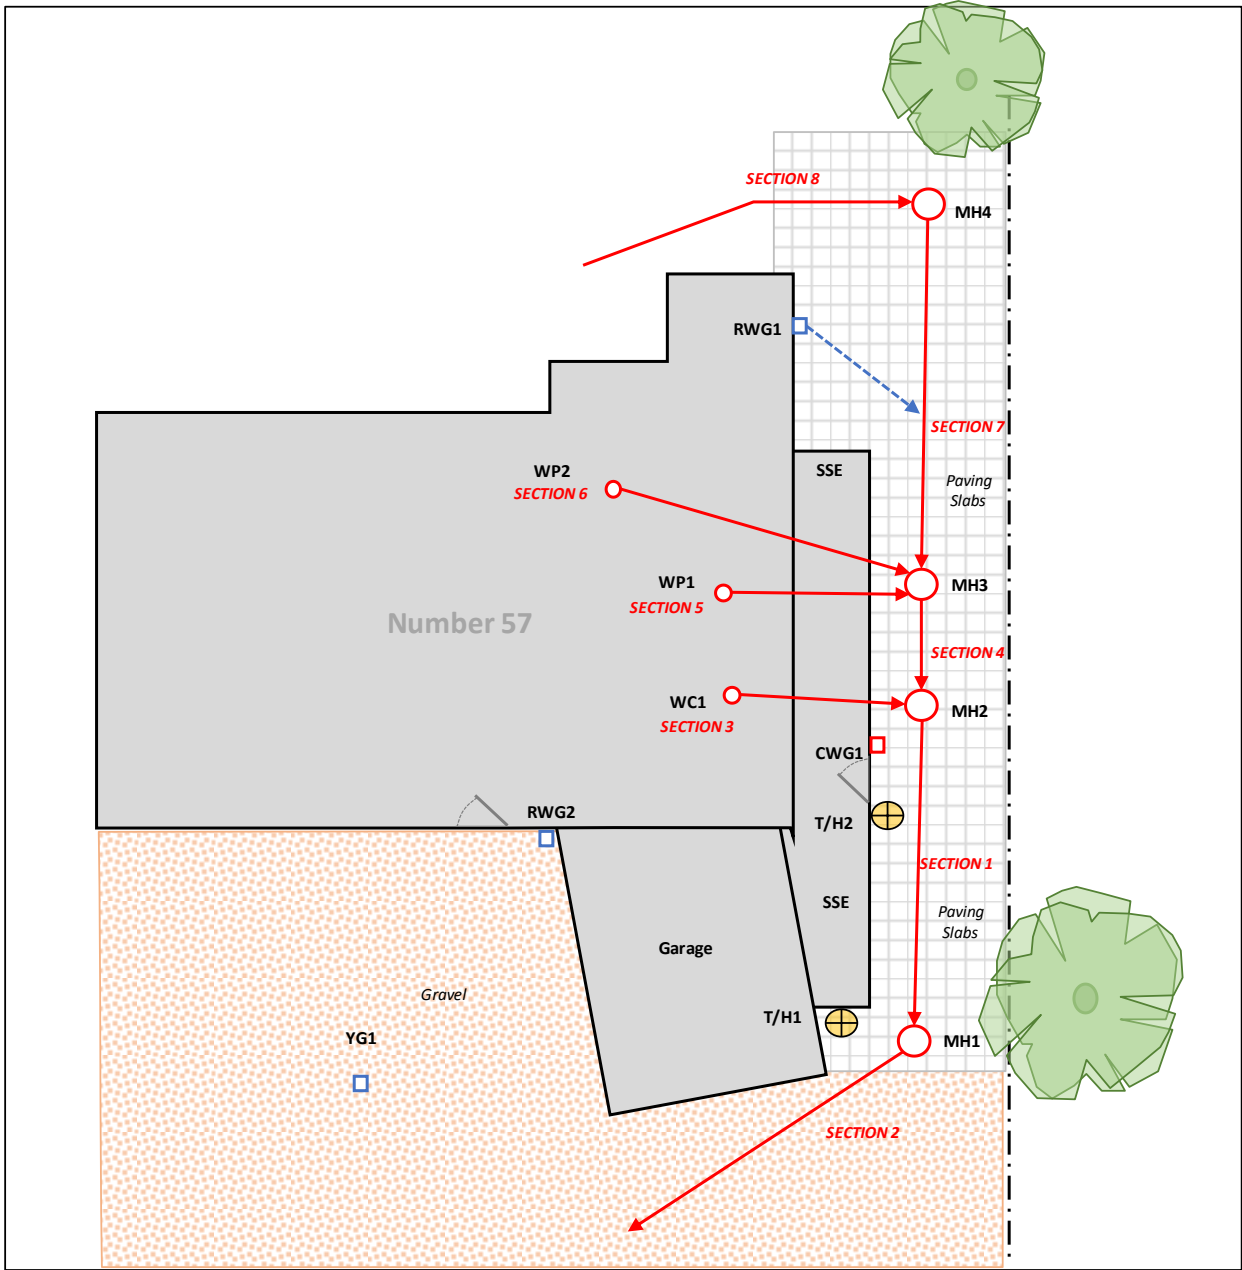
Site Plan

To the right hand side of the property (Single story extension to rear of garage)

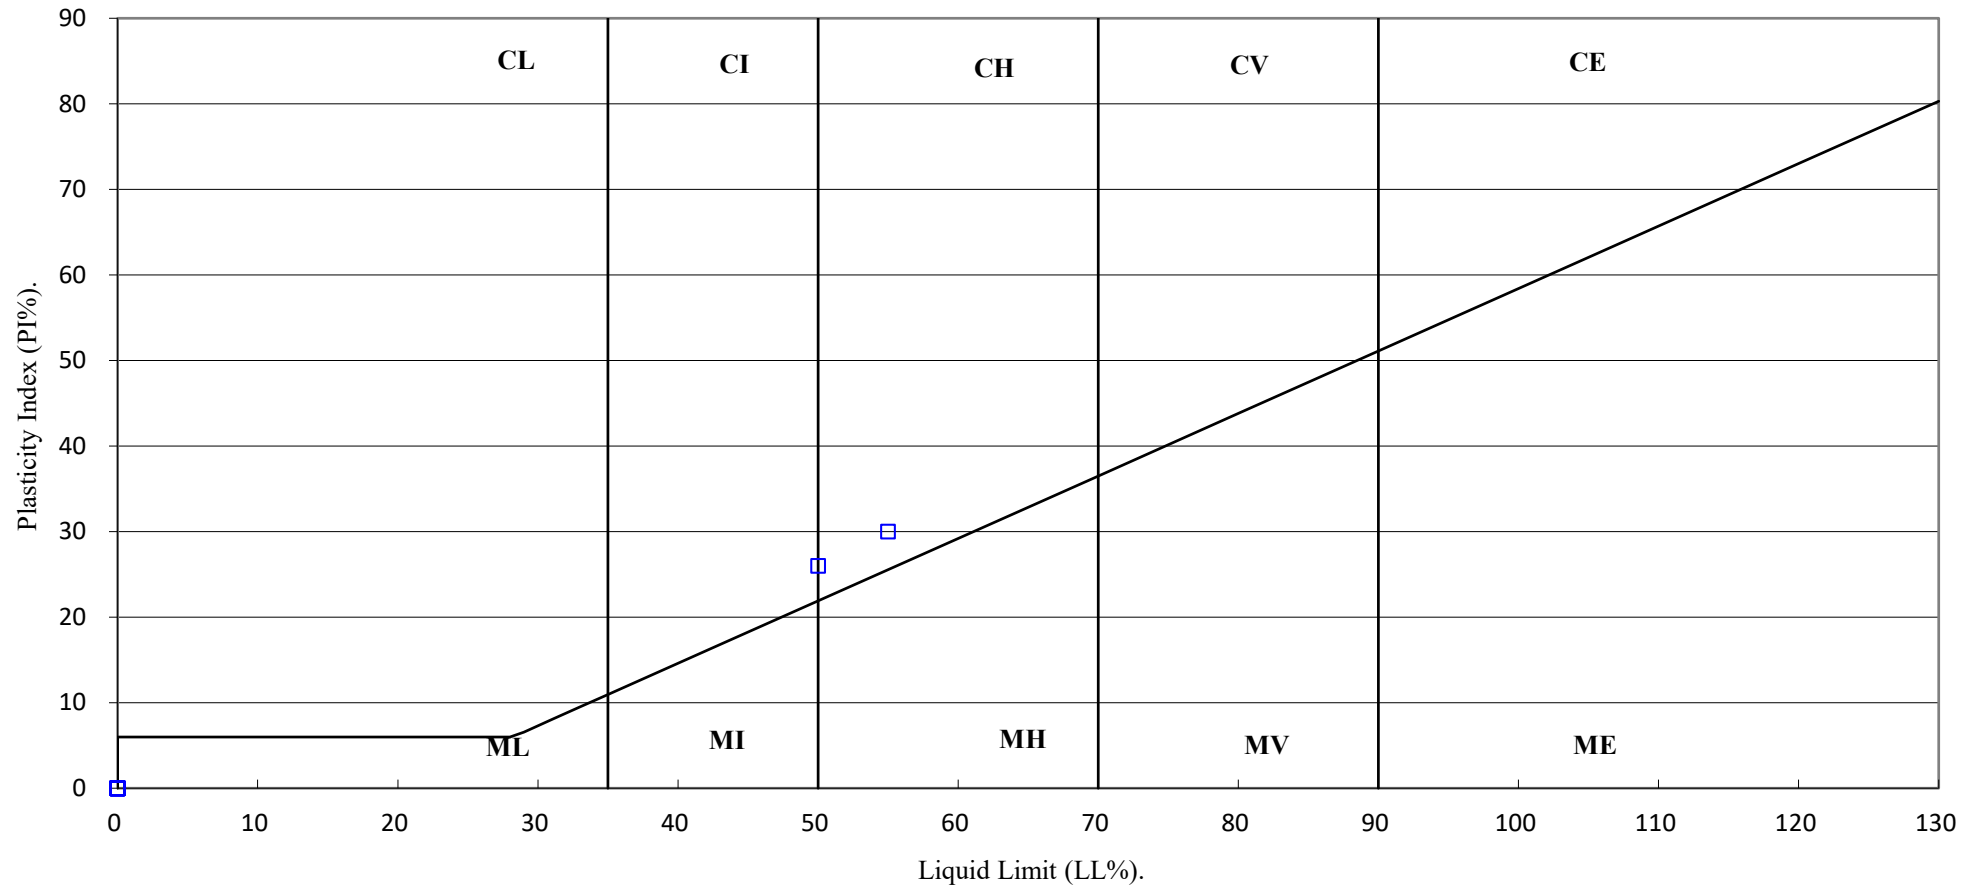
PLASTICITY CHART FOR CASAGRANDE CLASSIFICATION.

Hole Number	Sample Number	Sample Type	Top Depth m	Base Depth m	Moisture Content % <small>Clause 3.2</small>	Linear Shrinkage % <small>Clause 6.5</small>	Particle Density Mg/m ³ <small>Clause 8.2</small>	Liquid Limit % <small>Clause 4.3/4</small>	Plastic Limit % <small>Clause 5.3</small>	Plasticity Index % <small>Clause 5.4</small>	Passing .425mm %	Remarks
BH/TH1			0.70	1.20	28			55	25	30	97	High Plasticity CH
BH/TH2			0.70	1.20	24			50	24	26	93	High Plasticity CH
