Drainage Report

27 High Street
Barford
England
CV35 8BU

27 High Street, Barford CV35 8BU - CCTV Survey Report : 19/01/24

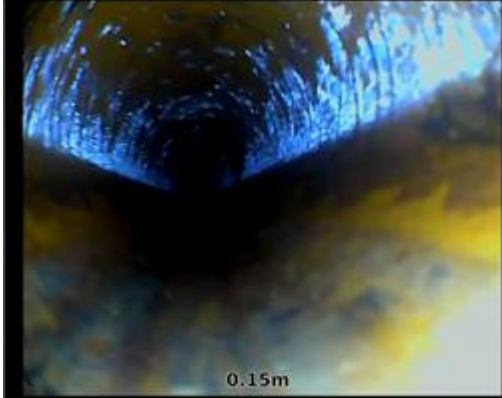
Pos	Video Ref	Code	Description	Image
00.00m		MH	Start node type, manhole MH1	<p>Image Provided - Ref: 0_0</p>

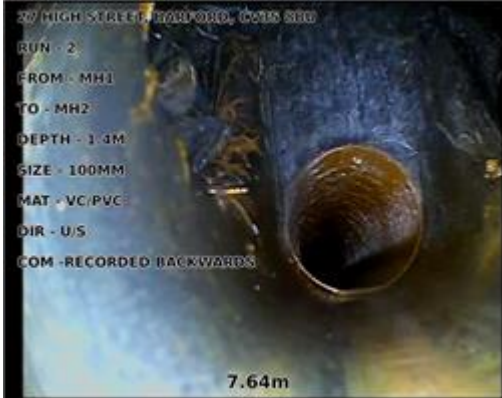
<p>0.15m</p>
00.00m	0:00:00	WL	Water level: 0% Height/Diameter	
07.64m		MHF	Finish node type, manhole MH2	<p>Image Provided - Ref: 0_9999</p>

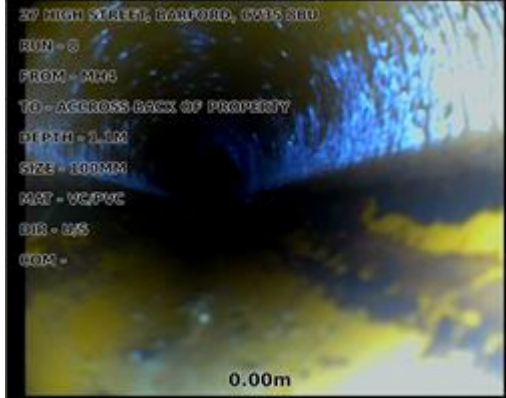
Pos	Video Ref	Code	Description	Image
00.00m		MH	Start node type, manhole MH4	<p>Image Provided - Ref: 7_0</p>
