Our Ref: 232777/TDent/mz
Your Ref: MUK.227980

Enquiries to: Tom Denton
Mobile: [REDACTED]
Email: tom.denton@gateleymitherspurslow.com

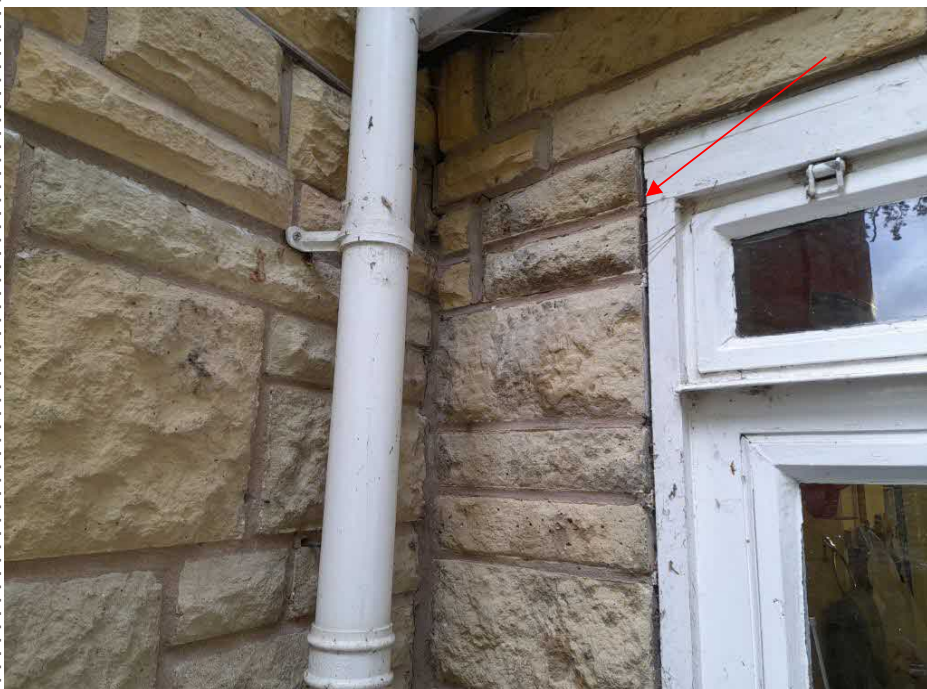
Plate 6. Vertical cracking to front elevation of single-storey addition.

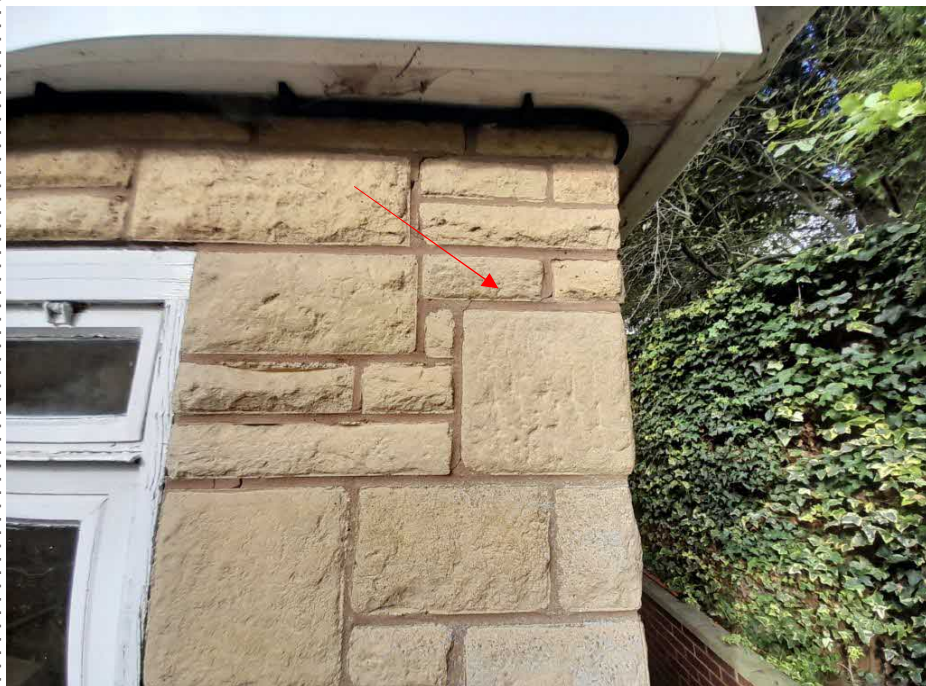
Plate 7. Stepped cracking front elevation of single-storey addition.

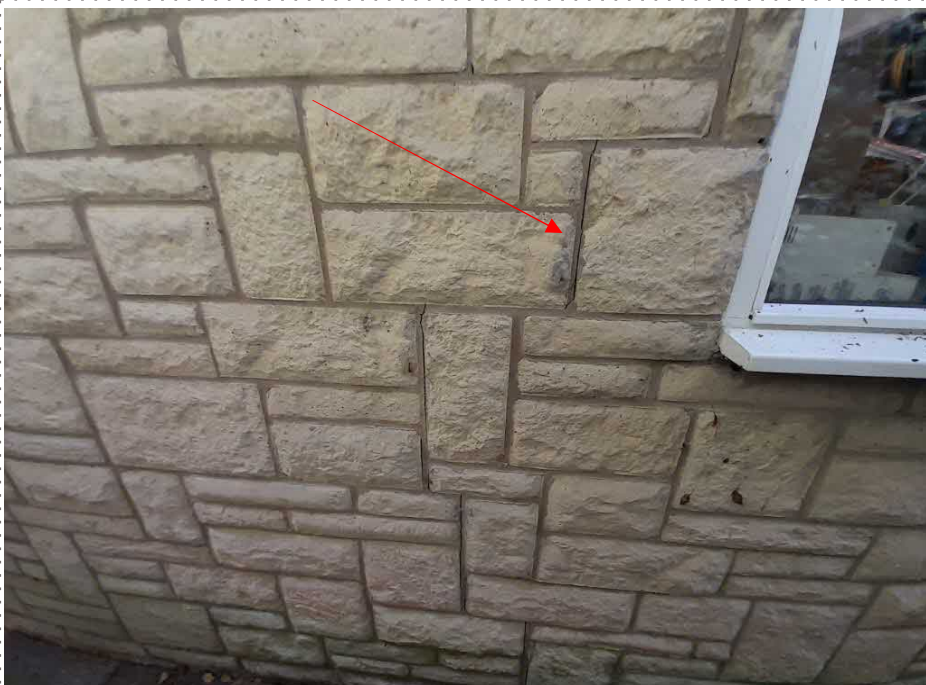
Plate 8. Stepped cracking to right-hand elevation of single-storey addition (garage/workshop).

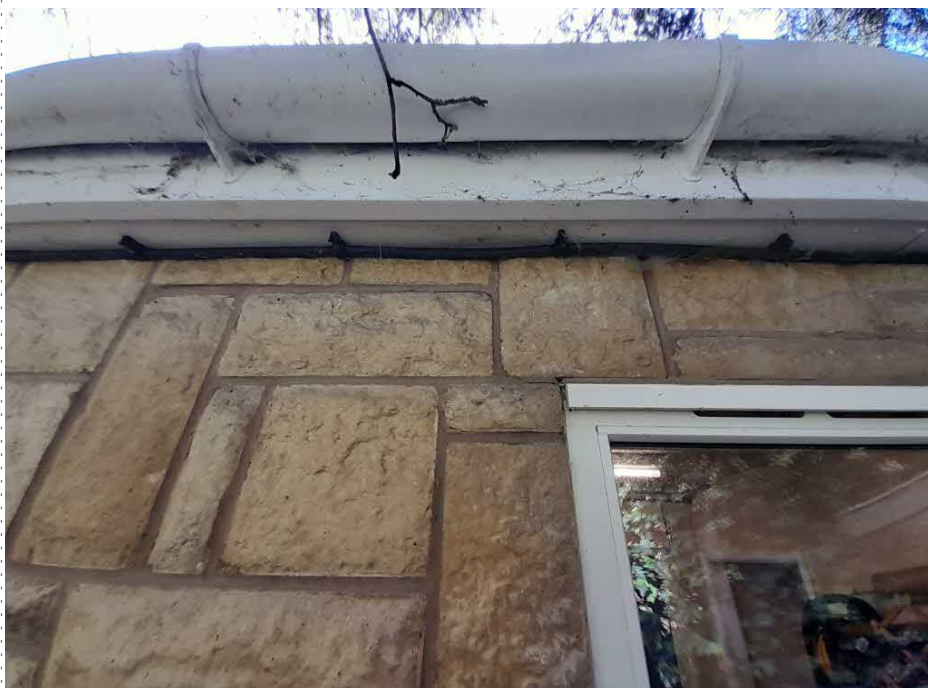
Plate 9. Stepped cracking above single-storey right-hand elevation window (garage/workshop).

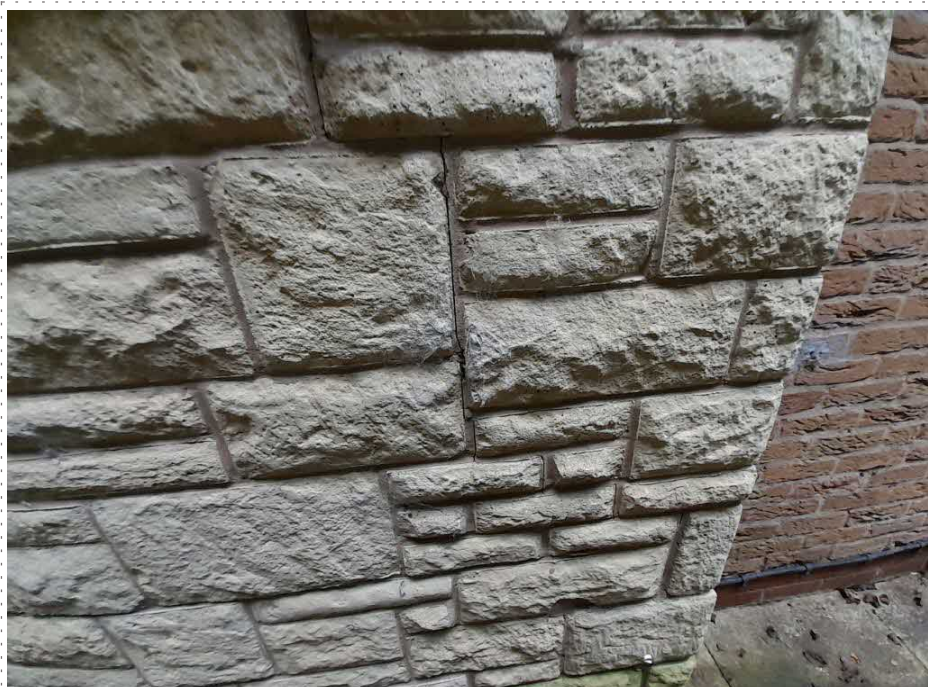
Plate 10. Stepped cracking below single-storey right-hand elevation window (utility).

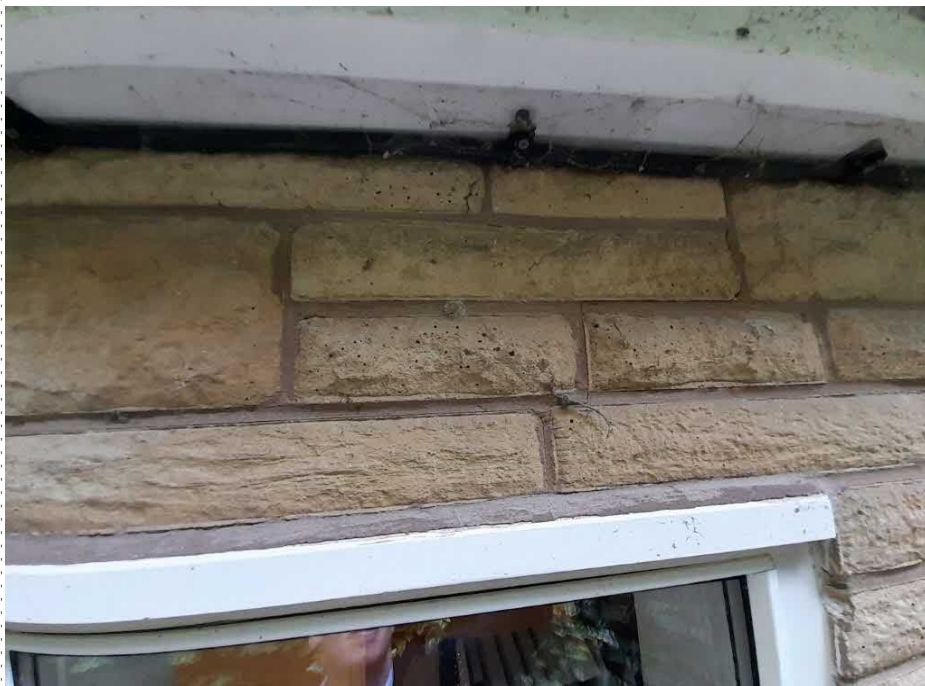
Plate 11. Stepped cracking above single-storey right-hand elevation window (utility).

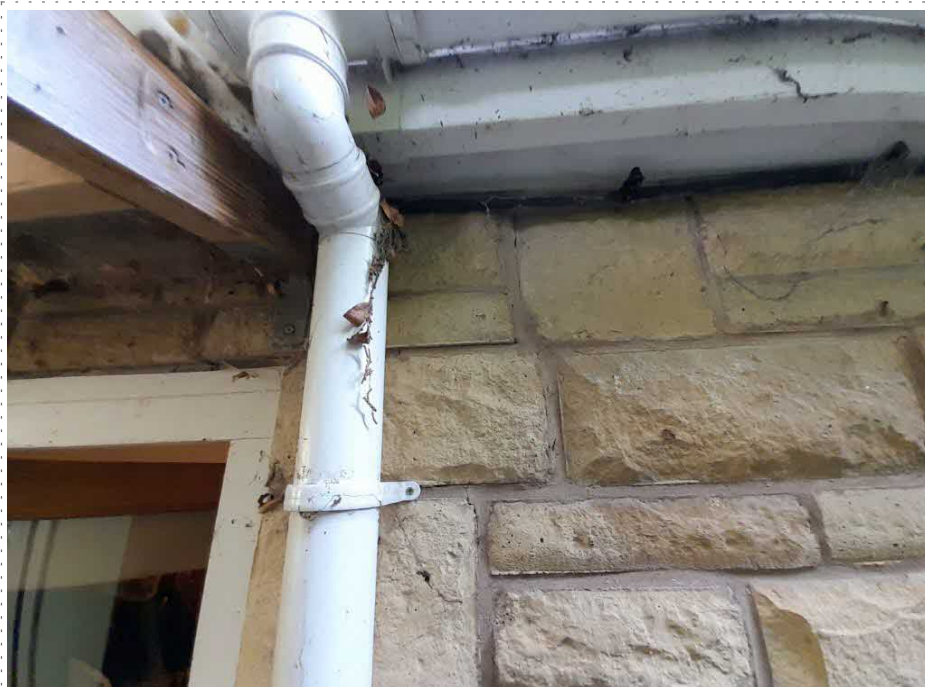
Plate 12. Vertical cracking to right-side single-storey addition external door opening.

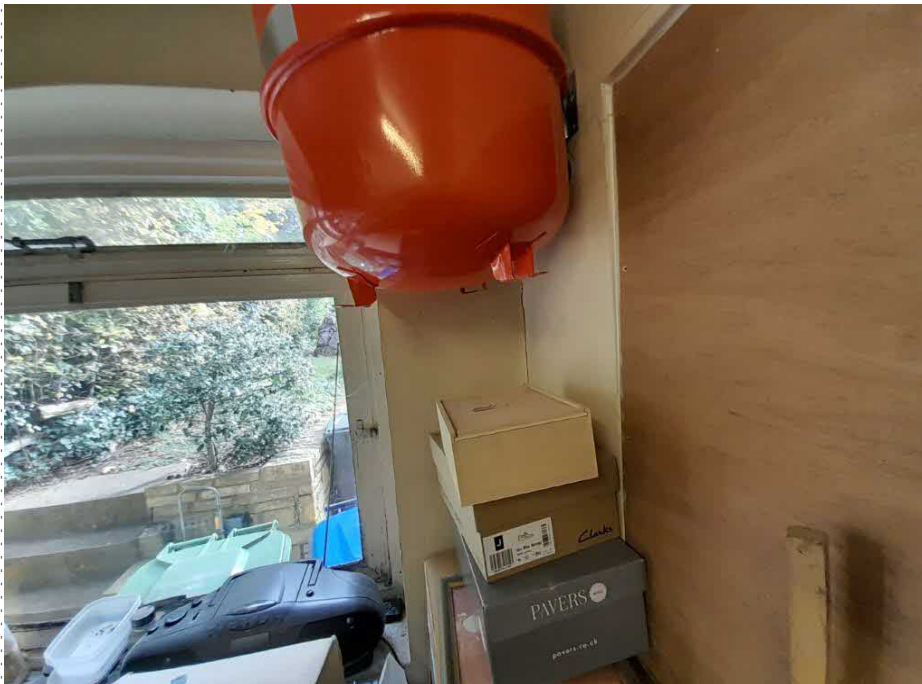
Plate 13. Vertical crack to front wall of garage/workshop at junction with original property.

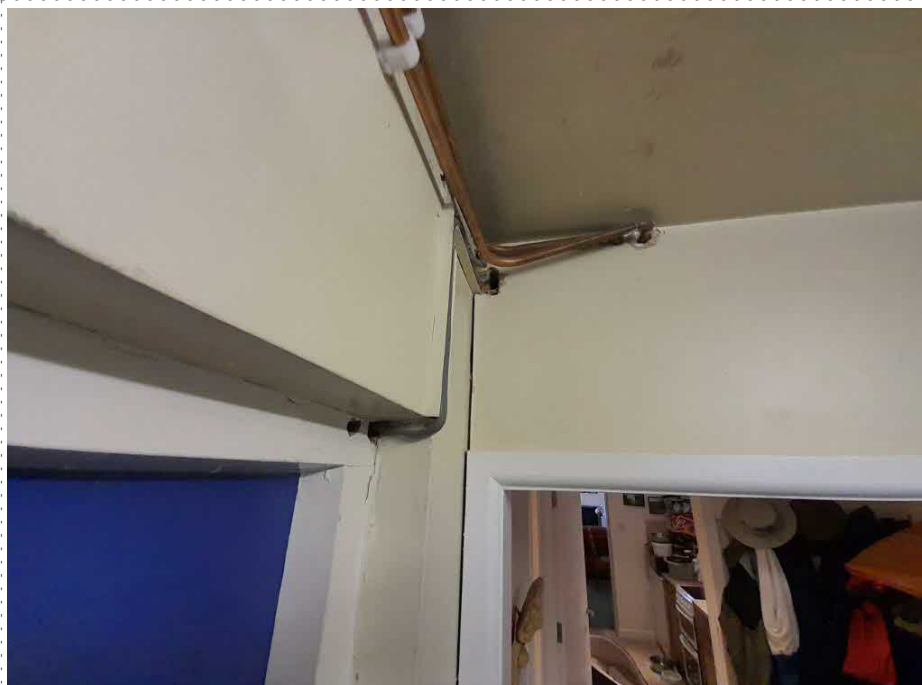
Plate 14. Vertical crack to rear wall of garage/workshop at junction with original property.

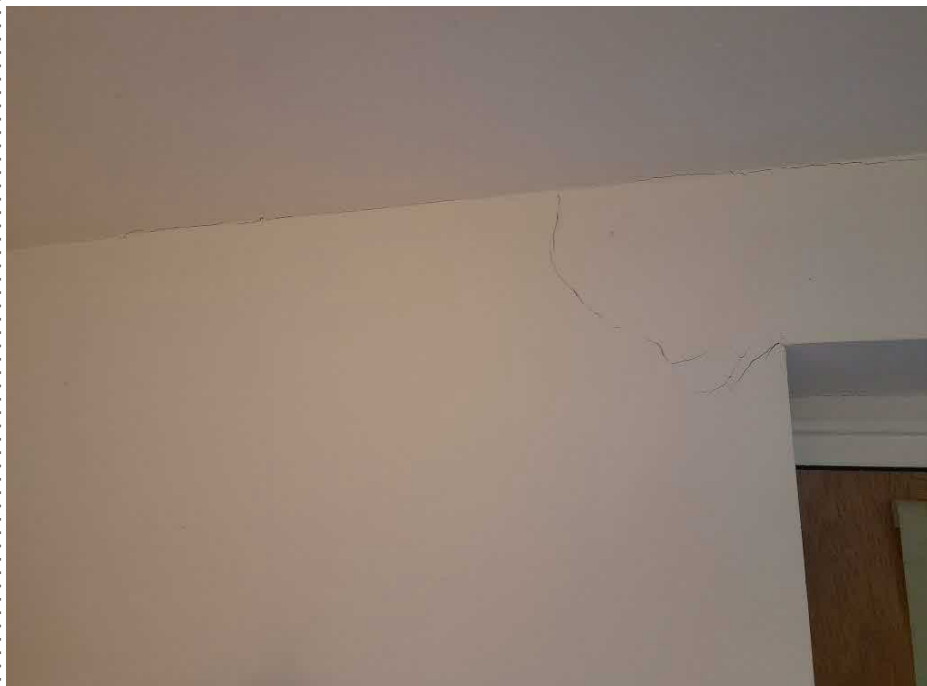
Plate 15. Diagonal crack above external door opening.

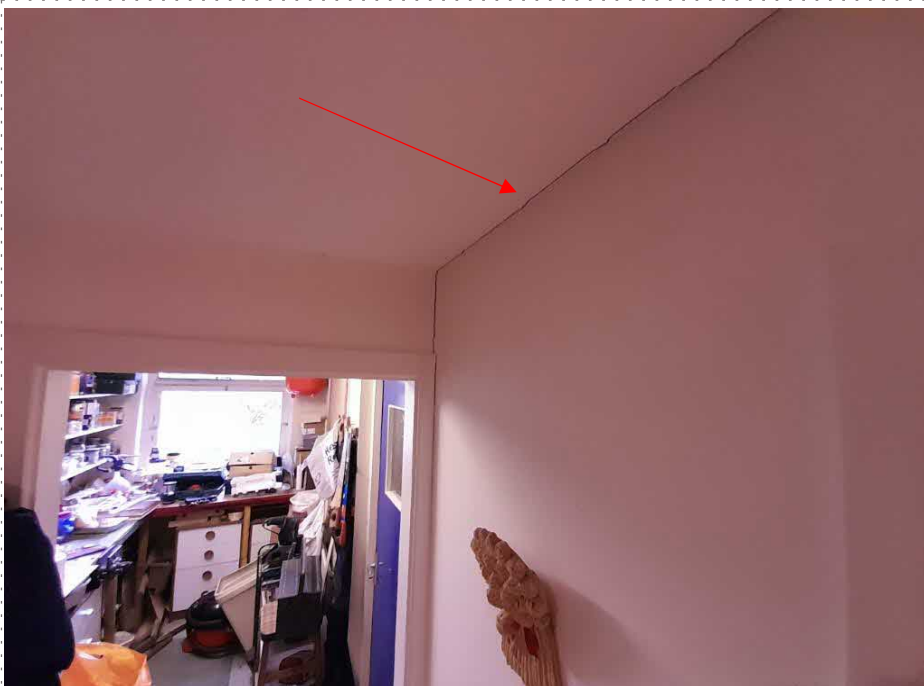
Plate 16. Cracking to junction between single-storey addition and main property.

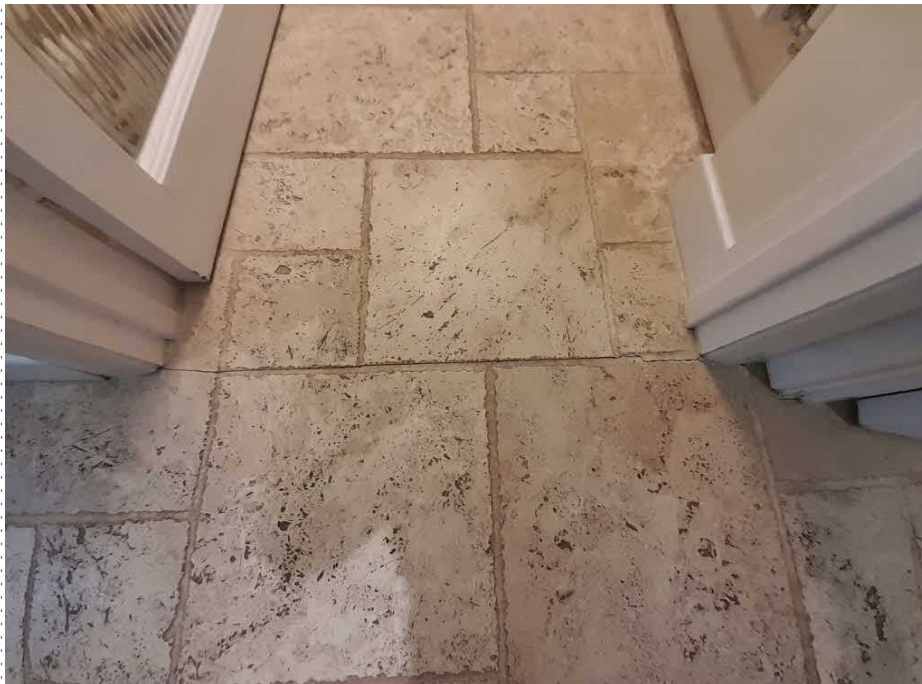
Plate 17. Cracking to floor tile.

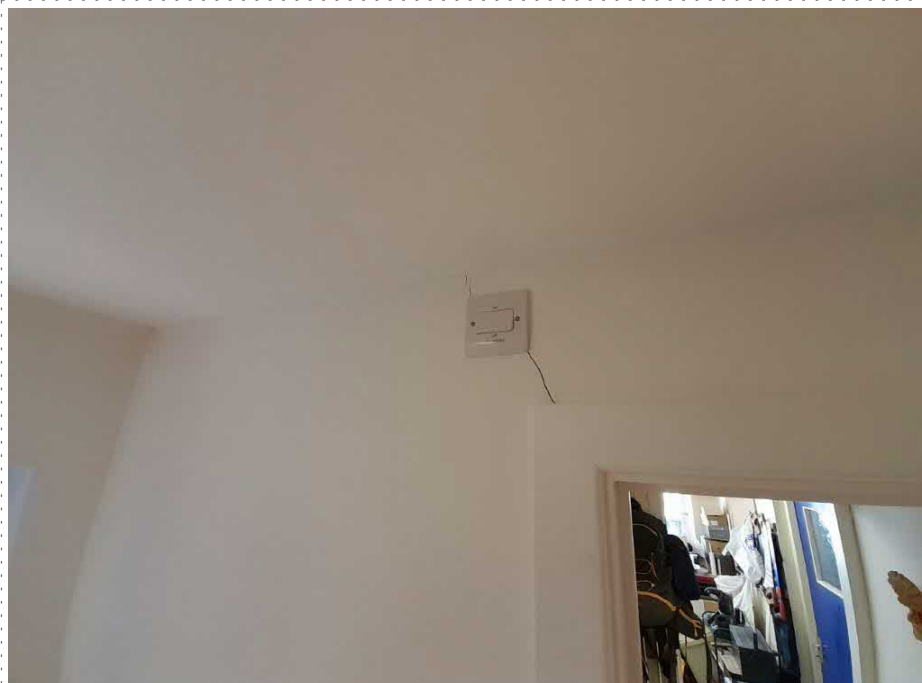
Plate 18. Diagonal cracking above second kitchen door.
