<b>AS(00)008</b>	
<b>Fireplace Schedule</b>	
<b>Project No:</b>	0096
<b>Project Name:</b>	Guildhall Bristol
<b>Client:</b>	Paton Developments Ltd
<b>Revision:</b>	A – revised format/general update to align with PL(00)011 and PL(00)012.
<b>Date:</b>	02.03.2024

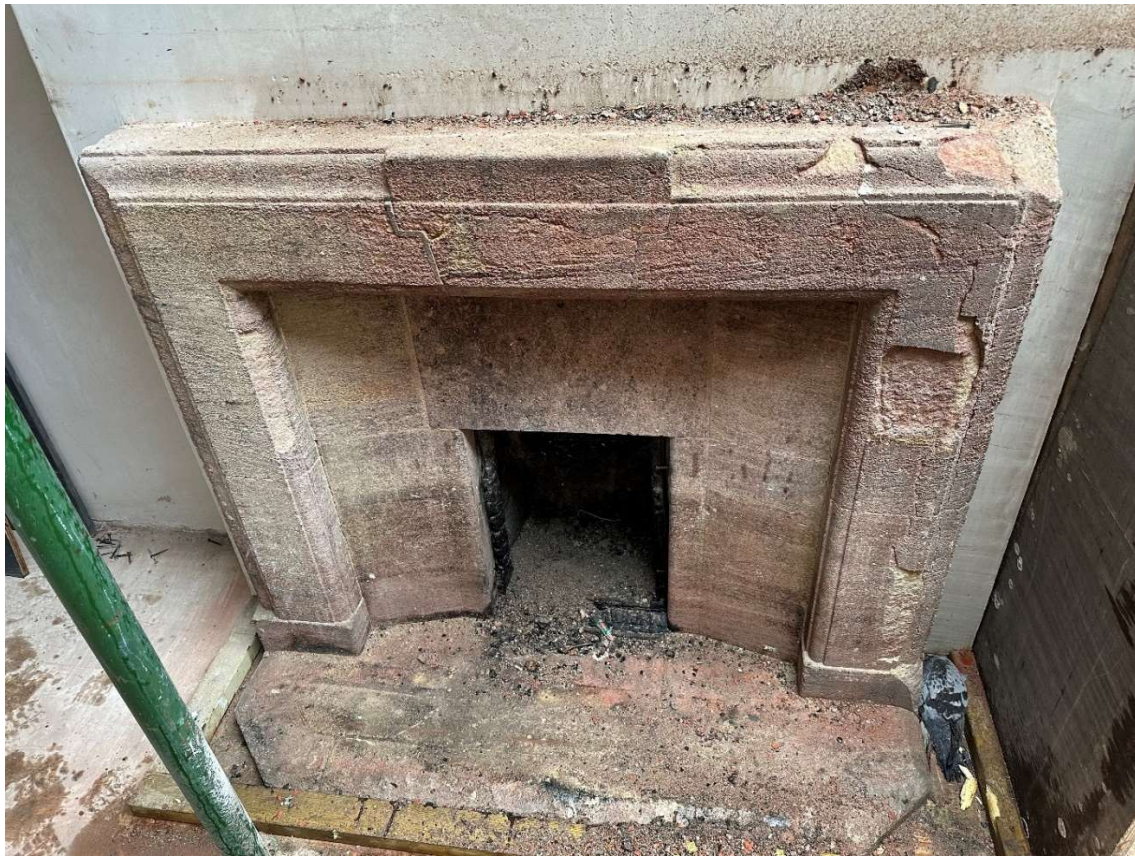
<b>Fireplace Reference: Z3.FP.01</b>	
<b>Type:</b>	Existing stone fireplace surround, mantle and hearth.
<b>Location:</b>	To be retained in current location.
<b>Condition:</b>	Damage to both right and left hand side of surround. Spalling to right hand side of mantle.
<b>Repairs:</b>	Localised stone repairs to be carried out by specialist. Existing brickwork firebox to be cleaned down and made good. Existing chimney breast to be closed off.
<b>Proposals:</b>	To be retained in open position to the proposed circulation area.

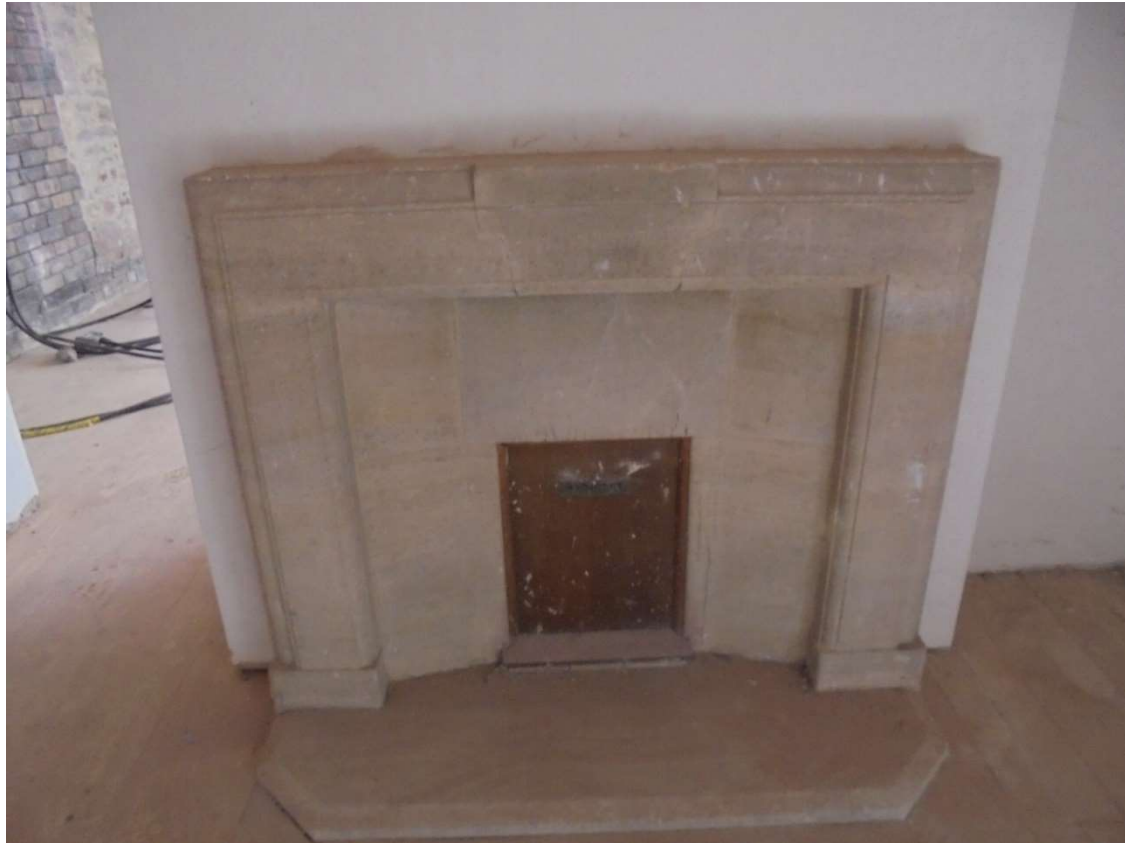
<b>Fireplace Reference: Z4.FP.02</b>	
<b>Type:</b>	Existing stone fireplace surround, mantle and hearth.
<b>Location:</b>	To be retained in current location.
<b>Condition:</b>	Minimal damage to mantle.
<b>Repairs:</b>	Localised stone repairs to be carried out by specialist. Existing brickwork firebox to be cleaned down and made good. Existing chimney breast to be closed off.
<b>Proposals:</b>	To be retained in open position to the proposed restaurant area.

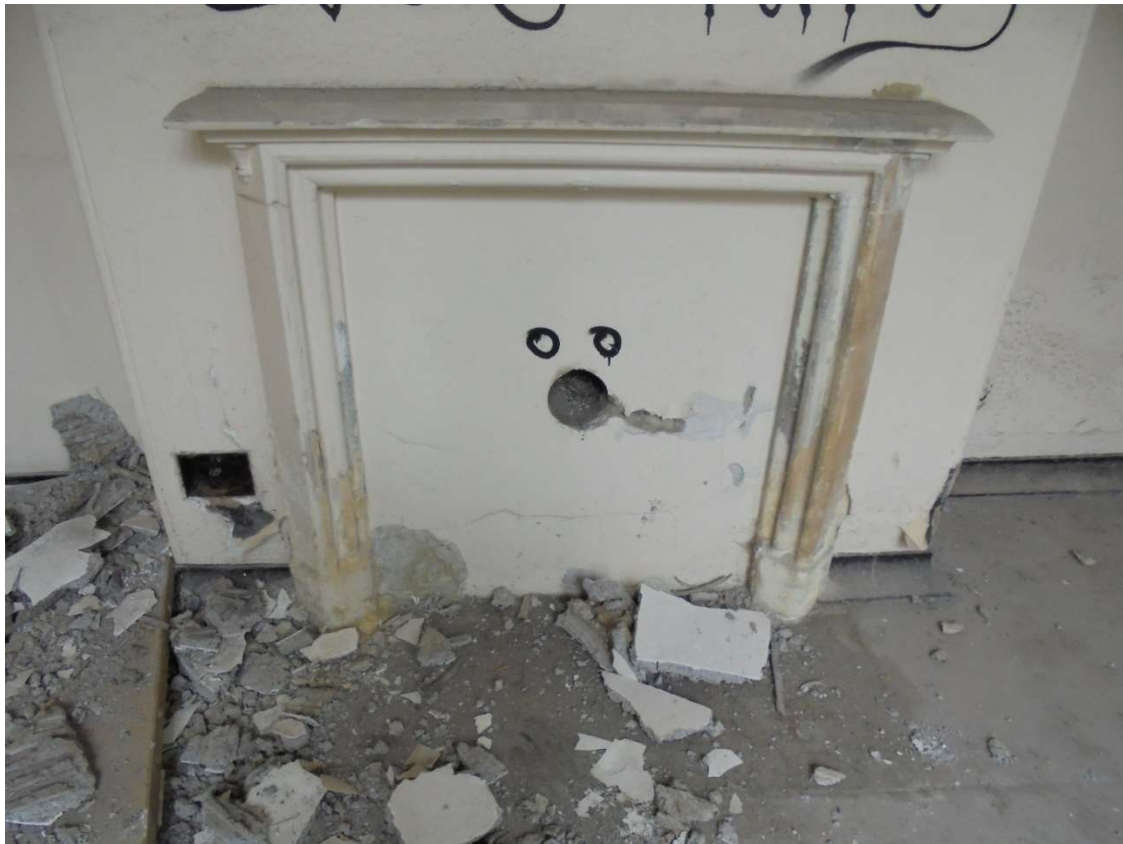
<b>Fireplace Reference: Z4.FP.04</b>	
<b>Type:</b>	Existing stone fireplace surround, mantle and hearth.
<b>Location:</b>	To be retained in current location.
<b>Condition:</b>	Damage to mantle. Lower half of stone surrounds significantly damaged.
<b>Repairs:</b>	Localised stone repairs to be carried out by specialist, including substantial infill to lower half of surround. Existing paint finish to be stripped by specialist. Existing firebox to be opened up and made good. Existing chimney breast to be closed off.
<b>Proposals:</b>	To be retained in open position to the proposed guestroom area.

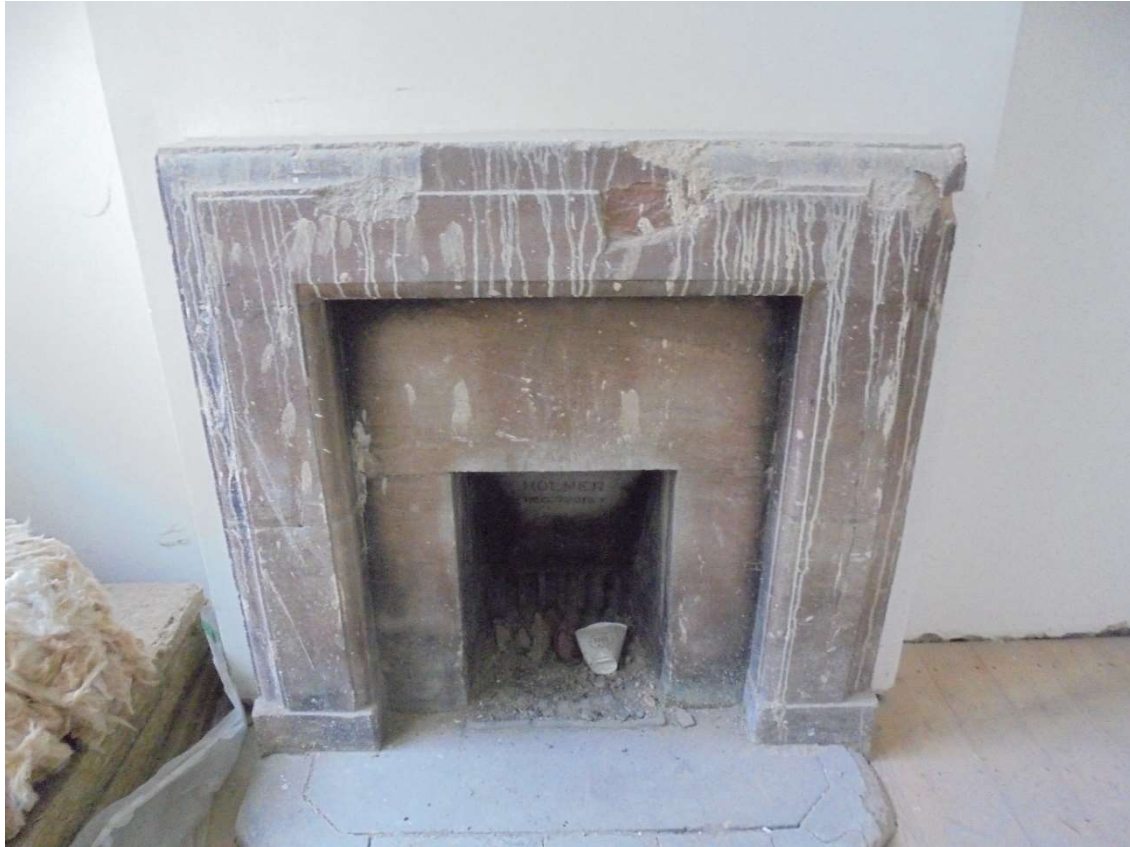
<b>Fireplace Reference: Z4.FP.06</b>	
<b>Type:</b>	Existing stone fireplace surround, mantle and hearth.
<b>Location:</b>	To be retained in current location.
<b>Condition:</b>	Damage to mantle. Damage and spalling to right hand side of stone surround.
<b>Repairs:</b>	Localised stone repairs to be carried out by specialist. To be cleaned down and existing paint covering removed as per specialist methodology. Existing brickwork firebox to be cleaned down and made good. Existing chimney breast to be closed off.
<b>Proposals:</b>	To be retained in open position to the proposed guestroom area.

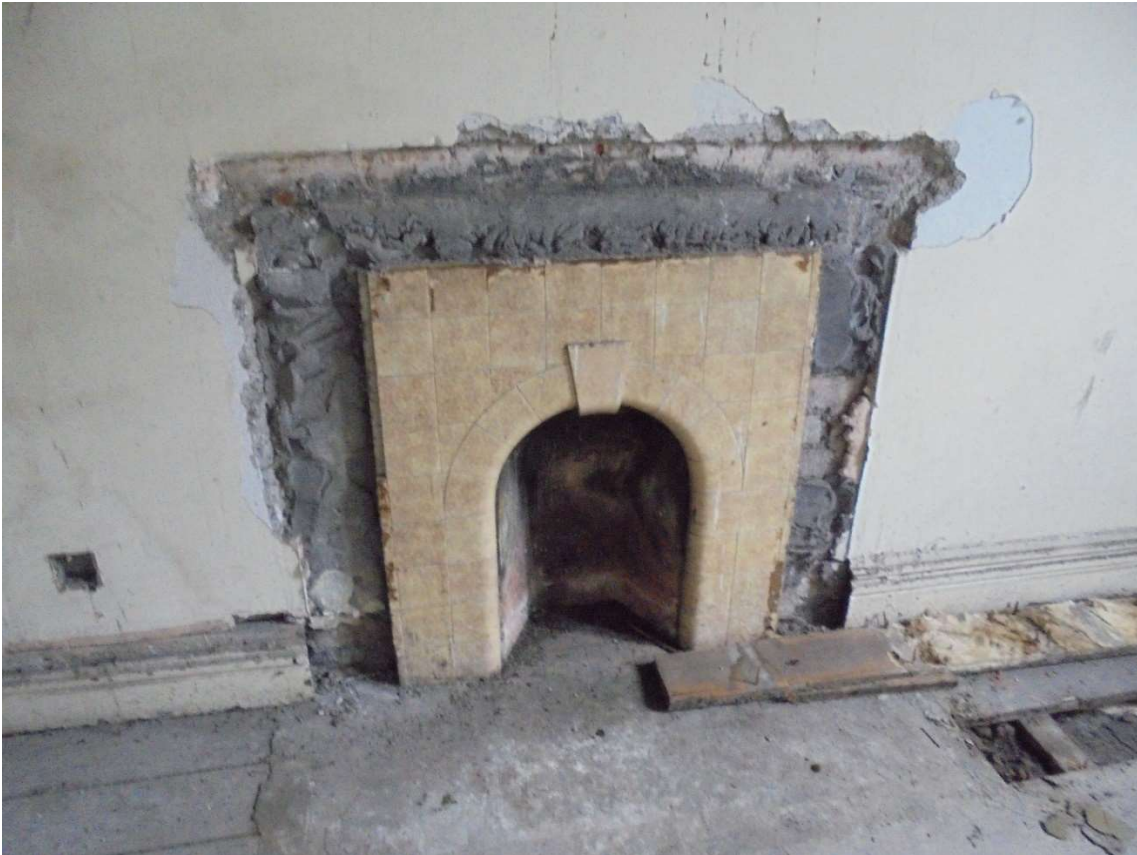
<b>Fireplace Reference: Z3.FP.02</b>	
<b>Type:</b>	Unknown as surround and mantle missing.
<b>Location:</b>	To be retained in current location.
<b>Condition:</b>	Fireplace surround and mantle missing. Inset tiles remaining.
<b>Repairs:</b>	None.
<b>Proposals:</b>	To be retained and encapsulated within proposed guestroom area.

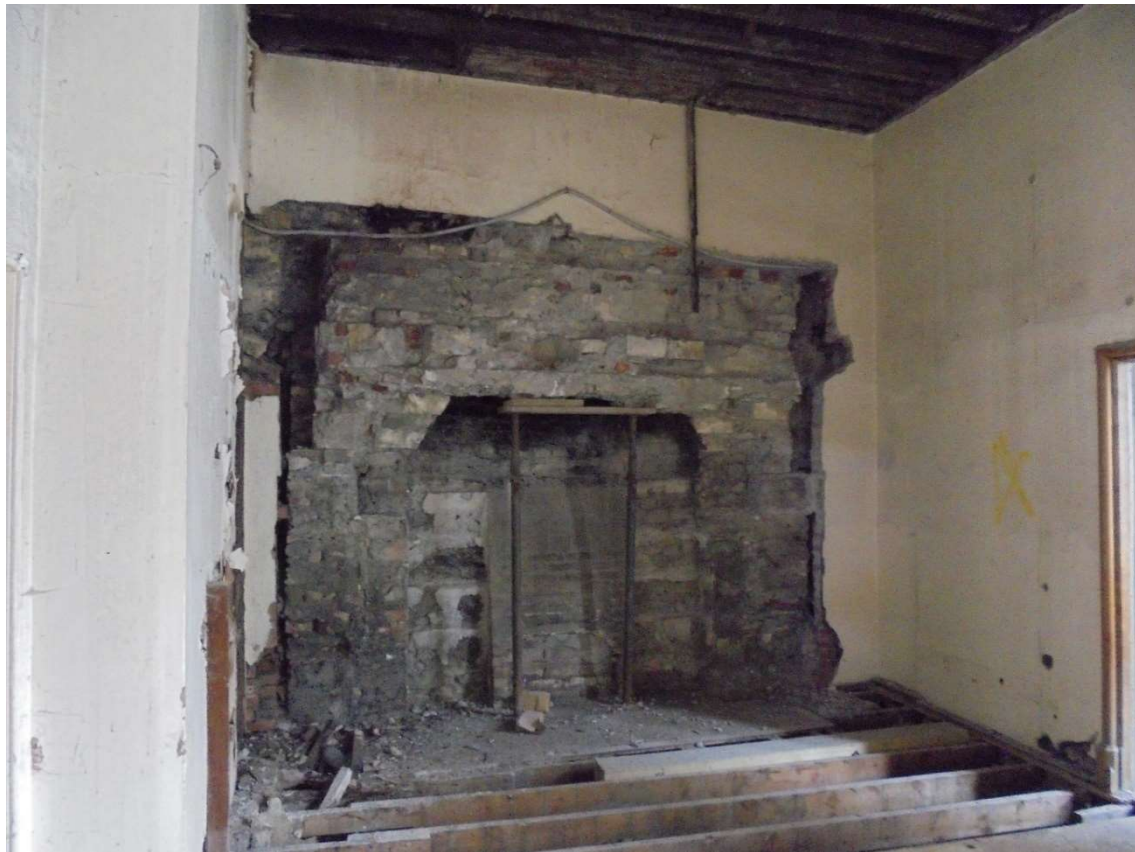
<b>Fireplace Reference: Z1.FP.01</b>	
<b>Type:</b>	Existing stone fireplace surround and mantle. Colston Fireplace.
<b>Location:</b>	To be relocated to the proposed reception area.
<b>Condition:</b>	Fireplace surround and mantle removed from site for protection through the construction works.
<b>Repairs:</b>	Localised stone repairs to be carried out by specialist. Relocation (including support structure) to be carried out by specialist.
<b>Proposals:</b>	To be in open position to the proposed reception area. Existing fireplace location to be infilled and relined to proposed guestroom.
