TREE SAFETY APPRAISAL

Land opposite 1-8 Royal Victoria Court, Royal Victoria Place,
Bristol BS10 6TL.

Clients; BPDML Admin Centre, on behalf of Brentry Park Development
Management Company Ltd Issue date: 15/03/2024

AJE/29526 Rev1

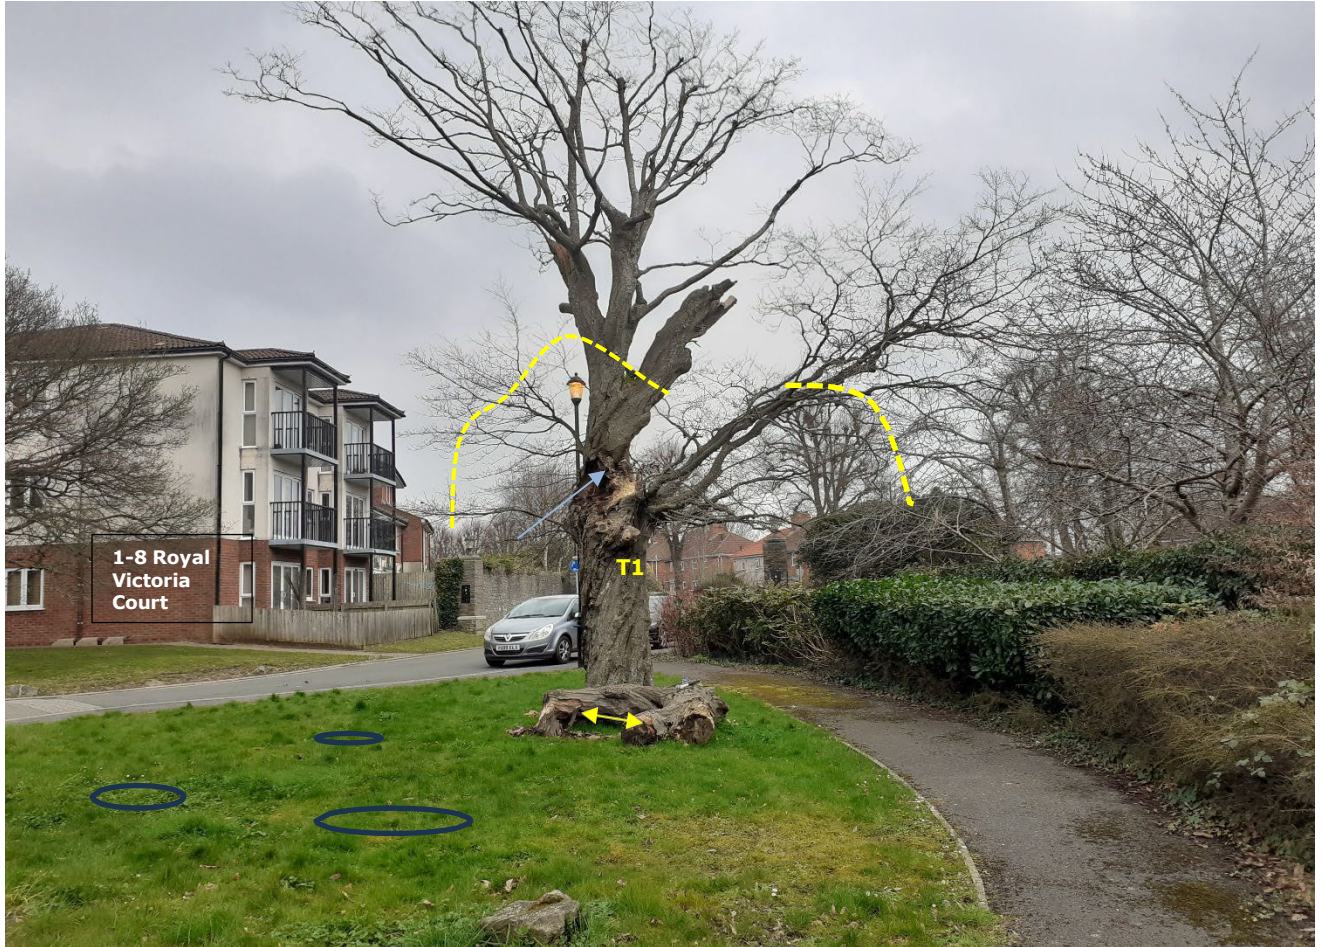
Viewed facing North-Northeast towards tree T1, with Charton Road out of view behind the hedge and young tree plantation to the right of the picture. The two fallen dead stumps (Yellow arrow) have no live growth, they fractured out from the principle trunk fork, light-colored breakage position (Blue arrow). For maximum net biodiversity gain, the wood and brush chippings are best left on site, close to T1. Note the proposed pruning cut positions, (yellow dash lines) and x3 possible long-term planting locations, (Blue ovals) needed to provide continuity of tree cover in this part of the conservation area.

- 1.1 This report is requested by the clients following tree safety and maintenance correspondence concerning a Hornbeam, *Carpinus betulas* (T1 of the tree location plan TLP) growing within the landscaped grounds above; it is a large decaying specimen that recently shed a dead, forked 45cm diameter limb, **(Page 1 picture)** of significance to safety and is increasingly vulnerable to further collapse. The tree safety appraisal and maintenance recommendations are below.

- 4.1 The overmature/near veteran T1 has a height of circa 12m, crown radial spread of 5m, trunk diameter of 78cm. The trunk buttressing is decayed for about 1.8m of the trunk circumference, with a southerly facing 25 cm diameter sporophore within the southerly indent, next to functioning, upward spiraling, live woundwood development, overlaying a hollowing trunk, up to a group of near-horizontal, healthy, ascending branches, growing around the recent fracture point at about 3m above ground level **(Page one picture)**.

- 4.2 On the northerly side of the trunk at about 1.4m height, are two old 3.5cm diameter rounded sporophores, above which are four, fully mature, blackened 'hoof' shaped' 50cm diameter sporophore brackets of *Ganoderma adspersum/applanatum* a serious wood decay fungus, adjacent to the recent breakage position, where the wood supports the upper trunk and a very sparse higher crown.

- 4.3 Combined with my binocular inspection, and mallet trunk sounding, I expect the trunk heartwood to be extensively decayed and the upper branches weakly attached to the trunk.

- 4.4 Effectively, trees do not 'heal', but the healthy, spiraling upwards trunk growth is 'retrenchment development', where the tree will form a new lower canopy supported by thick, solid wood growth, around the hollowing trunk, providing pillar-like support; the low new crown, could then be cut back to the original pruning points, **(Page one picture)**, with consent from the Council, on say 5-year return visits.

- Reduce the upper trunk to just above the secondary fork divide, cuts about 70cm diameters, shorten the healthy southerly branches in vertical alignment with the footpath join with the laurel hedge, cuts 2-12cm diameters, shorten the easterly outer low foliage by 2.5m, cuts at 1-3cm diameters.
- Plant x3 Hornbeam in the grassed area close to T1, the precise species, planting positions and sizes could be the subject of agreement between the client and Council.
