ROTTERDAM WHARF

EXTRACT FROM PUBLISHED
GEOLOGICAL SURVEY MAP
(MINING INFORMATION)

INVASIVE WEEDS SURVEY

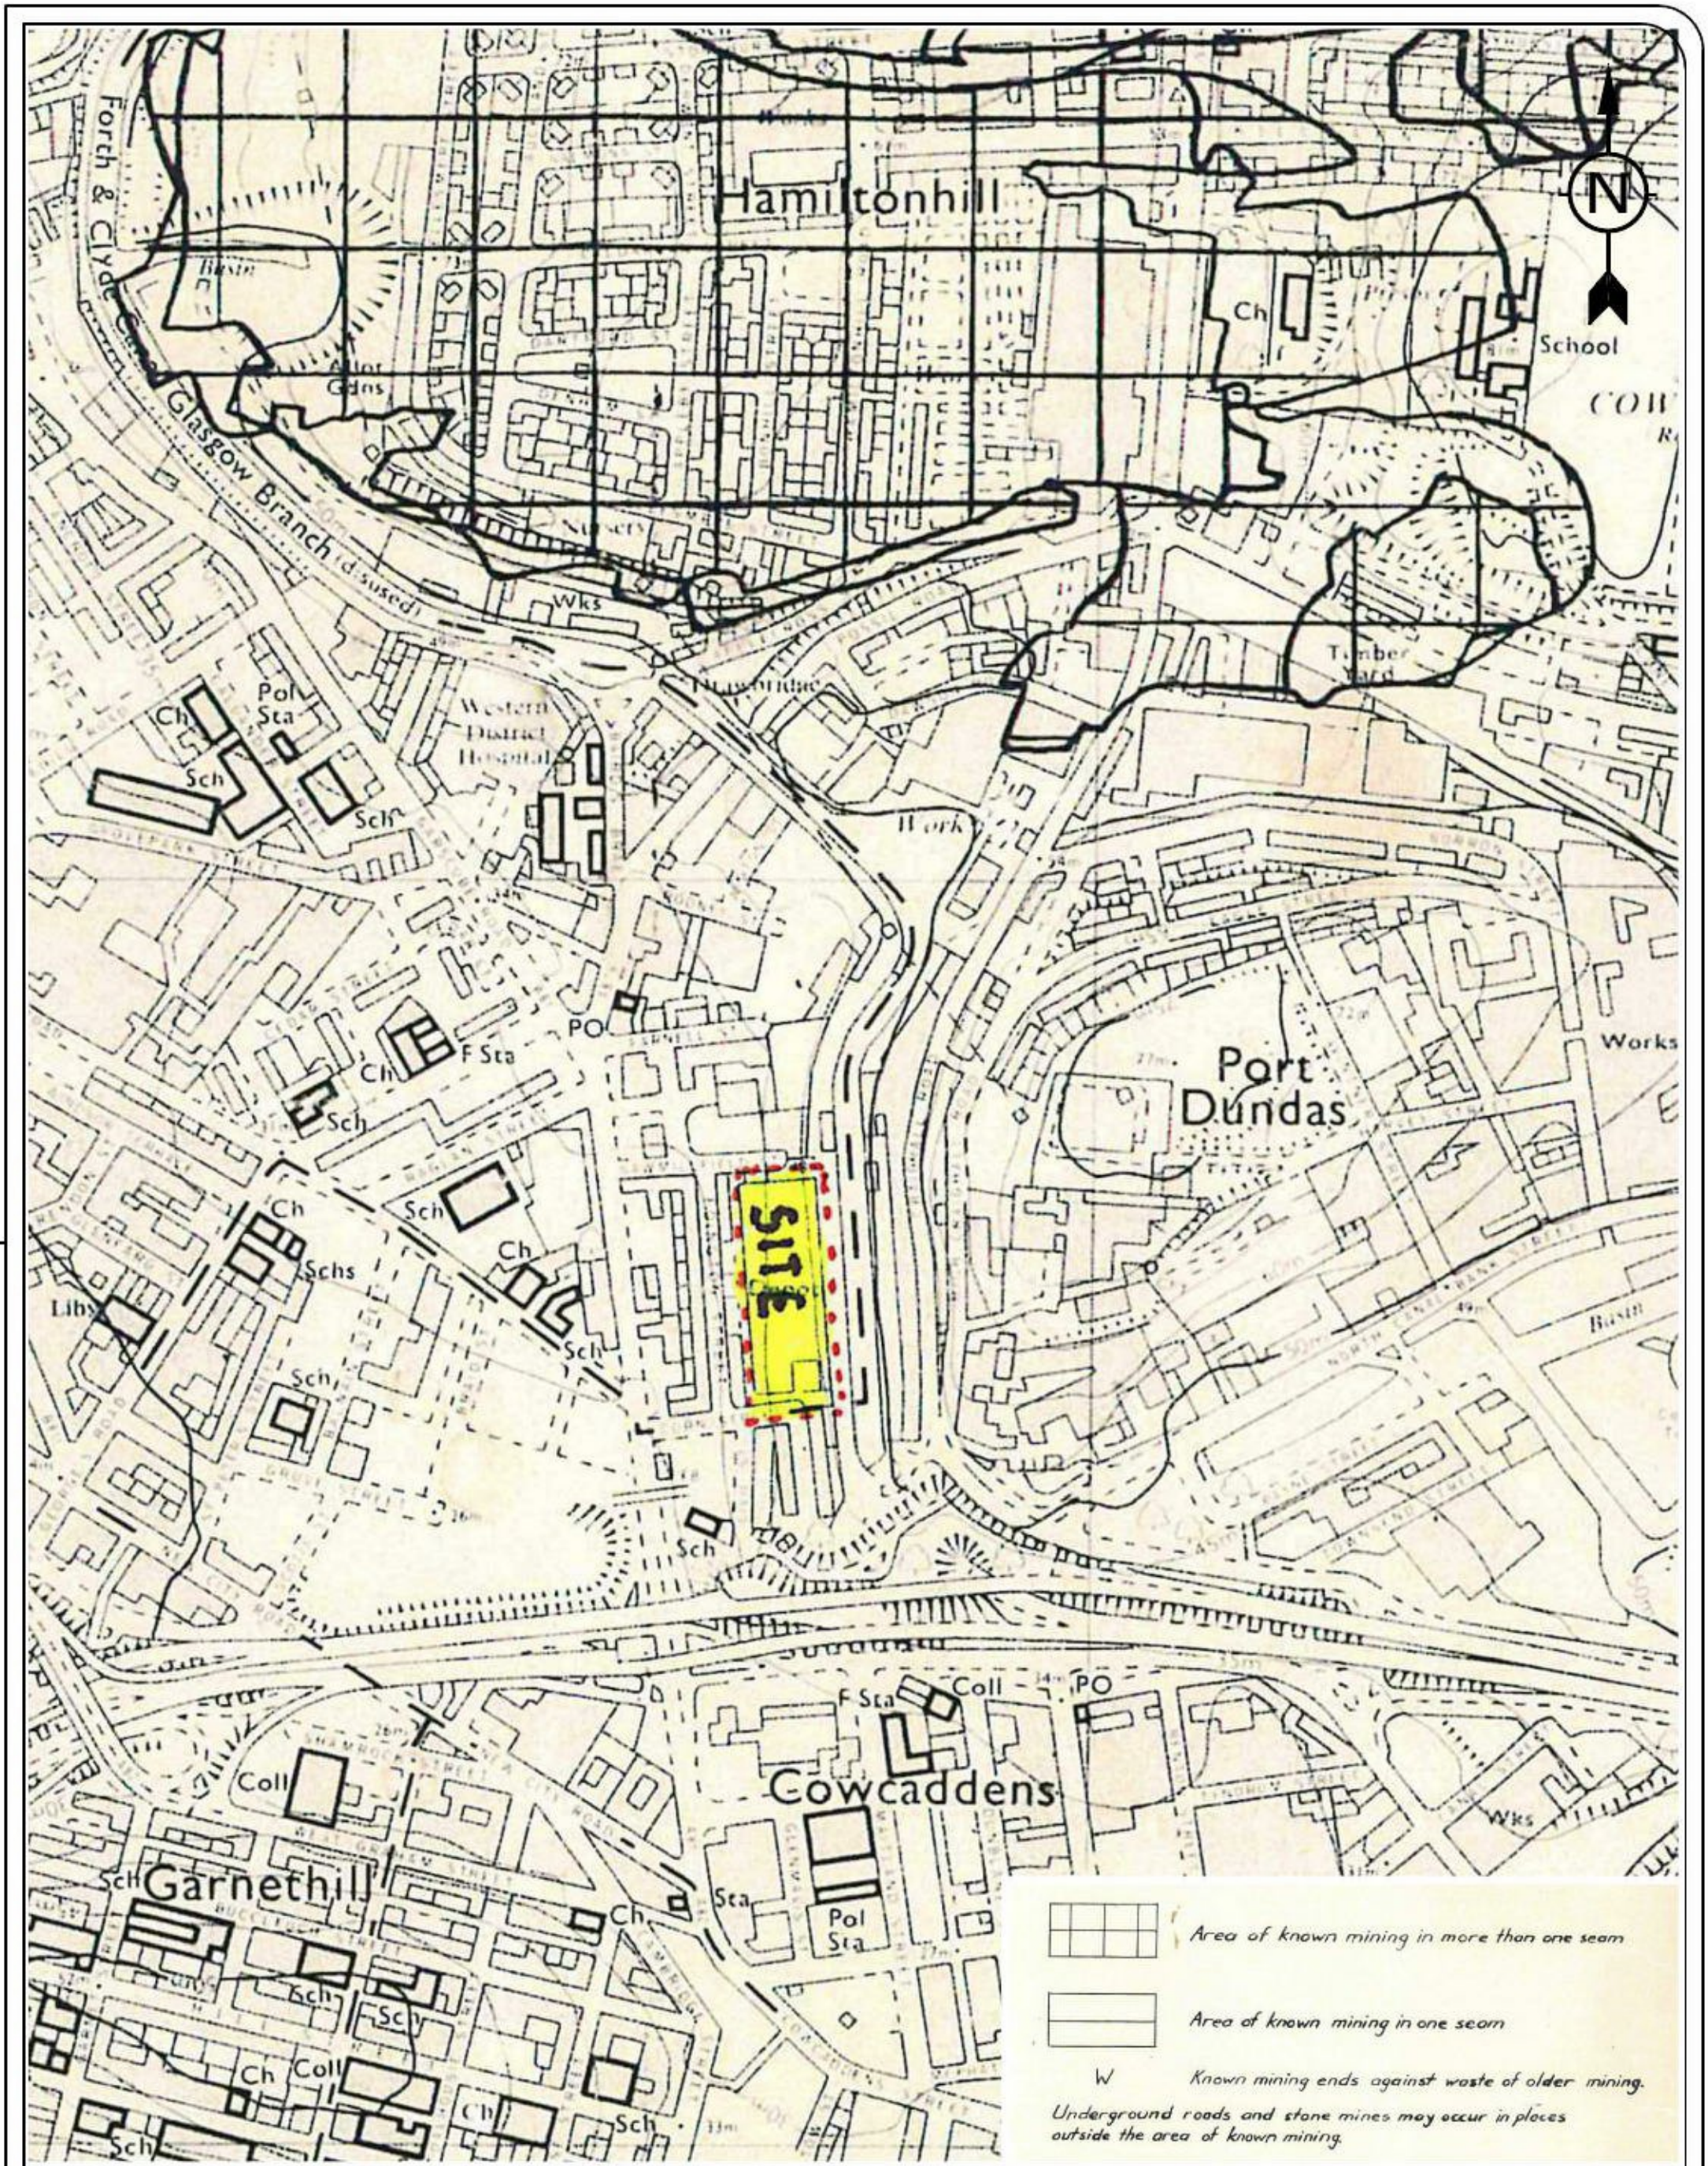
drawing no:
P22/271/DS/R/F/08

- 4.4.2 A site-specific Consultants Coal Authority Report (included in Appendix D) stated that there are no records of any past underground mine workings below the site. This is consistent with the BGS mining maps (Drawing Nos. P22/271/DS/R/F/08 and 09) which did not indicate any known records of mining to exist below the site.

- 4.4.3 Importantly however, The Coal Authority did indicate that there was a potential for unrecorded workings at shallow depth (i.e. < 30 m depth) below the site. We consider that any shallow mineral extraction would be associated with The Upper Possil Ironstone or Garscube Wee Coal (0.80 m thick), the Batchie Ironstone or Coal (up to 0.70 m thick) and/or the Upper Possil / Davy Coal (0.70 m thick) which were indicated to exist below the site at shallow depths.

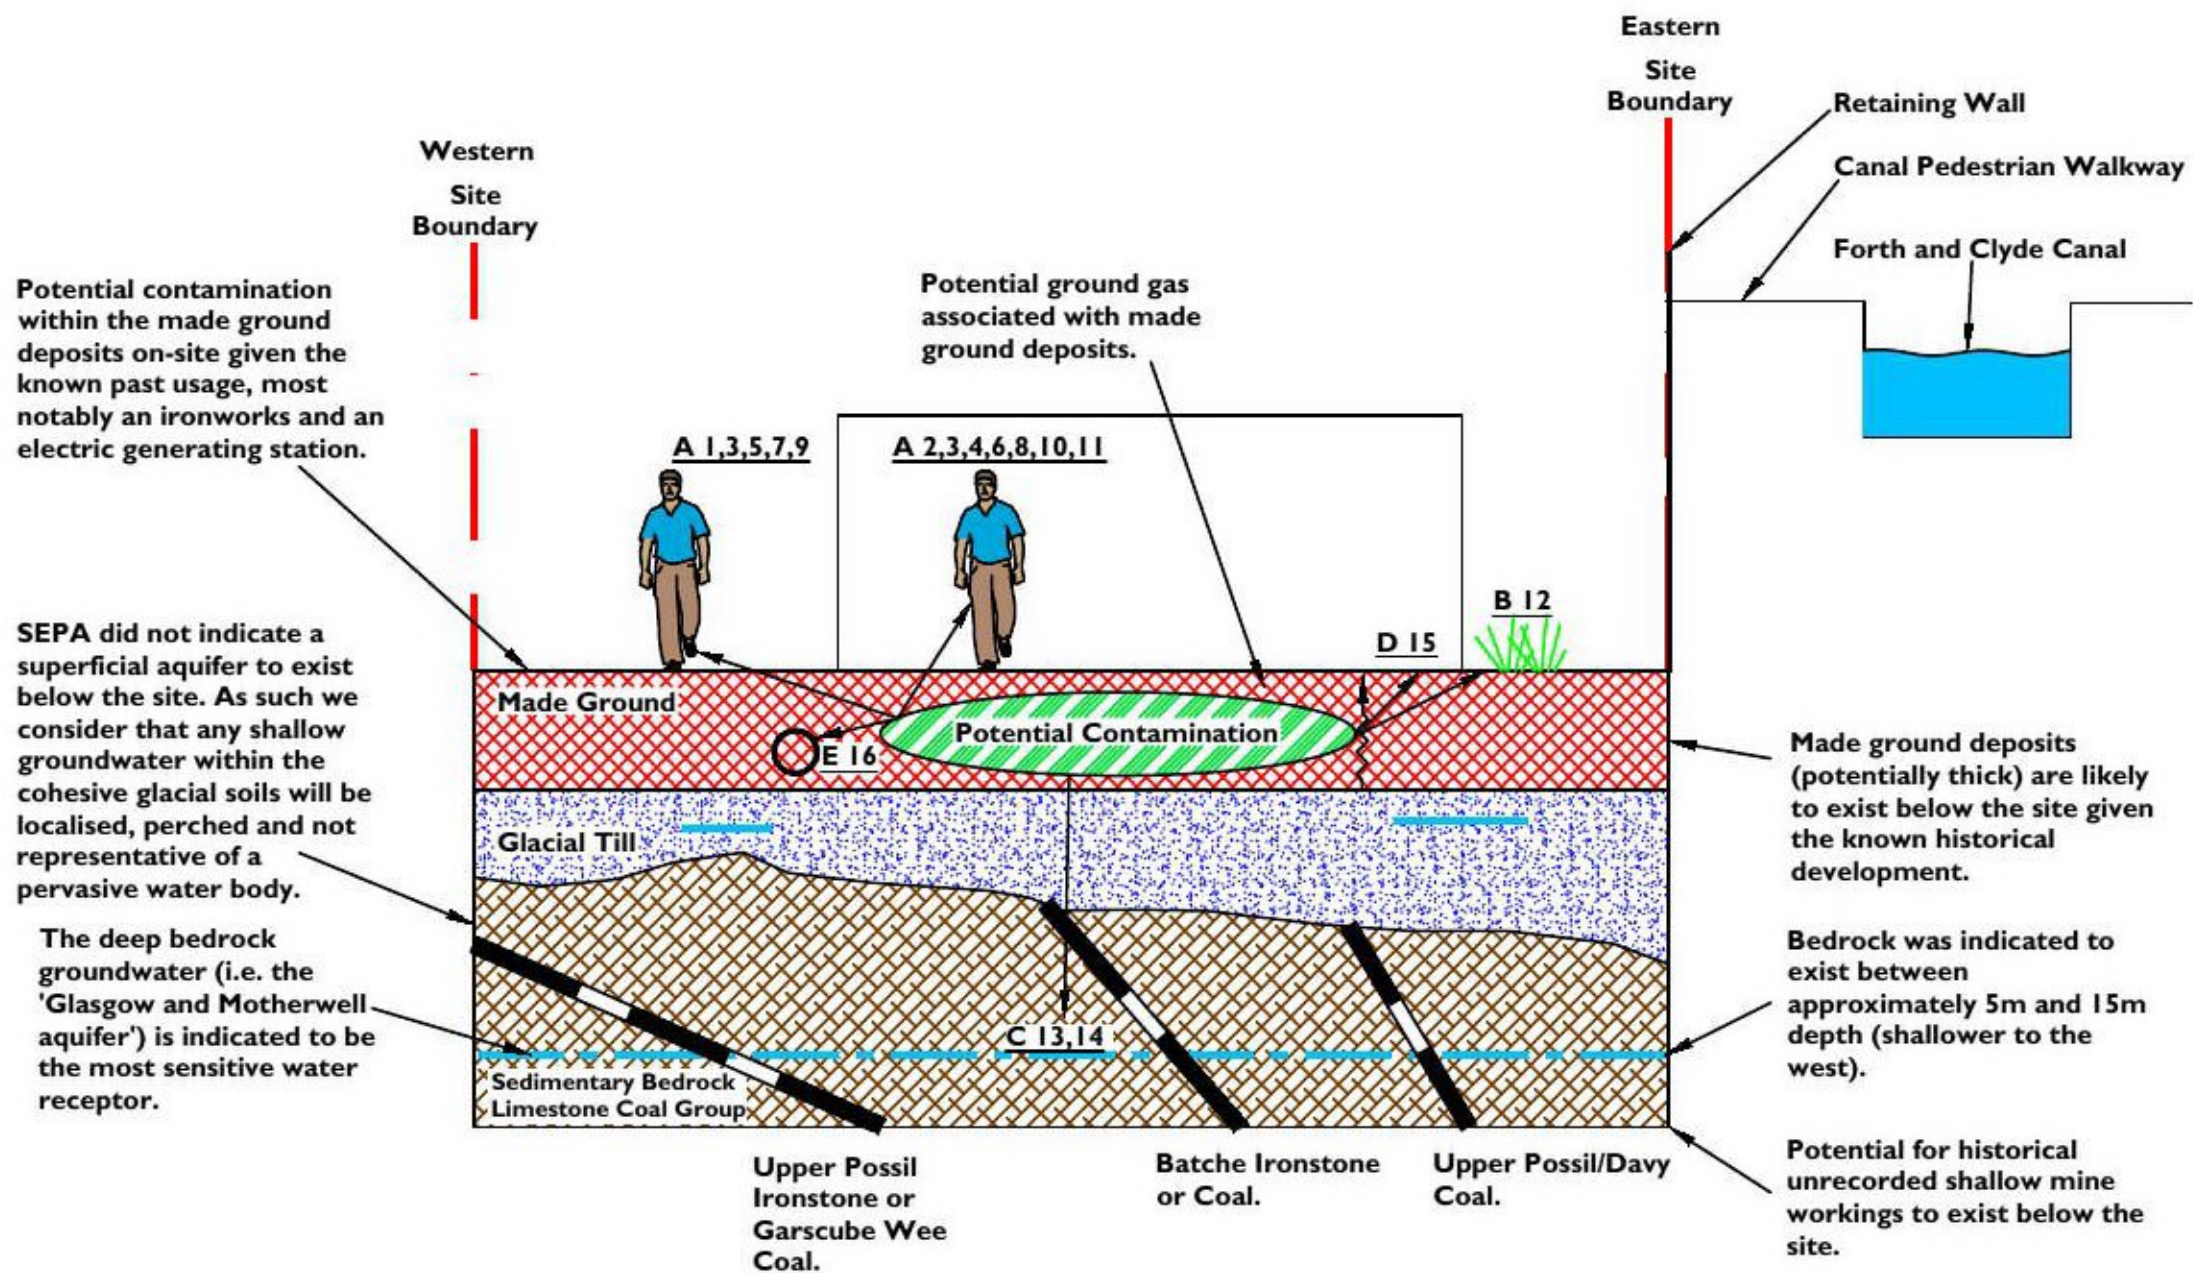
5.5.2 On the basis of the above, a qualitative risk assessment is described in Table 06 below and the potential source-pathway-receptor relationships identified at the site, based on the preliminary qualitative risk assessment, are summarised in Drawing No. P22/271/DS/R/F/10 - Preliminary Conceptual Site Model (CSM).

- Made ground (containing toxic/phytotoxic contaminants and acting as a source of ground gas).
- Mine workings (acting as a source of mine gas).

- An invasive plant species survey is to be undertaken once access into vegetated areas is made possible.

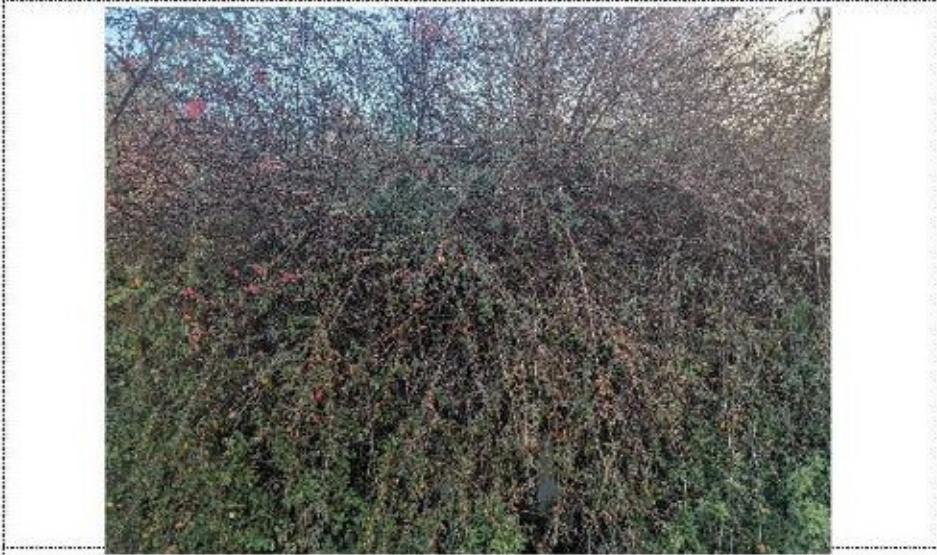
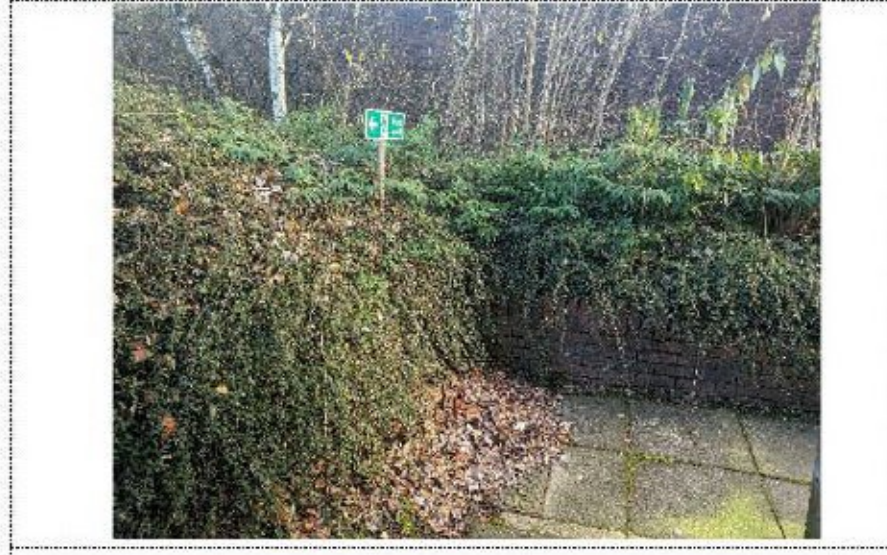
CT1 Cotoneaster

Cotoneaster is controlled by legislation in Scotland meaning that enforcement with 'clean up' orders can be put in place by regulatory bodies. This plant can be easily managed as part of a general vegetation clearance by following a few management rules. We recommend that a management programme is put in place and a sign-off for the works obtained.

We recommend that the developer/contractor agrees a suitable remediation strategy with a specialist contractor prior to commencing works on site.

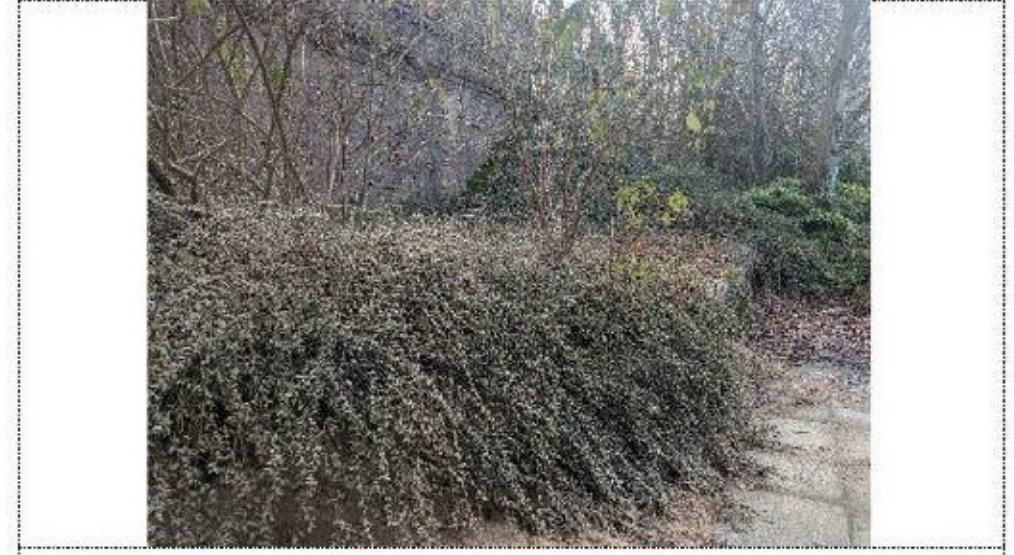
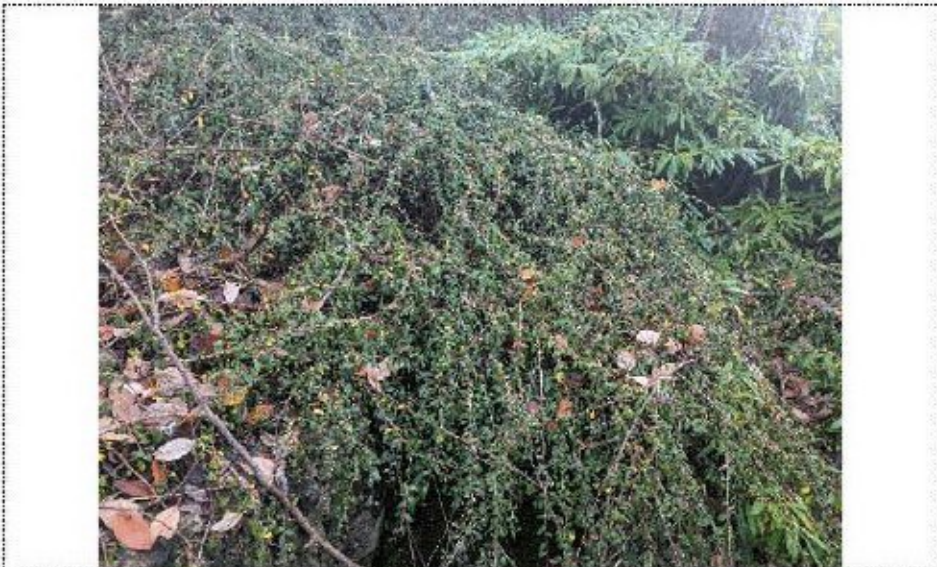
CT2 Cotoneaster

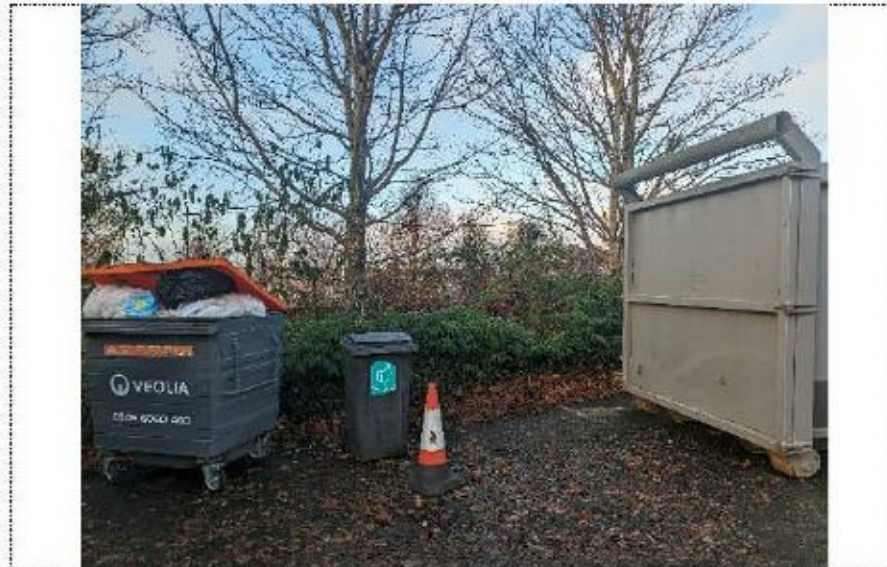
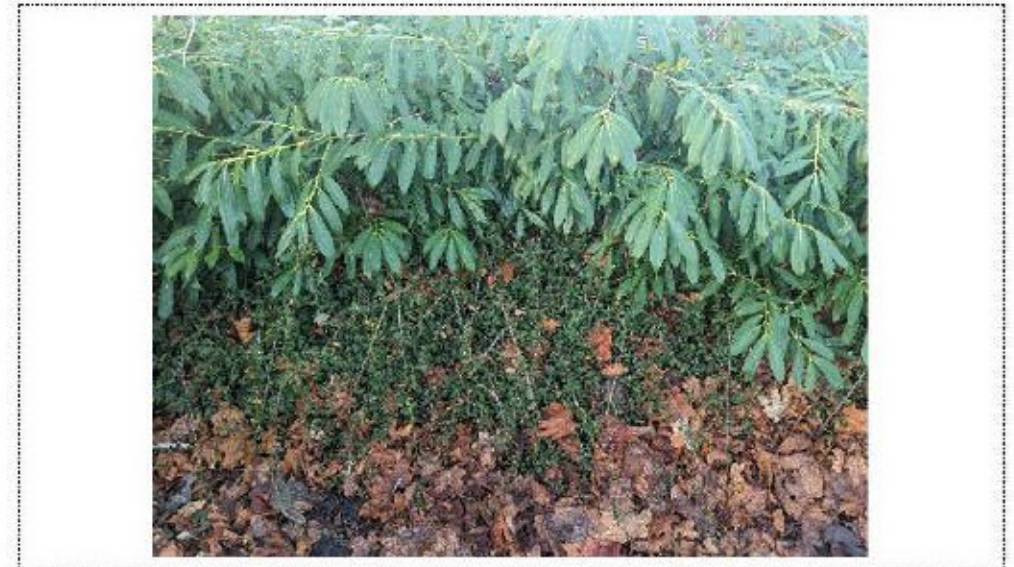
CT3 Cotoneaster

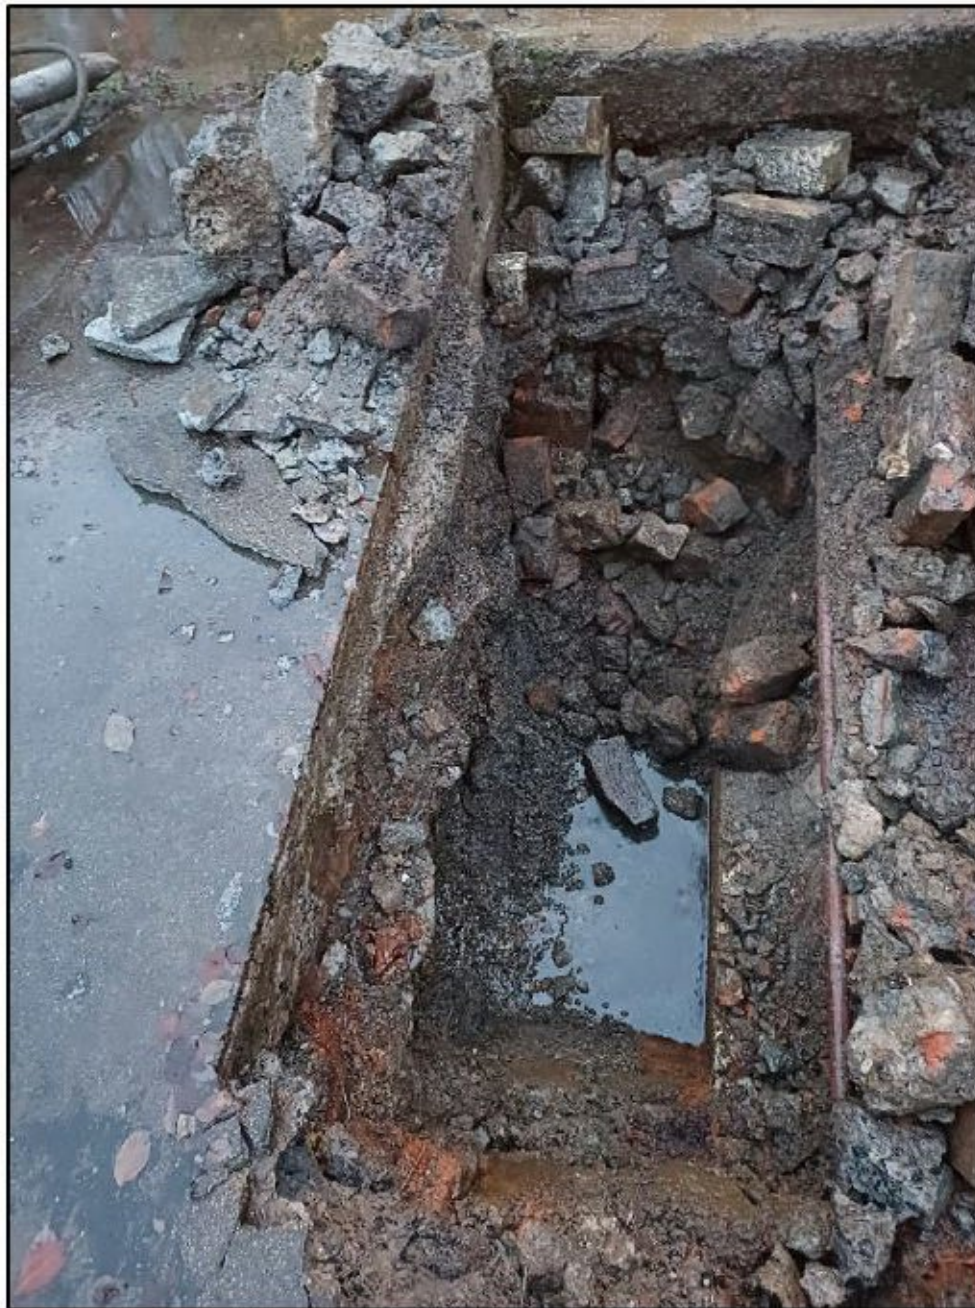
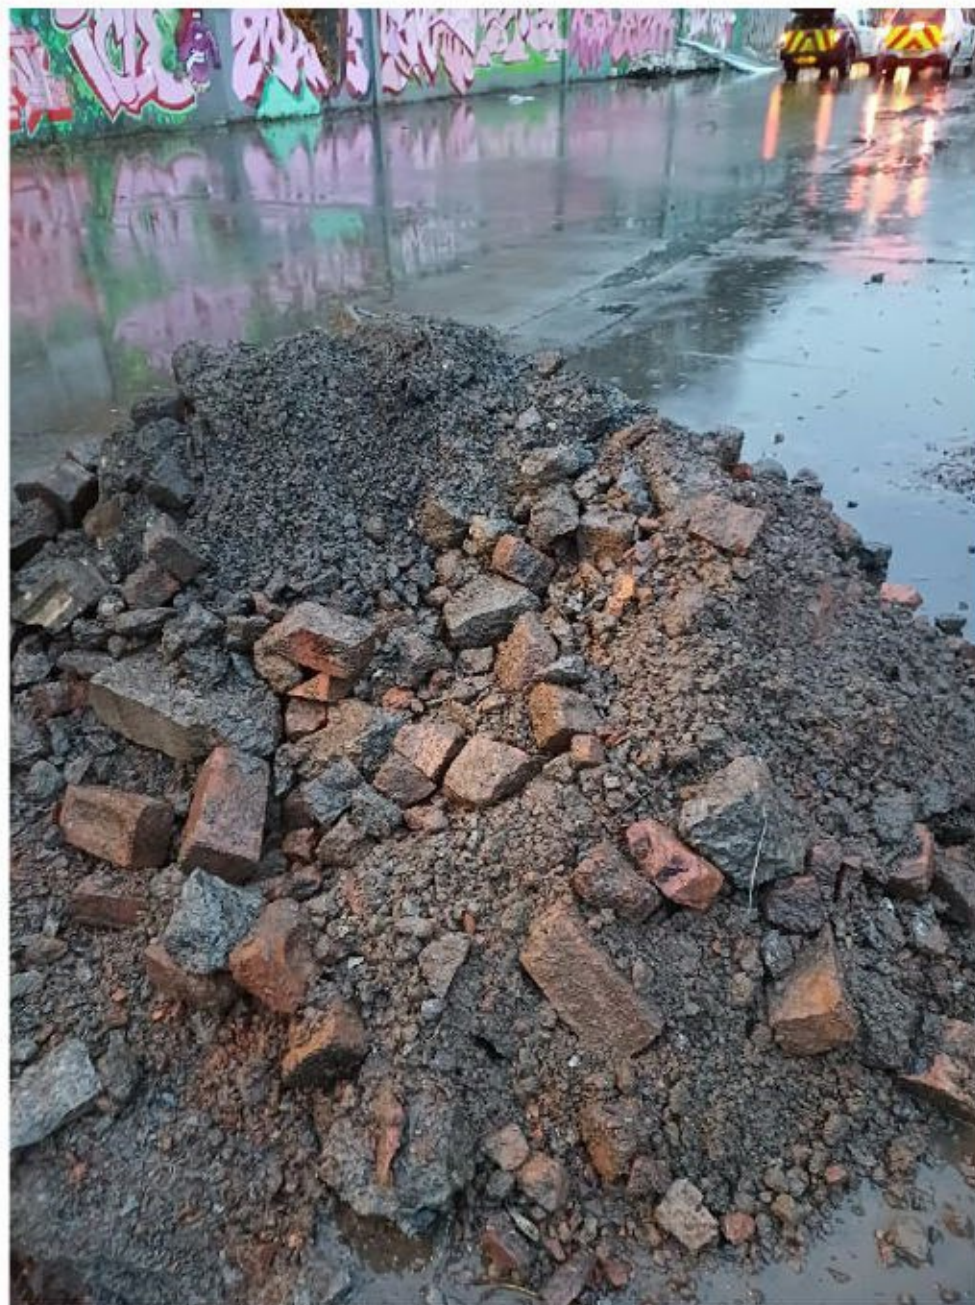
TP01

Depth	Sample/Tests	Water Depth (m)	Field Records	Level (mOD)	Depth (m) (Thickness)	DESCRIPTION	Legend
				40.13	(0.20) 0.20	Concrete with rebar.	
0.40	TJ				(1.40)	MADE GROUND: Brown, medium dense sand and gravel with rounded to sub angular cobbles and gravels with frequent broken red brick, ceramic and metal.	
1.50	TJ			38.73	1.60

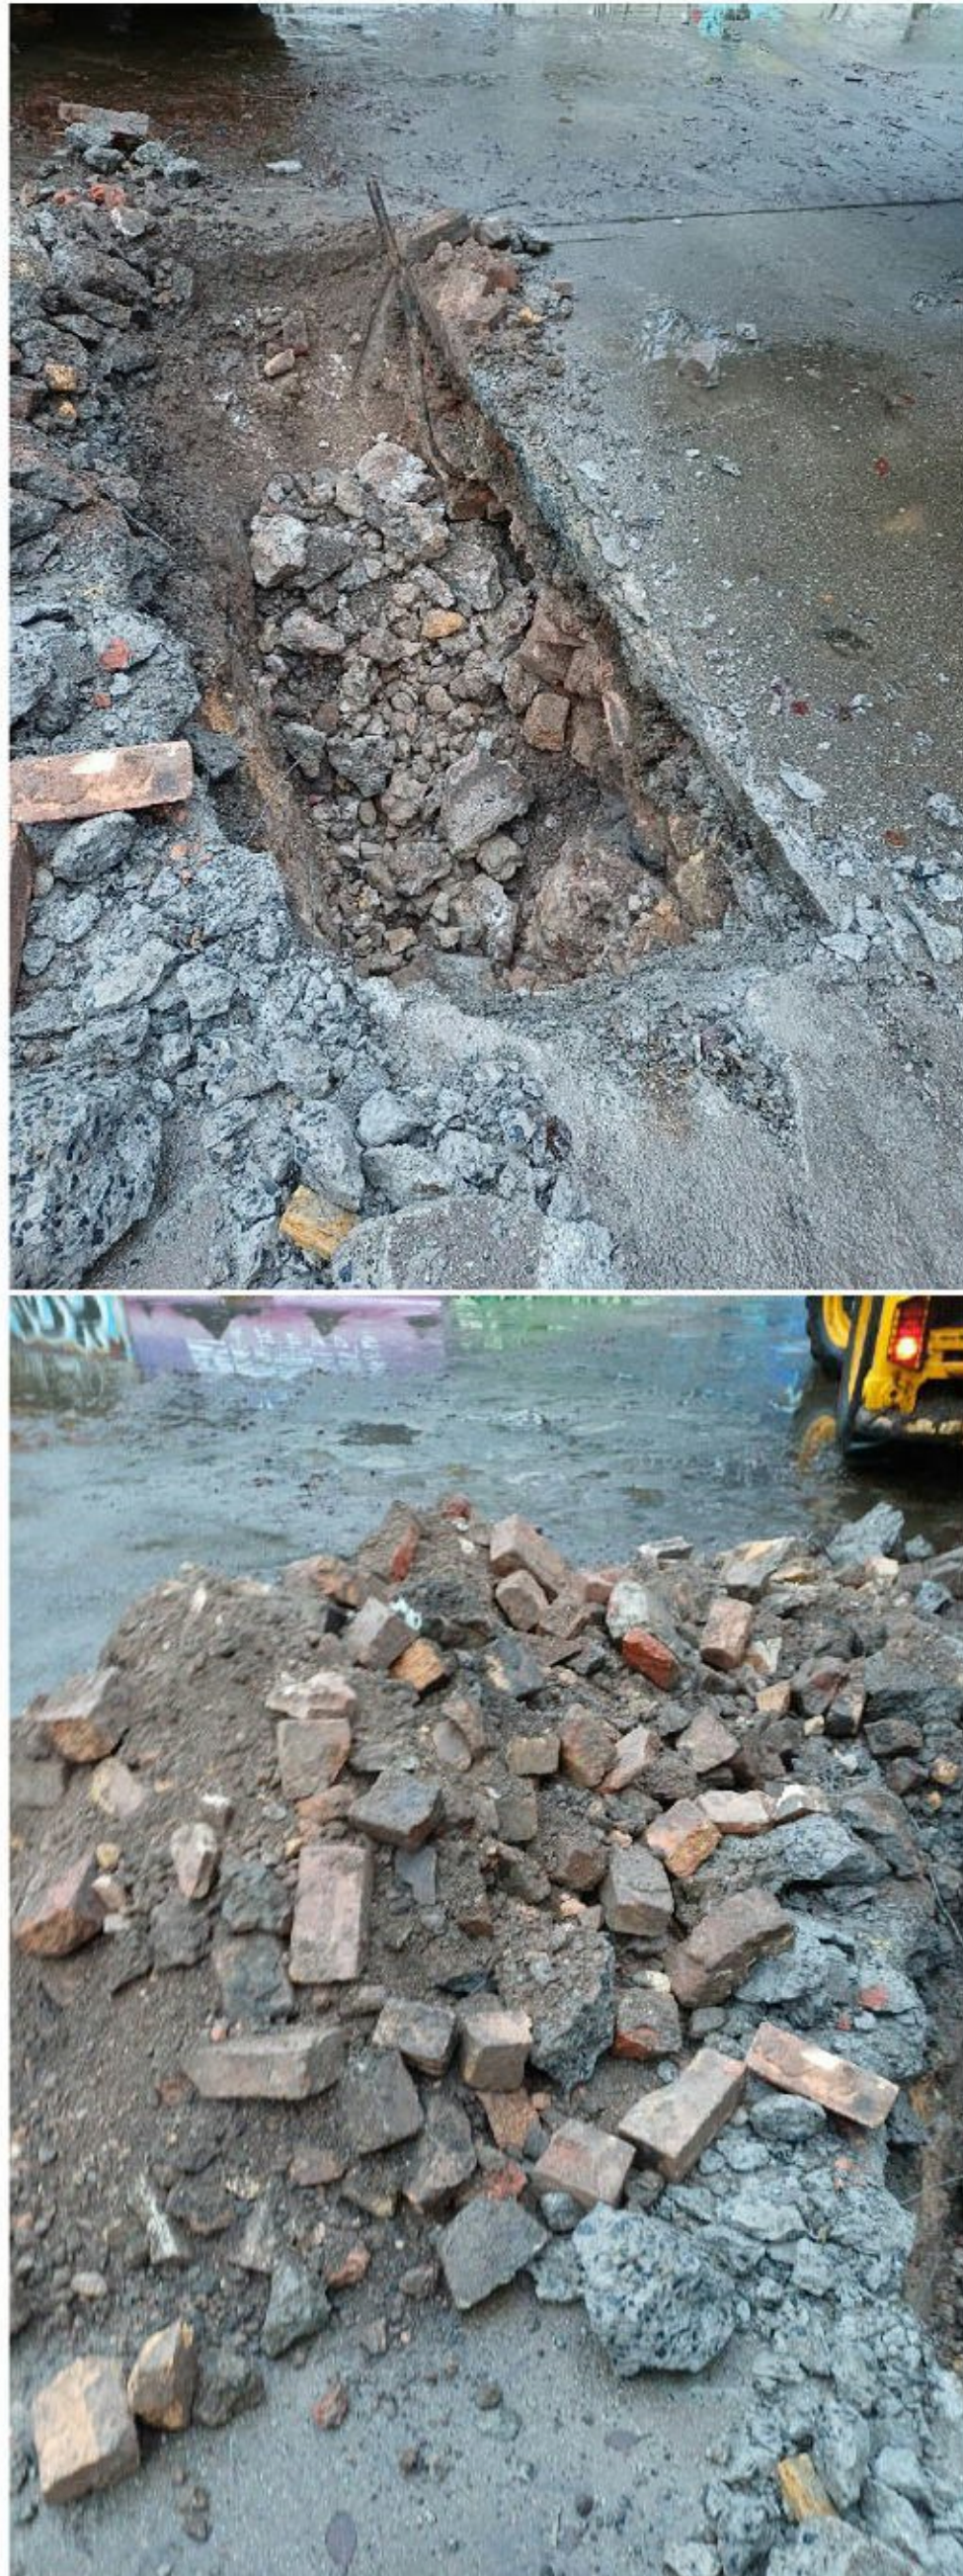
TP01A

Depth	Sample/Tests	Water Depth (m)	Field Records	Level (mOD)	Depth (m) (Thickness)	DESCRIPTION	Legend
0.40	TJ			40.19	(0.20) 0.20	Concrete (Tarmac) with rebar.	
				39.39	(0.80) 1.00	MADE GROUND: Brown, fine to coarse sand and gravel with broken red brick, intact bricks, metal and ceramic fragments.	
1.50	TJ			38.79	(0.60) 1.60	MADE GROUND: Black, fine to coarse sand and gravel with metal and bricks.

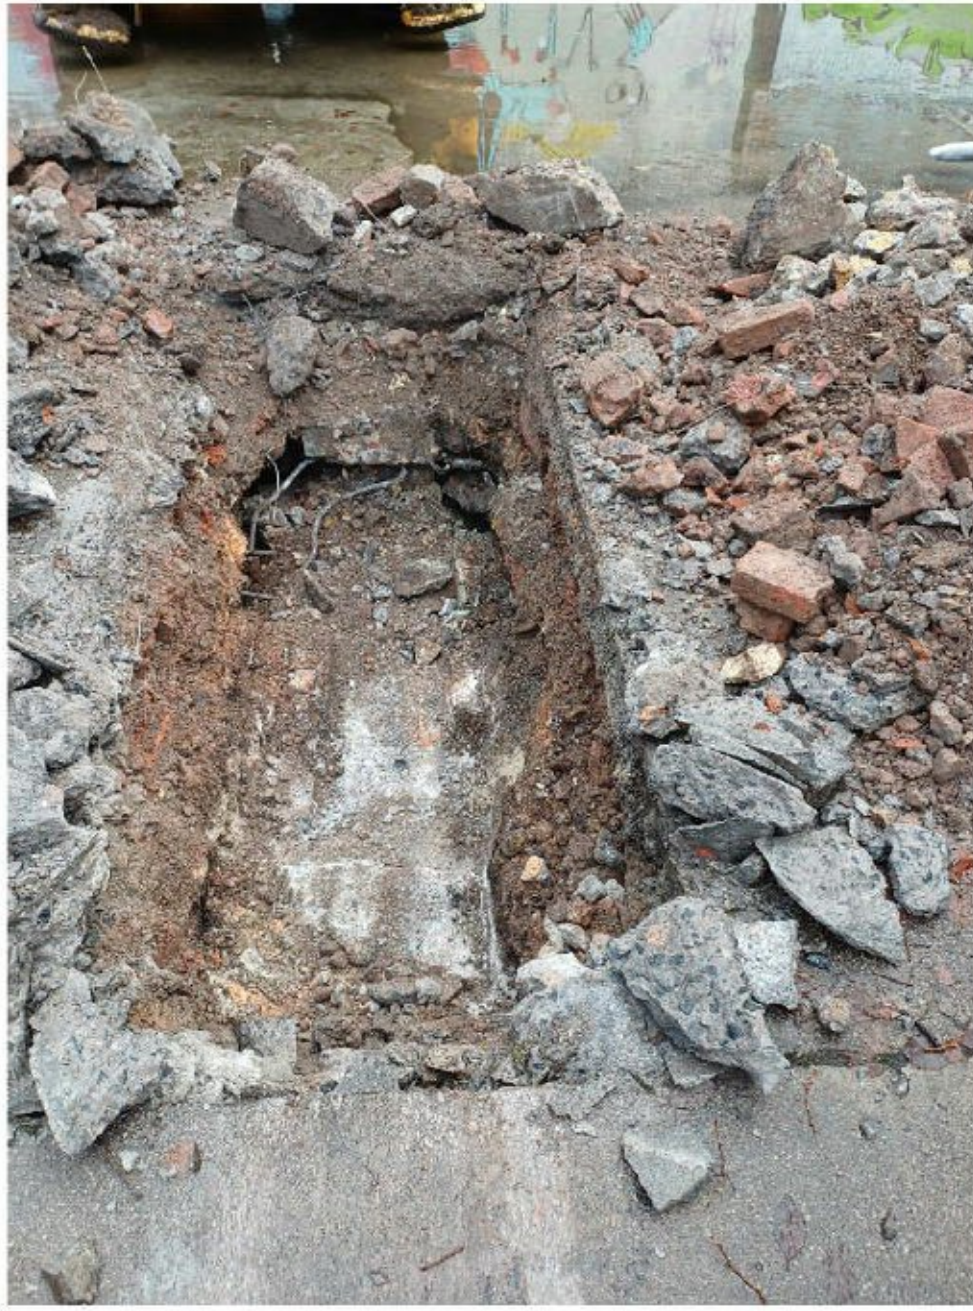
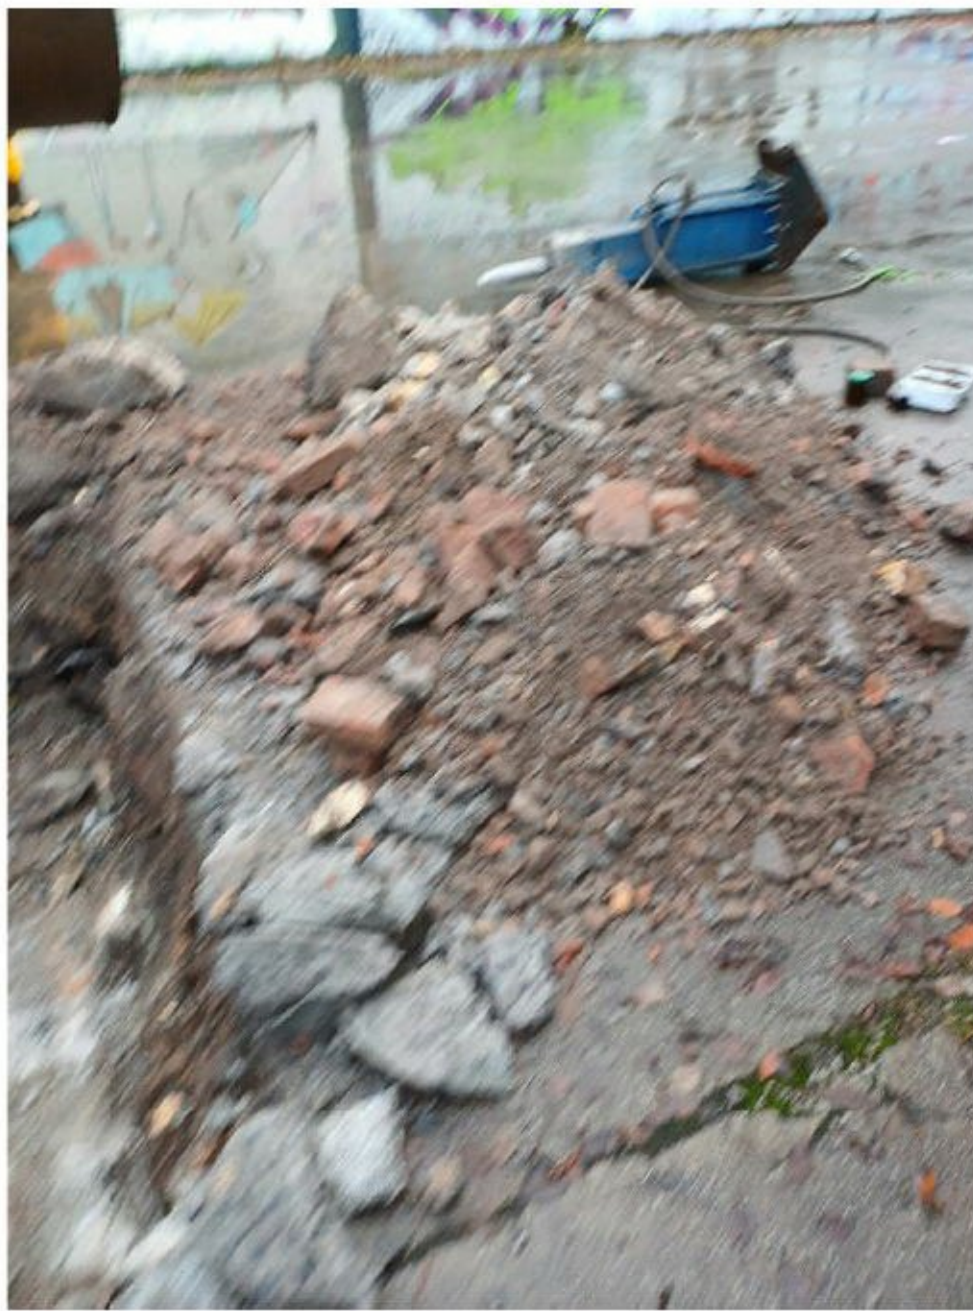
TP02

Depth	Sample/Tests	Water Depth (m)	Field Records	Level (mOD)	Depth (m) (Thickness)	DESCRIPTION	Legend
0.40	TJ			40.17	(0.20) 0.20	Concrete with rebar.	
				39.87	(0.30) 0.50	MADE GROUND: Brown, medium dense sand and gravel with rounded to sub-angular cobbles and gravels with frequent red brick.	
					(1.00)	MADE GROUND: Black, slightly clayey, gravelly sand with some sub rounded cobbles with plastic, metal and bricks.	
				38.87	1.50	MADE GROUND: Brown, fine sand with frequent broken red bricks.	
1.20	TJ						
2.20	TJ				(1.80)		
				37.07	3.30

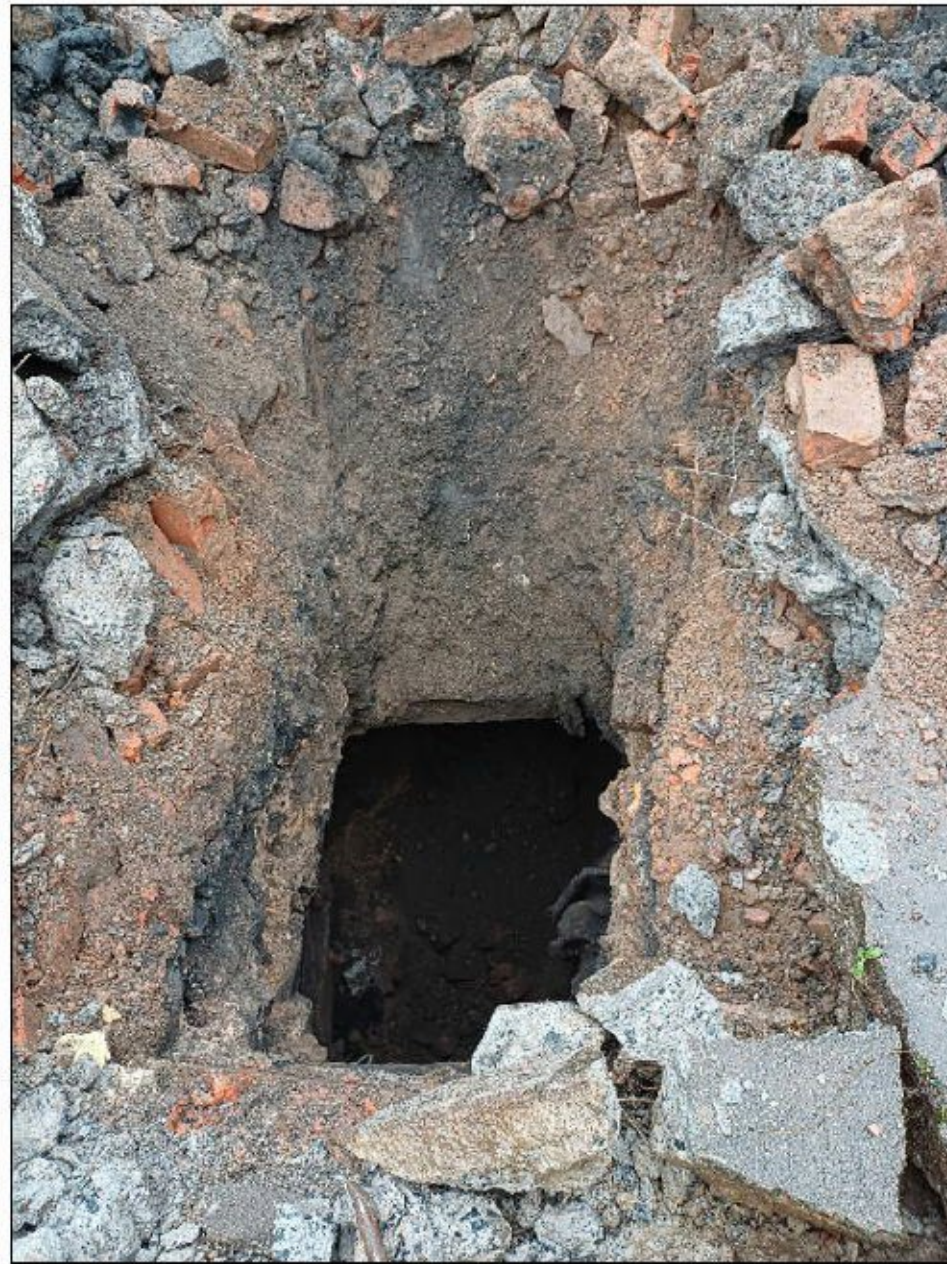
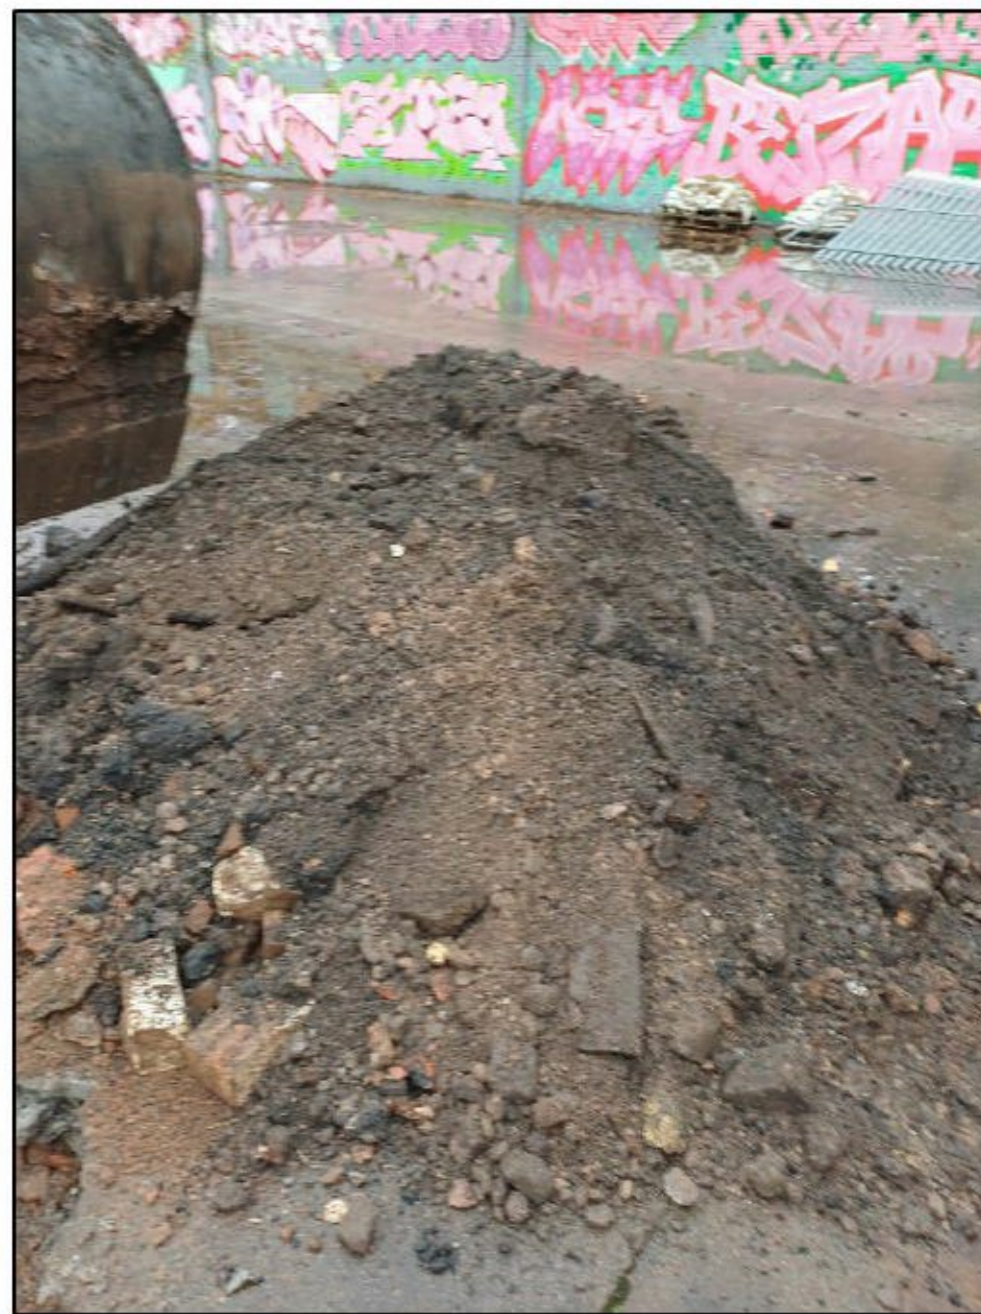
TP03

Depth	Sample/Tests	Water Depth (m)	Field Records	Level (mOD)	Depth (m) (Thickness)	DESCRIPTION	Legend
0.40	TJ			41.57	0.60	MADE GROUND: Brown, clayey, gravelly sand with some rounded cobbles and frequent broken red brick, intact bricks, timber and plastic.	
1.00	TJ				(1.40)	MADE GROUND: Loose, blackish brown, sand and gravel with rounded to sub angular cobbles and gravels with ceramic, broken red brick and plastic.	
1.50	TJ			40.17	2.00
